DANISH MARITIME ACCIDENT
INVESTIGATION BOARD

POLAR AASSIK

Summary report on fire

15. MARCH 2021

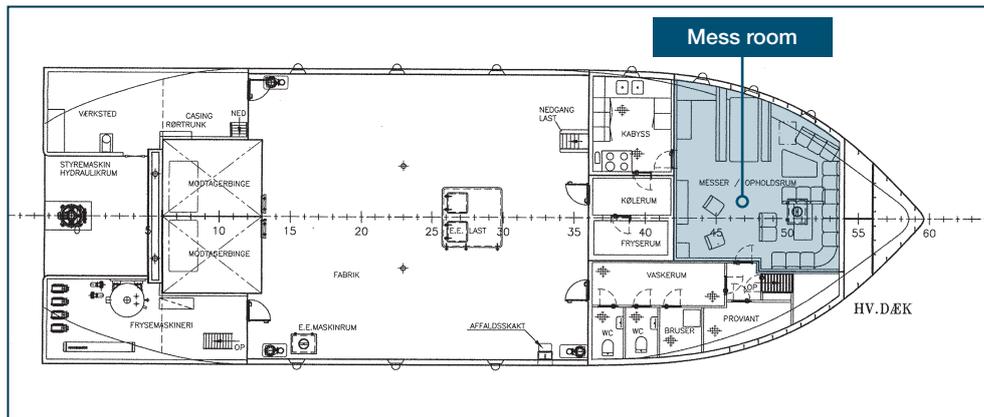
Figure 2: Mess room on POLAR AASSIK
Source: Polar Seafood/DMAIB

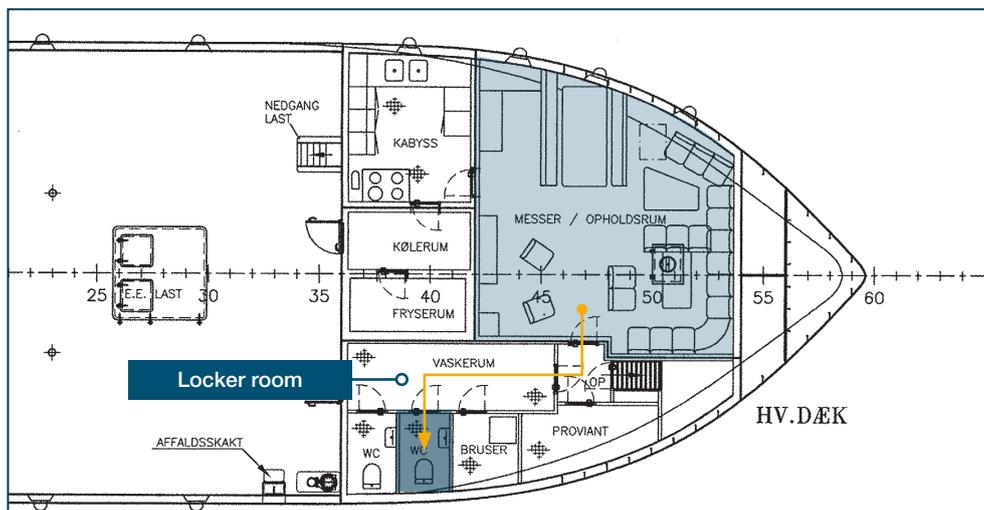
Figure 3: Toilet room and access from the mess on POLAR AASSIK
Source: Polar Seafood/DMAIB

The investigation found that the origin of the fire was in the toilet room by the locker room. There were several possible sources of ignition in the toilet room, but the most likely source of ignition was a heat blower, aimed to keep the room frost free. As the accident investigation board was unable to carry out the technical fire investigation on board, the circumstances surrounding the spread of the fire could not be clarified. On the basis of the information gathered, it could be established that the fire quickly spread upwards and forwards in the ship (Figure 4). The spread of the fire spanned 48 hours, until the ship sank.

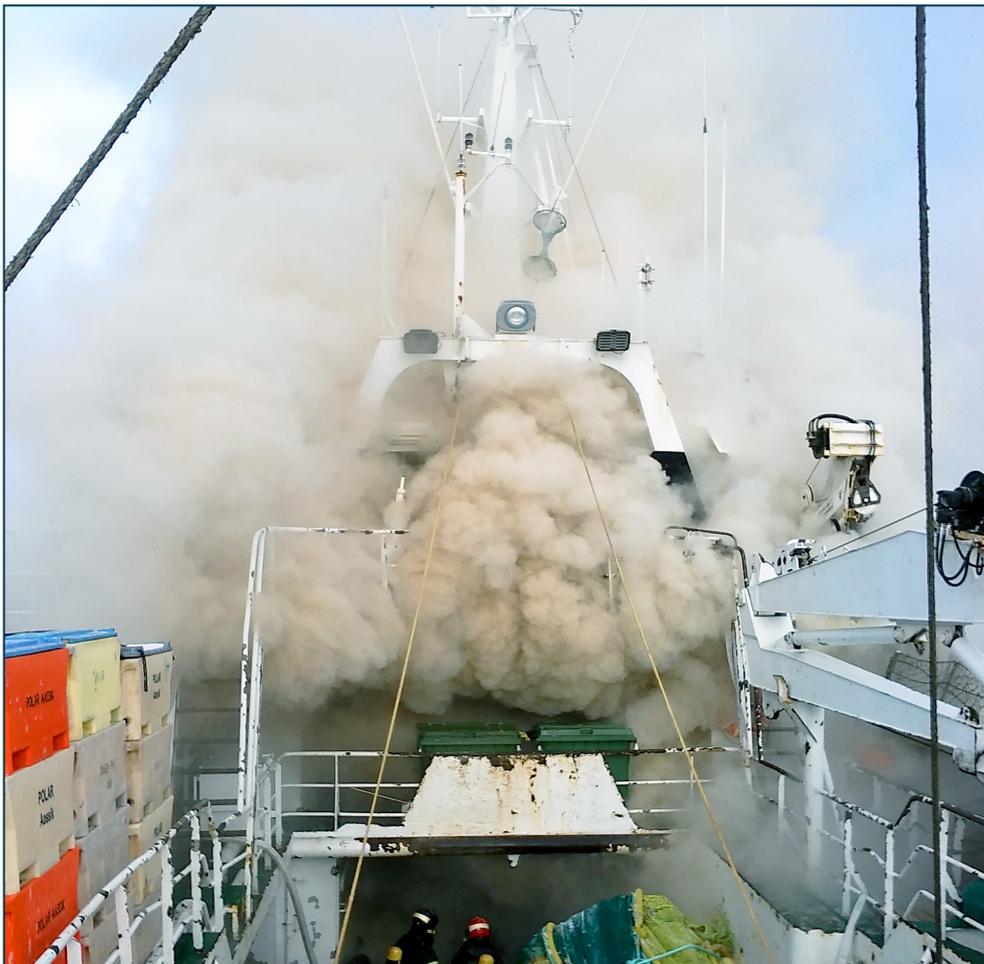
Figure 4: Firefighters on POLAR AASSIK
Source: Private photo

- The handling of the pressurised fire hoses and hose couplings down through the accommodation with its narrow corridors, sharp corners, door thresholds and frames was central to the firefighter teams running out of air before reaching the fire.

- The ship was equipped with two breathing apparatuses with no possibility of refilling the air bottles. This meant that the crew had only one attempt to gain control of the fire. When it failed, the crew had no option but to leave the ship or to obtain assistance for fighting the fire. In addition, there was no possibility for the ship's remaining crew members to come to the rescue of the firefighters, should problems arise.
- The ship's crew were not experienced firefighters, and periodic fire drills were not common practice on board. The above issues were thus not recognised before the fire, which evoked an uncertainty in the onboard firefighters, reinforced by the fact that they were not able to communicate effectively with one another.

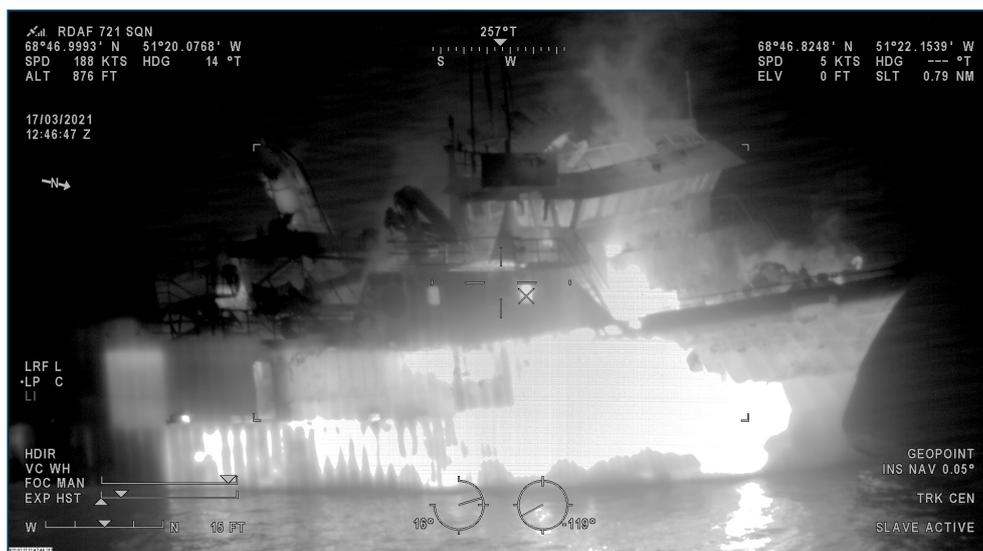
Source: Joint Arctic Command

Figure 5: POLAR AASSIK on 17 March 2021, when the ship sank

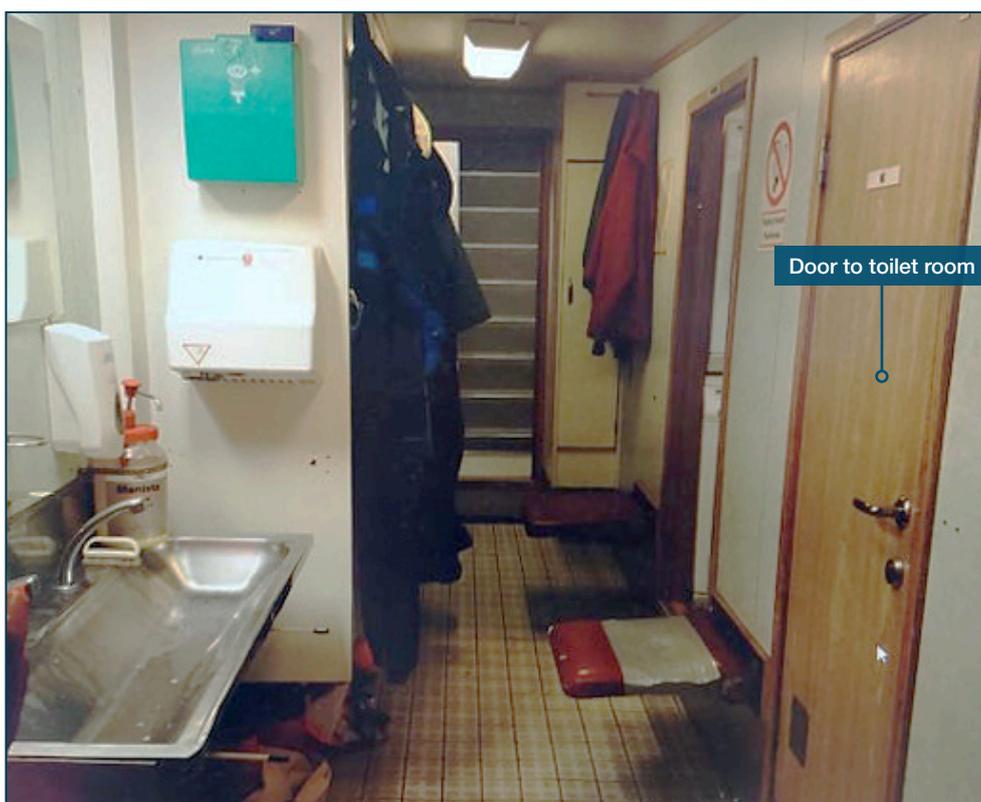
When the 2nd engineer opened the door to the toilet room (Figure 5), he was met with thick black smoke, but he saw no flames and there was no noticeable heat development. He thus assessed it to be a small fire that could be extinguished with a CO₂ fire extinguisher. POLAR AASSIK was characterised by small spaces and narrow corridors that quickly became smoke-filled. At the same time, there were materials in the toilet room that could develop large amounts of black smoke in a short time. In the minutes while the 2nd engineer fetched the CO₂ fire extinguisher, the locker room became smoke-filled, rendering it impossible to initiate an effective response to the fire.

Figure 6: Locker room and door to toilet room
Source: Polar Seafood
