DANISH MARITIME ACCIDENT
INVESTIGATION BOARD

BUSTER & STAVFJORD

Summary report on collision

SUMMARY REPORT ON COLLISION BETWEEN BUSTER AND STAVFJORD ON 16 MAY 2021

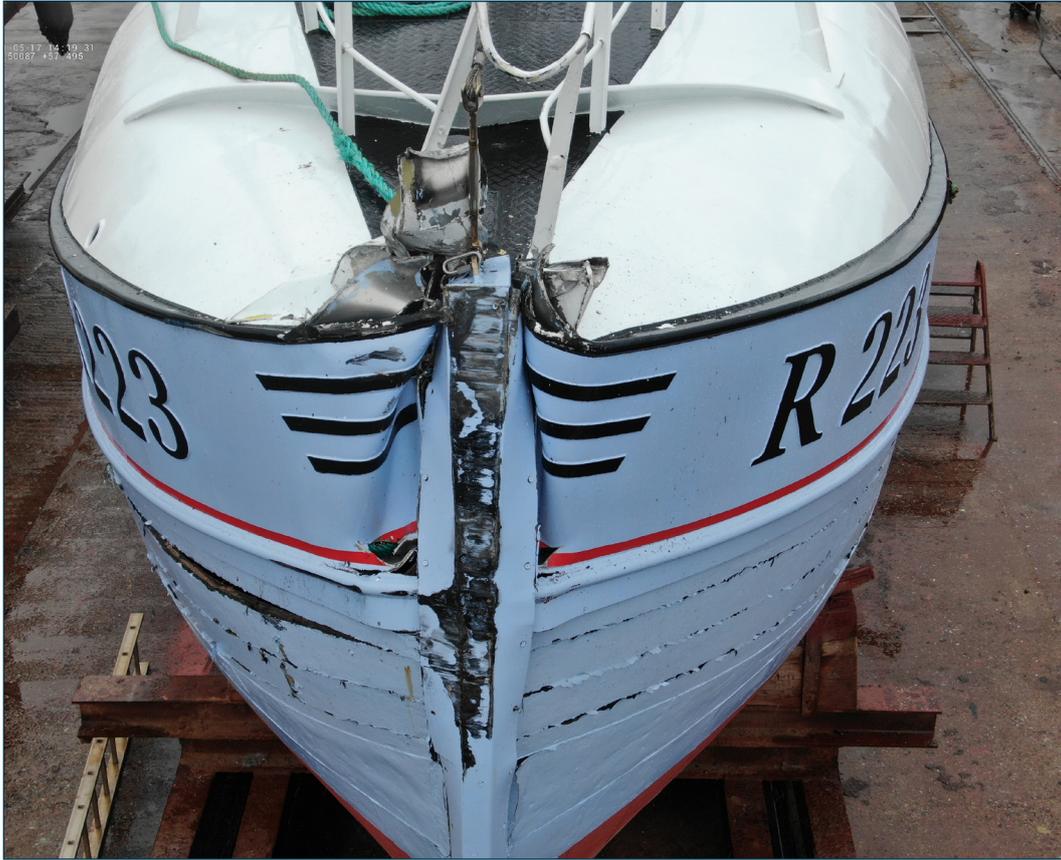
At the shipyard, it was determined that BUSTER's bow was severely damaged (figure 4, next page).

Figure 4: Damages on BUSTER's bow.
Source: DMAIB

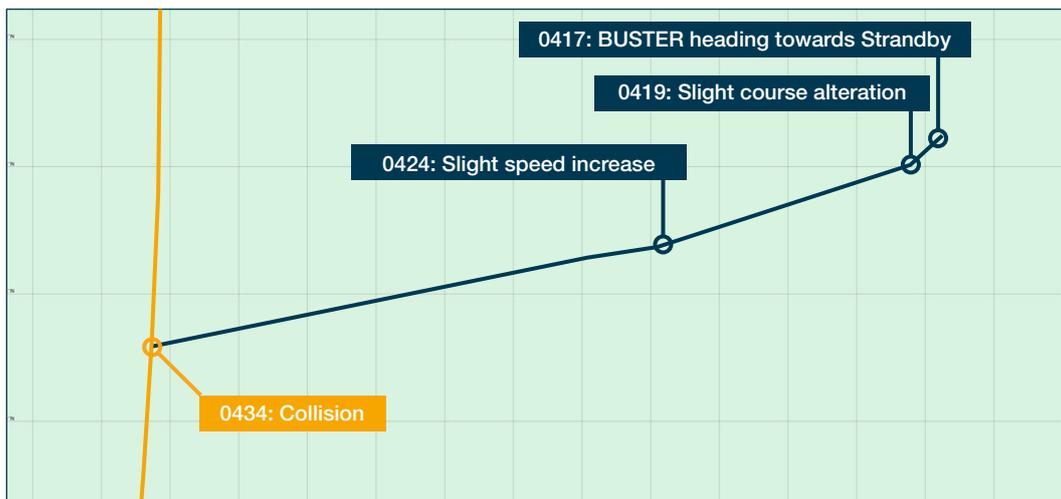
AIS data shows that BUSTER was proceeding at low speeds and varying courses (NNE-NE) from 0336-0413 on the morning of 16 May 2021. At 0417, the course was altered to a steady southwesterly course (233°), and the speed was increased to approx. 6 knots. At this point the ship was heading for port. At 0419, the heading was changed to 248°, resulting in a course over ground of 252°. At 0424, BUSTER's speed increased to 7 knots and was steady until the collision at 0434. The speed increase at 0424 is the last navigational adjustment according to AIS data. There is, however, no AIS information between 0419 and 0424, and hence the speed increase might have been initiated earlier than 0424. Figure 6 presents an overview of BUSTER's changing courses prior to the collision.

Based on AIS and interview data, DMAIB estimates that the conning station on BUSTER was unattended for a minimum of 10 minutes prior to the collision.

Figure 6: BUSTER's sailed route prior to the collision
Source: Made Smart GroupBV 2021 @ C-Map AS 2021/ DMAIB

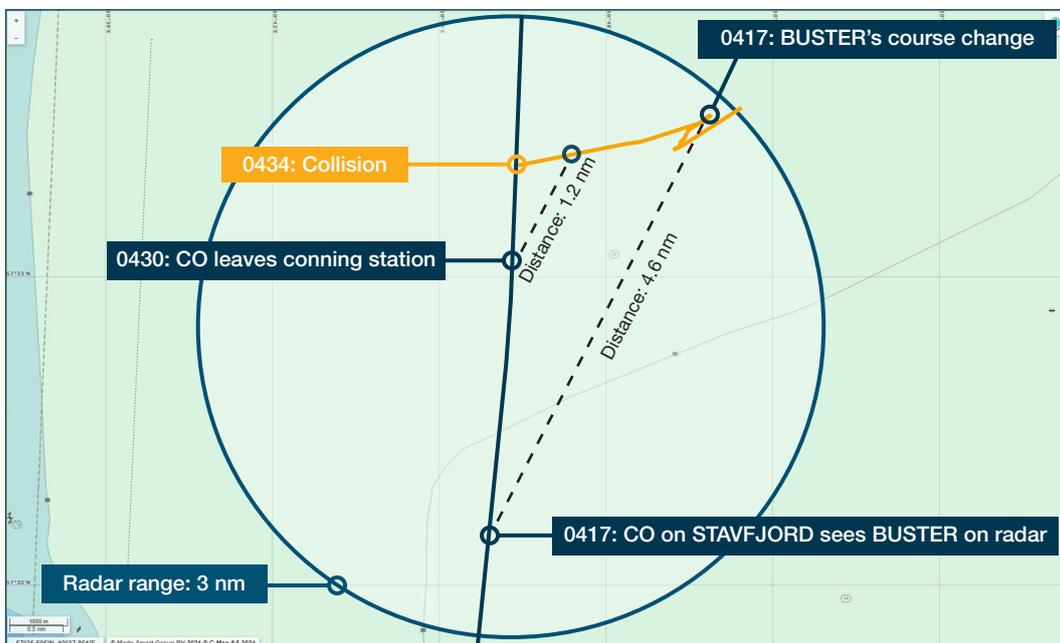
Analysis of AIS data shows that the bearing between STAVFJORD and BUSTER was unchanged from 0417 until the collision which is a clear indication that the ships were on crossing courses so as to involve risk of collision.

Based on an assessment of AIS information and witness accounts, DMAIB concludes that the chief officer did not verify BUSTER's CPA for 17 minutes prior to the collision, and that the conning station was unattended for 4 minutes prior to the collision because the chief officer was in the toilet room. An overview of the main events is presented on figure 7.

Figure 7: Distance and bearing at 0417 and 0430
Source: Made Smart GroupBV 2021 @ C-Map AS 2021/ DMAIB

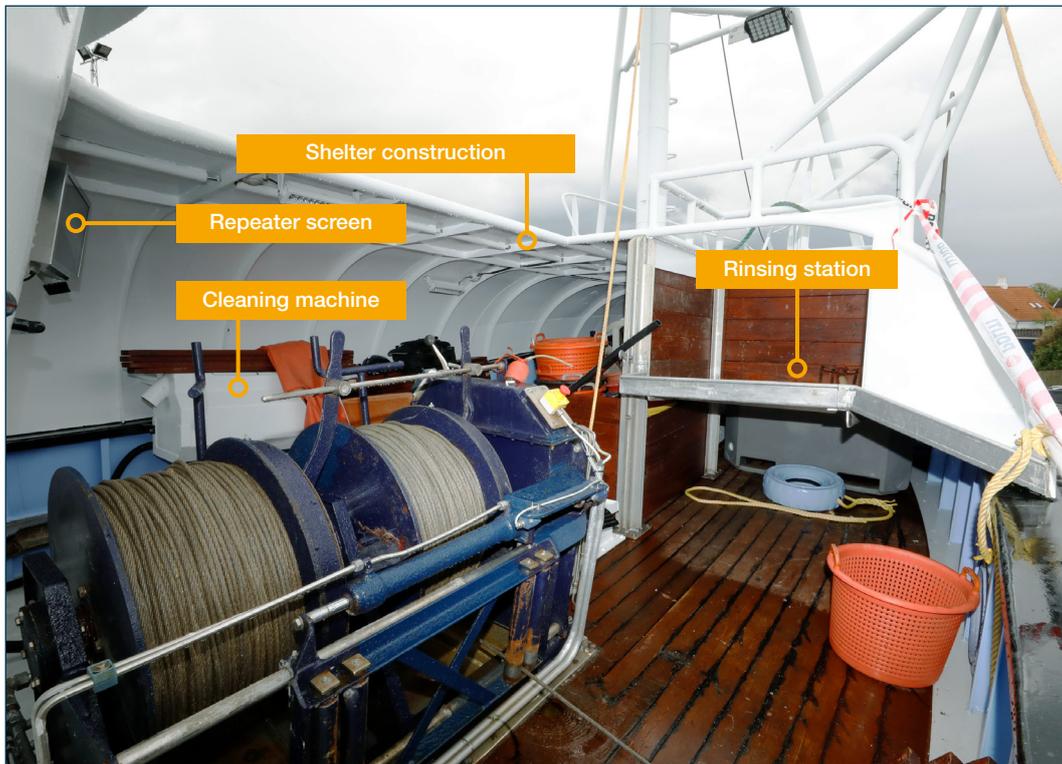
On deck, there was a rinsing station for cleaning the catch. When the skipper had rinsed enough langoustines to fill a basket, he carried them to the cleaning machine fitted on the port side. The deck was on port side enclosed by a shelter which made it impossible for the skipper to see oncoming ships from starboard side while working by the rinsing station and cleaning machine. Near the cleaning machine a chart plotter repeater screen integrated with automatic identification system (AIS) was fitted (figure 8, next page).

The skipper depended on the chart plotter repeater screen to monitor the traffic situation, though it only provided information about vessels equipped with an AIS transmitter. The skipper had established a work practise where he looked at the repeater screen each time he carried a basket of langoustines to the cleaning machine, which he usually did every 5 minutes. However, on the day of the collision, the catch was more difficult to clean, hence he did not monitor the repeater screen after he left the wheelhouse until the collision occurred.

Figure 8: Damages on BUSTER's bow.
Source: DMAIB
