STONE I

Marine accident report on loss of control

4 JANUARY 2020

The report is issued on 16 September 2020.

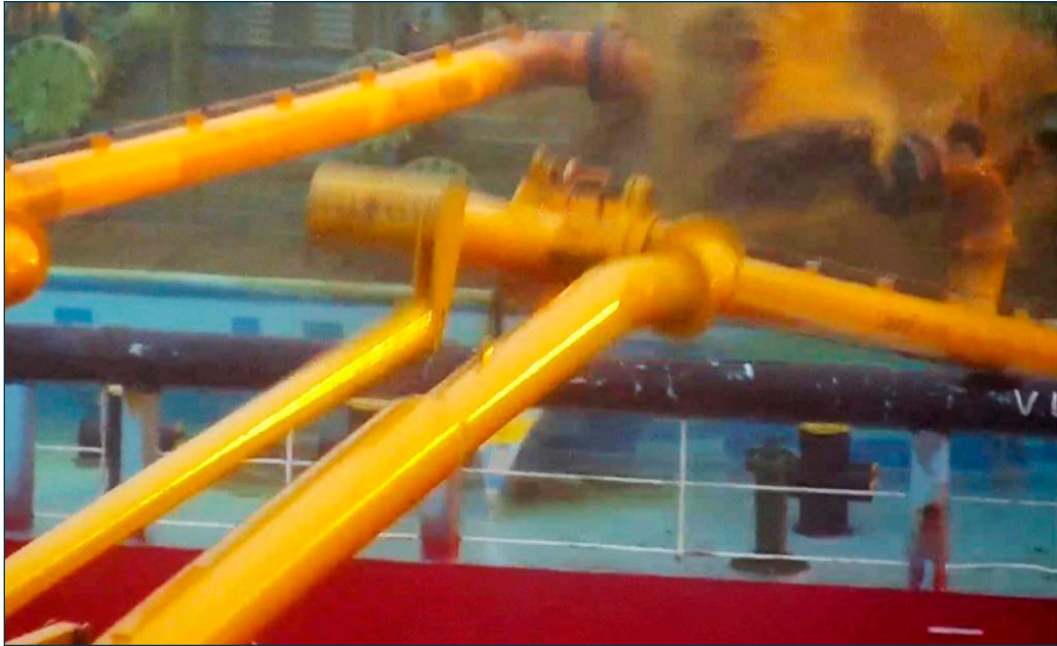
*Figure 3: CCTV footage of loading arms breaking off and oil gushing out.
Source: Inter Terminals Denmark EOT Aps*

Simultaneously, at 0930, the master received information from the deck crew that one of the aft spring lines had parted. An AB who was standby at the manifold rushed to the forward mooring station together with the 2nd officer. Another AB went to the aft mooring station to assess the situation, but he soon realised that he was not able to safely approach the mooring winches, as the mooring ropes payed out uncontrollably, and the brake bands developed heavy smoke. Both loading arms from the jetty broke off the ship's manifold and vacuum gas oil gushed onto the ship and into the water (figure 3 and 4, next page).

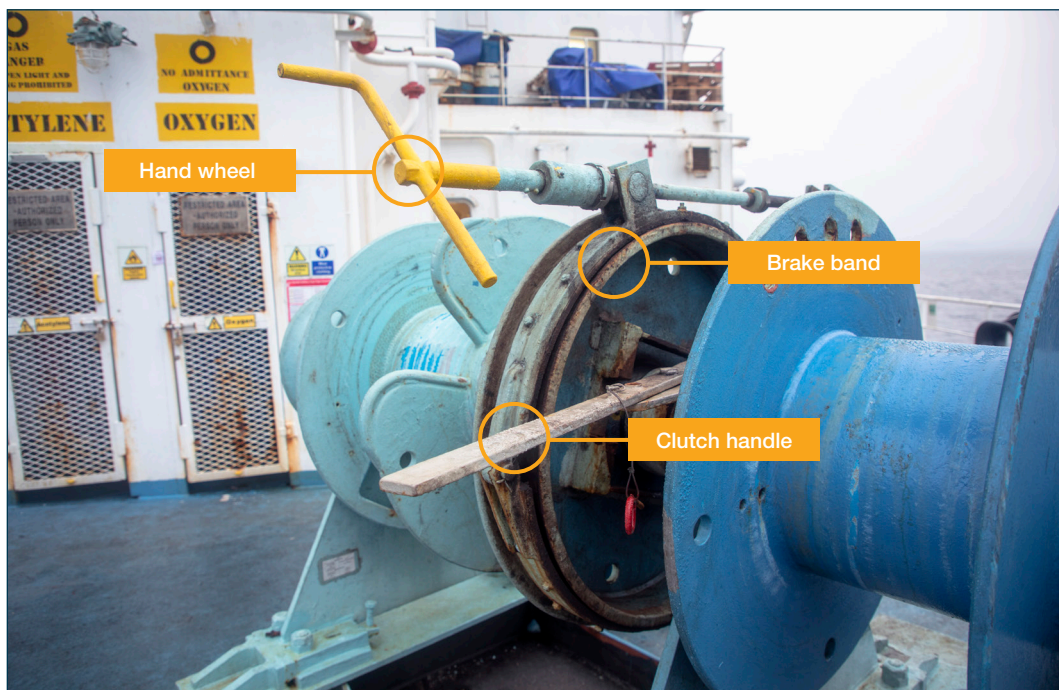
Figure 7: Hand wheel, brand brake and clutch on mooring winch.
Source: DMAIB

Each winch was fitted with a manually operated clutch and band brake with manual setting and release. The brake was tightened by turning the hand wheel (figure 7).

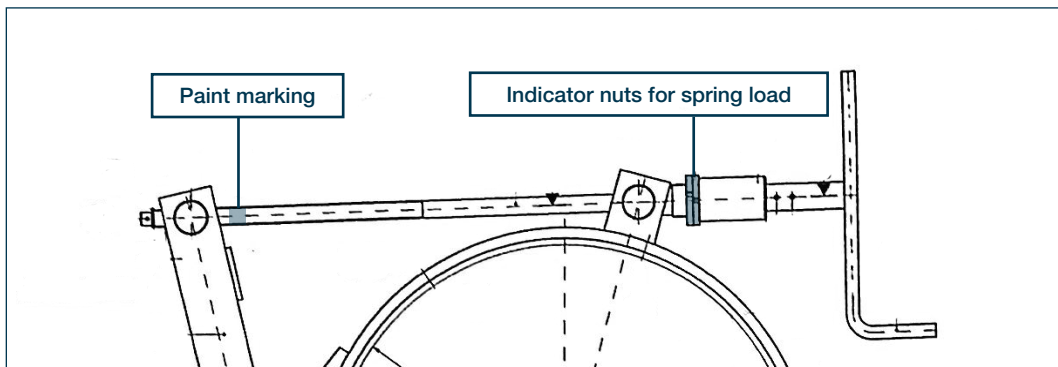
Figure 9: Visual indicators on the winch brake
Source: Zenith Gemi Isletmeciligi AS / DMAIB

During the investigation on the ship, it was not certain whether the winches had been adjusted during or after the accident. Therefore, it was not possible to determine on site if the winch brakes had been fully applied before the accident. Statements from witnesses affirmed that the brakes on the aft deck winches made a screeching sound and developed smoke, caused by friction between brake band and brake drum, when the ship drifted away from the jetty. This indicated that the brakes were tightened prior to the drifting of the ship; however, it did not verify whether the brakes had been fully or only partially applied.

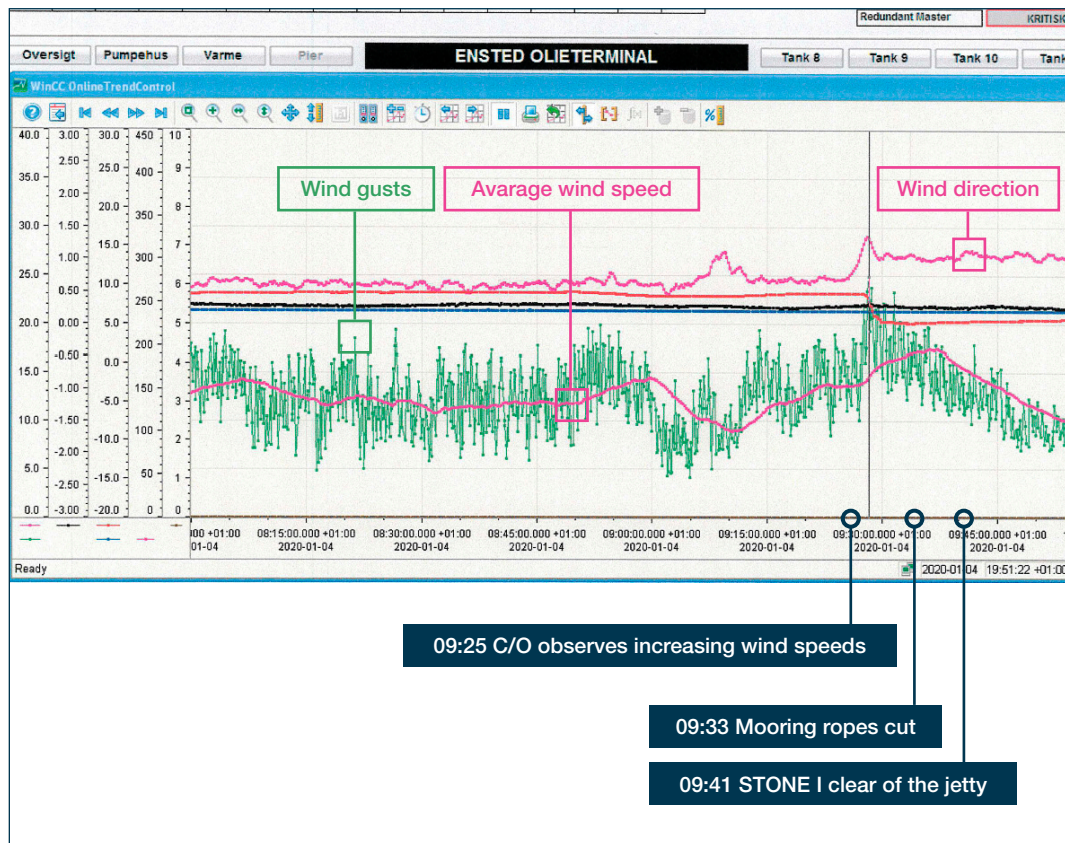
Figure 11: Screenshot from Inter Terminals' trend control panel
Source: Inter Terminals Denmark EOT Aps/DMAIB

According to the checklist, the loading operation was to be stopped, if the wind reached 20 m/s. It was not stated whether the wind criteria related to average or gust wind speed. During the investigation, the terminal informed DMAIB that the wind criteria in their checklist referred to an average wind speed, defined as the average wind speed measured within a period of ten minutes. Hence, the wind criteria allowed for continuation of the loading operation though the wind gusts exceeded 20 m/s, as long as the average wind speed was not exceeded within the 10 minute period.

On figure 11 next page, a record of wind direction and speed from Ensted Oil Terminal is presented. It shows wind measurements and trend data for the average wind speed for the period 0800-1000 on 4 January 2020. STONE I's mooring winches started to pay out at 0929. In the period of 0927 to 0940, the wind data shows a sudden increase in wind speed up to 25 m/s and a change of wind direction from 270° to 325 °. This wind speed was higher than the forecast predicted. However, the average wind speed did not at any time during the time period exceed the terminal's wind criteria for loading.

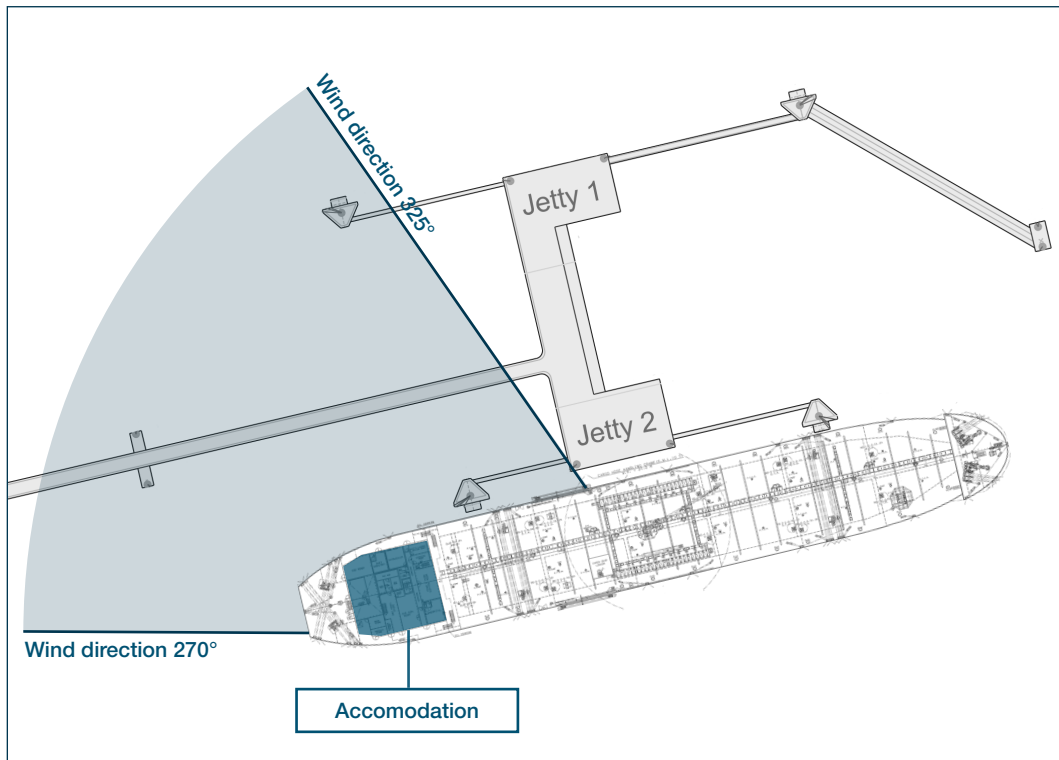
Figure 12: Wind forces acting on the ship during the accident

During the accident STONE I was berthed port side alongside, heading 080°, and the wind came from a WNW direction. The wind hence acted on the ship's aft on port side, where the ship's accommodation was located (figure 12, next page). The wind direction and location of the accommodation exposed the aft part of the ship to a higher lateral force than on the forward, which caused a higher the load on the aft moorings than on the forward.

The owner of the terminal contracted FORCE Technology to calculate at what wind force the winch brakes would release. The report prepared by FORCE concluded that the ship should not suffer from collapse of the winch holding capacity for wind speeds below 31 m/s for any wind direction. This finding implies that the winches had not been correctly applied or malfunctioned. However, the report contained several uncertainties. E.g. the pretension of the moorings and the mooring ropes vertical angles were not included in the calculation. These are significant factors for determining the load on the winches.

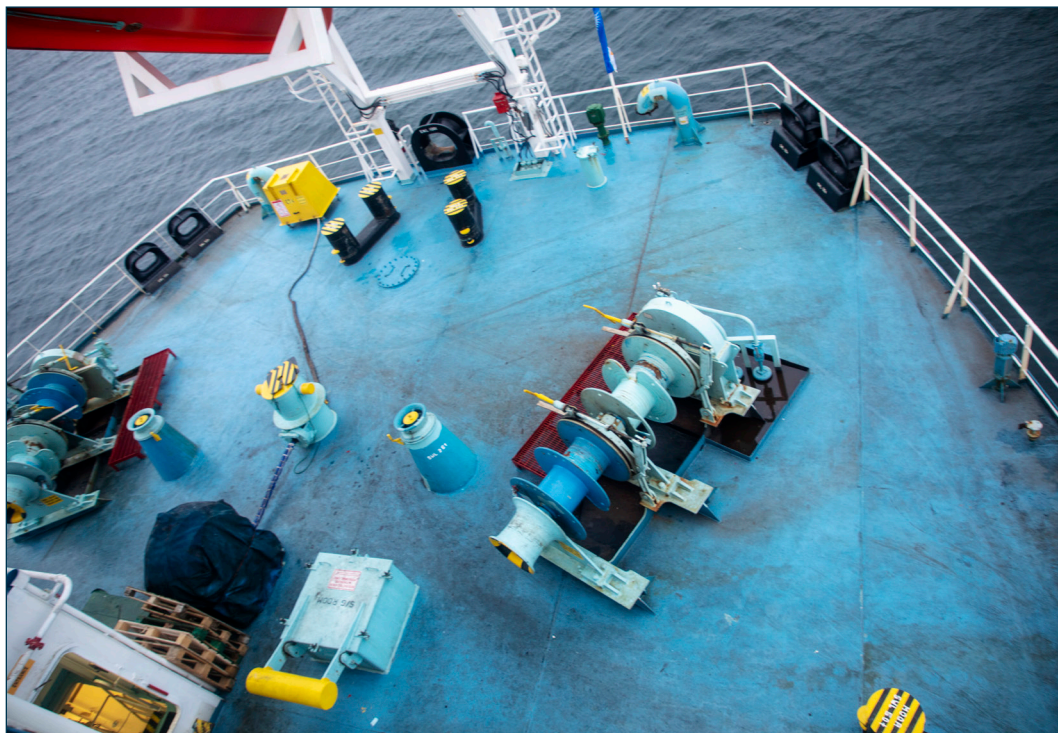
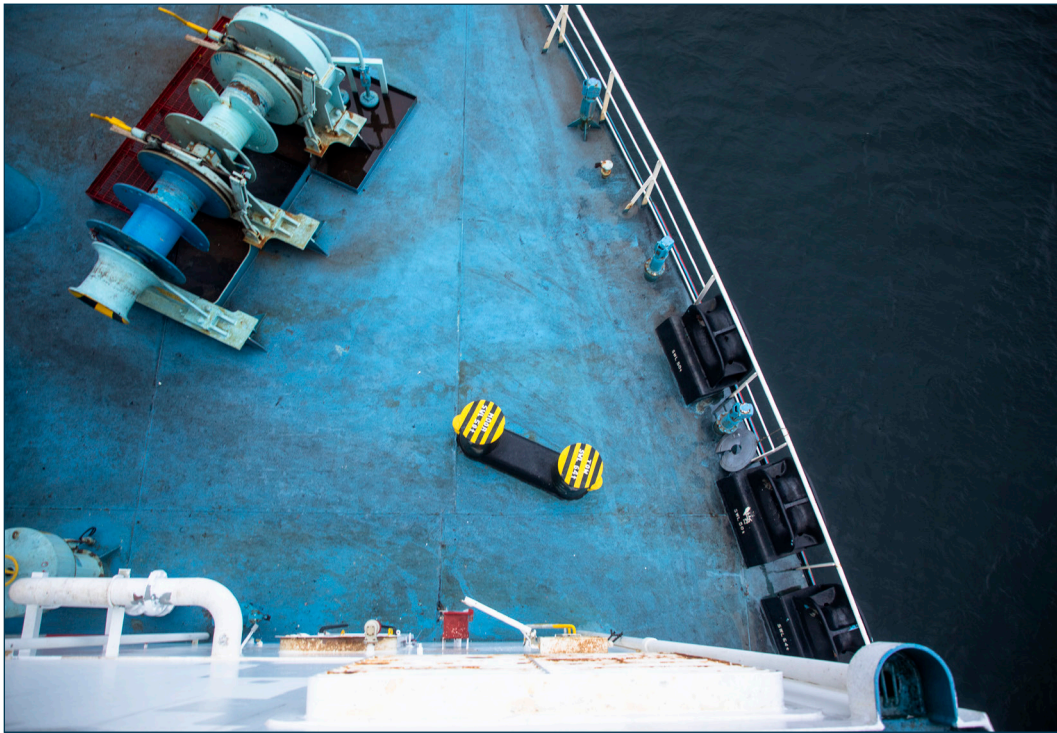
STONE I had four mooring stations: one aft, two on the main deck and one on the forecastle. On the aft mooring station, the mooring fittings consisted of two double drum mooring winches, Panama fairleads, bollards and pedestal rollers. Both winches had two specific fairleads allocated in each side of the ship to which the mooring lines could be led directly. The pedestal rollers could not be used for directing mooring lines from the winches to any other fairlead, because they were not aligned with the tension drum on the winches. The pedestal rollers were aligned with the winch head and were thus meant to be used for tightening loose mooring lines or bringing towing lines on board through the centre fairlead. It was only possible to use the centre fairlead for loose mooring lines or towing lines (figures 13 and 14, next page).

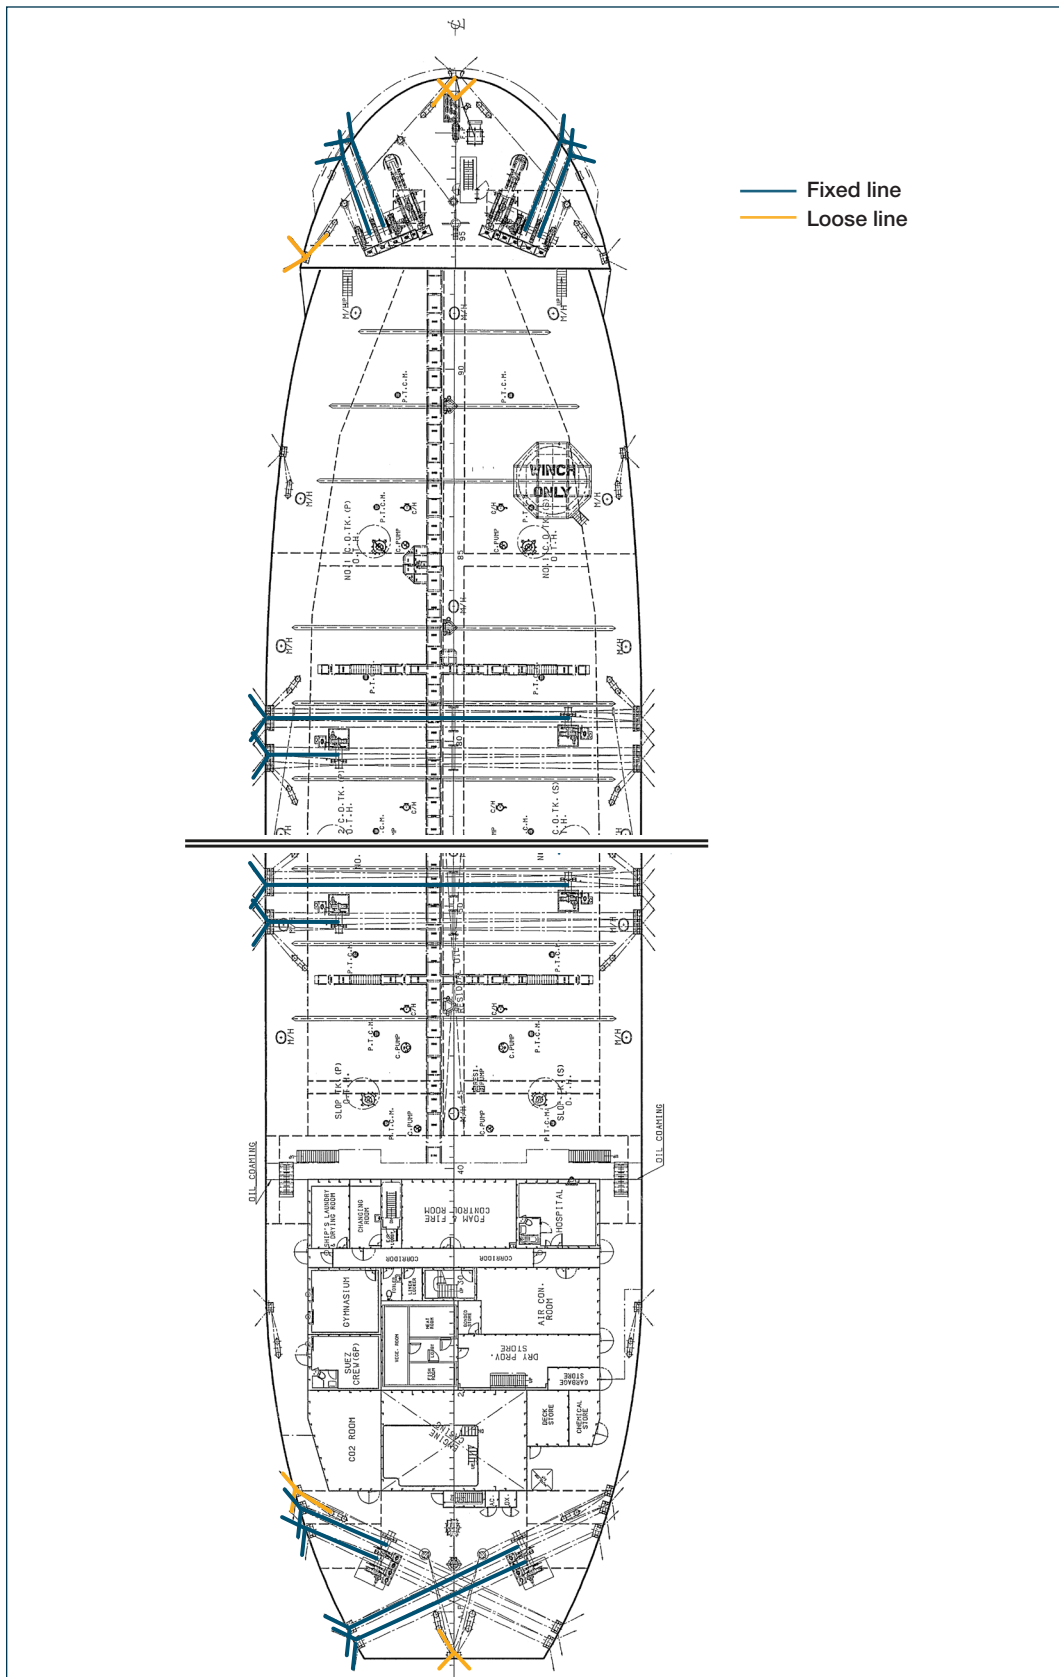
Figure 18: Possible ways of directing mooring lines on STONE I when berthed on port side.
Source: Zenith Gemi Isletmecilgi AS / DMAIB

The illustration below shows the possible ways of directing mooring lines on STONE I, when the ship was portside alongside. It is noted that on the aft mooring station the mooring layout did not allow for mooring lines to be directed from the winches to the berth via the transom (figure 18).

- The aft mooring station did not allow for mooring lines to be directed from the winches to the berth via the transom.
- The mooring management plan recognised that an optimal mooring pattern was not always achievable.
- In the event of deteriorating weather or sea conditions, the mooring management plan stated that the master should not hesitate to put out extra moorings, if he considered this to be necessary.

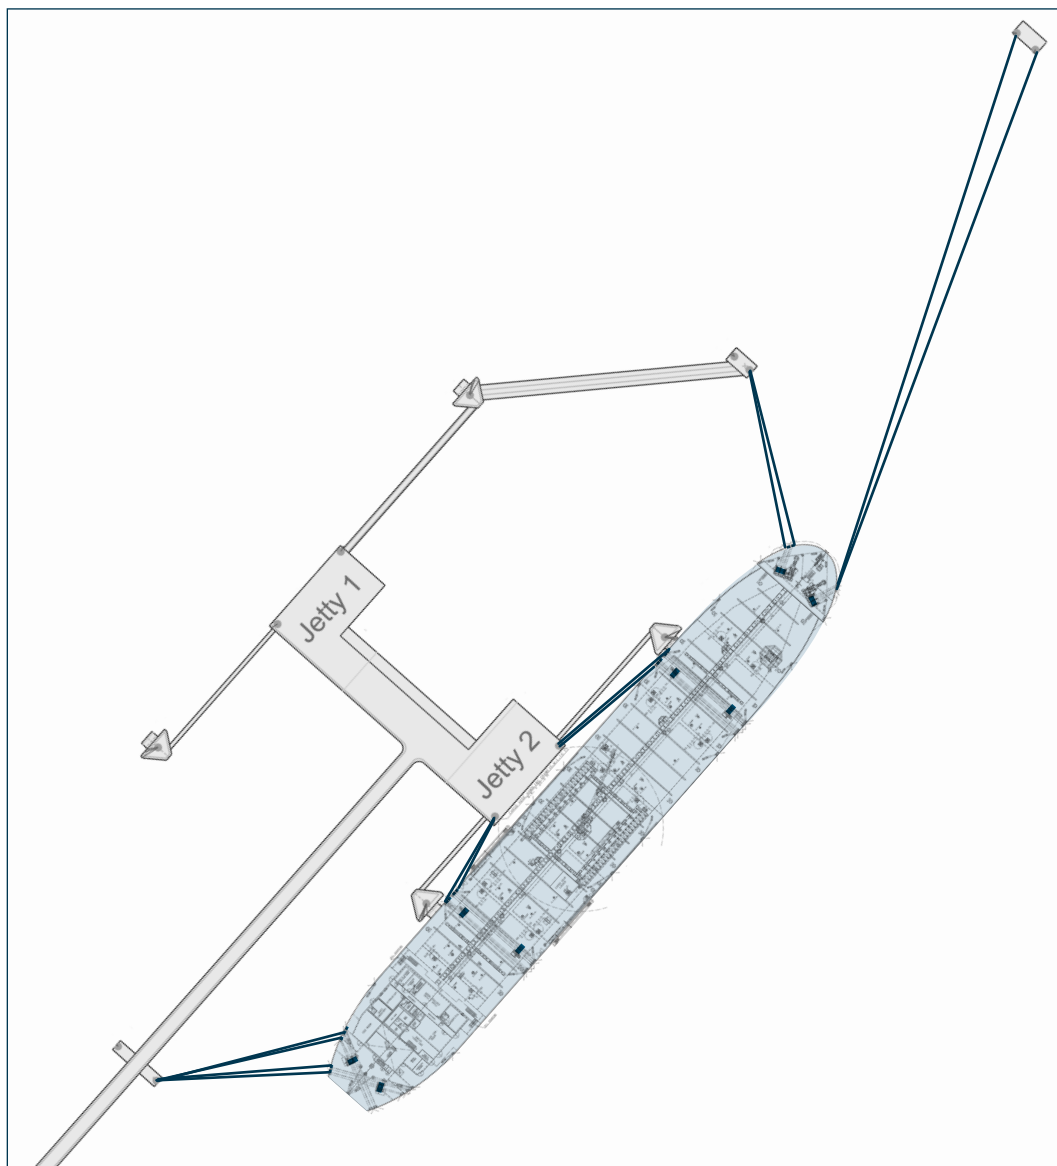
Figure 22: STONE I moored at Ensted Oil Terminal
Source: STONE I

The agreed mooring configuration was similar to the typical mooring pattern in the ship's mooring management plan. However, during berthing, the master was informed that the jetty's bollards and hooks were not aligned to direct the breast lines in an optimal angle. The master assessed the situation and decided to accept the mooring configuration as this seemed to be the only feasible option. STONE I was thus moored with four lines on the forecastle, four lines on the main deck and four lines on the aft (figure 22).

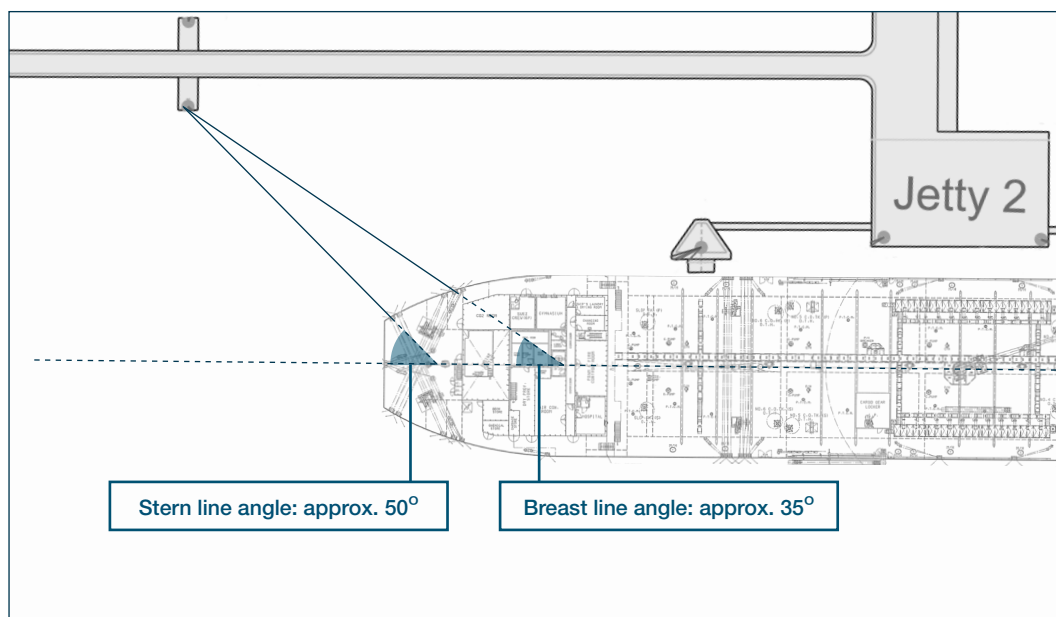
Figure 23: STONE I moored at Ensted Oil Terminal
Source: STONE I

An examination of the actual mooring configuration on STONE I at Ensted showed that it differed from the mooring configuration, which the master had initially planned, from the mooring pattern described in the ship's mooring management plan and from Ensted Oil Terminals' mooring plan. The main difference was that the intended breast lines on the aft deck had an angle of approx. 35° instead of the ideal 90°. In comparison, the stern lines had an angle of 50 approx., and was hence leading in a more perpendicular direction than the breast lines (figure 23).

- On the aft part of STONE I, the mooring configuration on the day of the accident differed significantly from the planned.

The actual mooring pattern and the direction of the mooring lines from the aft deck had the effect that the aft moorings had significantly reduced transverse restrain capacity. This resulted in an increased load on the aft mooring winches. When the wind force suddenly increased, the wind direction and location of the accommodation exposed the aft part of the ship to a higher lateral force than on the forward. This added an increased load on the aft mooring winches.
