# KARIN HØJ

Marine accident report on occupational accident

9 MAY 2019

**MARINE ACCIDENT REPORT ON THE OCCUPATIONAL  
ACCIDENT ON KARIN HØJ ON 9 MAY 2019**

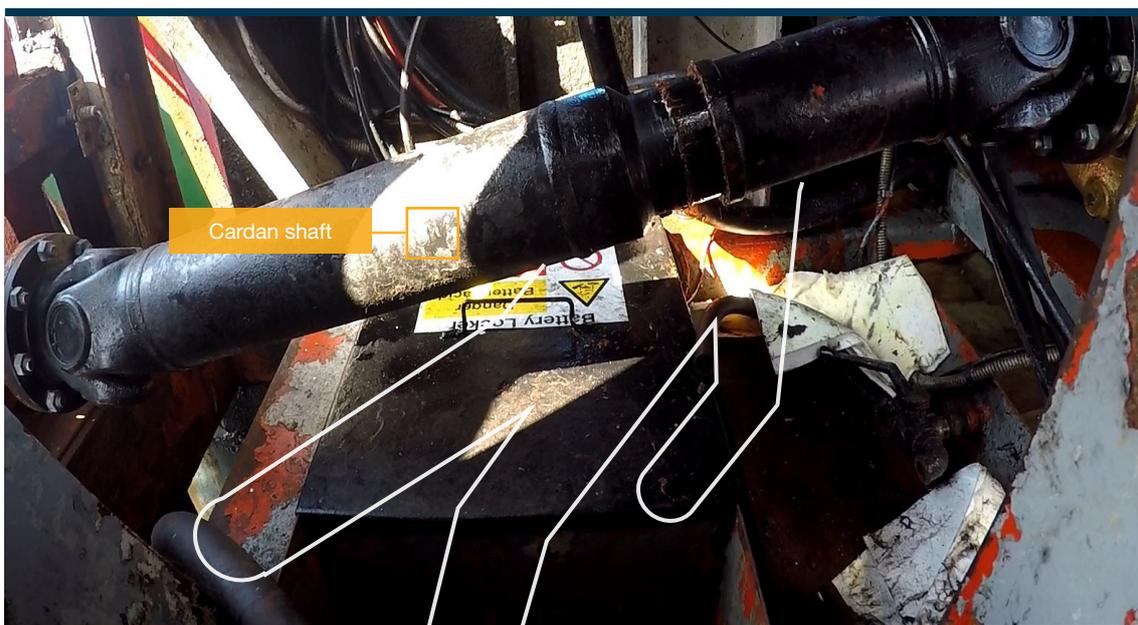
During the repair of the ship propulsion system, the first mate disassembled the hydraulic hose connected to the lifting cylinder of a cardan shaft. When the hydraulic hose was dismantled, the hydraulic pressure in the lifting cylinder immediately disappeared, and the cardan shaft sank down over the first mate.

Figure 5: Outline of how the mate was caught under the cardan shaft for starboard engine.  
Source: DMAIB, 2019

The accident on KARIN HØJ in Eemshaven in the Netherlands occurred when the ship was coming in to port in Eemshaven and hit the quay, causing damage to the hydraulic hoses on the starboard propulsion system. The first mate immediately started the repair work on the hydraulic system and was, in connection with this, trapped under a cardan shaft. The accident investigation carried out by DMAIB in conjunction with surveillance images from the port showed that the first mate entered the engine compartment from the starboard side and was lying under the cardan shaft while working to change the damaged hydraulic hoses that controlled the vertical propeller shaft. However, she did not dismantle the hoses that were damaged, but the hydraulic hose that was connected to the lifting cylinder of the cardan shaft. When the hydraulic hose was dismantled, the hydraulic pressure fell in the lifting cylinder, and the cardan shaft was lowered over her.

- *"Lock pins have been mounted in brackets on starboard and port side propeller shaft housing for manual securing of the cardan shaft.*
- *A new procedure for repair of the Schottel system has been implemented in the ship's safety management system. Furthermore, a machine repair procedure has been implemented.*
- *A new lockout-tagout procedure has been implemented. This procedure includes a checklist.*
- *The familiarisation checklist for change of officer has been updated to comprise the procedure for repair of the schottel system.*
- *Warning signs have been posted on access covers to the engine compartments on the port and starboard main engine.*
- *The shipping company Rederiet Høj has updated the ships safety management system with a risk assessment covering repair of machinery."*

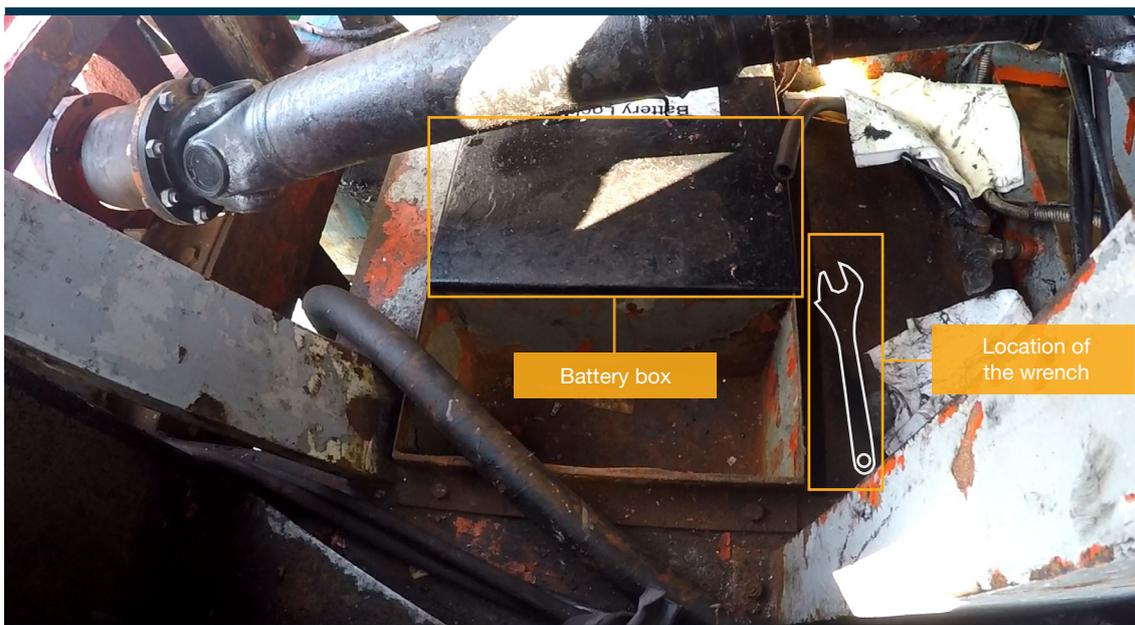
In connection with the investigation of the scene of the accident, the investigation board found some of the equipment and objects used by the first mate in connection with the repair of hydraulic components in the starboard engine compartment. At the bottom of the engine compartment, close to the battery box, the wrench used for the repair was found (figure 6). The distance between the jaws on the wrench was the same span as the converter of the hydraulic hose and can therefore be considered highly likely to have been the one used by the first mate for the work. No other tools were found inside the engine compartment.

Figure 6: Wrench found between the motor foundation and the battery box  
Source: DMAIB, 2019

At the scene of the accident, the investigators found the wrench used for the work by the first mate. The investigation showed that it was difficult to get the wrench onto the fittings of the hydraulic hoses, because the space around the valve battery was limited. It is thus possible that the first mate wanted to loosen the hose that was placed in front of the two hoses to be switched, in order to get better room for changing the hoses. When the hose was dismantled, the pressure immediately disappeared, and the lifting cylinder could not hold the cardan shaft up, causing it to lower, trapping the first mate.

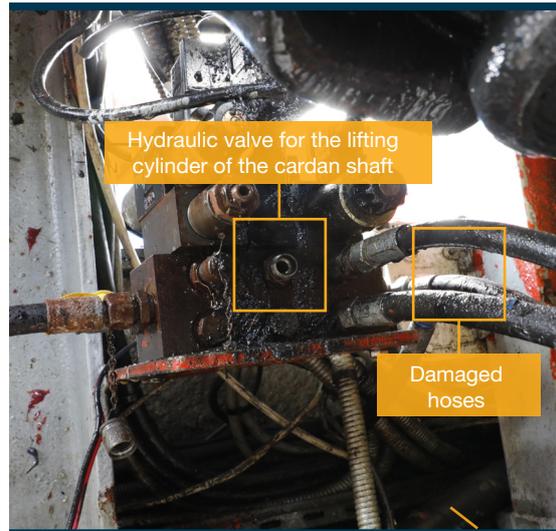
In the engine compartment it was found that the damaged hoses which had to be replaced were still fitted to the hydraulic valves. It was also found that the hydraulic hose connected to the lifting cylinder of the cardan shaft was dismantled (figure 7, next page).

Figure 7: The hydraulic valves in the engine compartment  
Source: DMAIB, 2019

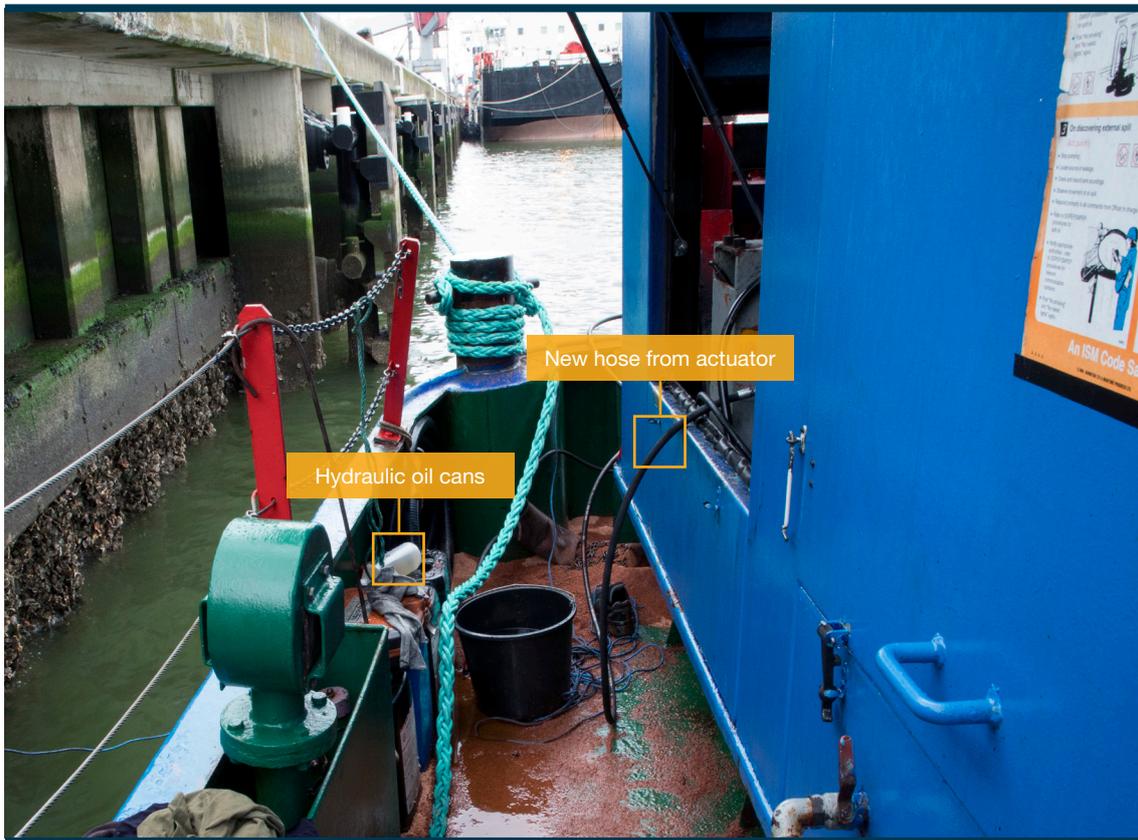
On the actuator situated aft on the ship's starboard side, the investigation board found a hydraulic hose which had been changed and brought into the engine compartment, but not yet attached to the valve (figure 8, next page).

Figure 8: Entrance to starboard engine compartment  
Source: DMAIB, 2019

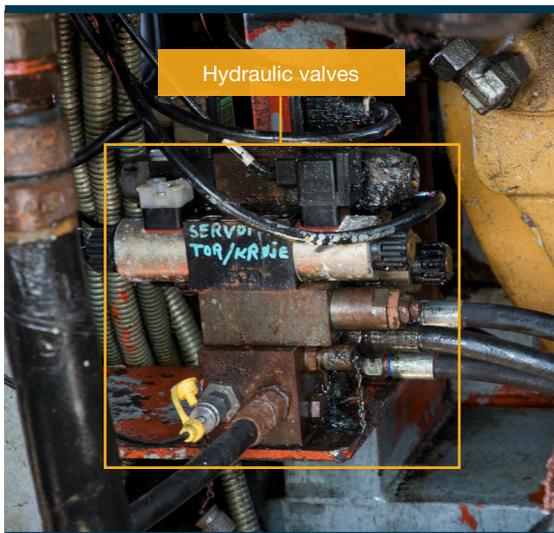
hydraulic piston and actuator respectively. DMAIB's investigation into the hydraulic system showed that it could be difficult to follow the connection between the hydraulic hoses from the hydraulic piston and the actuator to the valve battery, because the hoses were passed through a sock made of fire hose. The function of the sock was to protect the hoses on deck against wear.

In the engine compartment, the system components were mounted close to one another, which could somewhat complicate access to them when inspecting or replacing hydraulic hoses, etc.

Figure 11: Hydraulic valves  
Source: DMAIB, 2019

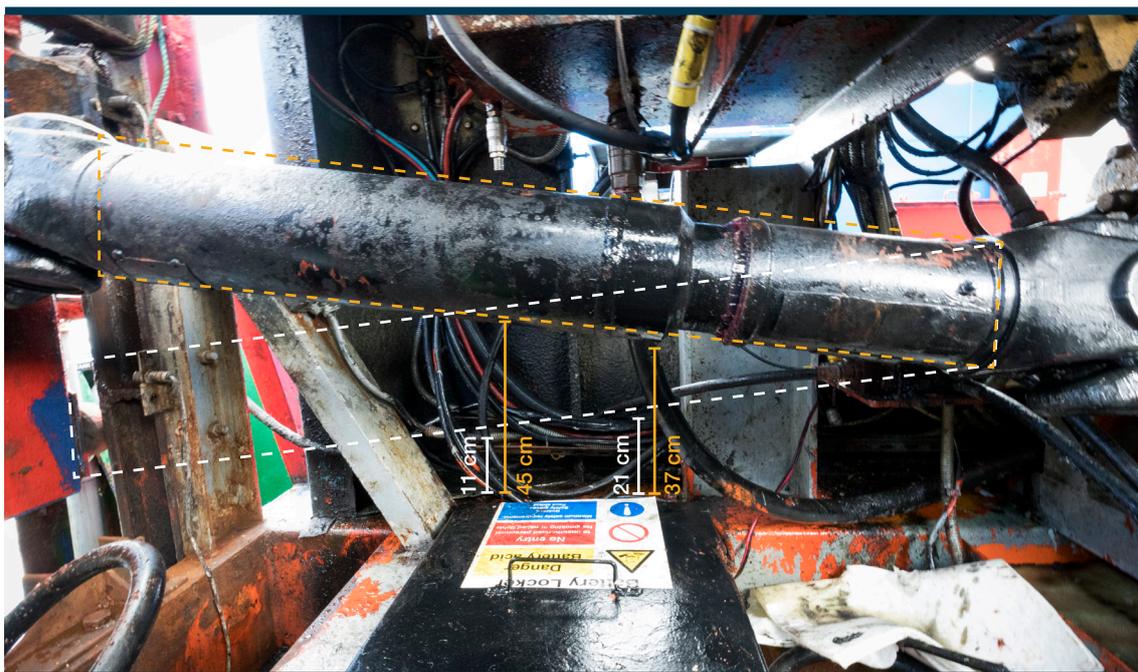
Figure 13: Distances between the cardan shaft and the battery box in elevated condition (yellow) and lowered condition (white)  
Source: DMAIB, 2019

The spacing in the engine compartment is shown in figures 13 (previous page) and 14. Between the battery compartment and the cardan shaft, there was a clearance of 11 cm, when the shaft was lowered, and 45 cm, when the shaft was raised. From the hatch in the engine compartment to the position of the valves, there was a distance of 145 cm. There was no access to the hydraulic valves, the battery compartment or the bodywork from any place other than the hatch on the starboard side.

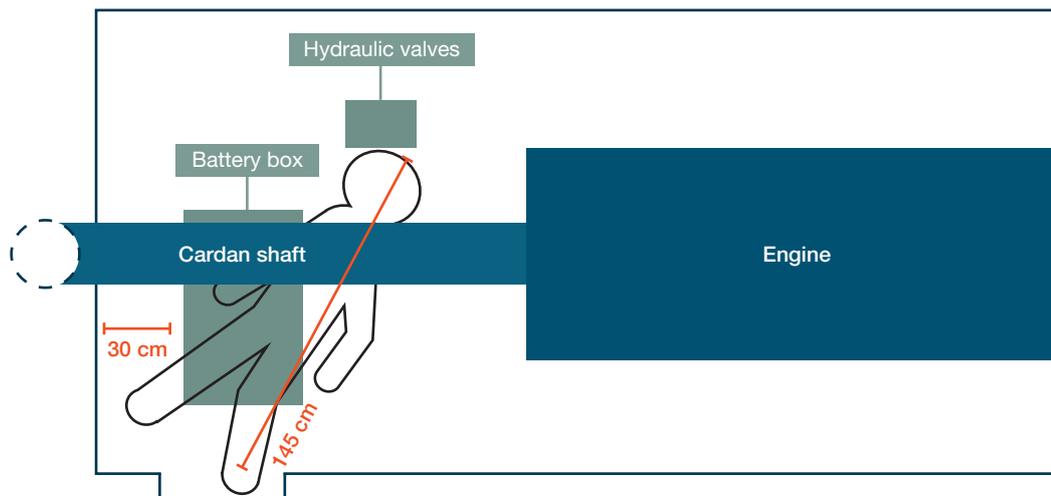
Figure 14: Distances between various system components in the starboard engine compartment.  
Source: DMAIB, 2019

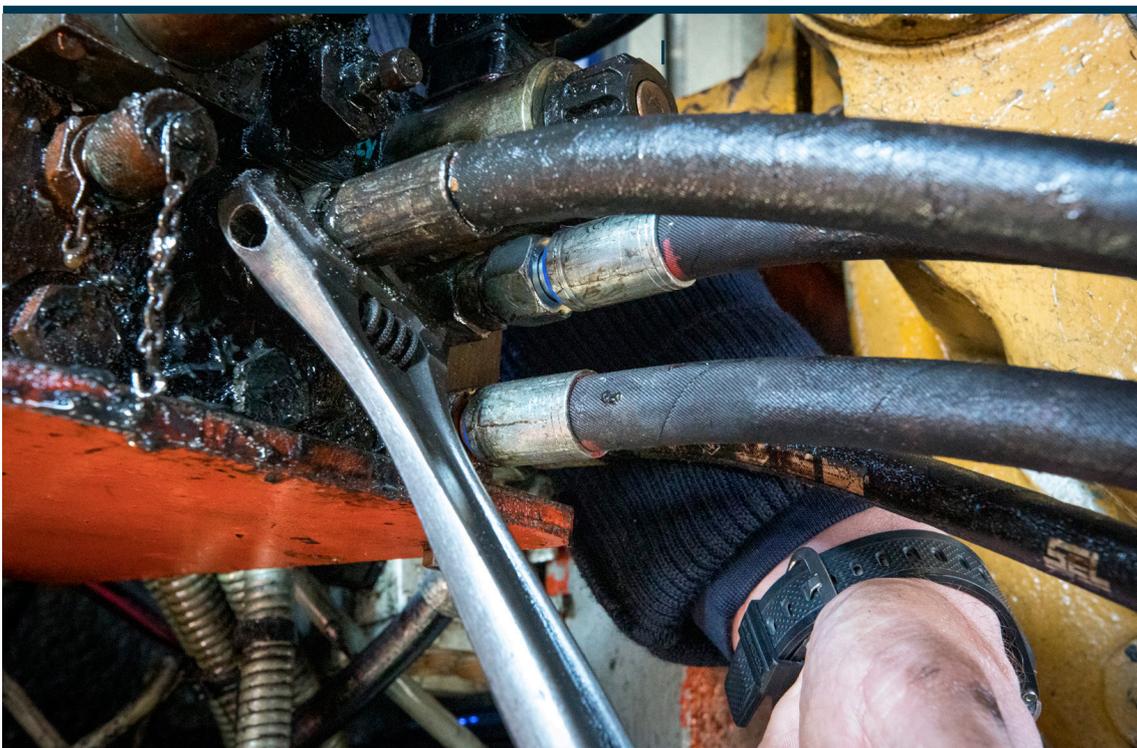
The hydraulic hoses were mounted on the valves at such a close distance that it could be difficult to dismantle the individual hoses with a wrench (figure 15). In the picture, the wrench is placed on the hydraulic hose which caused the cardan shaft to lower. It may well be the natural choice to dismantle this hose in order to access the other hoses that were damaged.

Figure 15: The wrench on the hydraulic hose, reconstruction  
Source: DMAIB, 2019
