HAV STREYM

Summary report on occupational accident

2 NOVEMBER 2019

**SUMMARY REPORT ON OCCUPATIONAL ACCIDENT
ON HAV STREYM 2 NOVEMBER 2019**

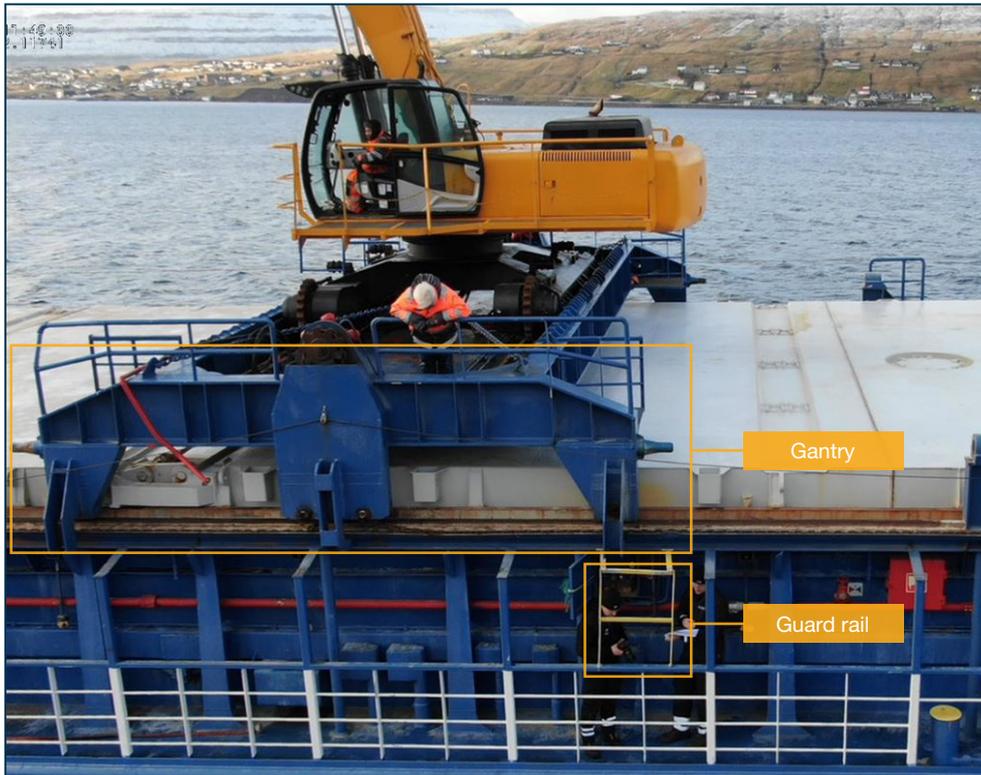
Before opening the hatch cover, the excavator had to be moved aftwards. One AB therefore went to the excavator cab to operate the travelling gantry that carried the excavator. Meanwhile, the other AB stood by on the main deck at the hydraulic control station waiting for the travelling gantry to move aftwards, so he could open the hatch covers. When he heard the travelling gantry stop, he reckoned that the gantry had passed and the space above the hydraulic control station was clear. He climbed the guardrail to check the hatch covers visually to make sure they were clear to open (figure 2). As the AB climbed the railing, the gantry moved aftwards and the AB's upper body was jammed between the guardrail and the gantry (figure 2).

Figure 2: Guard rail and gantry that AB was caught between.
Source: DMAIB

On the day of the accident, the lighting conditions were such that the AB on deck could only rely on the noise from the gantry to determine its exact position. As the gantry made a short stop, he misjudged its position and climbed the railing before the gantry had passed and was jammed between the guardrail and the gantry.

This accident exemplifies how risk mitigation can have adverse side effects when the circumstances change. In this case, the guardrail, which was designed to prevent the AB from falling overboard, became a hazard, because it made it possible for the AB to become jammed. However, the fundamental safety issue was the inexpedient location of the hydraulic control levers, which provided a poor overview of the hatch covers.

On HAV STREYM there was no other place to mount the hydraulic control levers, which offered a significantly better overview. Therefore, it would be more expedient to introduce measures, which separately mitigate the risk of falling overboard and the risk of becoming jammed. E.g. having a fixed ladder, warning lights, which indicate that the gantry is moving and where it is, etc.

- A safety light will be fitted on the excavator, which will indicate when the gantry is moving.
- A ladder will be fitted at the control station by the hatch coaming.

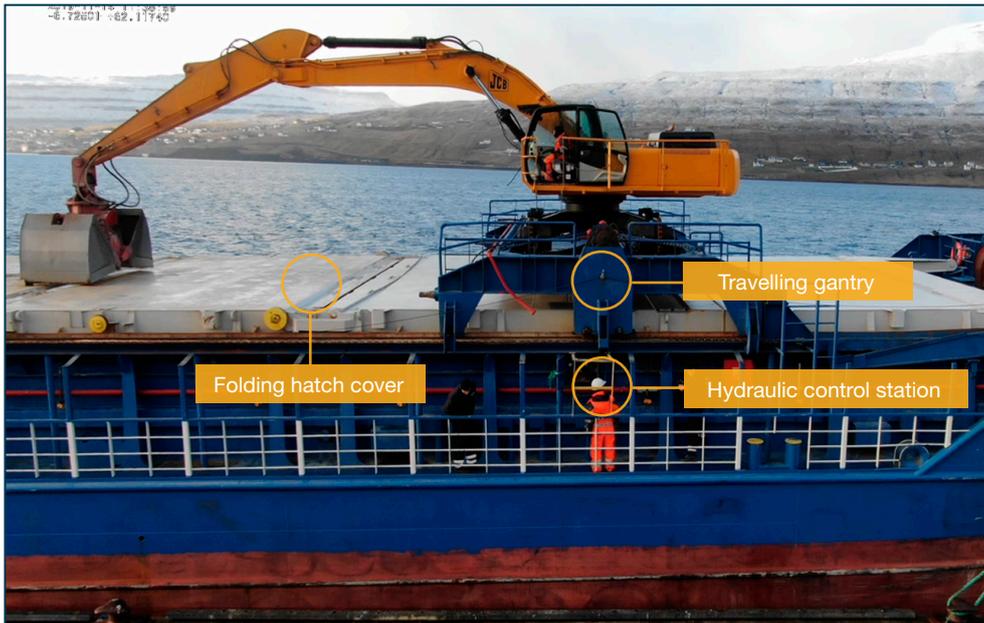
HAV STREYM was equipped with hydraulic folding hatch covers operated by hydraulic control stations forward and aft on the vessel's starboard side. On top of the hatch covers a travelling gantry carried an excavator which was used for loading and discharging the vessel (figure 3, next page).

Figure 3: Deck layout
Source: DMAIB

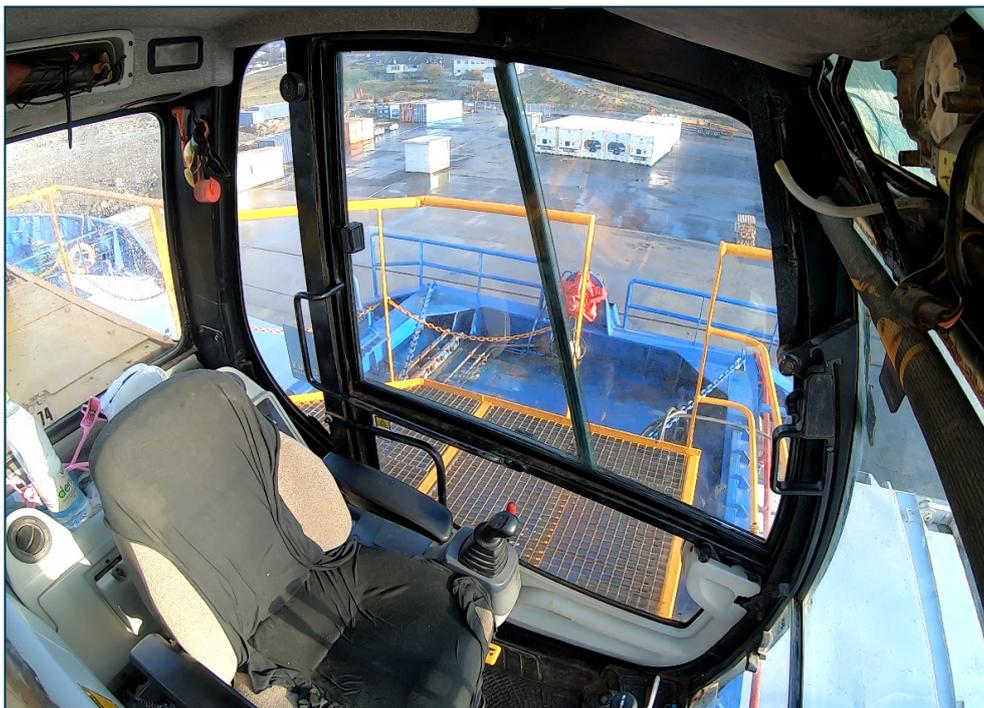
The travelling gantry moved along the top of the hatch covers by use of chains. If the excavator was positioned on top of the hatch covers, it was necessary to move it so the hatch covers could be opened. The travelling gantry was operated from inside the excavator cab. The hatch covers were operated from a hydraulic control station mounted on the hatch coaming below the gantry. Inside the excavator cab, the hatch cover and the hatch coaming restricted the view to the main deck. This meant that the driver was unable to see persons on the main deck (figure 4, next page).

Figure 4: View to the starboard from the excavator cab
Source: DMAIB

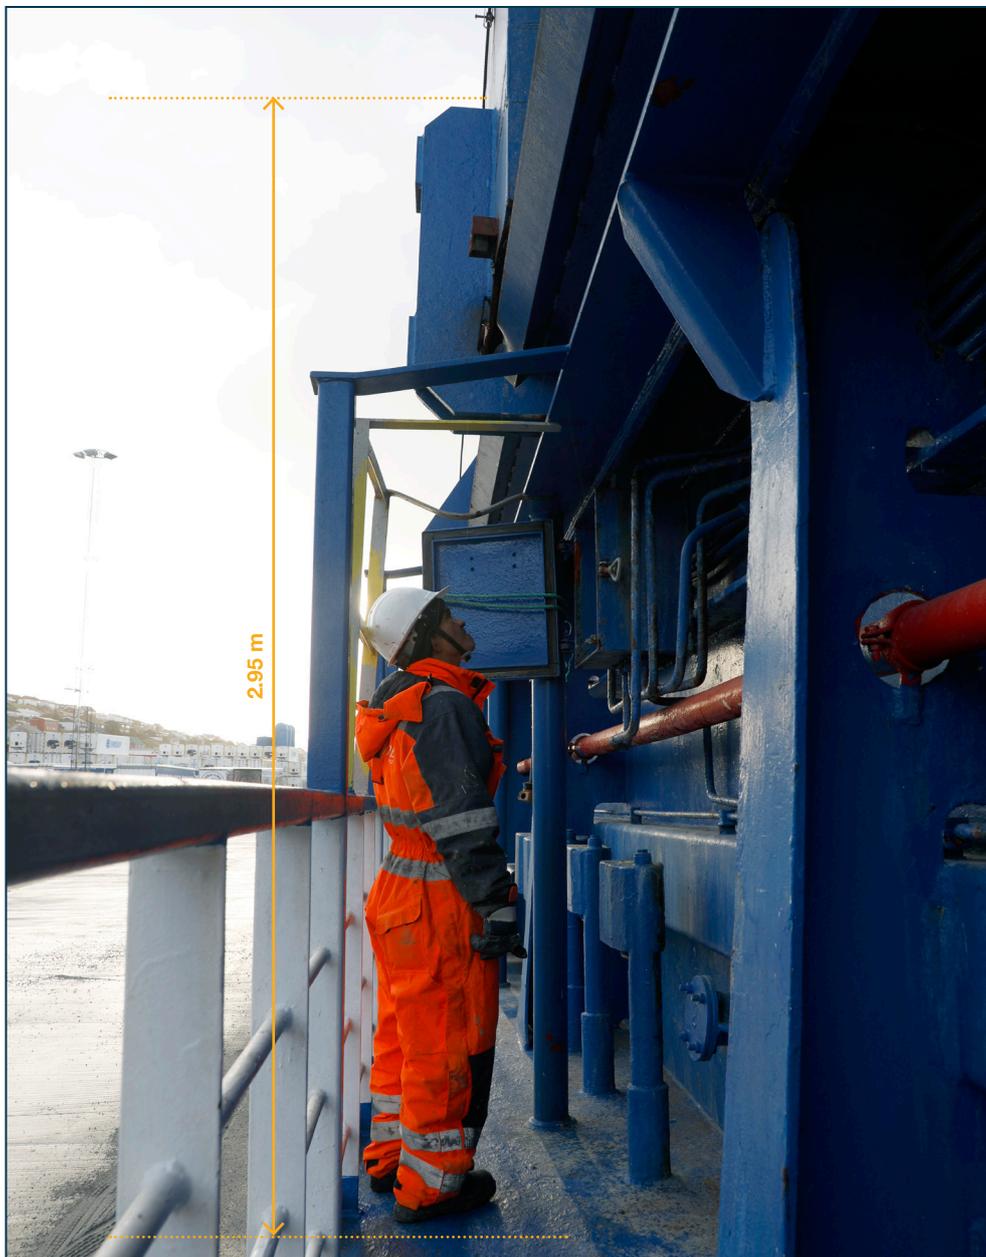
The height from the main deck to the top of the hatch covers was 2.95 meters (figure 5). On the main deck at the hydraulic control station, it was not possible to see the top of the cargo hold. This meant that it was not possible to see the excavator cab or the hatch covers. In order to make sure that no persons were on the hatch covers before opening them, the AB operating the levers had to climb the railing as the operating levers in the control station were 1.25 m below the top of the hatch cover. To protect the ABs from the risk of falling over board when climbing the railing, the ABs had mounted a guardrail on the railing.

Deck lights to illuminate the hydraulic control station were in place, but not functional at the time of the accident. The deck area was only illuminated by lights mounted on the forward part of the accommodation and on the forecastle. During DMAIB's investigation, it was observed that this light had a blinding effect when working at the hydraulic control station, making it difficult to visually identify the position of the travelling gantry. Additionally, the hatch coaming and the gantry had the same colour, making it difficult to identify when the gantry was moving.

Figure 5: View from the main deck to the travelling gantry
Source: DMAIB

The hydraulic control panel was mounted in a place, which gave a restricted overview of the hatch covers. To gain an overview of the hatch covers, the ABs therefore had to climb the railing. This inexpedient location of the hydraulic control station led to several risk factors. When standing on the railing, the AB was exposed to the risk of falling overboard. This risk was mitigated by installing the guardrail.
