DMAIB
Danish Maritime Accident Investigation Board

BERGENSFJORD

Summary report on unintended release of rescue boat

6 DECEMBER 2017

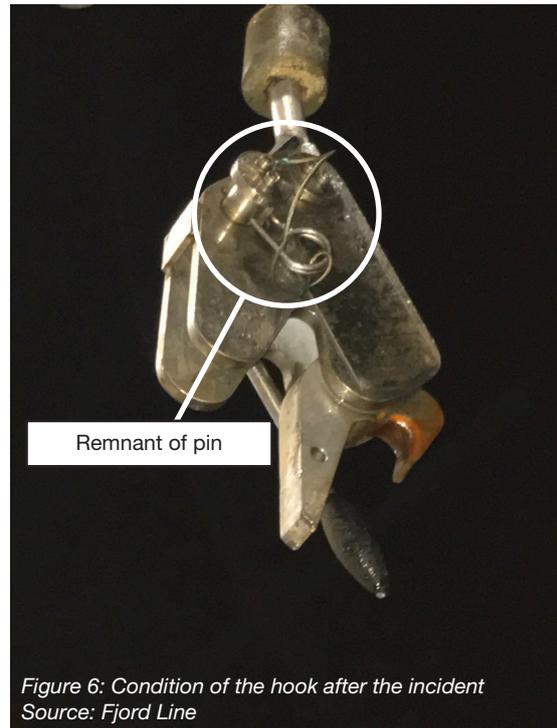
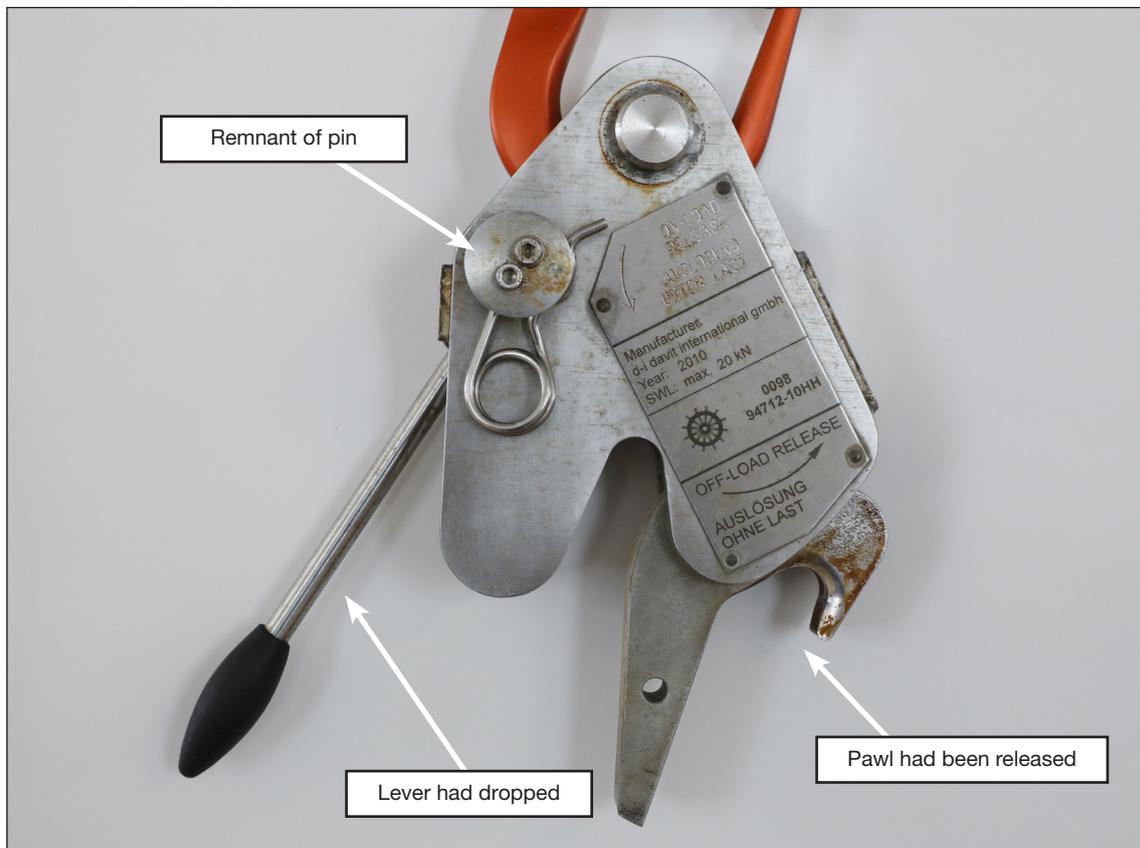
After the incident, it was found that the release hook had been triggered (figure 6). In figure 7, a reconstruction of the condition of the hook is shown: A remnant of the pin was stuck in the hook, the lever had dropped, and the pawl had been released.

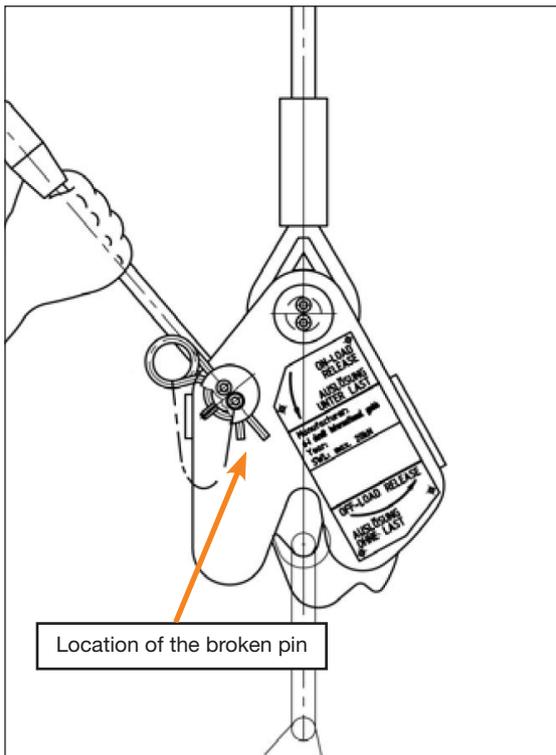
It was found that the tip of the pin that held the release lever in place was broken, which meant that the lever could drop thus releasing the rescue boat (figure 8 and 9, next page). However, what had caused the pin to break was unclear.

Figure 8: Location where the pin was broken
Source: DMAIB

The pin was examined by FORCE Technology at DMAIB's behest, in order to ascertain whether the pin had broken due to, e.g. fatigue, or if it had been severed at the time of the incident. The examination showed that the pin had been cut in one motion.

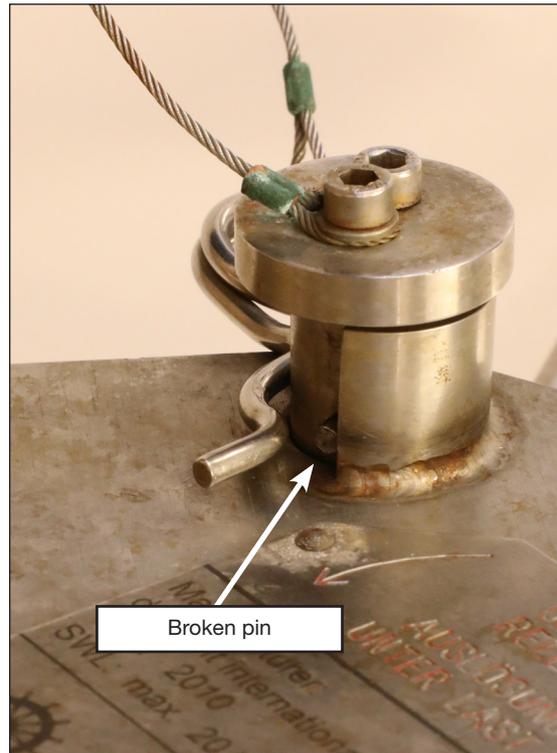
Figure 9: Broken pin on the release hook
Source: DMAIB

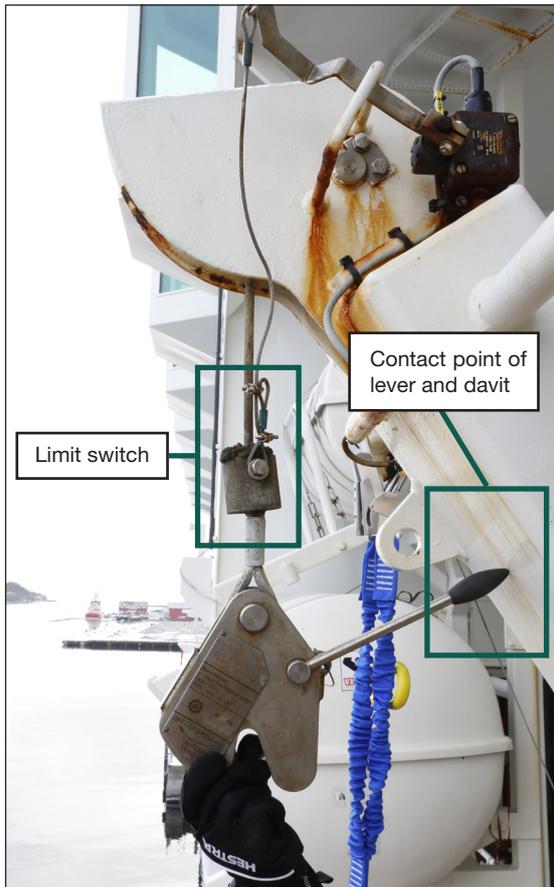
Figure 10: Reconstruction of the handle hitting the davit
Source: DMAIB

By conducting a number of reconstructions on board STAVANGERFJORD, it was demonstrated that when the boat was hoisted by the wire, the release lever could, under certain circumstances, make contact with the davit (figure 10) and be pulled downwards at such a force that the pin could be severed.

However, it was a prerequisite for this to happen that the limit switch was set in such a way that the wire could run far enough to hit the davit.

The reason the rescue boat was unintentionally released was that when the rescue boat was hoisted out of the cradle, the release lever hit the arm of the davit and was impacted by such a downward force that the pin in the release lever was severed. The release lever could then drop down freely, releasing the pawl. In other words, an on-load release of the hook took place, once the split pin had been severed.

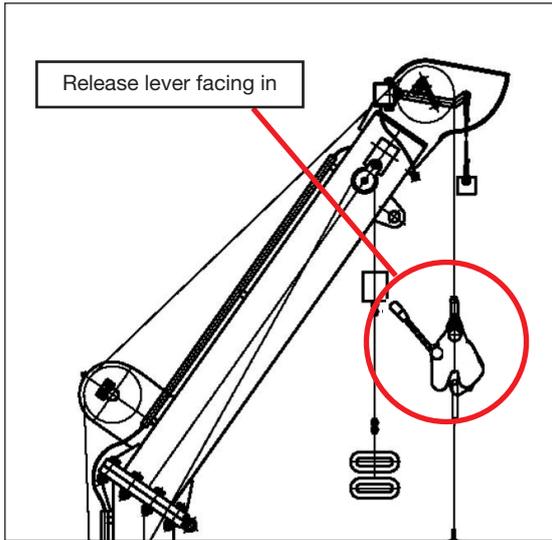
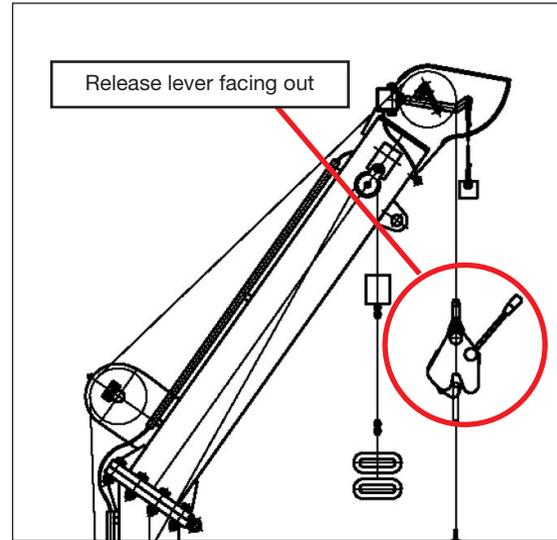
Figure 11: Sketch showing the release hook's respective orientations, inwards towards the davit and outwards, away from the davit

1) The release hook was usually turned in such a way that the handle pointed outwards and not inwards toward the davit, as shown in figure 11. This meant that when the boat was hoisted out of the cradle, the release lever would not hit the davit.

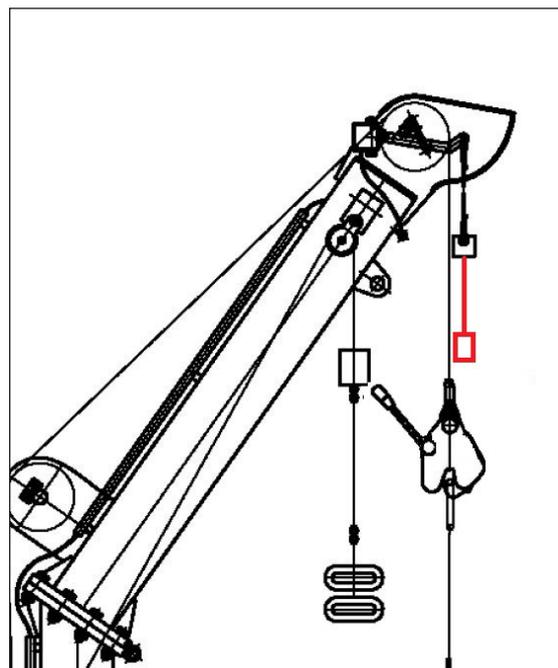
2) The boat was not always hoisted this far out of the cradle before the davit was lowered because the limit switch had been mounted further down the hoisting wire on STAVANGERFJORD than on BERGENSFJORD (figure 12).

Figure 12: Sketch showing the extended limit switch on the wire

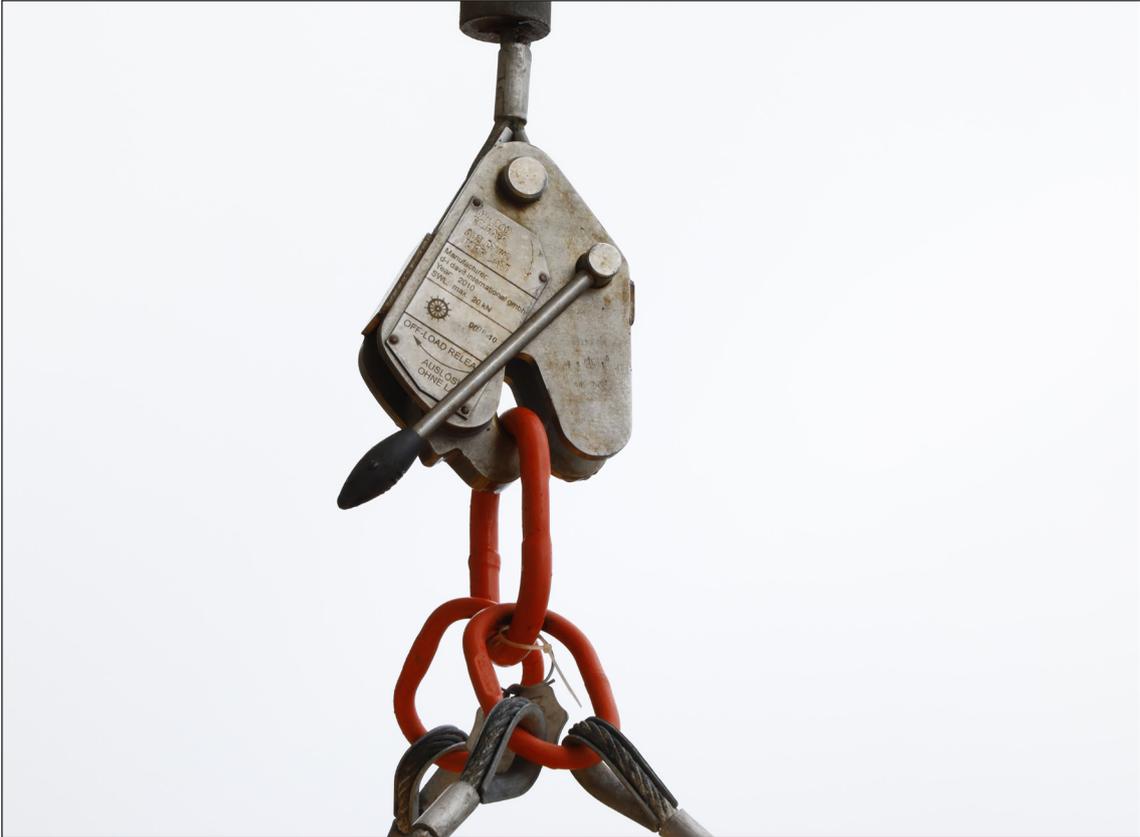
3) The information gathered indicates that, at times, the hook was attached to the boat's suspension in such a way that the release lever pointed downwards (figure 13) and not upwards (figure 14). The correct setting of the lever was upwards. The incorrect fitting of the hook, with the lever downwards, prevented the inadvertent release of the hook because the lever could not come into contact with the davit. However, in that case the emergency release ("On-load release") would not work.

Figure 13: Release hook with the lever pointing downwards (incorrect setting)
Source: DMAIB

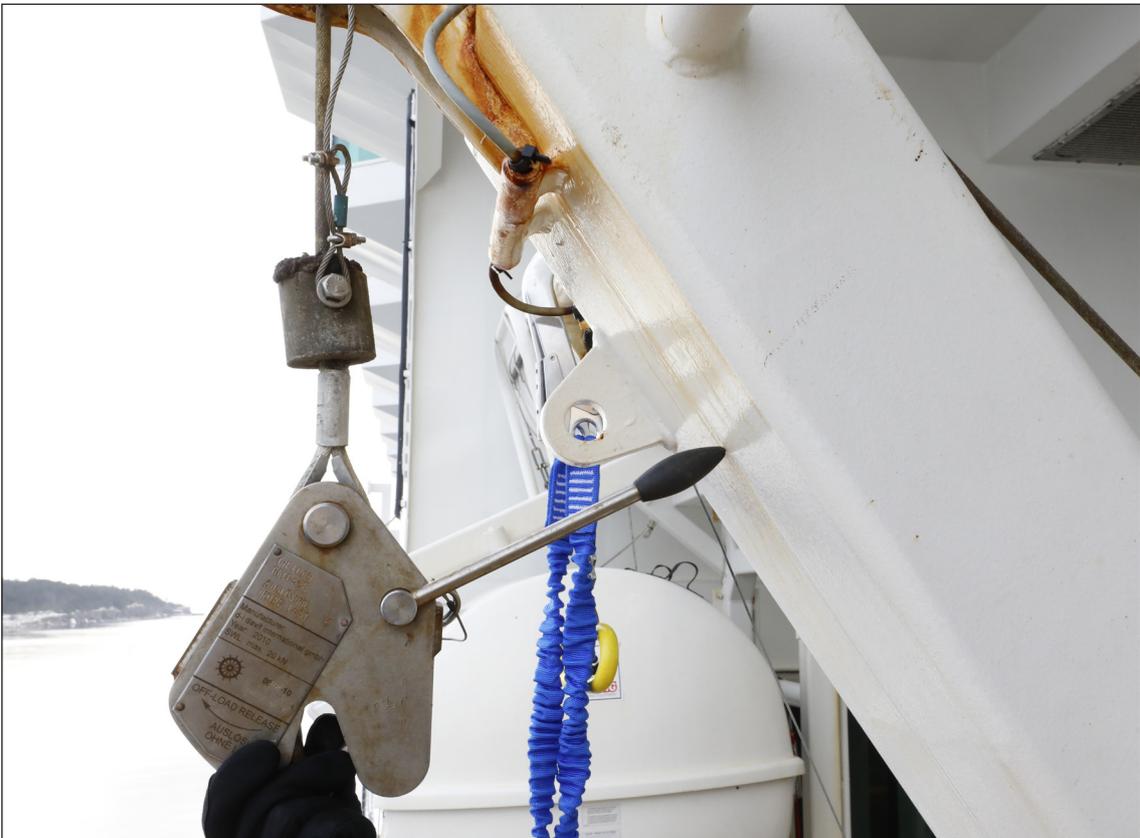
Figure 14: Release hook with the lever pointing upwards (correct setting)
Source: DMAIB

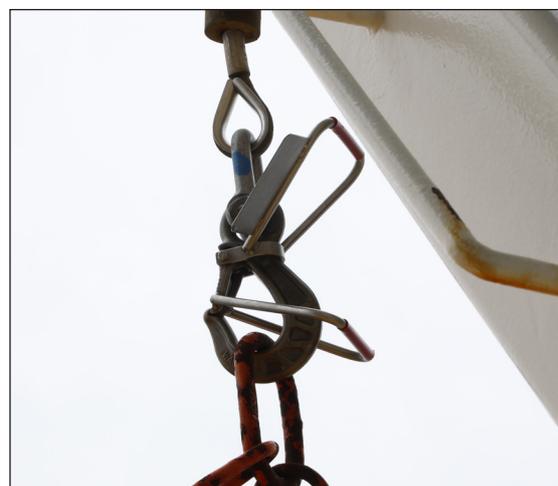
*Figure 15: New hook mounted on BERGENSFJORD
Source: Fjord Line*

In connection with the accident, the shipping company suspended use of the type of hook, as both they and the employees no longer had confidence in the system used. The task of finding a trustworthy and user-friendly solution was assigned to the ship's crew, who scoured the market. The chosen solution was the hook shown below (figure 15).

The hook is simple and intuitive. It is easy to get an overview of and it does not prompt any immediate doubts as to whether it has been fitted properly or not. It is also easy to inspect during maintenance.
