MARINE ACCIDENT REPORT

AMBER II and SEA WORKER
Loss of tow on 27 January 2016

This marine accident report is issued on 16 December 2016

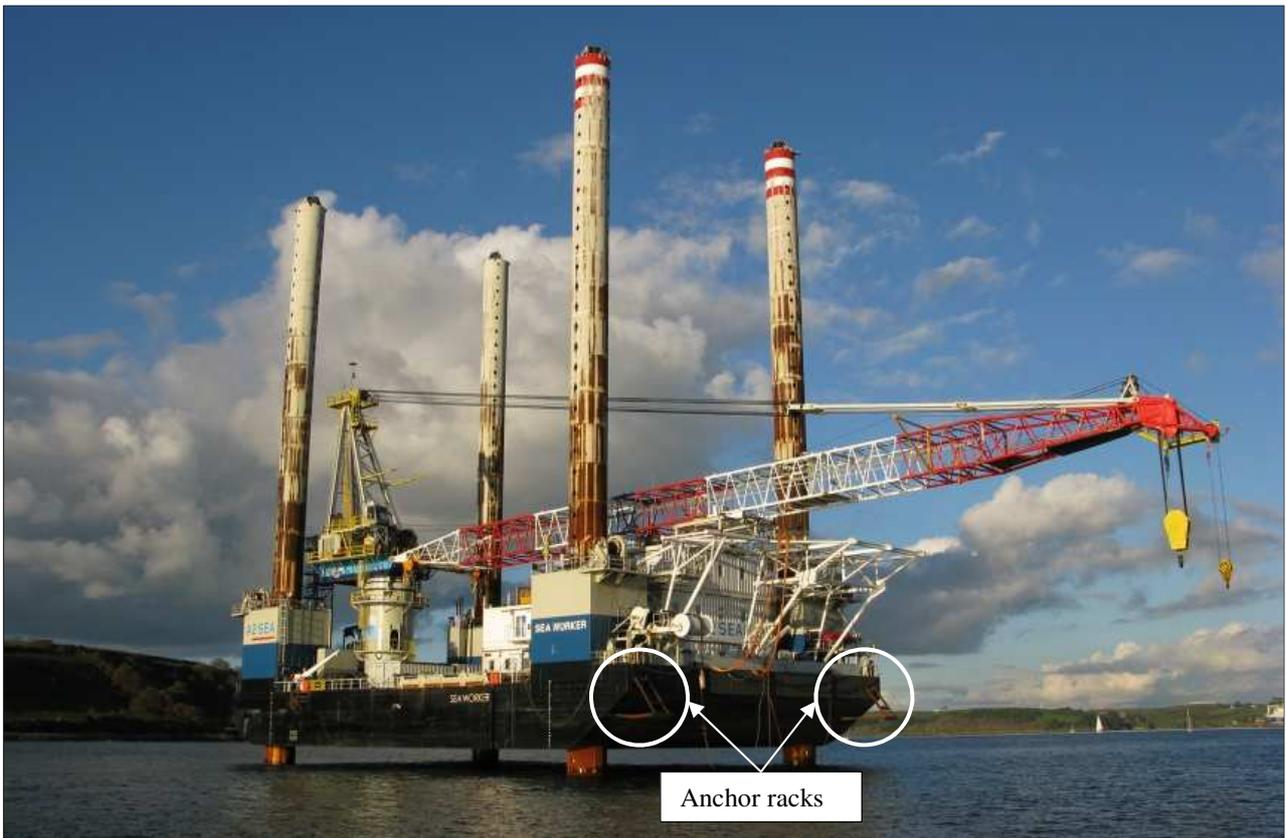
Figure 5: Anchor racks on SEA WORKER
Source: A2SEA

As the raft was lowered down the side of the platform, it got caught by an edge on the platform's hull and started to tilt. The chief officer climbed out of the raft and up on top of it, where he managed to free the raft from the edge while holding the raft's wire with his hand and pushing with his feet on the ship's side. The chief officer climbed inside the raft and lowered the raft on to the water. Once in the water, the chief officer had to climb out of the raft to manually operate the release hook, which succeeded after a couple of attempts. The raft drifted alongside the platform. At each corner of the platform, anchor racks protruded (figure 5), and due to the motions of the sea these were constantly moving up and down several metres. As the raft drifted very close to the platform's side, the chief officer was worried that the raft could get caught underneath one of these racks, but as it passed the rack, the raft steered clear of the platform.

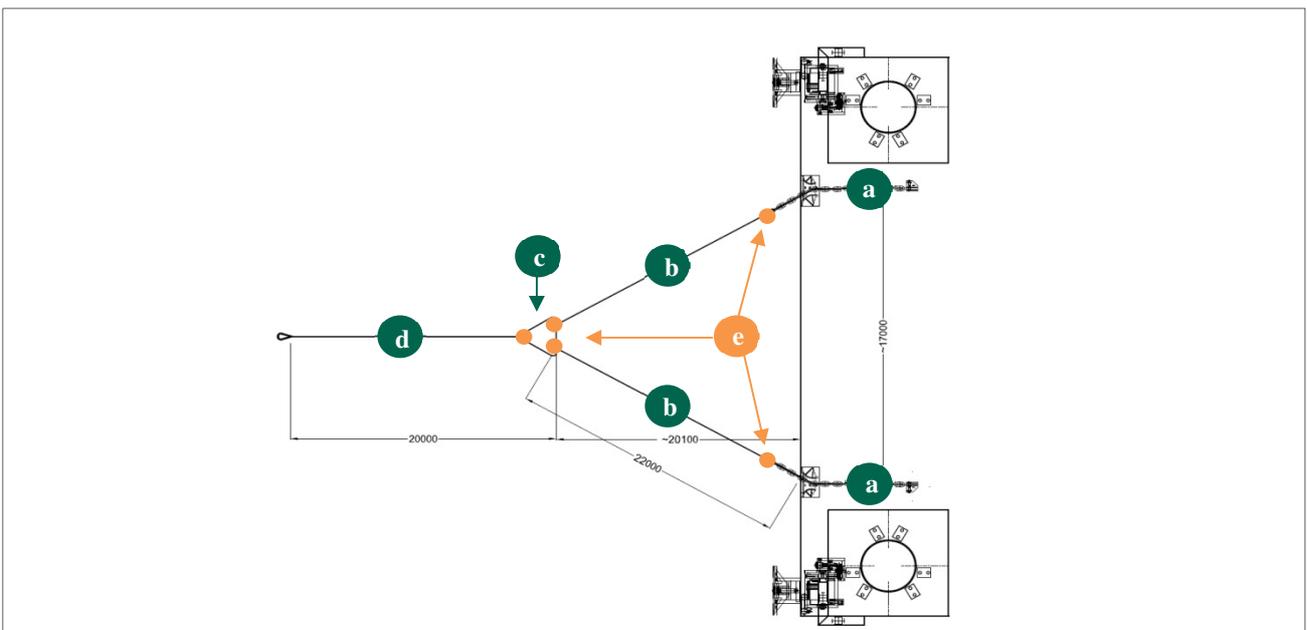
Figure 6: SEA WORKER's towing arrangement

In SEA WORKER's general towing arrangement, information on the different components was stated, e.g. dimension, safe working load and minimum breaking load (figure 7). However, the different types of components were described by different sets of information. In the figure below, it should be noted that a safe working load was given for shackles, stud link chains and the towing plate, but not for the steel wires.

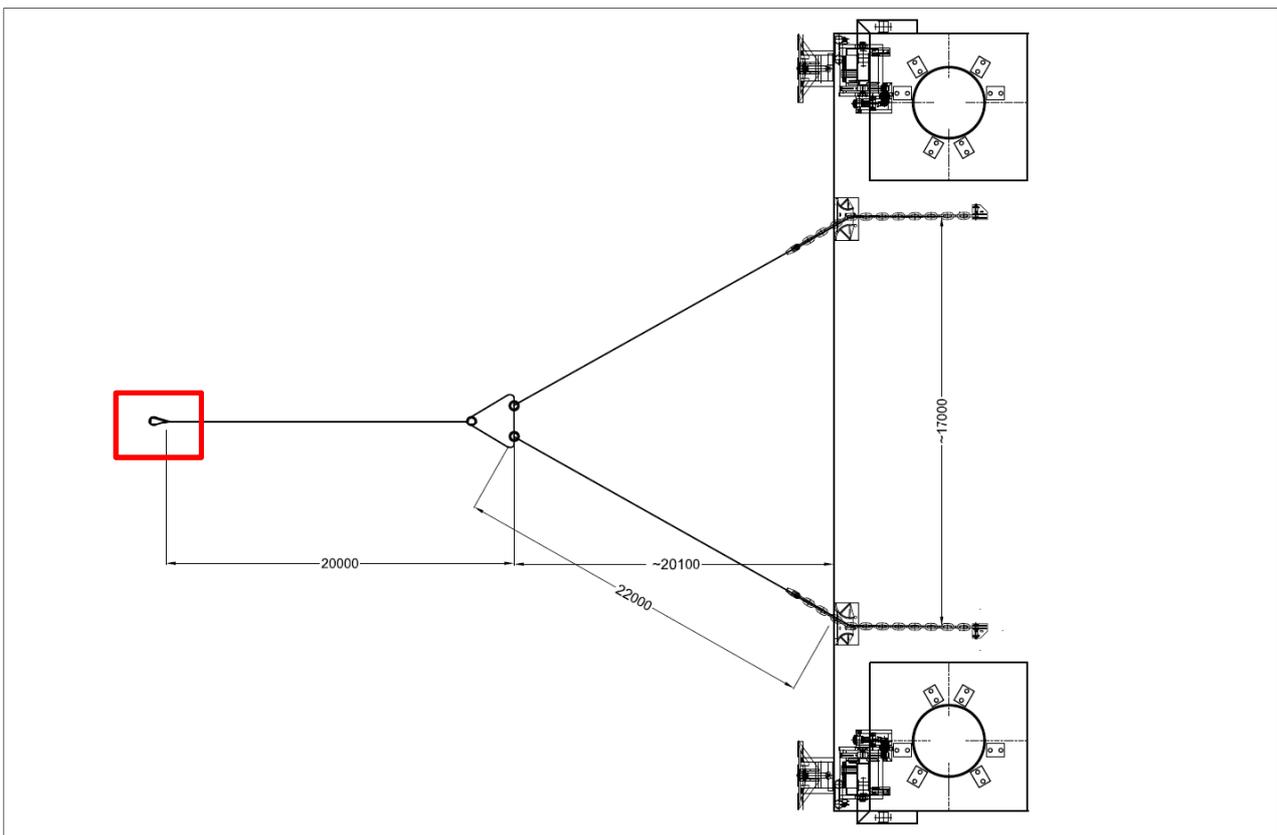
Figure 8: Location of the wire fracture

The tow broke at SEA WORKER's towing pennant, just behind the aluminium clamp of the pennant's thimble eye (figures 8, 9, 10). The fractured wire has been examined by FORCE Technology with the purpose of establishing the condition of the wire and a cause for the fracture.

Based on the FORCE report and the facts provided on the weather conditions at the time the wire broke, the DMAIB has found it likely that the towing pennant broke due to overload. The strain on the wire, caused by heading up against strong winds and current, the impact and movements of towing in high waves with short roll periods, and the tug pulling at a constant engine power, exceeded the wire's minimum breaking point, causing the wire to break at its weakest and least flexible point, the aluminium clamp.

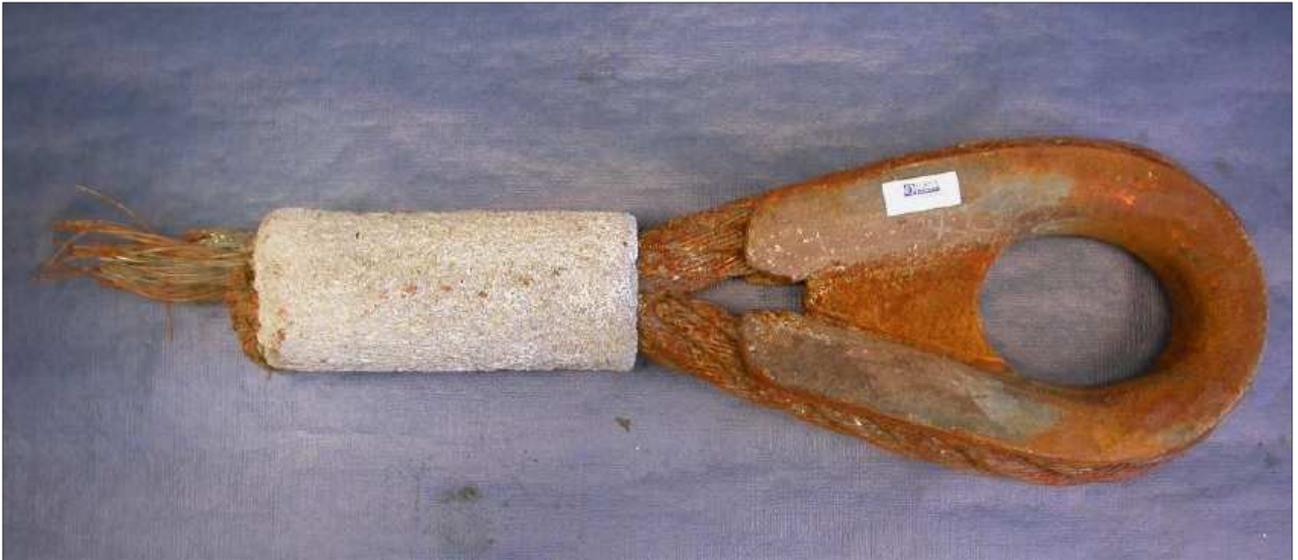
Figure 9: The fractured steel wire
Source: FORCE Technology

The FORCE report concludes that the wire showed no signs of material defects or manufacturing imperfections. The wire appeared with slight surface corrosion as expected due to normal wear and tear, which might cause the tensile strength of the individual wire strands to be slightly below the required value. The Talurite clamp appeared severely corroded. However, the FORCE report does not ascribe these results as significant factors for the fracture. Instead, FORCE suggests that, based on the location of the fracture, the angle of the individual wire strands' fractures and contractions at the fracture surfaces: *"the cause for the fracture is a sudden overload at an unfortunate angle for the wire rope end"* (figure 10).

An examination of the wire carried out by FORCE Technology concluded that the fractured steel wire showed signs of wear and tear as expected for a wire that had been exposed to sea water in normal service, and that it showed no sign of manufactural defects. However, the corrosion found on the wire was not linked directly to the parting of the wire. Instead, the report concluded that the nature of the fracture indicated that the wire broke due to overload.

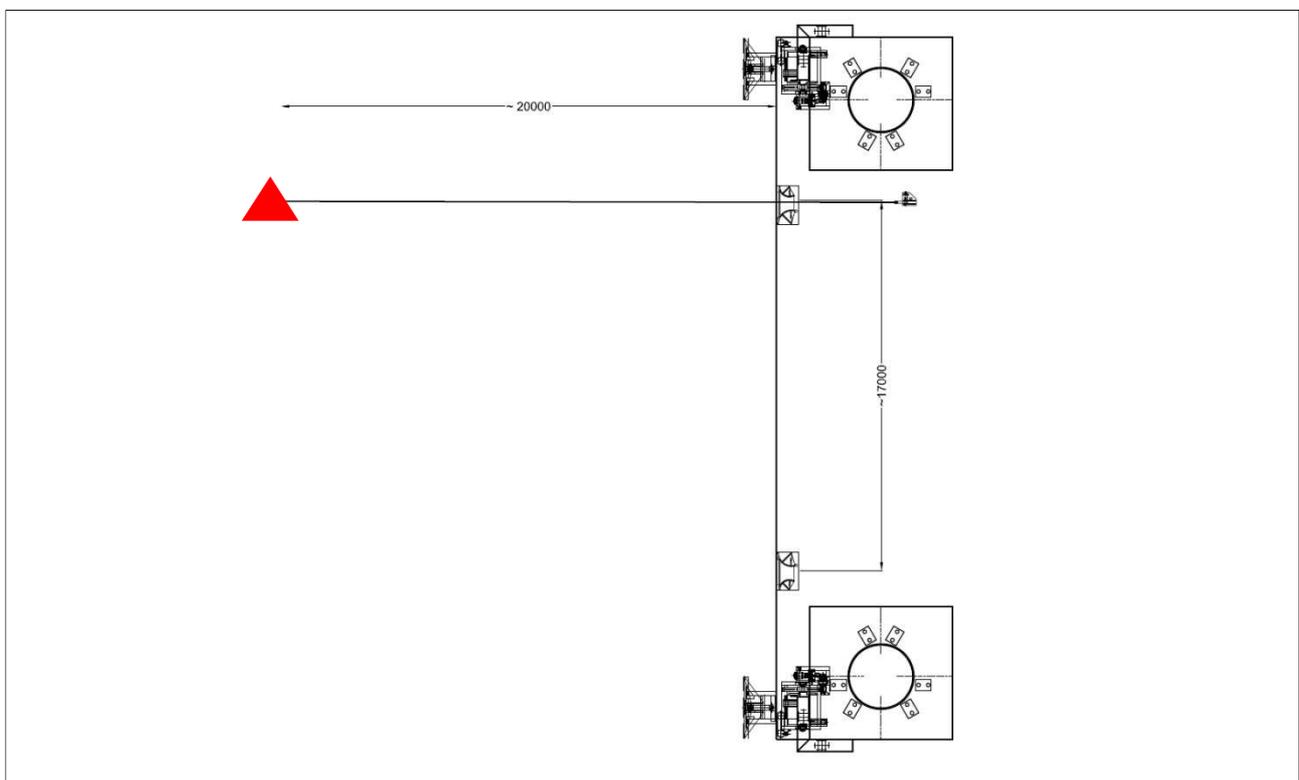
Figure 11: Excerpt of SEA WORKER's general arrangement
Source: DMAIB

SEA WORKER was equipped with an emergency towing wire fastened and stowed on deck at the bow. The emergency towing wire consisted of a single steel wire fastened on deck with a Smitt bracket and with a buoy mounted at the end of the towing wire (figure 11). The emergency towing wire was not fitted with a bridle, which meant that the ability for the tug to keep the platform within a desired angle was reduced. Therefore the emergency towing line was intended for the limited purpose of bringing the towage into sheltered water or a port of refuge, in case of emergency. The towing wire's safe working load was 20 t.

No procedure described how the emergency towing equipment was to be used, but the general principle of the emergency towing arrangement on SEA WORKER was that the equipment was to be deployed in case the main towing wire failed, and that the equipment then would drift alongside the platform and fall behind the platform, clear for the tug to pick up. During the release of the emergency towing line following the failed main towing connection on 27 January 2016, the buoy was caught alongside SEA WORKER making it impossible to pick up for AMBER II.

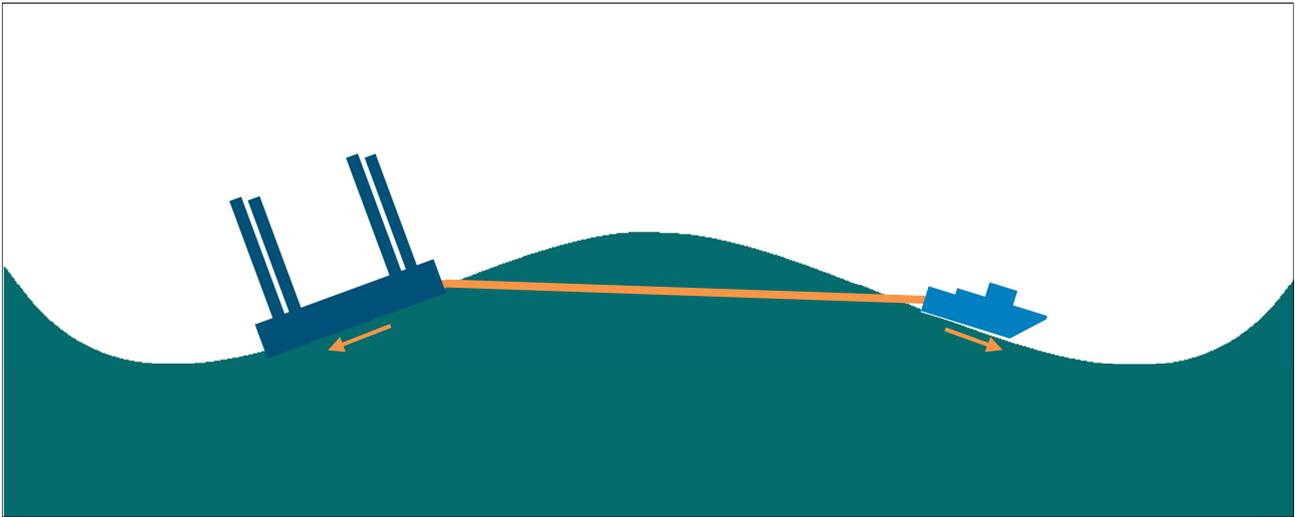
Figure 14: Towing situation with a tightening towing wire due to waves
Source: DMAIB

The bottom figure shows an undesirable situation where the towing vessel and the towed object are situated on each side of a wave. In this situation the towing vessel will pull forward, while the towed and often heavier object pulls in the opposite direction, causing substantial extra load on the towing line. Thereby, the towing wire is tightened, and the elasticity is lost. This can cause the wires or the joints of the tow to fail. When this situation occurs, the only way of reducing the strain on the towing wires is for the tug to idle or even reverse its engines, in order to let itself being pulled in the towed object's direction.

a significant height and frequency while maintaining speed or position most likely imposed situations where the tug and the platform were situated on each side of a wave. This caused the tug and the platform to pull in opposite directions on the wire, significantly increasing the load on the wire, and causing the wire to tighten up and lose its flexibility while being exposed to significant movements. As the towing pennant fractured at its least flexible point at the clamp, the heavy load, frequency and movement of waves coming between the tug and platform most likely contributed to the parting of the wire.

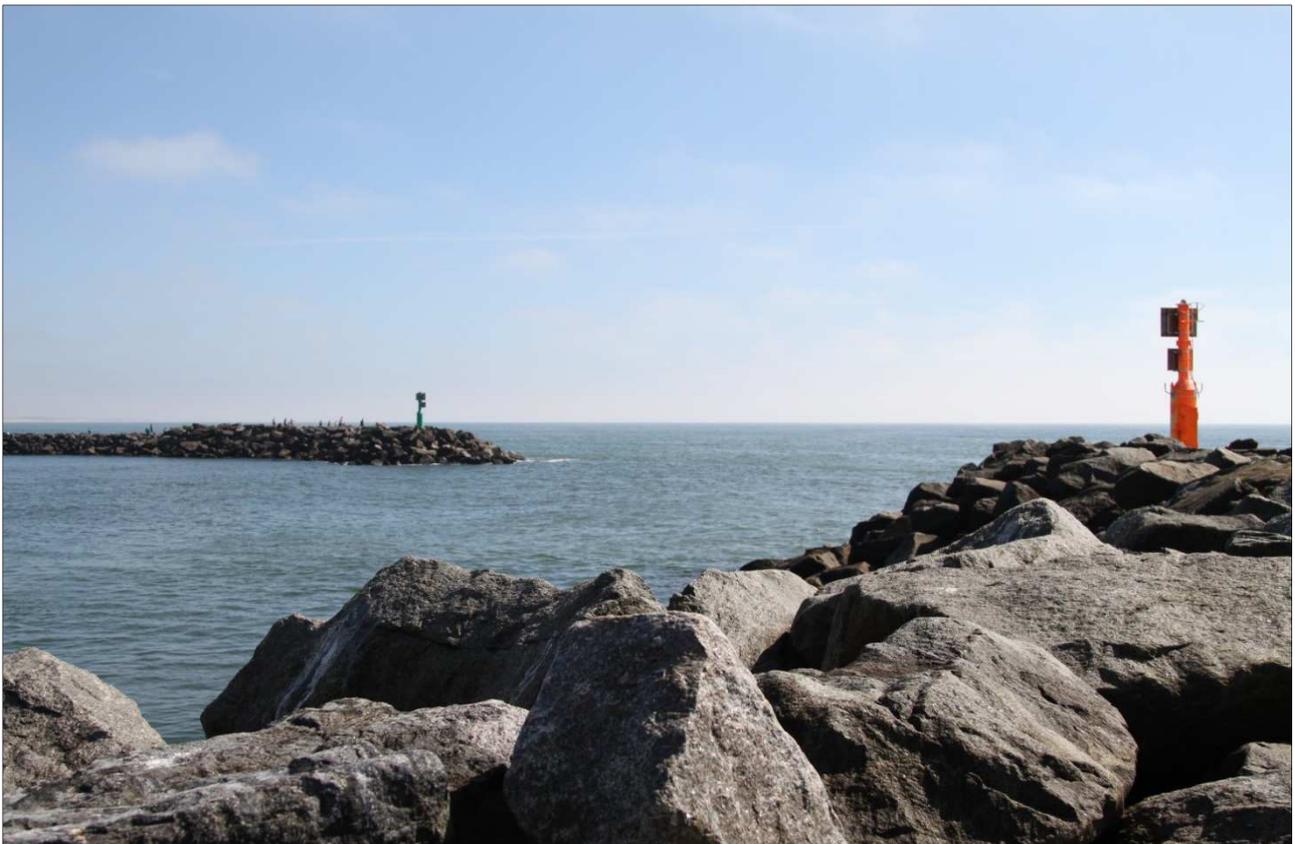
Figure 14: Breakwater, port of Hvide Sande
Source: DMAIB

- *Nature of the break water:* The breakwater at the port's entrance consisted of rows of piled large, edged stones (figure 14). The construction broadened from the top down, which meant that the stone breakwater would extend considerably under the water. Both pilots perceived contact with the breakwater as a serious event and even life-threatening, because the stones could tear up the ship's hull.
- *Waves and possibility to board AMBER II or SEA WORKER:* In Hvide Sande, the rescue boat serves as a pilot boat. The rescue boat has an operational limit of 3 m wave height for this service. This means that the port effectively closes for pilotage at this wave height. At the estimated time of arrival, it was forecasted that the limit would be exceeded.
