# MARINE ACCIDENT REPORT

## April 2016

**CAROLINE MÆRSK**  
**Fire in containers on 26 August 2015**

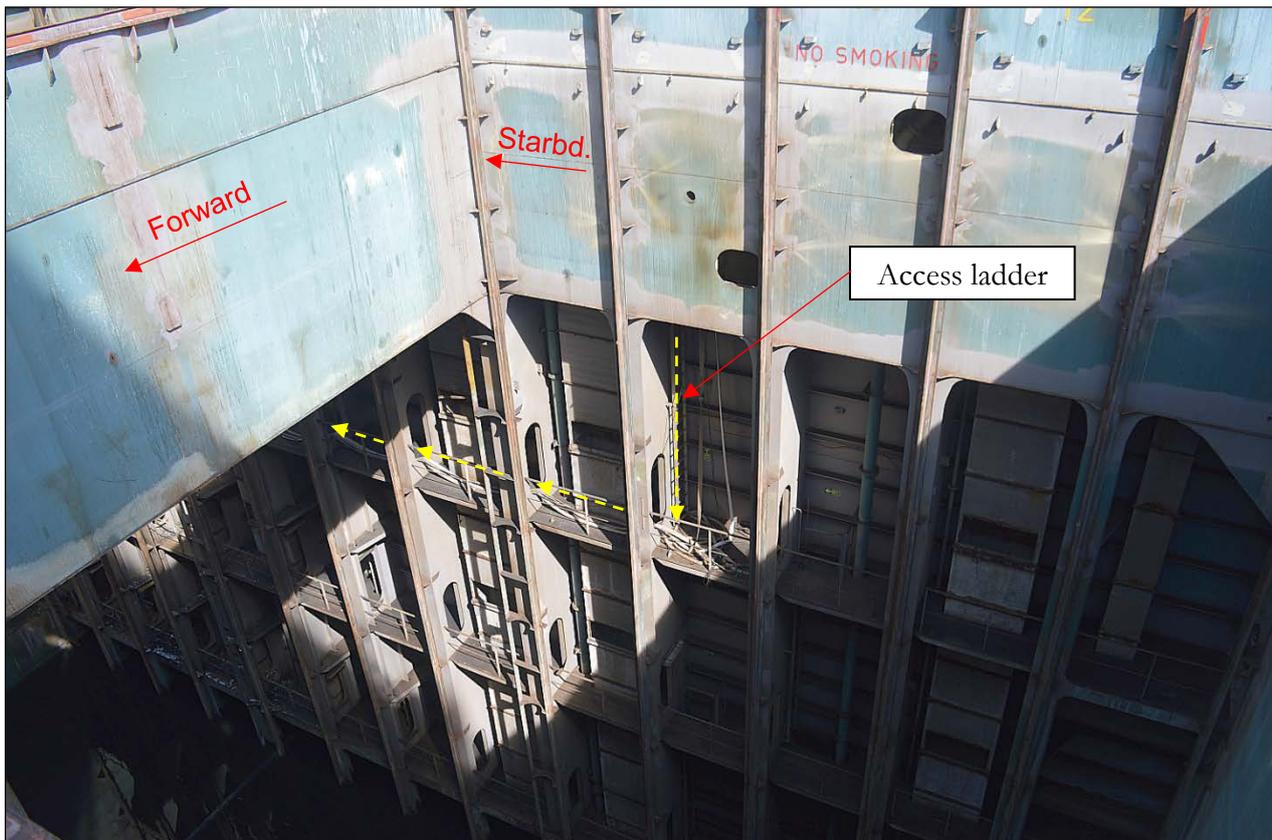
Figure 4: Cargo hold 9, transverse gallery decks, firefighters' access route to fire indicated in yellow  
Source: DMAIB

Equipped with firefighter's outfits, breathing apparatuses and fire hoses, the two firefighters had great difficulties entering and manoeuvring in the hold, struggling with dragging the pressurized fire hoses with them through the steel structure, mainly because the hose couplings kept getting stuck whenever passing a manhole. The firefighters saw no flames and felt no significant heat while searching for the fire, and when the air supply was running out after about 20 minutes, they made their way back up, without having been able to locate the source of the fire. Having returned to the deck, they briefed the second firefighting team.

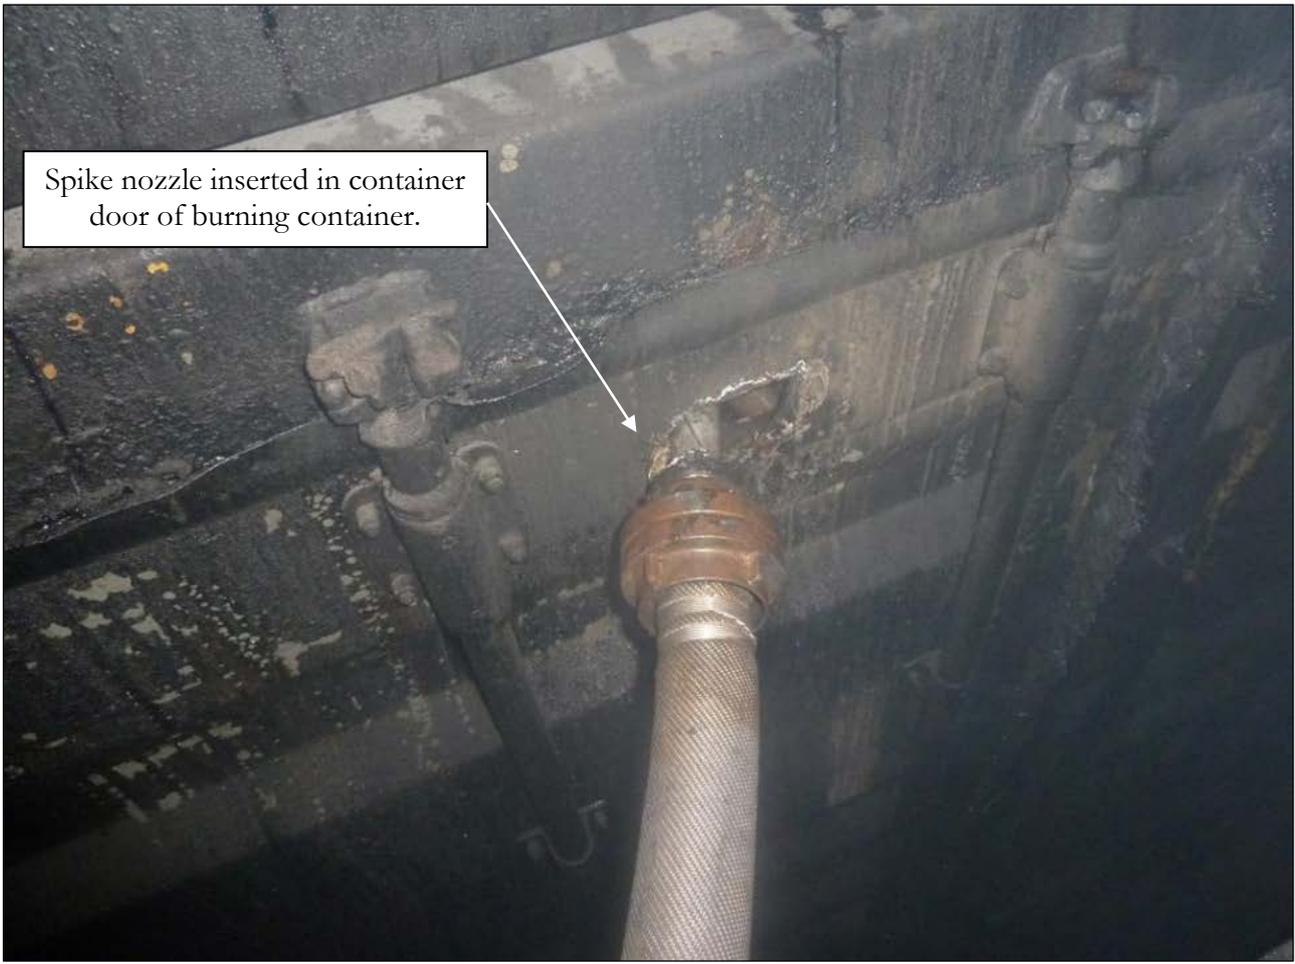
It was decided to close the hold, maintain the cooling, and allow the crew some rest and time to consider alternative approaches. The company crisis team advised the master to make another attempt at placing the spike nozzle in the burning container, this time using an angle grinder. The 2<sup>nd</sup> officer volunteered for the task. To pre-empt unnecessary difficulties once he was in the hold, the chief engineer instructed the 2<sup>nd</sup> officer in effective use of the angle grinder by practicing on containers on deck, well away from the constrictions of wearing the firefighter's outfit, and operating in darkness, heat, noise, and a limited amount of time. Just after 0400 on the second day, the 2<sup>nd</sup> officer had managed to cut a hole, place the spike in the container (figure 6), and turn on the water flow inside it. Soon after, the fire was considered under control.

*Figure 6: Burning container with spike nozzle inserted.*

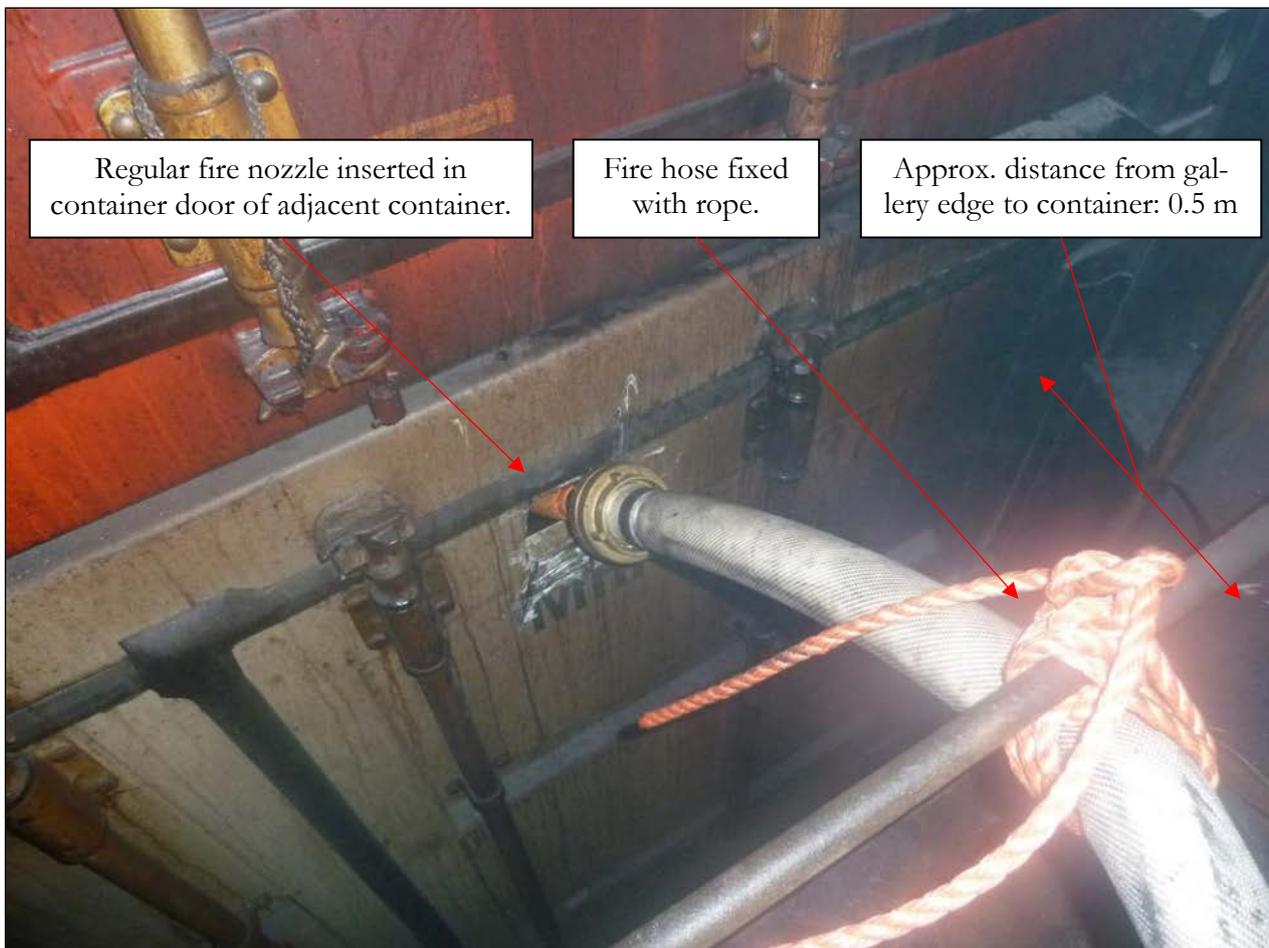
Later in the morning of the second day, smoke and steam in increasing amounts were observed coming from the cargo hold. A firefighting team entered to investigate and evaluate the situation. When they returned, they reported elevated temperatures (65°C as compared to the surrounding temperature of approximately 45°C) in the containers adjacent to the burning one. During the following 12 hours, the situation was kept under observation, and another three teams entered the hold during that period to measure temperatures and check the water level in the hold. Based on these evaluations, it was decided to cut holes in the two adjacent containers and flood them with water as well. Since only one special container spike nozzle was available, the crew instead inserted standard fire nozzles into the two containers (figure 7).

*Figure 7: Container with regular fire nozzle mounted.  
Source: MÆRSK Line*

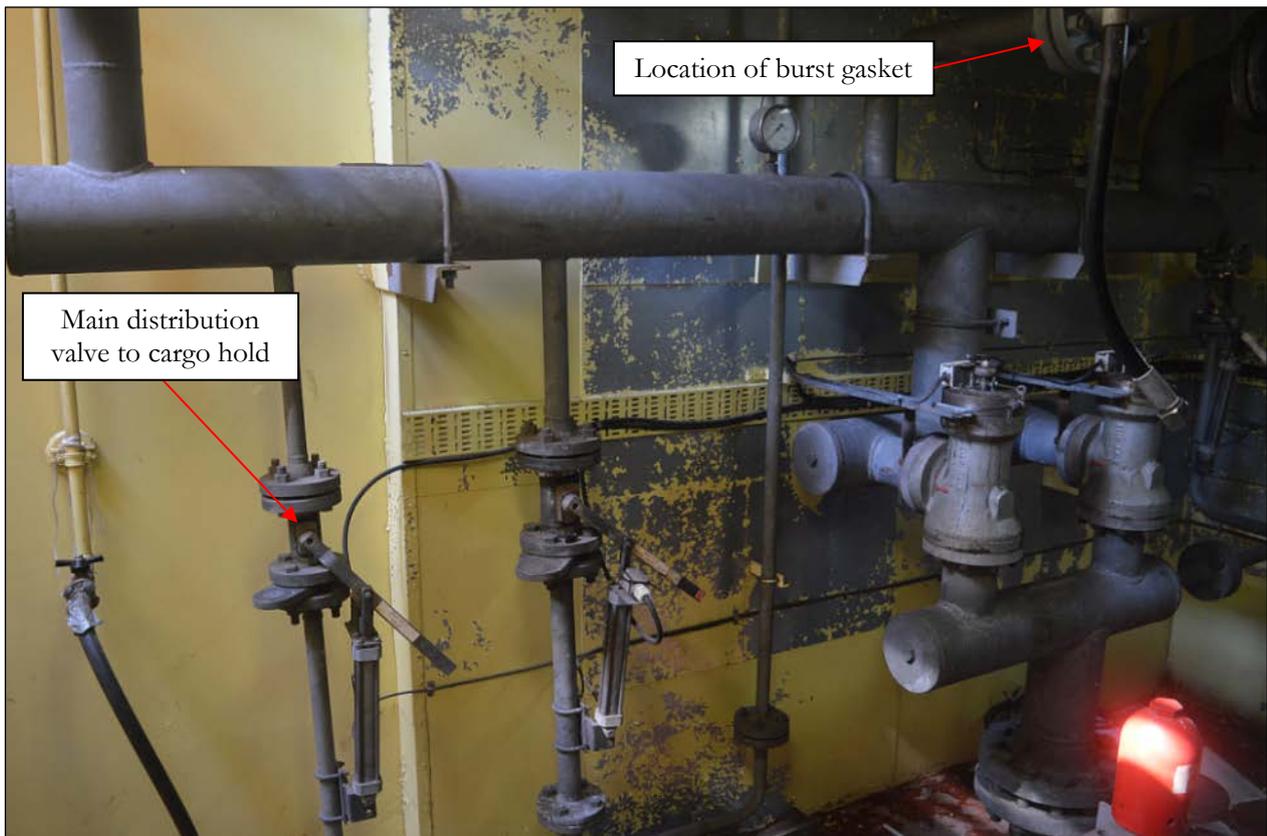
On the day of the accident, although operated in accordance with the procedures, the system failed to release CO<sub>2</sub> into the cargo hold. A subsequent third party examination of the CO<sub>2</sub> system indicated that the cause of failure was that the control valve in the fire control station (ship's control centre) release cabinet was not in the fully opened position. This could have led to the venting of CO<sub>2</sub> from the pilot line causing the distribution valve to not open. The examination showed no signs that the burst gasket in the main pipeline had been of a wrong type or mounted incorrectly. It

is likely that the gasket burst as a result of the sudden blast from the released CO<sub>2</sub> building up high pressure due to the stuck valve. Figure 9 below shows the CO<sub>2</sub> room after the accident.

*Figure 9: CO<sub>2</sub> room on CAROLINE MÆRSK, main distribution valve indicated  
Source: MÆRSK Line/DMAIB*

The CO<sub>2</sub> system failed as a main distribution valve did not open, resulting in a near-explosion in the CO<sub>2</sub> room, which presented a serious risk to the crew who had mustered in the area. Another consequence was that very little CO<sub>2</sub> actually reached the cargo hold. At the time of the fire discovery, the crewmembers did not know the source of the fire nor the extent and therefore had no way of knowing the most effective way to fight it, before assessing the situation. As they also did not know the contents of the cargo in the containers, they had no chance of knowing whether releasing CO<sub>2</sub> into a cargo hold would be the most effective approach, or if manual extinguishing would be effective or even possible. For some fire scenarios, such as a smouldering fire inside a container, CO<sub>2</sub> is not a particularly effective method, as the fire will often flare up again when oxygen levels in the hold are restored.

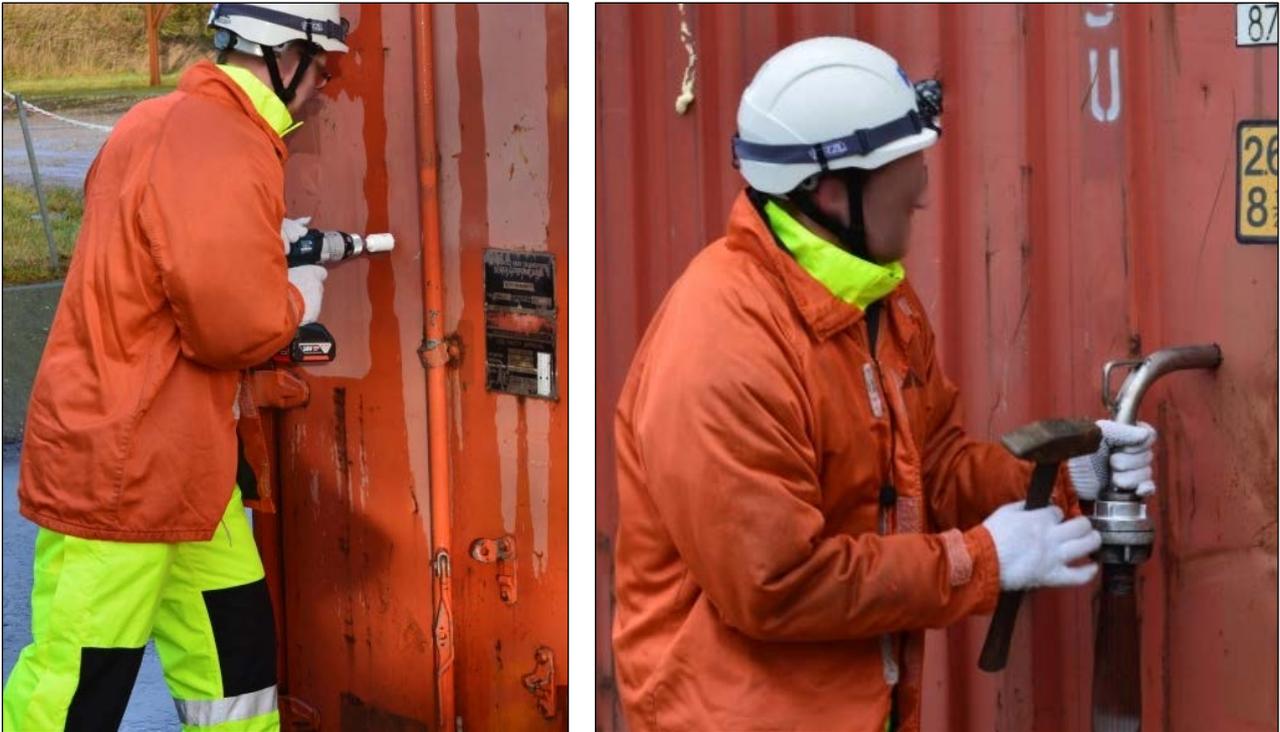
*Figure 11: Container firefighting equipment – photos from DMAIB tests*  
*Source: DMAIB*

The hole saw bit similar to the one on board CAROLINE MÆRSK could penetrate a standard container door. However, by coincidence the first attempt with the hole saw was made in a location where there was a structural reinforcement on the inside of the door. After one attempt, the hole saw was worn down and not capable of further attempts. During the attempt, the centre bit (pilot drill bit) fell out and had to be refitted.

Subsequent tests with higher quality bits and hole saws showed that these were capable of drilling several holes in the container without showing significant signs of wear.
