The Danish Maritime Accident Investigation Board
Carl Jacobsens Vej 29
DK-2500 Valby
Denmark

This marine accident report is issued on 15 January 2016.

2.1 Photo of the ship

Name of vessel:	SELANDIA SWAN
Type of vessel:	Chemical/products tanker
Nationality/flag:	Denmark
Port of registry:	Middelfart
IMO number:	9371787
Call sign:	OYIN2
DOC company:	Uni-Tankers A/S
IMO company no. (DOC):	4012481
Year built:	2008
Shipyard/yard number:	Gisan Gemi Ins. San - Istanbul Yard/hull No. 40
Classification society:	DnV GL
Length overall:	147.50 m
Breadth overall:	138.00 m
Gross tonnage:	11,711
Deadweight:	17,998 t
Draught max.:	9.49 m
Engine rating:	6,300 kW
Service speed:	14 knots
Hull material:	Steel

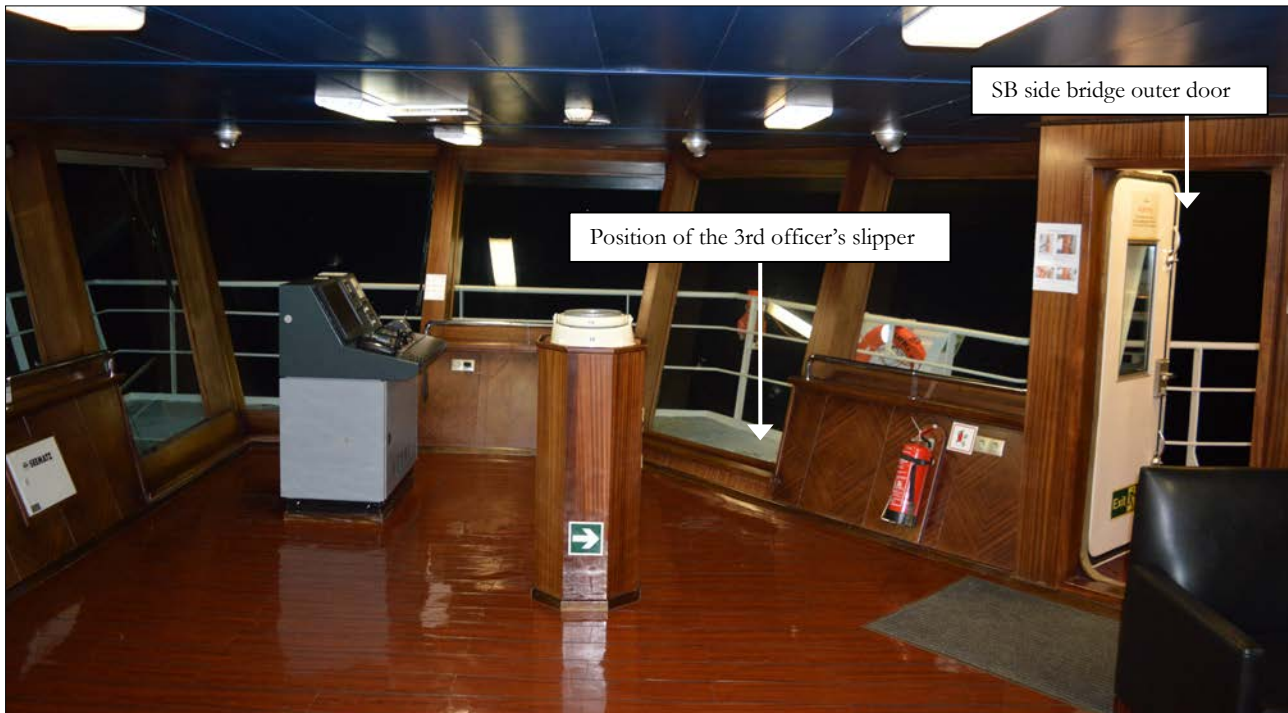
Figure 3: Picture of the starboard side bridge wing
Source: DMAIB

SELANDIA SWAN's navigation bridge had closed bridge wings with outer doors on each side facing aftwards. In the picture below (figure 3) the starboard side bridge wing can be seen from where the AB noticed the open outer door and a slipper lying on the grating. The aim of the investigation of the navigation bridge was to establish the time when the 3rd officer fell overboard and the causal circumstances of the accident.

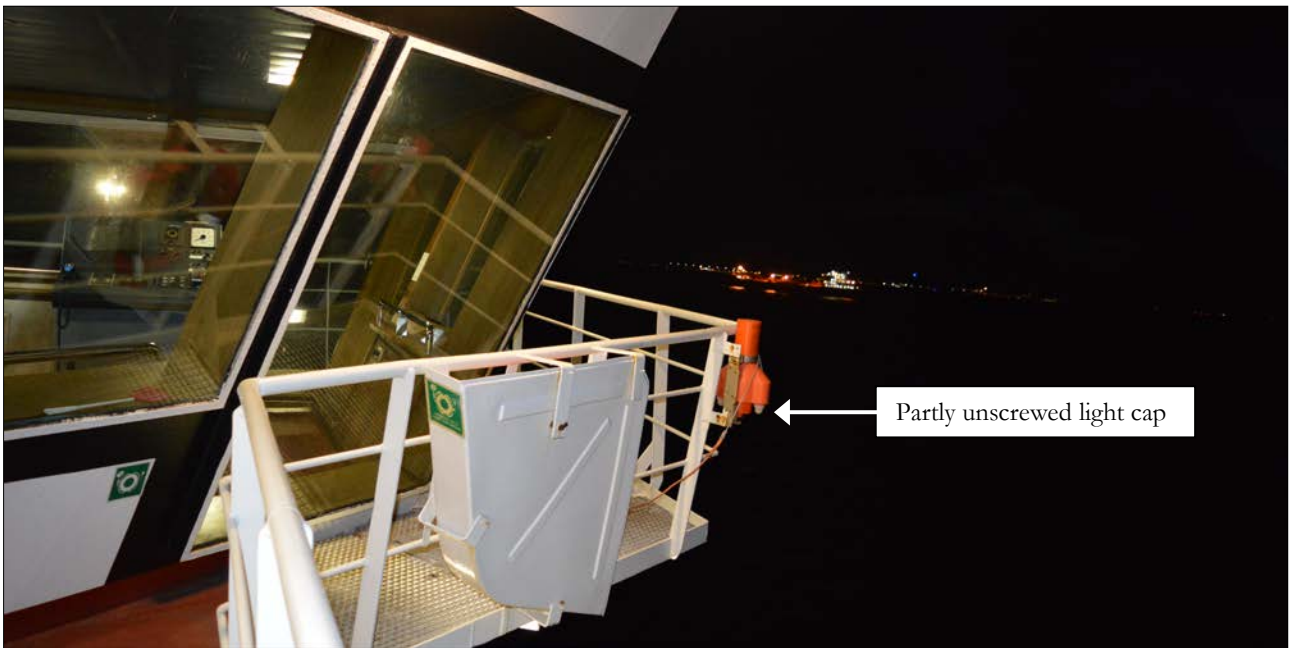
Figure 4: Picture of the starboard side lifebuoy
Source: DMAIB

An investigation of the navigation bridge indicated that the 3rd officer fell overboard while he was inspecting the buoy mounted on the outside of the starboard side bridge wing (figure 4).

This assumption was based on the fact that a slipper belonging to the 3rd officer was found by the starboard side lifebuoy, and there were indications that the 3rd officer was in the process of inspecting and dismantling the light caps from the lifebuoys (figure 4) on each side of the navigation bridge.

The light cap on the starboard side lifebuoy was found to be partly unscrewed (figure 4).

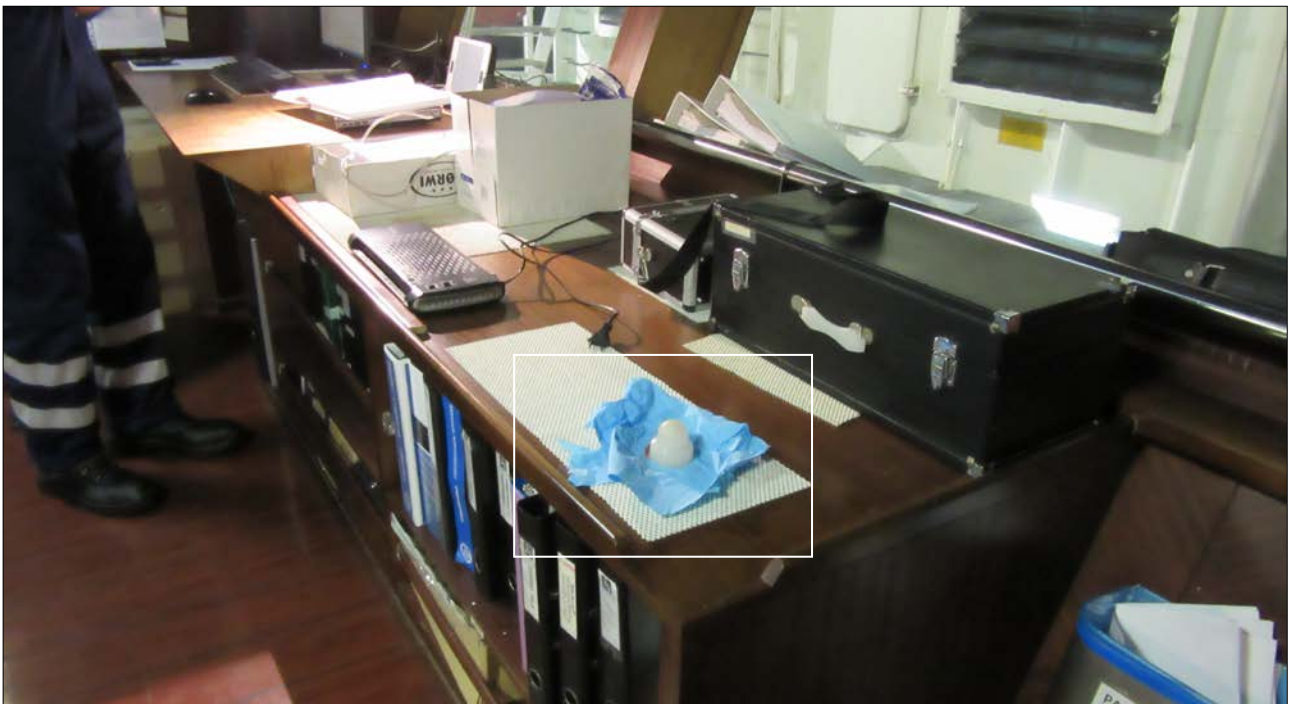
Figure 5: Picture of the light cap as it was found on the chart table
Source: DMAIB

One of the light caps and two O-rings from the port side lifebuoy were found on the chart table on the port side of the bridge (figure 5). The light bulb was found mounted on the smoke signal and showed no sign of being defective.

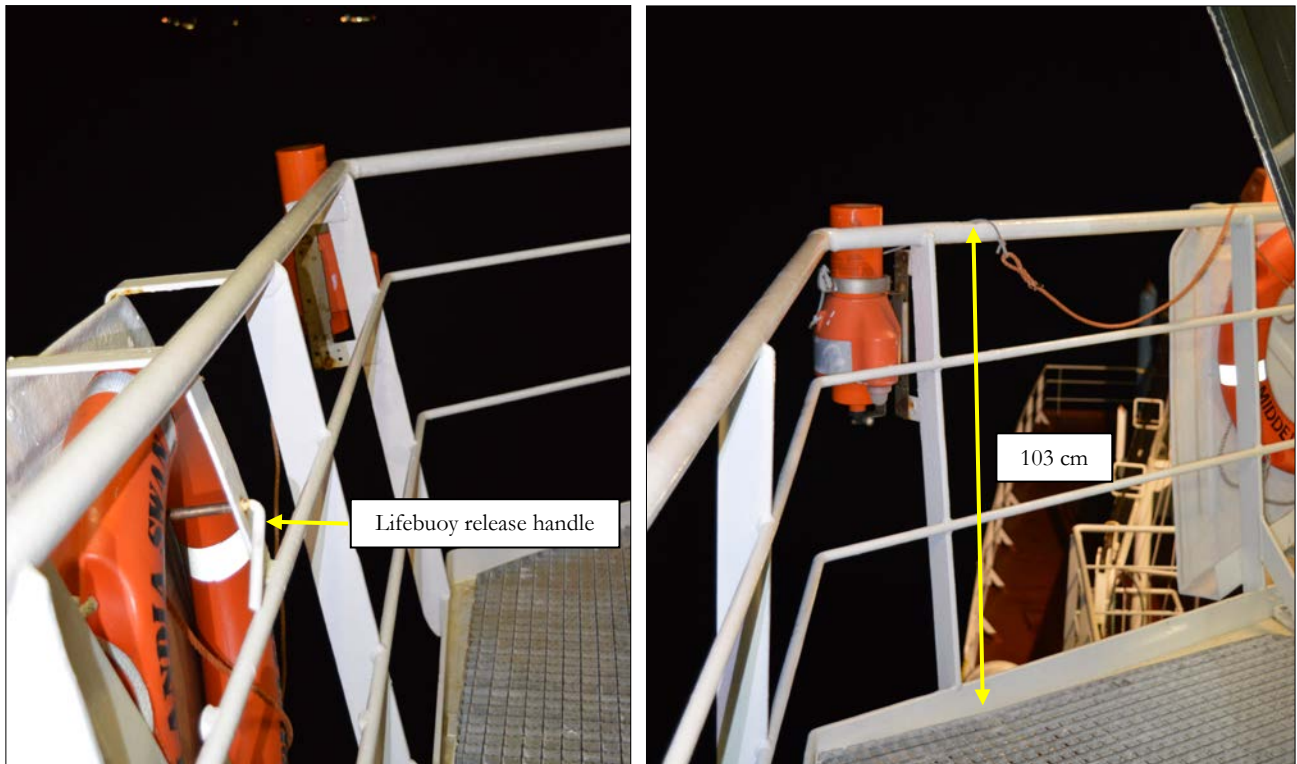
Figure 6: Overview of the workplace
Source: DMAIB

On the starboard side, where the 3rd officer's slipper was found, the guard rail was 103 cm in height with two intermediate bars with between 20 and 30 cm clear width. The buoy was mounted on a steel bracket by the passageway on the outside of the guard rail stanchion (figure 6), which made it inconvenient to access.

The only way to have a complete view of the lifebuoy was either to lean over the guard rail or to kneel on the grating to have a view between the intermediate bars. It would most likely be considered inexpedient to dismantle the smoke signal from the bracket, because it was difficult for one person to hold the device while removing the locking pin at a risk of dropping the smoke signal overboard.

The 3rd officer was 173 cm tall, which would make it difficult for him to lean over the guard rail without stepping up on the intermediate bar. It is therefore likely that the 3rd officer stepped on the intermediate bar and leaned over the guard rail in order to loosen the light cap with the purpose of inspecting the light. In that process he most likely fell overboard.

The accident was therefore not a result of a lack of structural barriers, but rather due to the absence of clear instructions on how to go about inspecting the buoy. In the absence of instruction or guidance, he made a detailed inspection of the only item he could – namely the light. Neither the workplace nor the lifebuoy was designed for maintenance work. In order to carry out that inspection he had to climb the guard rail, thereby exposing himself to the risk of falling overboard. Presumably, he did not don a harness and fall arrester, because the risk of falling was not apparent to the 3rd officer as he was still behind the guard rail.

- The work descriptions in the maintenance systems will be revised so they are more specific in describing the work tasks during monthly and weekly inspections on components that require visible inspection.
- Two railing extensions have been mounted on the bridge wings thereby making the railing higher.
- The company has decided to limit the number of different types of lifebuoys.
