Danish Maritime Accident
Investigation Board

MARINE ACCIDENT REPORT

ORION and NECKAR HIGHWAY
Collision and foundering on 1 July 2015

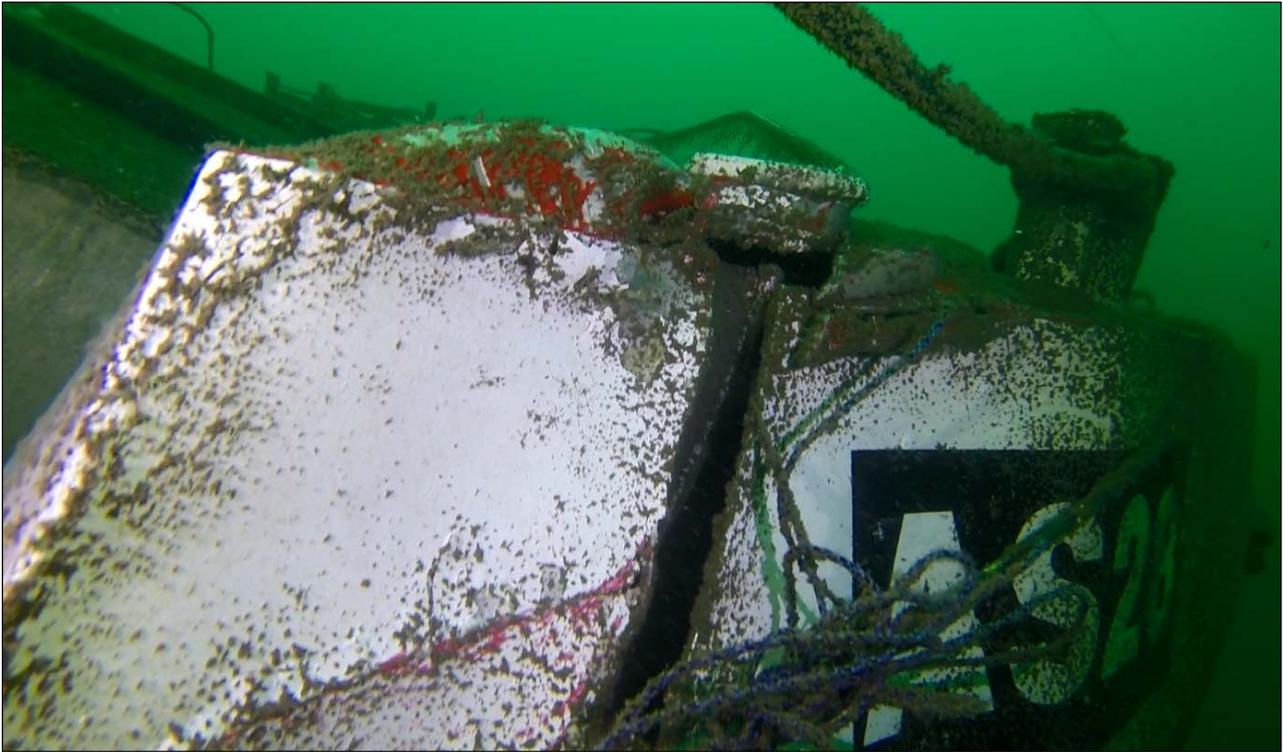
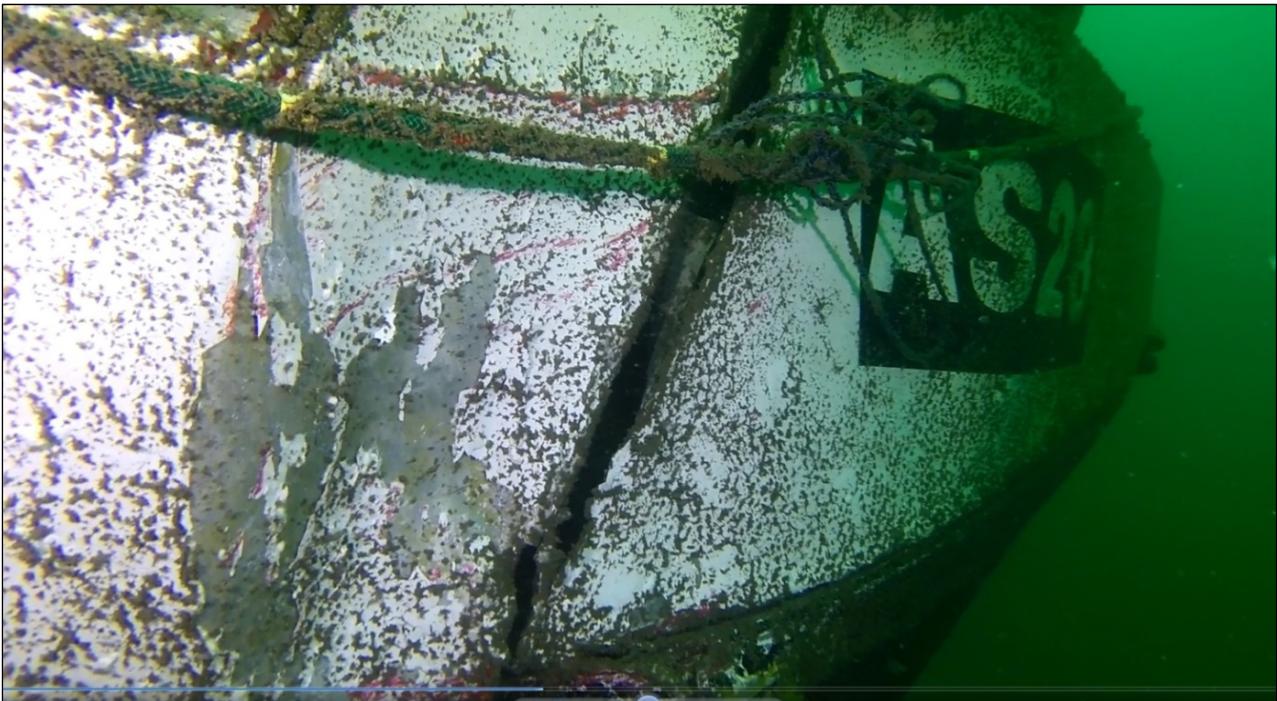
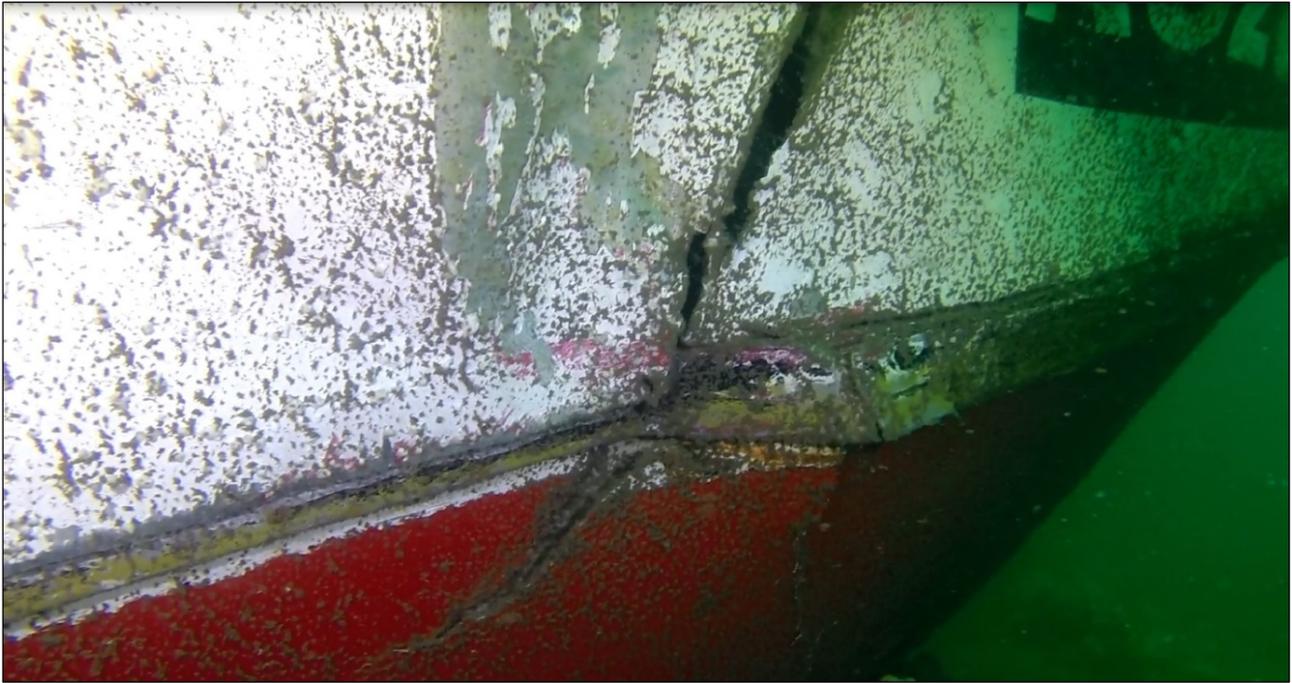
The wreck of ORION was photographed during the diver's investigation. Significant damage was found in two locations on the starboard side of the hull. Figures 4-6 show the indent and hull cracks on ORION's forward starboard side:

1. A significant, deep and almost penetrating scraping in the hull forward on the starboard side near the keel. A large rock on the seabed was situated nearby and was of a size that fits the scraping on the hull. The damage was most likely caused by the impact of the ship hitting the rock on the seabed.

2. A significant indent in the hull on the starboard side on the forecastle near the ship's port registration letters. In connection with the indent, an almost vertical crack in the hull was running from the gunwale and down to the middle of the ship's side where the alloy construction of the forecastle met the GRP hull (figures 4, 5, 6). From there, the crack divided in four cracks running further in the direction of the keel and horizontally along the joint between the alloy and the GRP construction of the hull. It has not been possible to identify the exact dimension of the cracks at the indent; therefore the description of the damages to the hull is based on an estimate: the vertical gaps stretched for approx. 1.5-2 metres from the gunwale towards the keel, and the horizontal gap was of a metre's length. A significant occurrence of red paint scrapings was visible on the starboard side along the indent (figure 5).

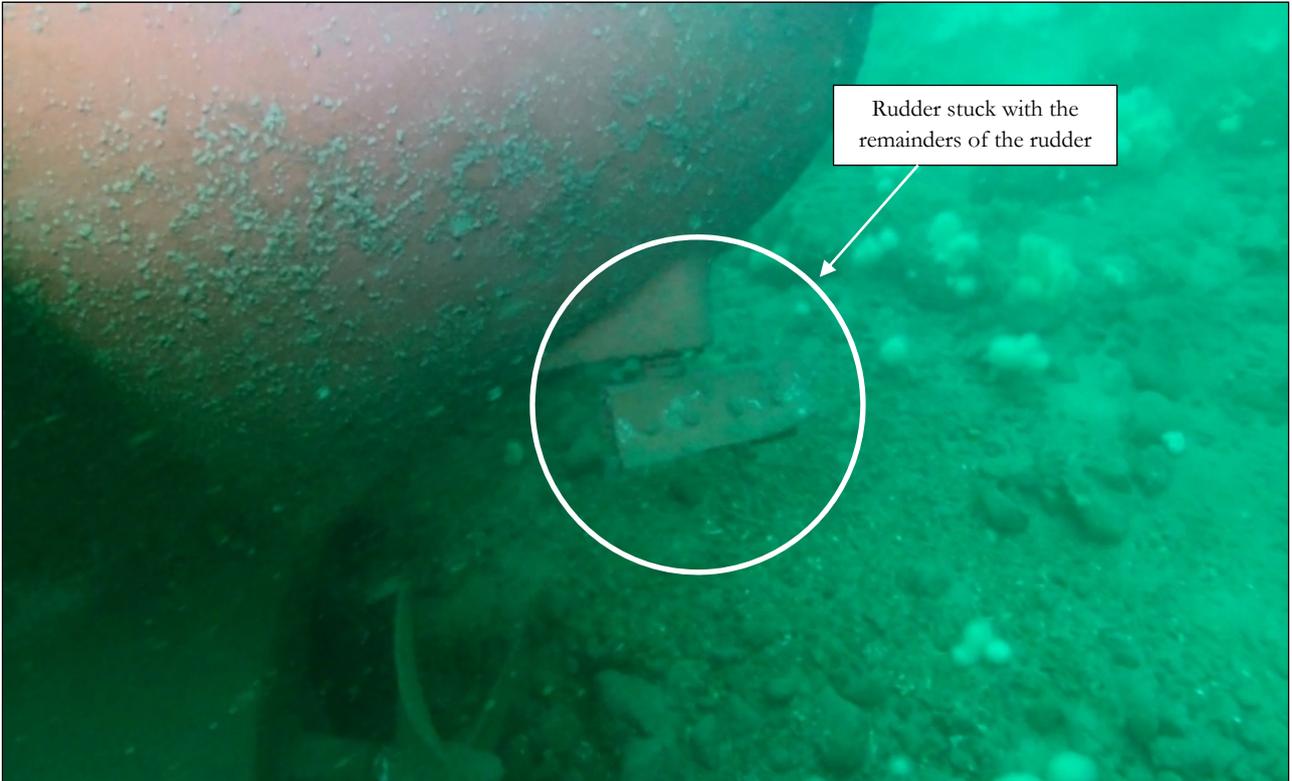
Figure 7: Scene of the accident
Source: DMAIB

Figure 7 below shows ORION's heel. The rudder was missing with only the rudder stock left. The rudder was most likely torn off by the impact of the collision. The remaining part of the rudder was bent to the port side.

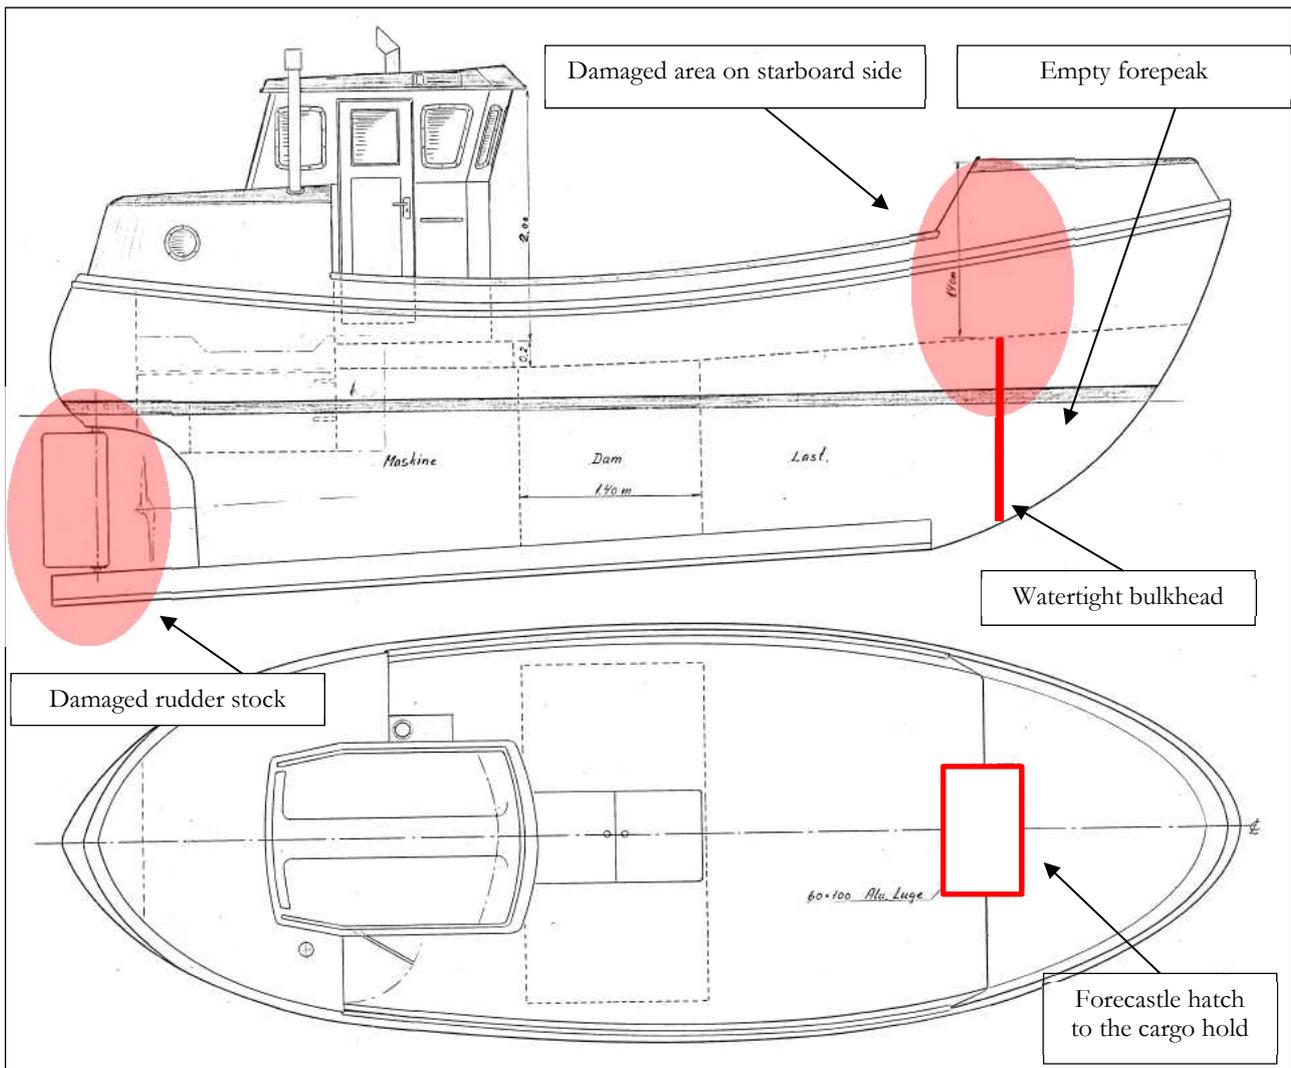
Figure 8: General arrangement of ORION before alterations
Source: DMAIB

Figure 9 shows the general arrangement of ORION with the DMAIB's indications of the damaged areas found on the wreck of ORION. The drawing does not fully represent the ship's arrangement at the time of the accident as the ship had been altered. No drawings of the rebuilding exist.

There were two hatches on deck leading to the ship's cargo hold: one below the forecastle and one amidships. On the day of the accident, the hatch on the forecastle was open.

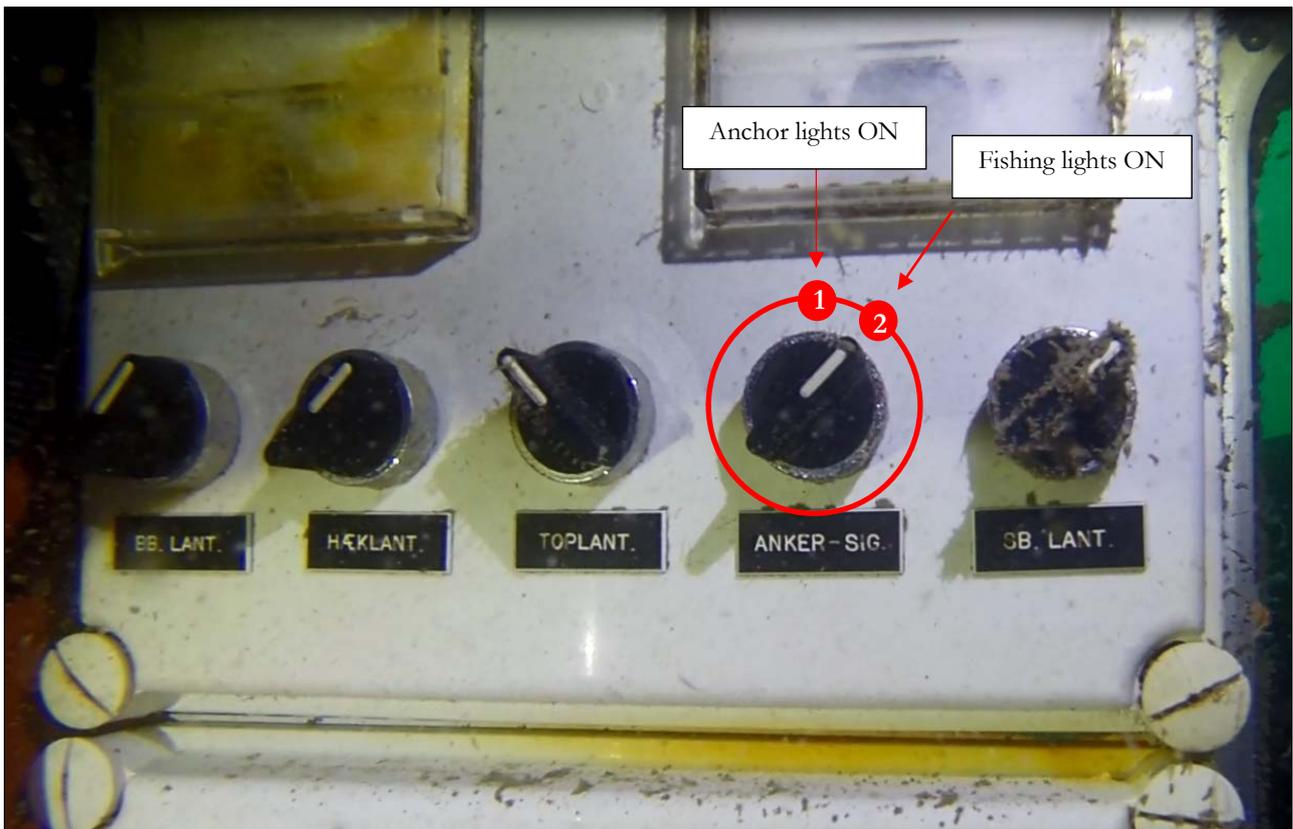
Figure 9: Light panel on ORION
Source: DMAIB

Investigations in the wheelhouse showed that the throttle control was in a neutral position. The switches on the light panel indicated that ORION's fishing lights were on at the time of the accident (figure 9). The switch for the anchor lights ("ANKER-SIG") had two modes: 1) Pointing up: the anchor lights were displayed, 2) Pointing to the right: fishing lights were on. No day signal was displayed in the ship's mast. The lights were turned off by turning the button to the left.

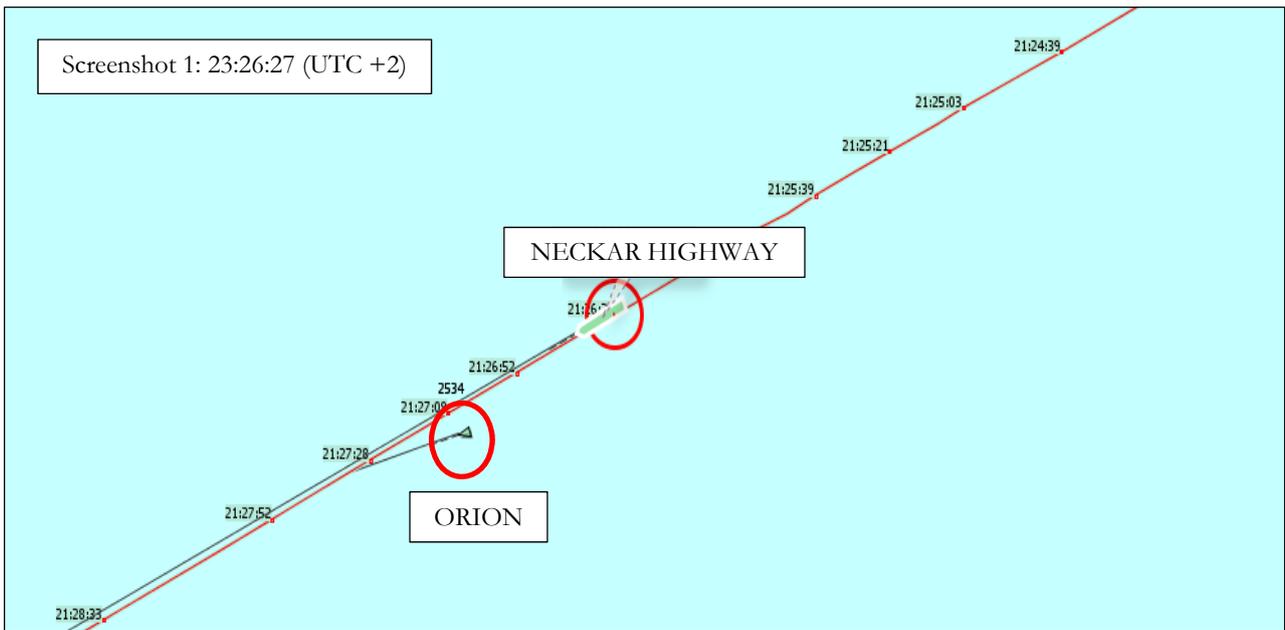
Screenshot 1 (fig. 10):

NECKAR HIGHWAY in passage on a south-westerly course at a speed of 16 knots. ORION was situated close to NECKAR HIGHWAY's expected track at one minute's distance. Though it appears that ORION was situated just outside NECKAR HIGHWAY's heading, the actual size of NECKAR HIGHWAY means that ORION was in fact drifting at a maximum of a few metres' distance from NECKAR HIGHWAY's expected track.

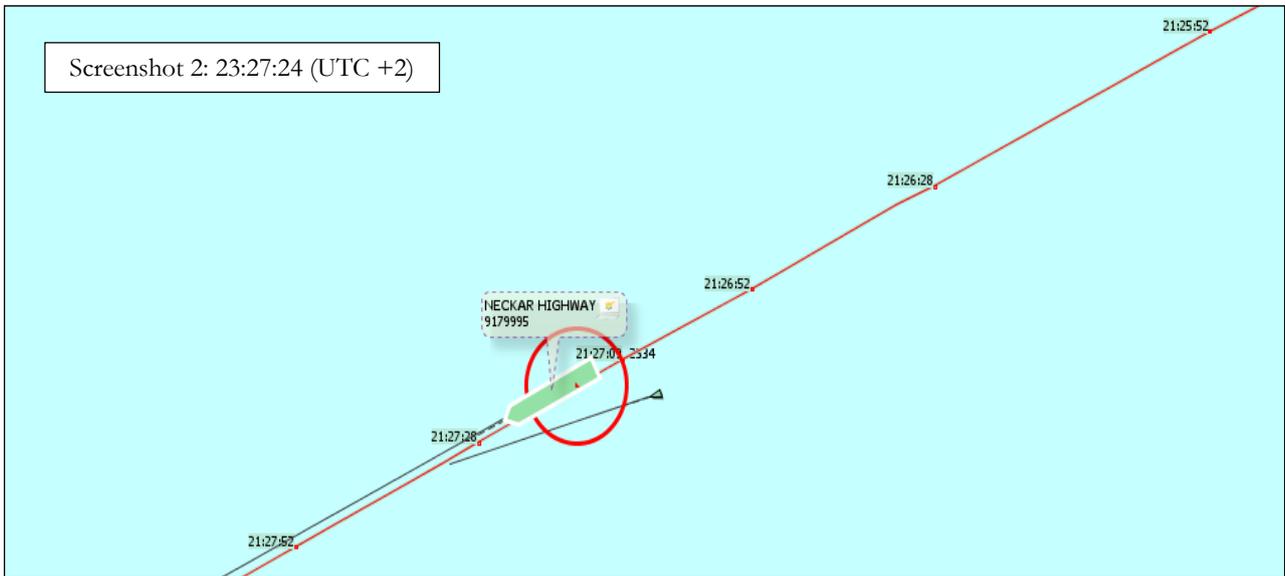
Screenshot 2 (fig. 11):

NECKAR HIGHWAY passed ORION at 23:27. Once again, the inaccurate representation of the ships' dimensions must be taken into consideration. Although it appears that NECKAR HIGHWAY passed ORION at some distance, the screenshot might actually represent a zero distance. NECKAR HIGHWAY's course and speed was unaltered while passing ORION.

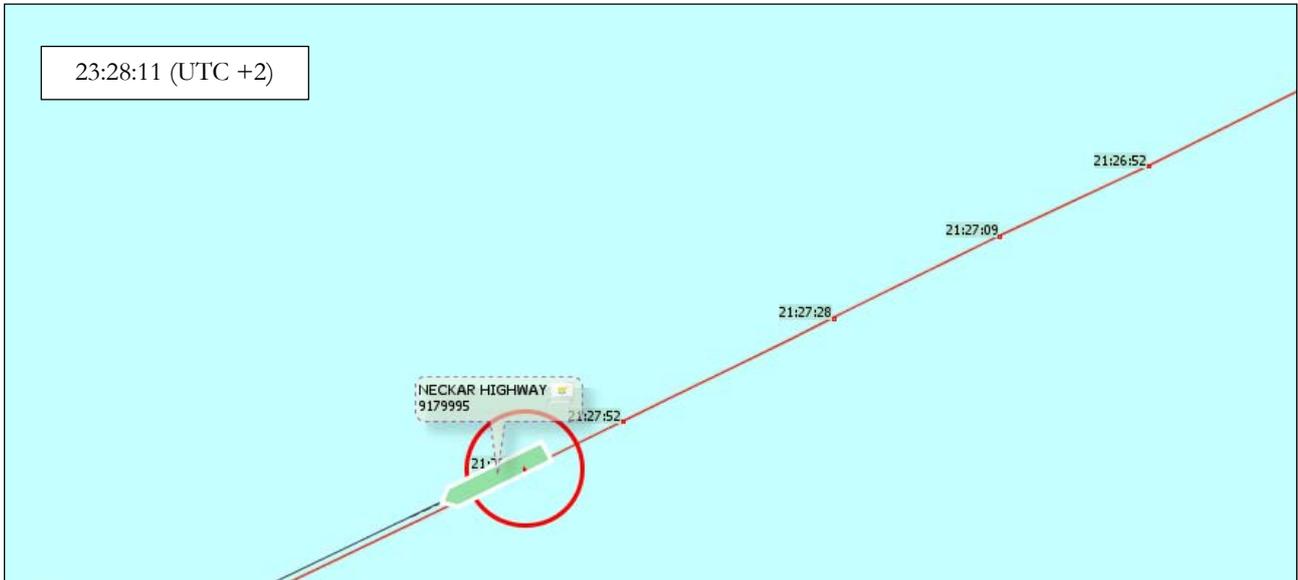
Screenshot 3 (fig. 12):

One minute after NECKAR HIGHWAY passed ORION, ORION's echo disappeared. The echo most likely disappeared because ORION was about to sink and, as the ship was lying deep in the water, it could no longer be detected on the radar. NECKAR HIGHWAY's course and speed were still unaltered.

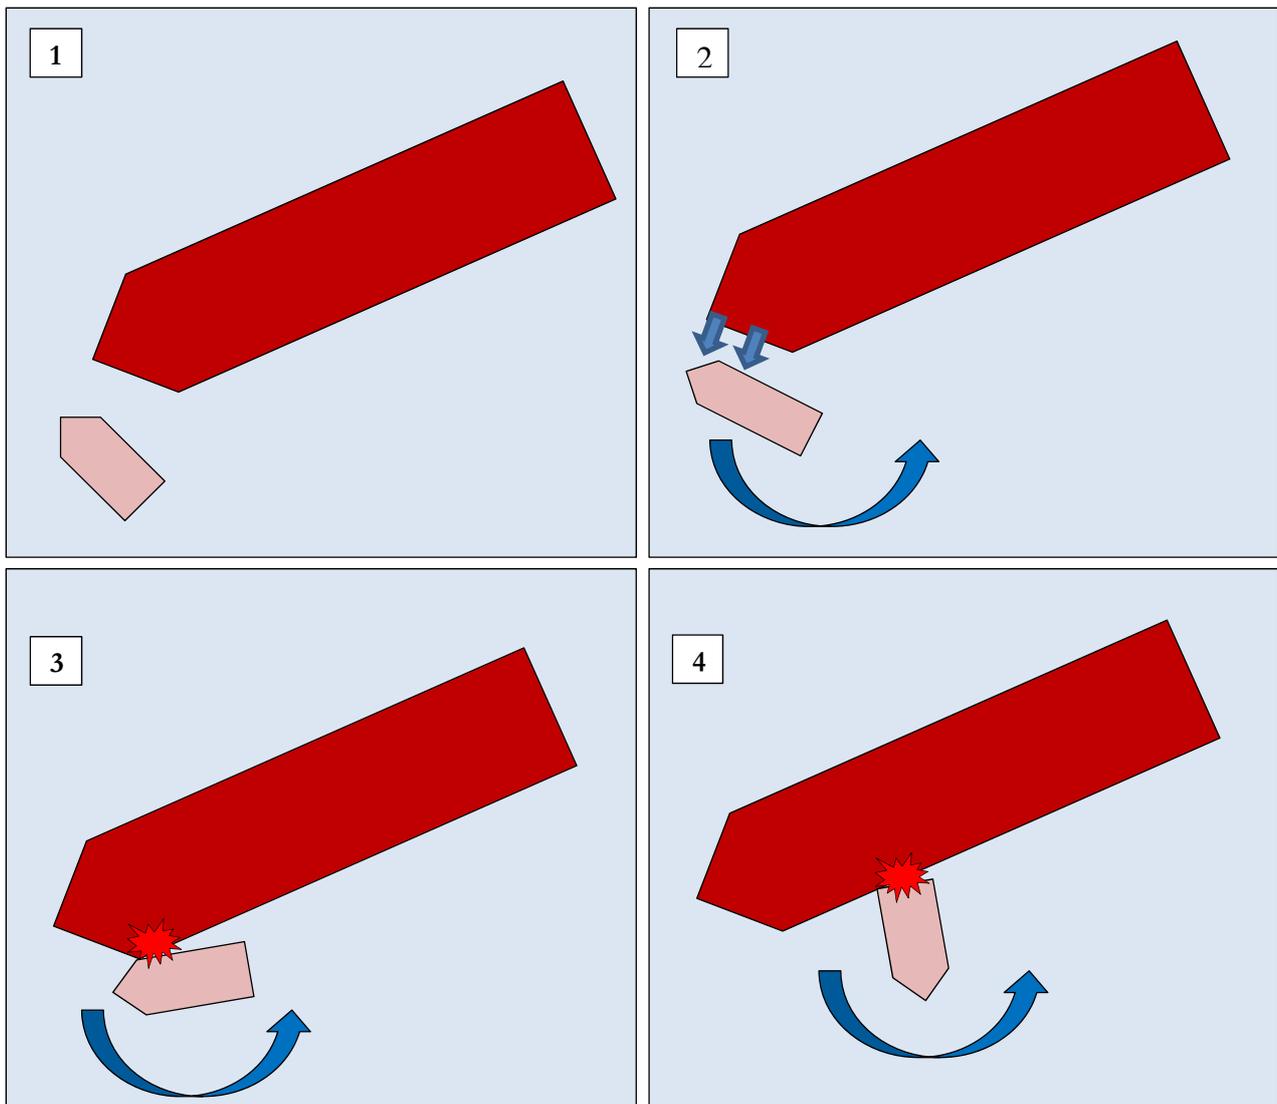
Figure 13: Sketch of reconstruction of the collision sequences
Source: DMAIB

Based on AIS data, the damages to the ships and statements from involved persons, the DMAIB has constructed a likely scenario of how the collision happened (figure 13).

NECKAR HIGHWAY was in passage at a speed of 16 knots on a south-westerly course as ORION drifted in NECKAR HIGHWAY's heading with the bow in a north-westerly direction. When NECKAR HIGHWAY reached ORION, the bow waves most likely imposed a pressure on ORION's bow causing it to start rotating to port. NECKAR HIGHWAY hit ORION with the portside bow on ORION's starboard side. ORION was pushed through the water by the impact and started to heel and trim heavily to port and forward causing half of the ship to become submerged in water. ORION kept rotating to port with a heel to port and suffered a second impact at the aft which tore off its rudder.

Due to the heavily imposed heel and trim, water came in through the open cargo hold hatch in the forepeak; the cargo hold was flooded with water in such a way that ORION could regain stability. The forward end was lying deep in the water and water started to gush in through the cracks on the starboard side caused by the impact of the collision and into the empty forepeak. The flooding caused ORION to sink quickly with the bow first. The ship disappeared from the surface of the sea approximately 20 minutes after the first impact.

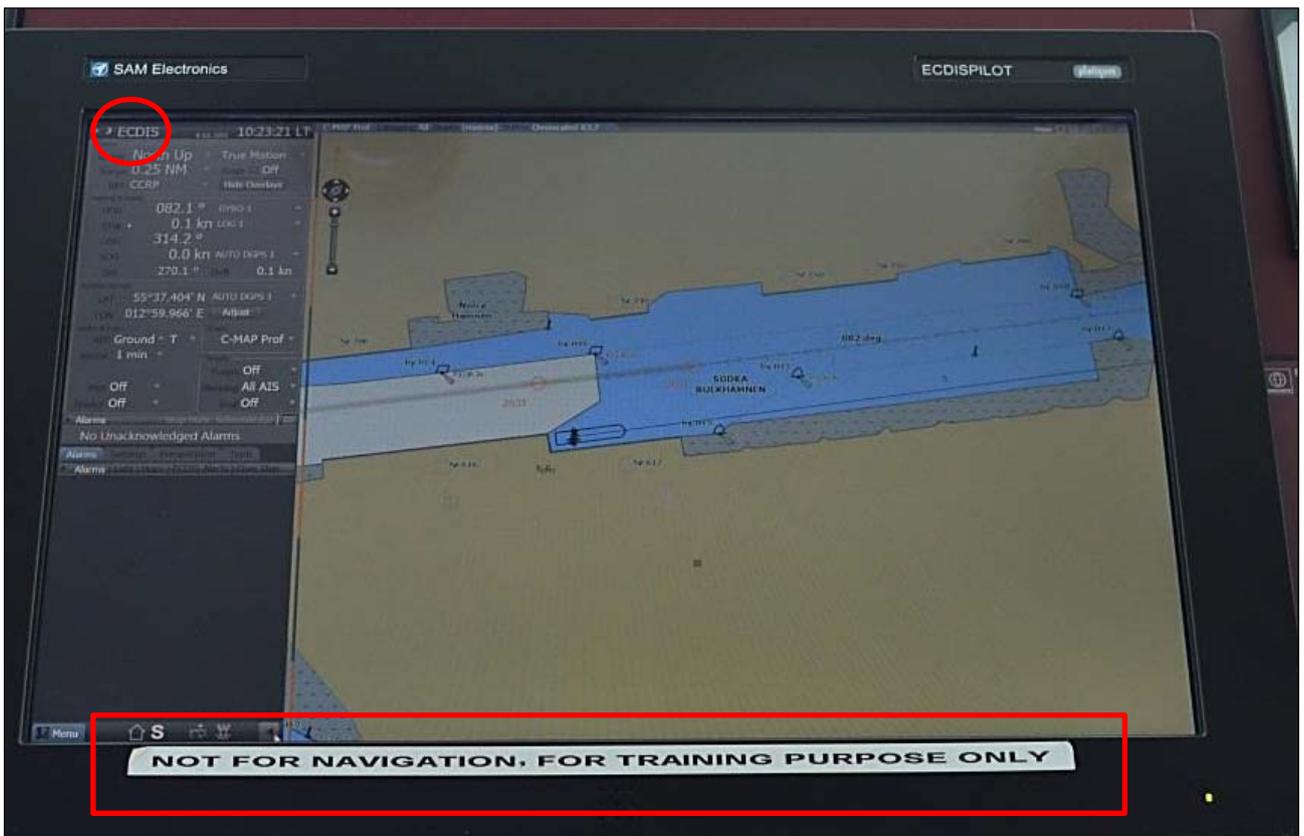
Figure 16: ECS on NECKAR HIGHWAY
Source: DMAIB

At the centre of the centre console an ECS⁴ was fitted. A label on the screen read “for training purpose only” (figure 16). Though the software indicated that the ECS was an ECDIS⁵ and therefore could be used for navigation alone, the charts were not updated frequently enough to meet the ECDIS standards, and the system did not consist of two redundant units. Therefore, the navigators were not allowed to use the ECS for navigation. The navigators considered the ECS a help in their daily work. The sparse number of positions plotted in the paper charts, even during coastal voyages, indicates that the ECS was used for navigation, and that navigation was carried out by mixing use of both charts and ECS. The sparse number of plots in the charts furthermore indicates that plotting the charts was mainly a log activity more than an actual navigational activity.

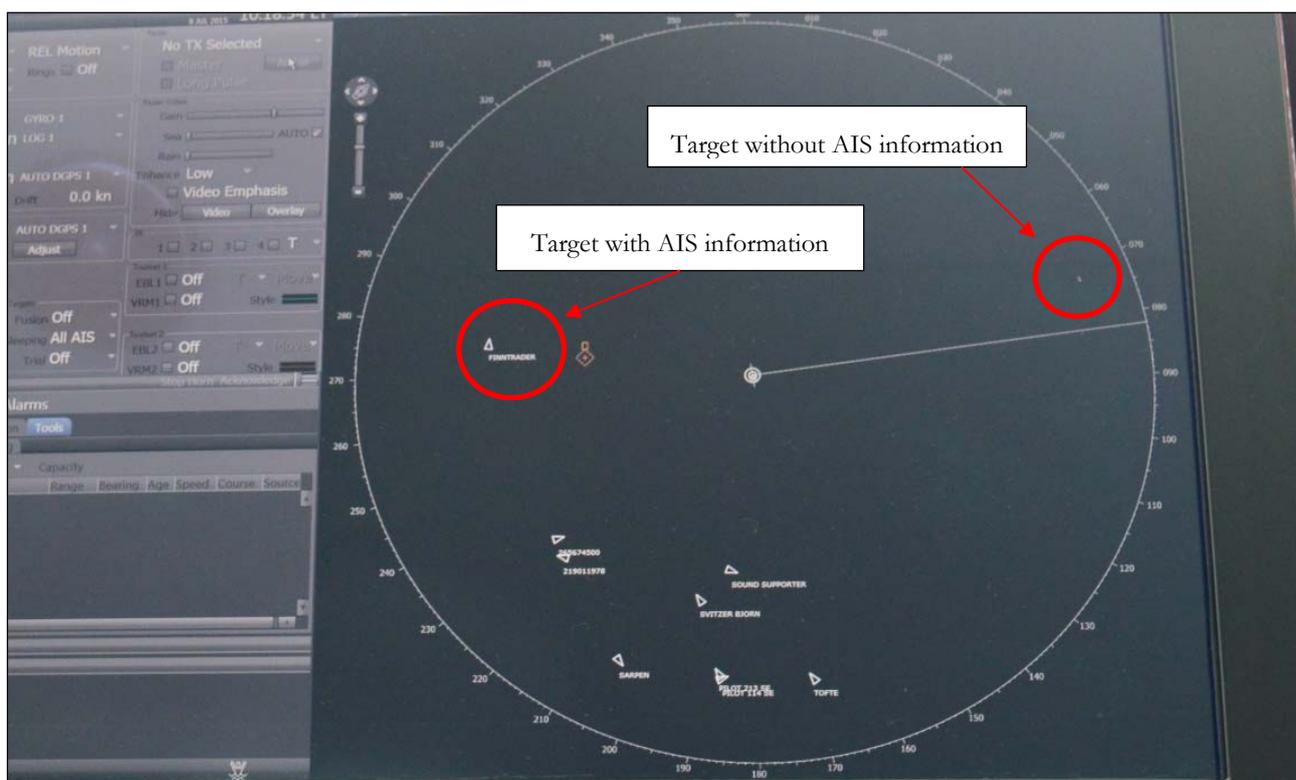
Figure 17: Radar screen with AIS overlay
Source: DMAIB

The centre console was fitted with X-band and S-band radars, usually set at a range of 6 or 12 nm. The radars were configured with an AIS overlay. This means that most of the ships in range of the radar were clearly marked on the radar with AIS identification. Small ships without AIS were displayed as small unidentified echoes (figure 17). On the S-band radar, the echo of a small fishing vessel could be so weak that it would be hard to spot on the radar.

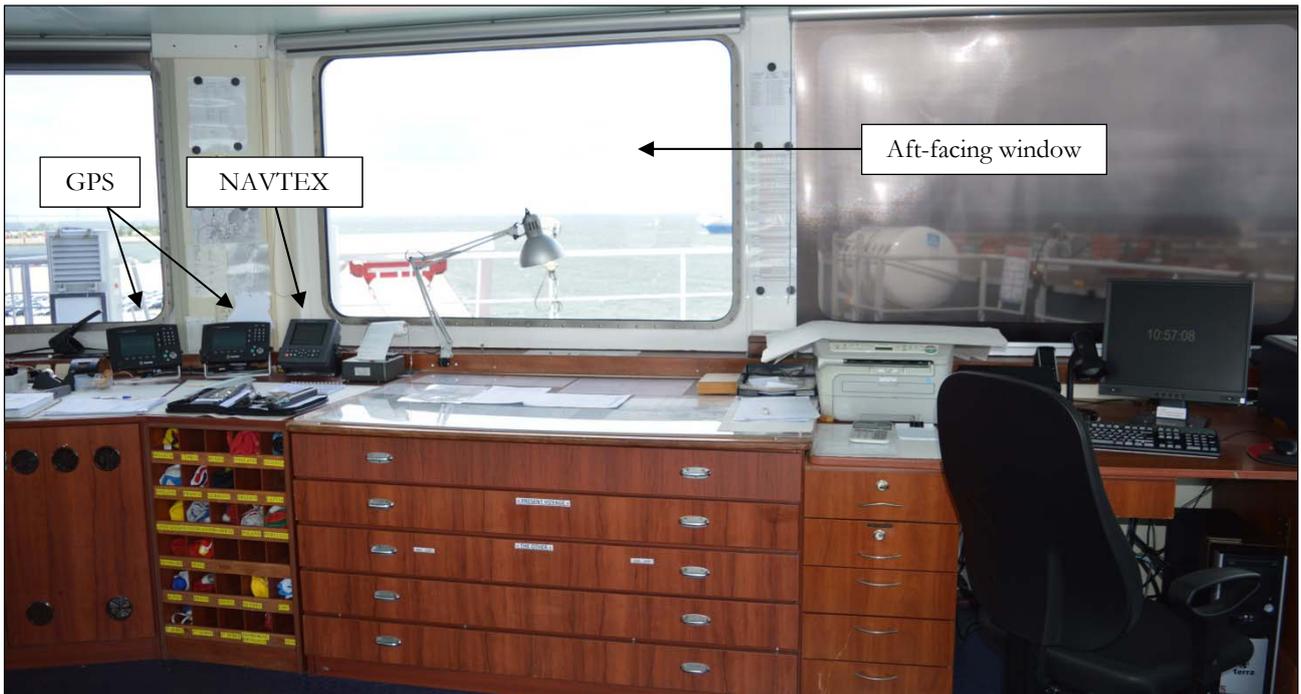
Figure 17: View of the chart table on NECKAR HIGHWAY looking aft
Source: DMAIB

The ship’s NAVTEX⁶, two GPS charts and the log book were placed at the chart table. As the chart table was facing aft, the navigating officer had to stand with his back to the ship’s heading in order to use these as well as plotting positions in the charts. On the chart table, there was an architect lamp fitted with a regular light bulb and a dimmer.

The difficulty of spotting a ship at twilight might have been increased due to the light from the architect lamp on the chart table. Although the architect lamp was fitted with a dimmer, it might have caused light pollution or reduced the navigational officer's night vision when going back and forth between the light at the chart table and keeping a lookout through the bridge windows.
