Danish Maritime Accident
Investigation Board

MARINE ACCIDENT REPORT

TRITON
Foundering on 18 July 2015

This marine accident report is issued on 4 November 2015.

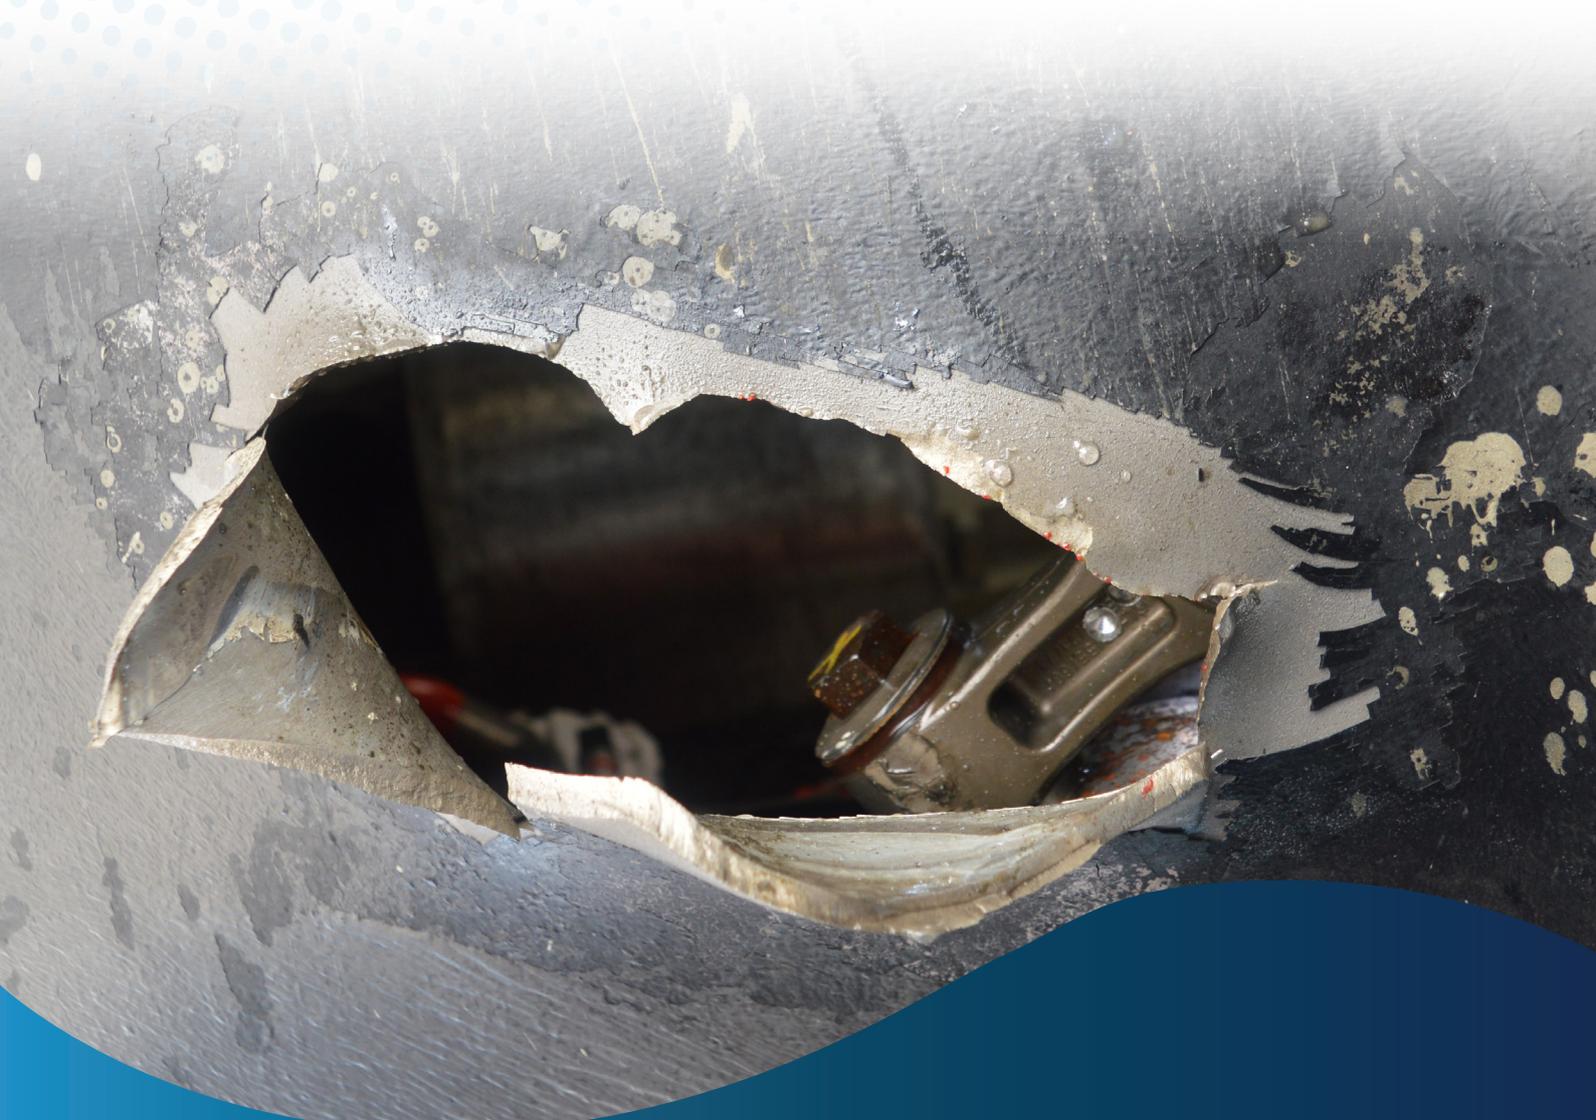
Front page: Damage to the hull of TRITON. Source: DMAIB

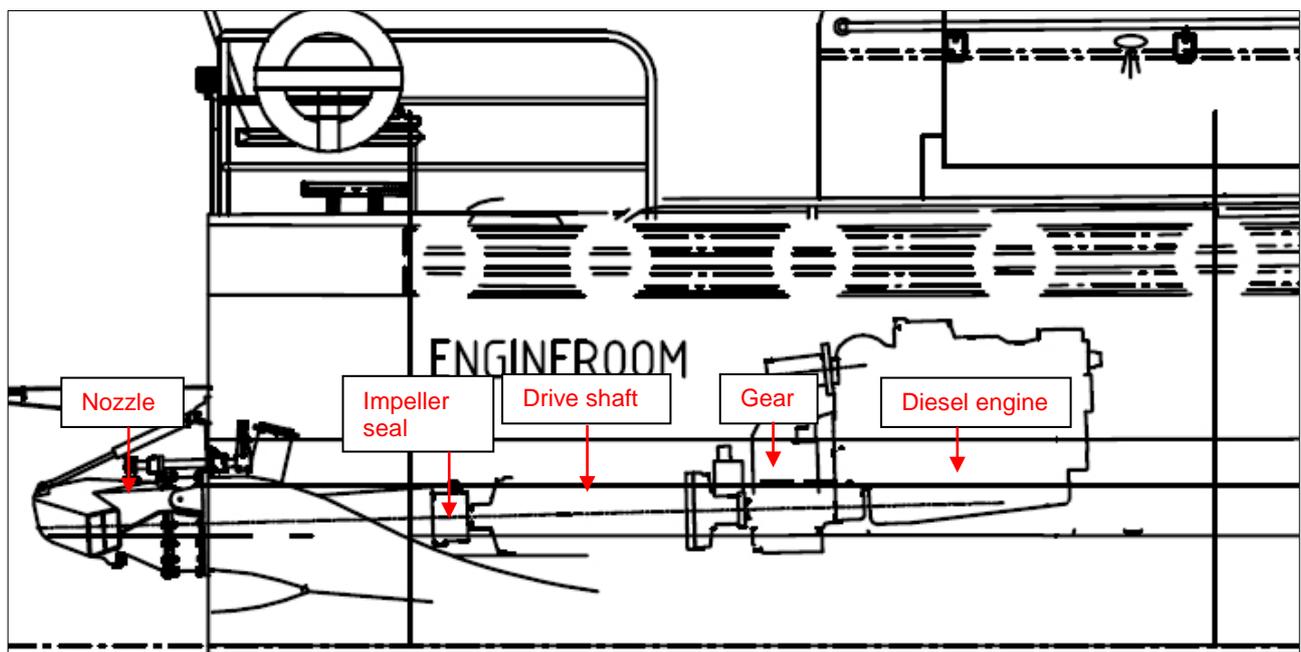
Figure 3 below gives an overview of the propulsion engine layout. From the right, the following components are highlighted: diesel engine, gear, drive shaft, impeller drive seal and water jet nozzle.

Figure 3: Damage to hull and machinery
Source: DMAIB

When TRITON had been salvaged, extensive damage was found caused by the water ingress into the various compartments of the boat. The initial source of the water ingress was found in the engine compartment. It came from an elliptically shaped hole in the aluminium hull of approximately 250 mm in

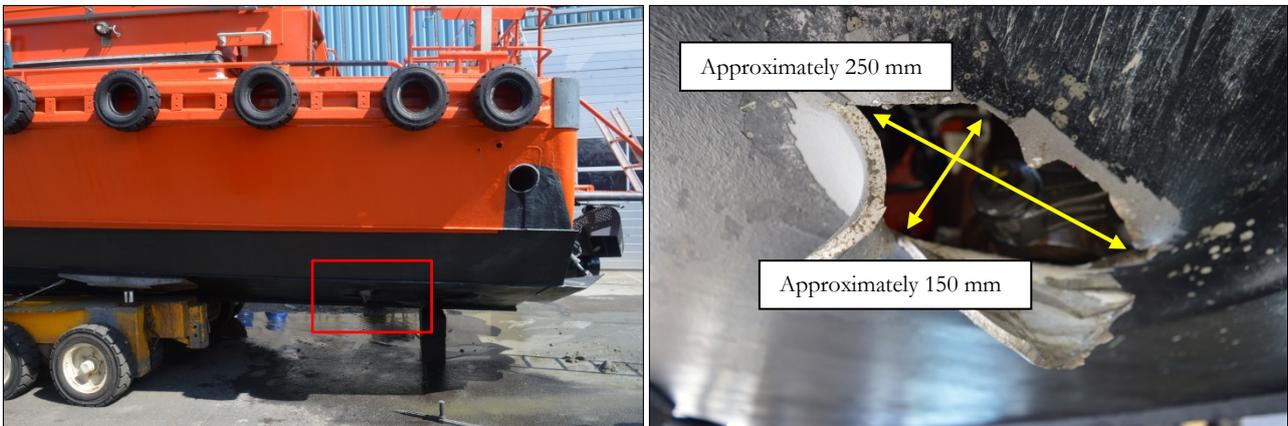
length and 150 mm in breadth. The plating around the edge of the hole was buckled in an outward direction, showing that an object had penetrated the hull from inside the engine compartment. The hole was in the hull bottom plating on the port side aft part of the boat (figure 4).

Figure 4: Damage to hull
Source: DMAIB

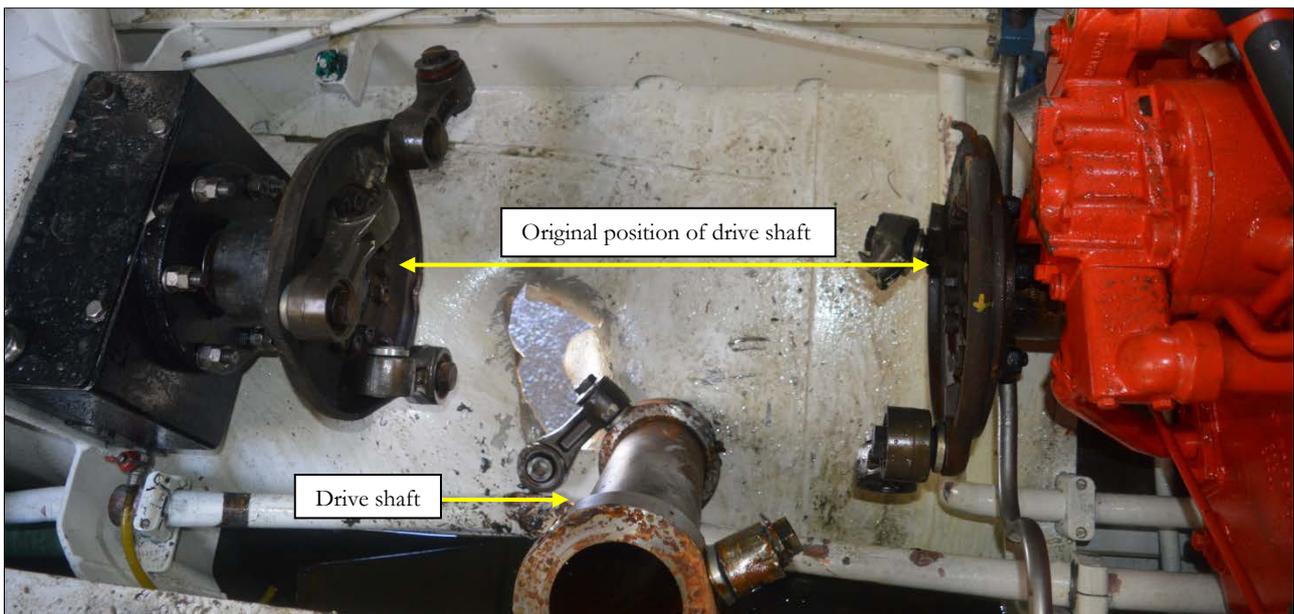
Above the hole in the hull the shaft drive was found to be severely damaged (figure 5). All radial link connections were damaged and all fastening bolts, except one, had been torn. The drive shaft was not found in the position seen in below picture, but was placed in an upright position before the photograph was taken. At the time of the breakdown, an aluminium cover was mounted above the drive shaft intended to protect an operator from the rotating shaft.

Figure 5: Damage to hull and machinery
Source: DMAIB

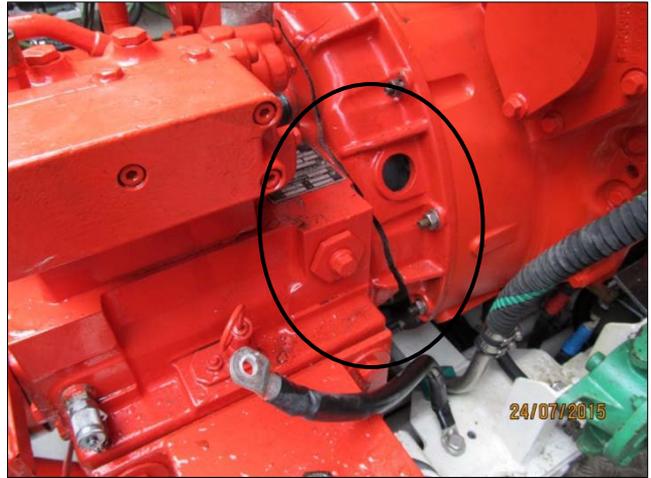
A picture of the intact starboard side drive shaft can be seen below on figure 6. The port side engine clutch housing was fractured (figure 7), presumably due to the excessive vibrations from the drive shaft breakdown.

Figure 7: Fracture of clutch housing
Source: Survey Association

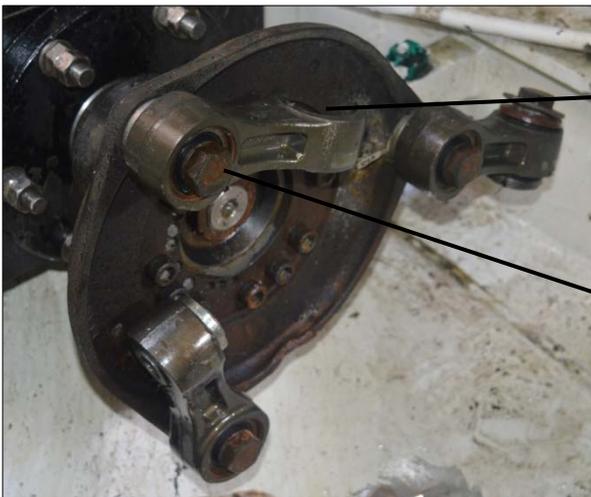
The drive shaft system consisted of the shaft that was connected to the engine gear and the water jet drive by three links (figure 8). These are designed to minimize the shaft's sensitivity to vibration, to offer electrical insulation and to reduce mechanical noise. The links were attached to the shaft by bolts (figure 9).

The drive shafts had been shortened and the engines moved aft wards approximately one year before the breakdown when vibrations were detected after the replacement of the main engines two years earlier. After the modifications of the drive shaft had been made, the new drive shaft arrangement was surveyed by the DMA.

Figure 8: Links on drive shaft
Source: DMAIB

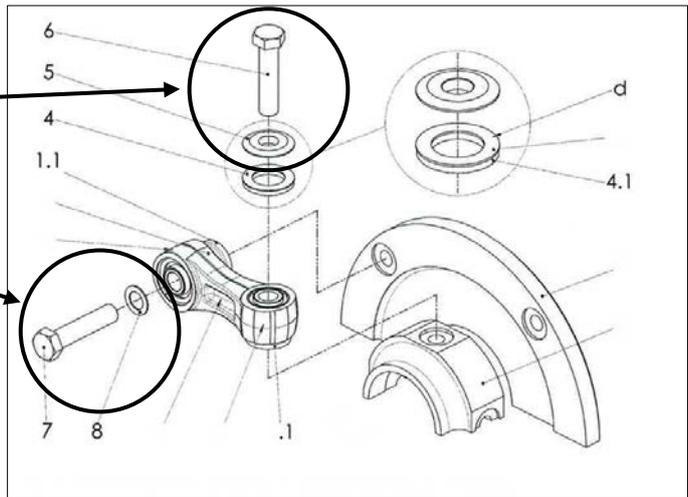
Figure 9: Bolt on drive shaft link
Source: DMAIB

The independent survey company, SurveyAssociation, made an analysis of the damaged drive shaft parts. It was found that one of the bolts that held the aft shaft drive link had loosened and fallen out. This analysis was based on the fact that only one of the bolts had an undamaged thread and only one of the drive shaft links had an undamaged thread.

As the bolt fell out, an imbalance occurred in the alignment of the drive shaft, which caused the vibrations that the boatman experienced. It is likely that the shaft came loose when the boatman reversed the propulsion, and the forces on the radial links shifted. The rotation forces on the shaft made it rotate uncontrollably, and when the shaft came loose, it penetrated the aluminium hull at the bottom of the boat.

It was found that the bolts were standard bolts of unknown grade and specification and not the 10.9 grade bolts as specified in the technical documentation for the drive shaft. Furthermore, there was no indication that the bolts had been secured with thread-locking fluid or wire. Interviews with the service mechanics from the company that modified the drive shaft confirmed that the bolts had not been fastened by using a torque wrench because the general perception was that it was not necessary. It is given that without any specification indicated for the bolt, it would not be possible to determine what would be the correct torque needed to fasten the bolt. Therefore, the bolt would likely be tightened too little or too much. In any circumstance it would eventually become loose and fall out.

The mechanical condition that caused the breakdown of the drive shaft was therefore a non-approved loose bolt in one of the aft radial drive shaft links, which had not been fastened according to the manufacturer's specifications.

As lessons learned actions, - DanPilot has emphasized the requirements and the obligations to suppliers of repairs and deliveries, to ensure that the manufactures instructions and guidelines are strictly followed, and surveyed by the technical superintendent

The planned maintenance system defines routine checks of the vessels critical systems and in detail the surveillance of critical mechanical fitted connections.

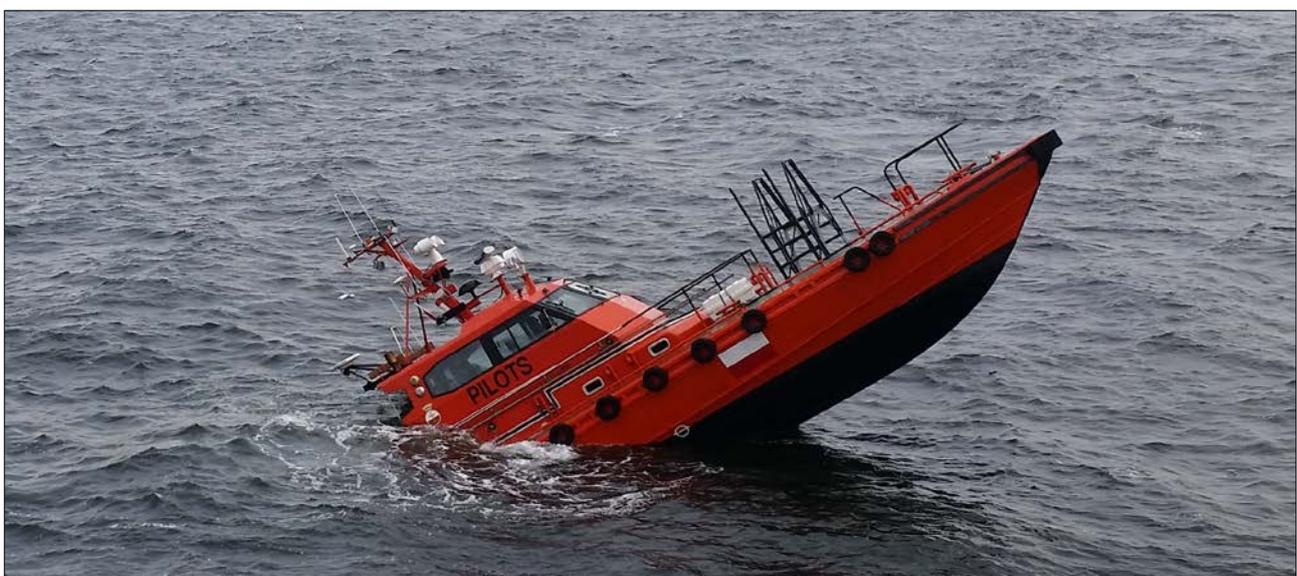
When the stern had been completely submerged, the buoyancy in the forepeak and forward part of the crew cabin made the boat float at an angle of approximately 45° (figure 11).

*Figure 11: Picture of TRITON at 0740 on the day of the accident
Source: Private photo*
