This marine accident report is issued on 2 July 2015.

On 1 November 2014, the Marshall Islands-registered chemical/products tanker KRASLAVA collided in restricted visibility with the St. Kitts & Nevis-registered refrigerated cargo ship ATLANTIC LADY in the Drogden Channel in the southern part of the Sound, Denmark.

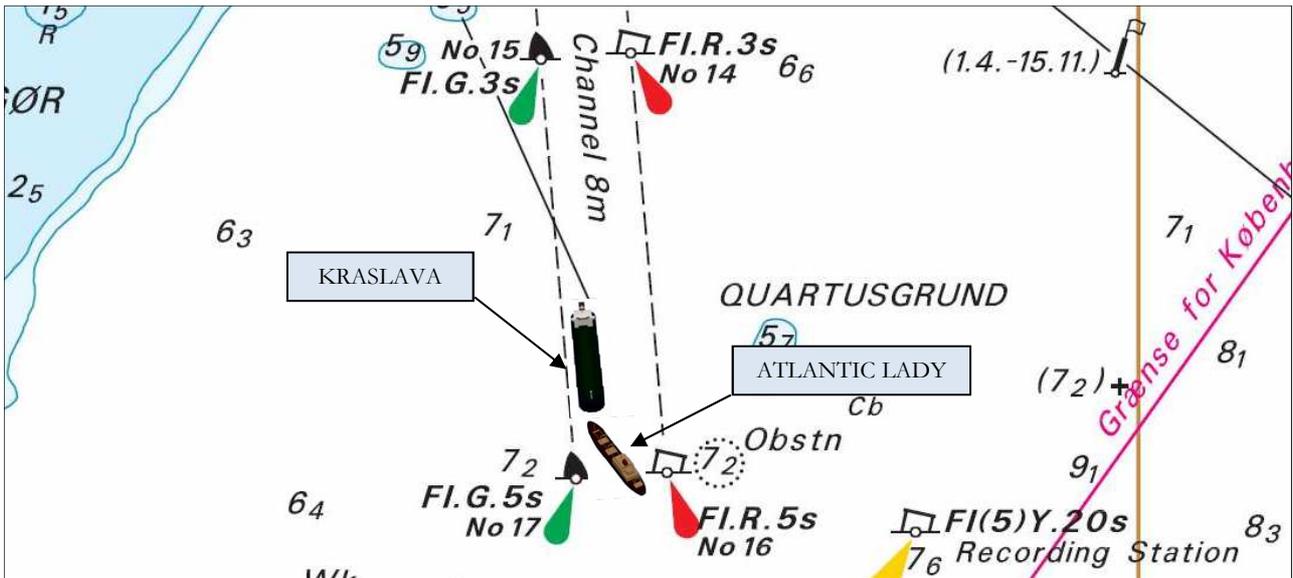
Figure 4: Perception of the collision – KRASLAVA bridge team perspective (not to scale)
 Source: DMAIB/Chart no 133, Danish Geodata Agency

The bridge team on KRASLAVA, including the pilot, was convinced that ATLANTIC LADY had passed across the channel towards the western part of the channel ahead of KRASLAVA as illustrated below in figure 4.

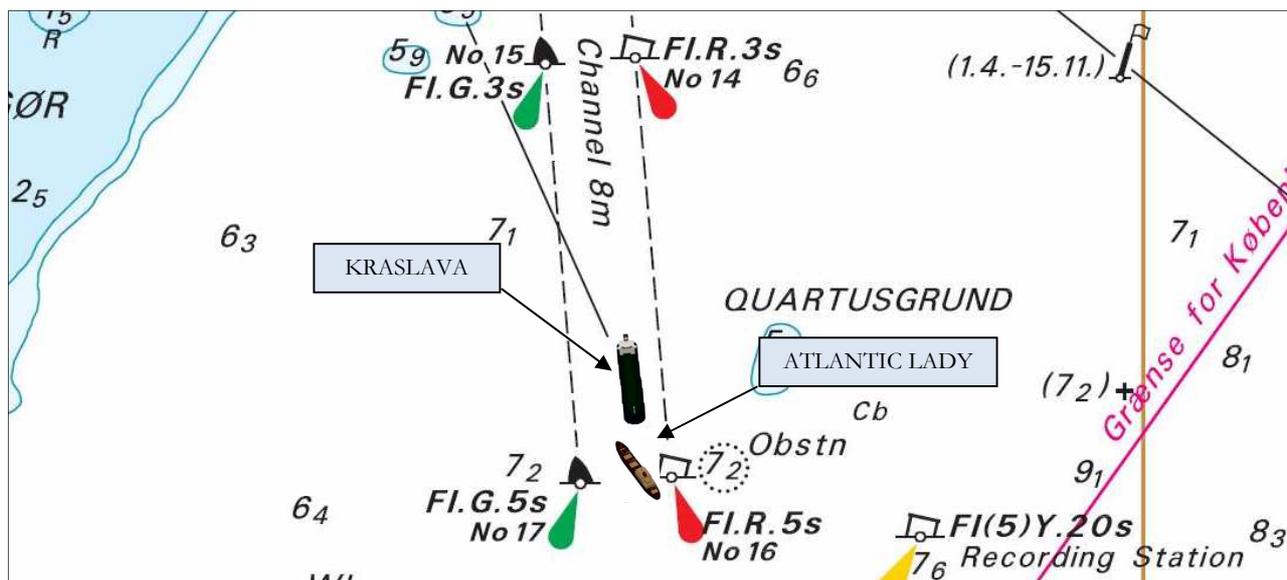
Figure 5: Perception of the collision – ATLANTIC LADY bridge team perspective (not to scale)
 Source: DMAIB/Chart no 133, Danish Geodata Agency

The master and chief officer were convinced that KRASLAVA was positioned too far to the east as illustrated below in figure 5.

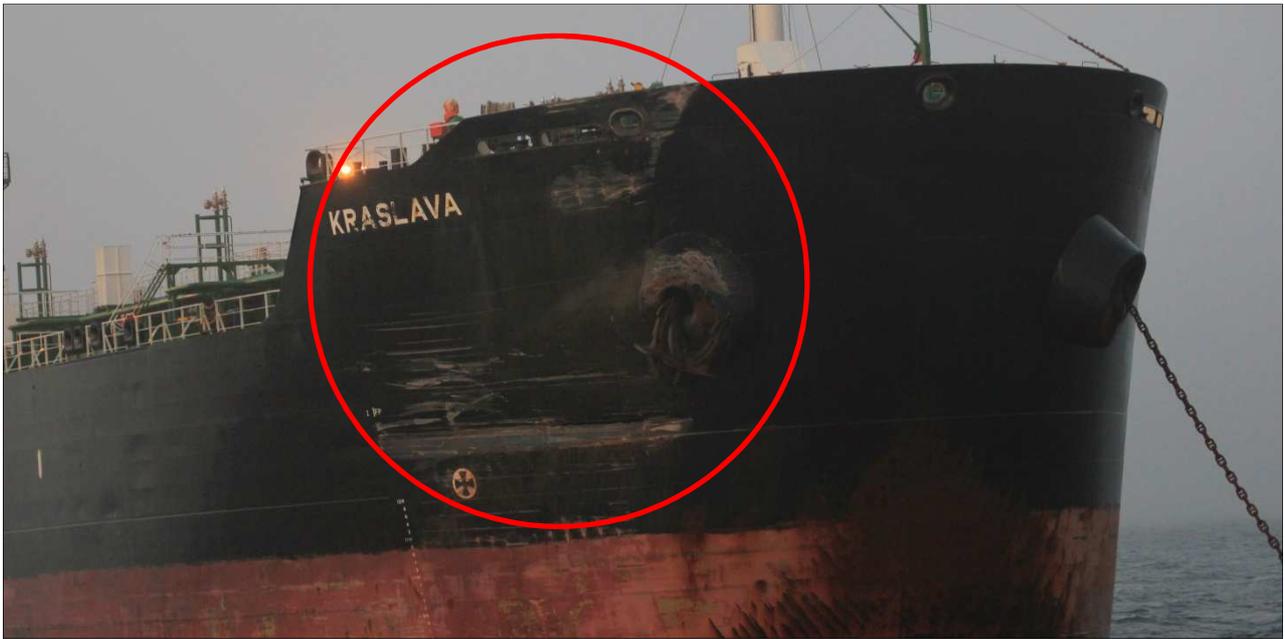
Figure 6: Damages on KRASLAVA
Source: Danish Naval Home Guard

KRASLAVA was mainly damaged on the starboard side of the bow and forecastle, with indentations starting from under the hawse pipe and proceeding aftwards (figure 6). Several frames in the forepeak tank and bosun store under the forecastle were bent, and the hull had been penetrated in a horizontal line of 3-4 metres, approximately 7 metres above sea level. The damage to the anchor and anchor hawse was 10-12 metres above sea level. The anchor chain stopper locking pin was bent (figure 7), indicating that the anchor had been pulled when it made contact with ATLANTIC LADY.

At the time of the collision, KRASLAVA had a heading of 180°, and ATLANTIC LADY had a heading of 332°. The angle of collision was therefore approximately 28°, which meant that the collision was in an acute angle that to some extent deflected the impact. The initial impact on ATLANTIC LADY was at the hull amidships, which caused surface damage to the hull but no penetration of the plating. Because KRASLAVA did not have a bulbous bow, the damage to the hull was limited.

After the initial impact, both ships still had a forward momentum. The heading of both ships changed to almost the opposite direction, so the anchor and anchor hawse on KRASLAVA came into contact with the accommodation on ATLANTIC LADY. The anchor on KRASLAVA was 10-11 metres above the water surface, which is consistent with the damage to ATLANTIC LADY's accommodation, which was about 10-12 metres above sea level.

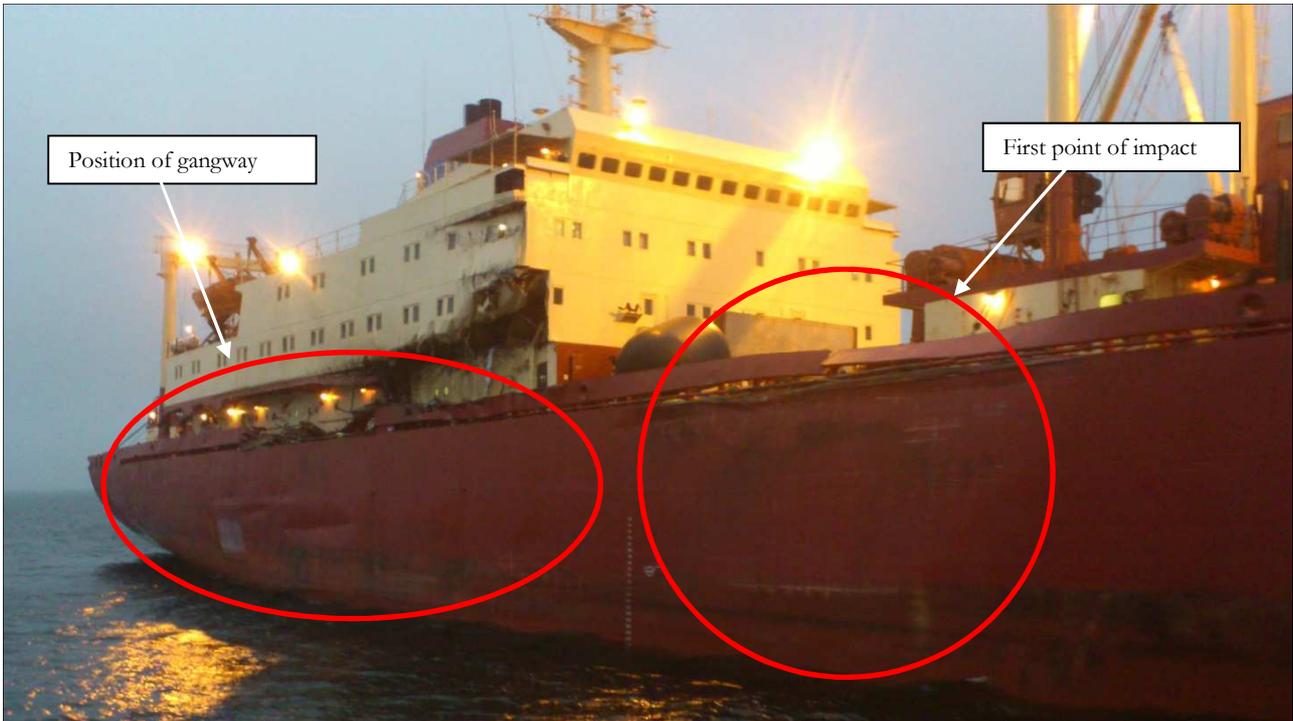
Figure 8: Damage on ATLANTIC LADY
Source: Danish Naval Home Guard

The hull of ATLANTIC LADY on the starboard side was damaged from amidships to aft of the accommodation (figure 8). There were only minor penetrations of the hull amidships and by the gangway, which was torn off. The accommodation had suffered extensive damage 10-12 metres above sea level, from the upper deck up to the deck below the bridge. Specifically, three cabins on the deck above the upper deck were substantially damaged (figure 9). No crewmembers were in the cabins at the time of the collision, because it occurred during normal working hours.

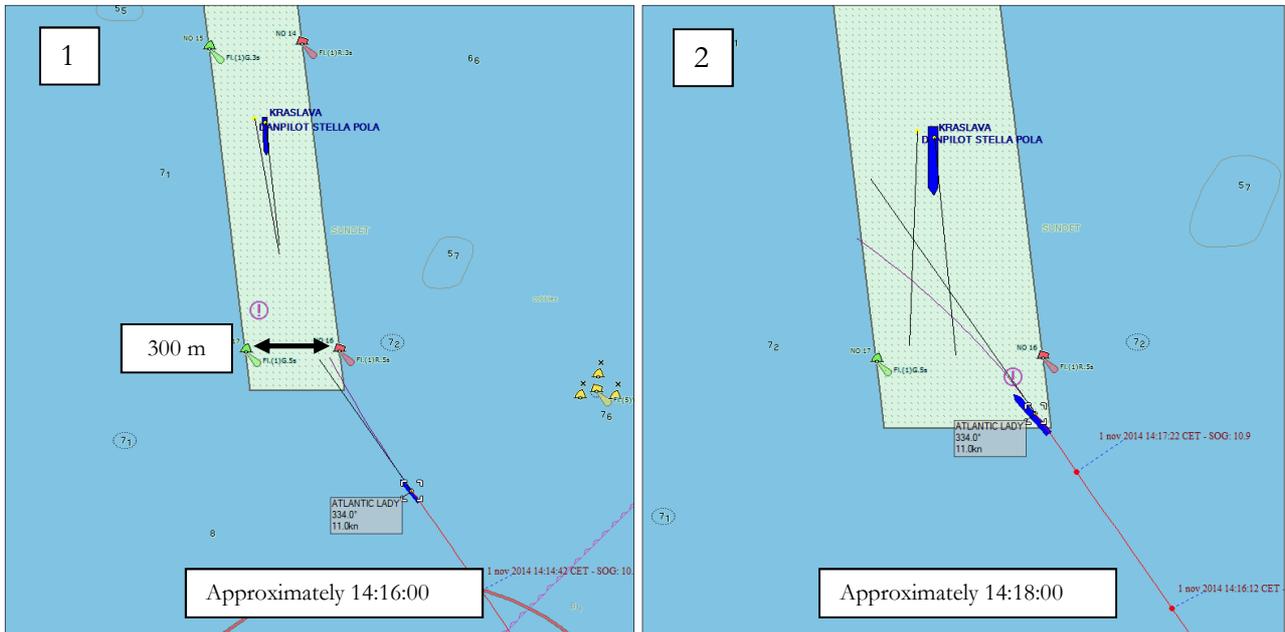
Figure 10: AIS tracks of KRASLAVA and ATLANTIC LADY prior to the collision
Source: Danish Maritime Authority

Screenshot 1: Both ships were approaching the southern entrance/exit to the Drogden Channel. The pilot boat DANPILOT STELLA POLARIS was positioned alongside KRASLAVA, while assessing the conditions for bringing the pilot on board.

Screenshot 2: ATLANTIC LADY was approaching buoy 16 on the starboard side at a distance of approximately 20-30 metres. The intention was to initiate a starboard turn after the buoy was in sight and abeam.

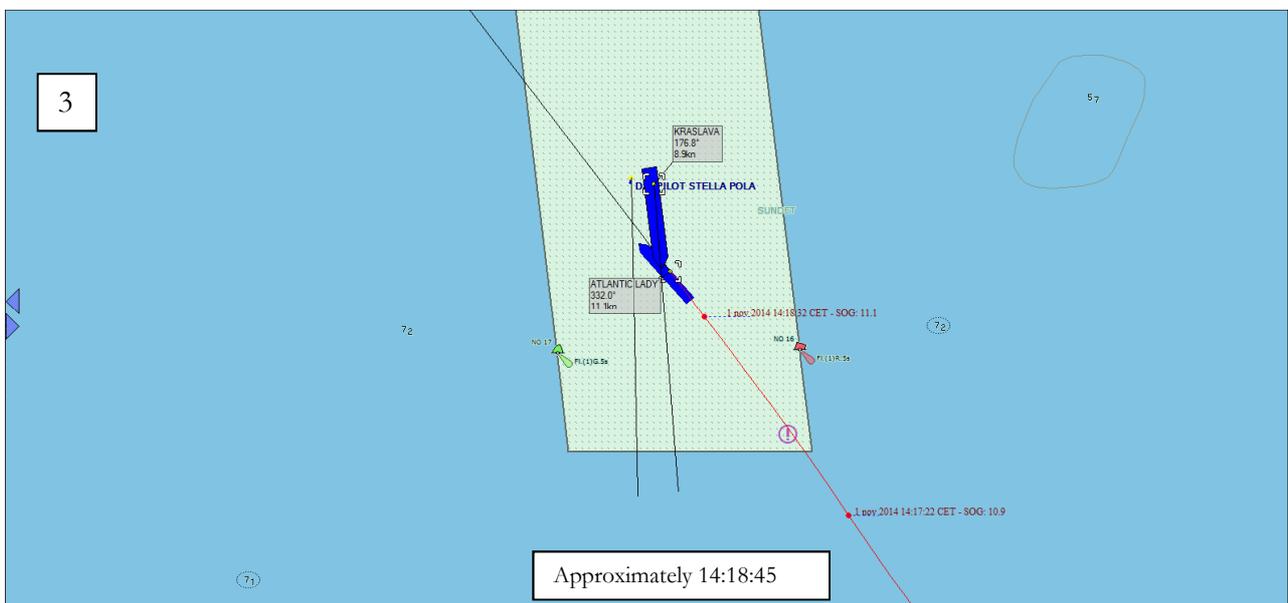
Figure 11: AIS tracks of KRASLAVA and ATLANTIC LADY at the time of the collision
Source: Danish Maritime Authority

Screenshot 3. On both ships the perception was that they were positioned on the outward outer part of the channel, and that the other ship was on the wrong side of the channel. As it is seen on screenshot 3 below, the collision occurred more or less in the middle of the channel.

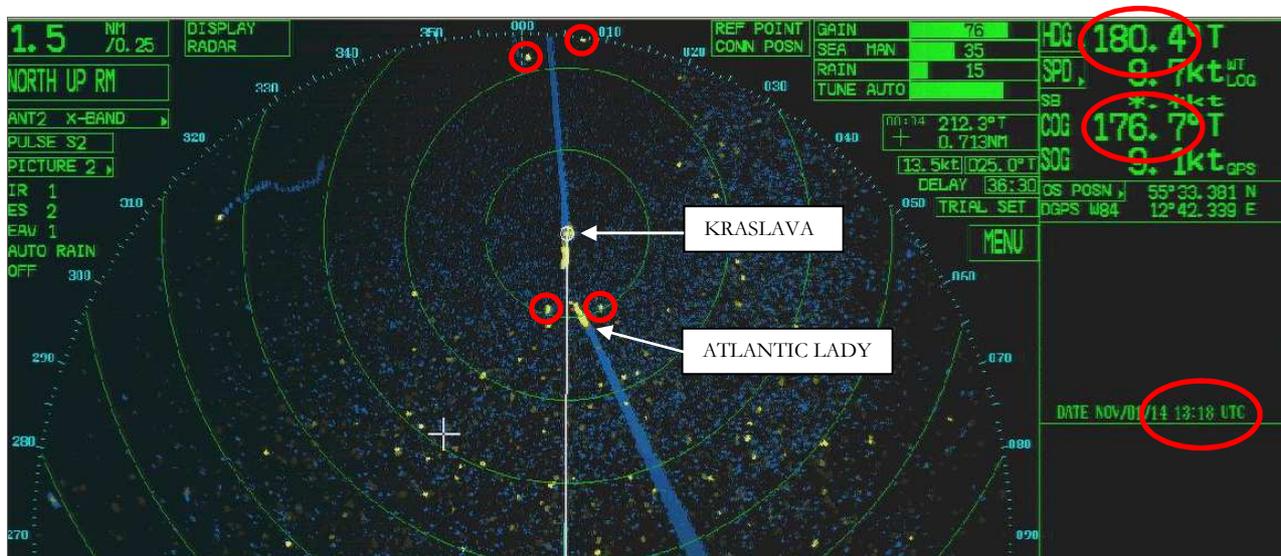
Figure 13: Extract from X-band radar on KRASLAVA
Source: DMAIB

The time shown in the screenshot from the radar is 1318 UTC, i.e. approximately 30 seconds before the collision. KRASLAVA is seen on a southerly course and ATLANTIC LADY on a north-westerly course. KRASLAVA's heading was 180.4° and the course over the ground was 176.7°. The range was set to 1.5 nm with 0.25 nm distance rings.

The buoys no. 16 and 17 in the southern entrance/exit from the Droghda Channel are marked with red circles.

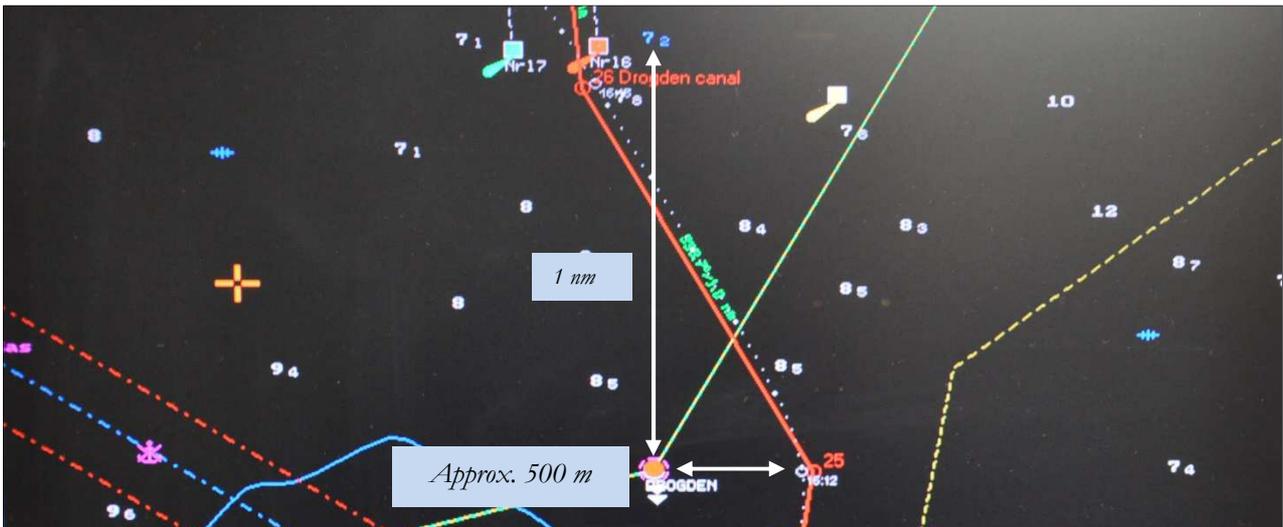
Figure 15: AIS track and planned course – ATLANTIC LADY
 Source: DMAIB

The approach to the entrance of the Drogden Channel was east of the planned route in order to enter the canal close to buoy 16. This enabled the ship to be turned onto a northerly course while being on the easterly side of the channel (figure 15). After having passed Drogden Lighthouse, ATLANTIC LADY's course was aligned with buoy no. 16, so it could be used as a turning point when entering the Drogden Channel. The speed during the approach was approximately 11-12 knots.

The position of Droghda Lighthouse made it necessary for ATLANTIC LADY to manoeuvre in such a way that the turn into the Droghda Channel could only be started after having visually observed and passed buoy no. 16 at the entrance to the channel. At a speed of 11 knots, the late turn would bring the ship closer to the centre line of the channel. It was not possible for ATLANTIC LADY to align the course with the Droghda Channel earlier, because Droghda Lighthouse was positioned 1 nm south of the channel, as seen in figure 15 above.
