Danish Maritime Accident
Investigation Board

MARINE ACCIDENT REPORT

SEA GALE
Fire on 20 May 2014

This marine accident report is issued on 4 May 2015

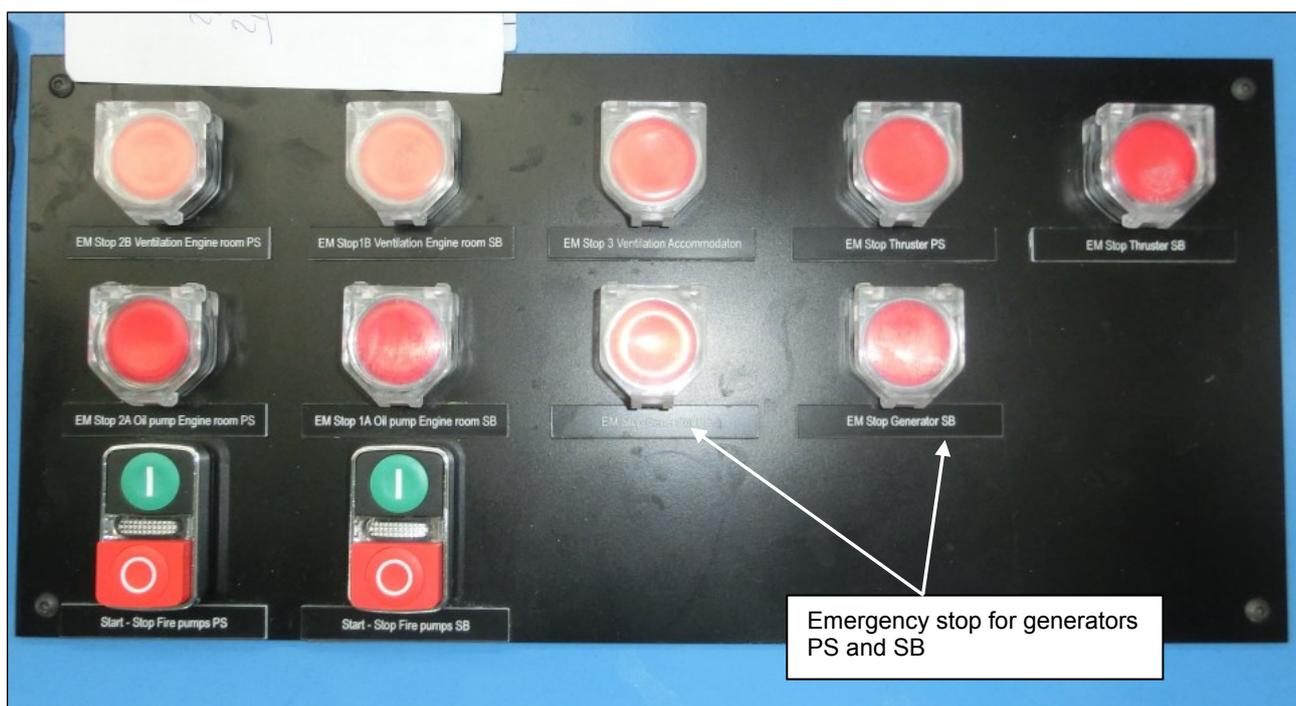
At 0820, the chief officer pushed the emergency stop buttons for the main engines. After a few minutes, he noticed that the starboard main engine was still running. The master then stopped the engine by means of the normal stop button. The chief officer then activated all emergency stop buttons, and by doing so, unintentionally also stopped the generators which caused a black-out that surprised the crew (figure 6). The power interruption stopped the water mist system after it had been activated for roughly one minute. The black-out caused an abundance of audible and visual alarms on the bridge, indicating multiple system failures. Because the noise from the alarms stressed the crew, the master silenced as many as he could by acknowledging them on the alarm panel.

Figure 6: Bridge panel for emergency stop of main engines, generators, thrusters, ventilation etc.

- They did not have the equipment needed to effectively assess the extent and intensity of the fire in the casing,
- and the layout of the controls for the firefighting and engine systems caused an unintended blackout.
- The large amount of audible and visual alarms impaired the crewmembers' handling of the emergency situation.

- *The evaluation of the layout of the emergency buttons made A2SEA remark the emergency stops on the bridge to better distinguish between them and to which redundant engine they belong. Same with the quick closing valves which have been marked more thoroughly with green and red markings.*

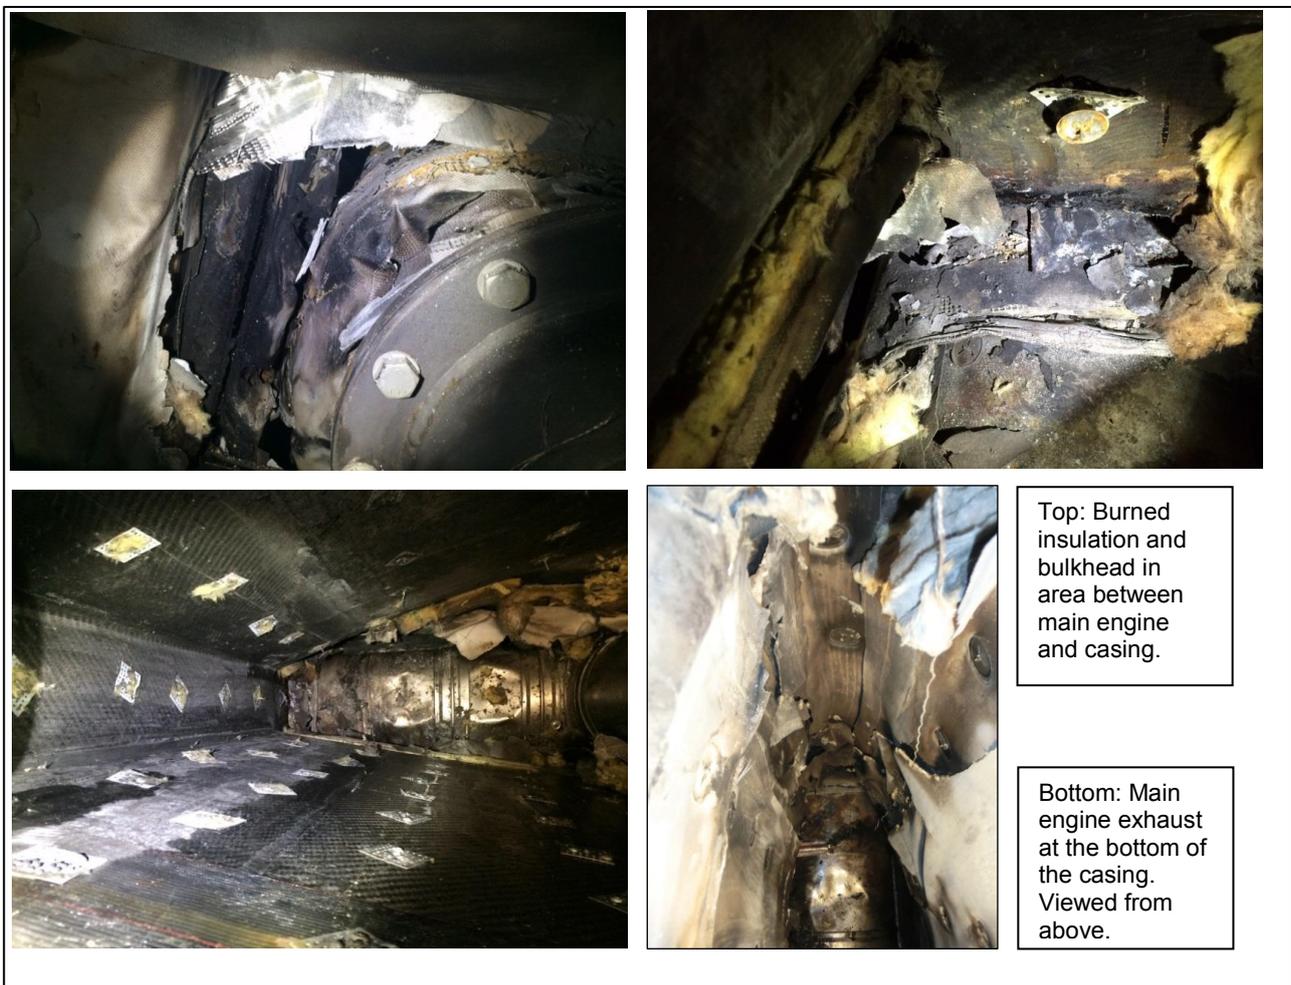
The fire originated in a carbon composite panel and insulation above the main engine exhaust pipe, in the transition area between the aft engine room bulkhead and the casing. The panel was most likely overheated by radiating heat from the exhaust pipe. It is likely that insufficient ventilation of the engine room caused excessive exhaust gas temperatures which led to overheating of the exhaust pipe.

A few weeks prior to the incident, the ship had been docked for maintenance, including an overhaul of the starboard main engine. As a part of the overhaul, insulation was removed and later replaced. From the owner's investigations, it seems likely that the insulation in the transition area between the engine room and the casing, had not been replaced properly, thus leaving an area exposed to excessive radiant heating from the exhaust.

Assessment of damage revealed that insulation material, electrical cables, composite panels and GRP bulkheads in the main engine room area and casing were damaged by the fire. Additionally, there was some damage caused by smoke and water from the firefighting (figure 8).

Figure 8: Damaged main engine exhaust and surrounding bulkheads.
Source: A2SEA

Following technical investigations, A2SEA have initiated several preventive measures including a design review of the insulation in the area of the manifolds, exhaust pipes and funnel. The changes were implemented on SEA GALE during the reconstruction. All other A2SEA operated vessels were inspected for signs of similar weaknesses.
