**This marine accident report is issued on 3 March 2015.**

## 1. SUMMARY

On 10 July 2014, the Danish fishing vessel INGER MARIE and the Maltese general cargo ship RIG collided approximately 11 nautical miles north-east of the Island of Læsø, Denmark. INGER MARIE foundered shortly after the collision and the skipper, who was the only crew member on board, perished.

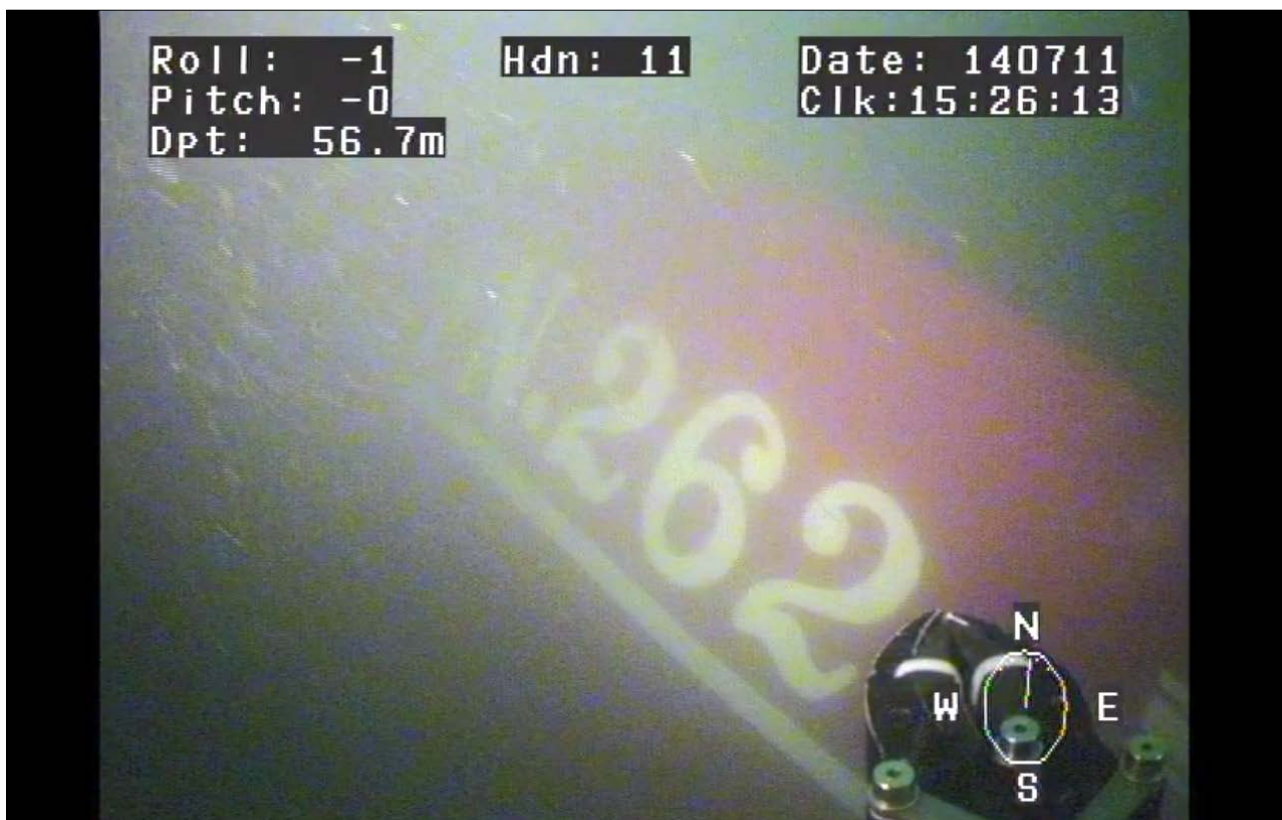
On 11 July 2014, the Swedish Coast Guard, by the use of an ROV<sup>3</sup>, located a wreck that was identified as INGER MARIE (figure 5). The vessel was found on a depth of 58 metres, upright with the bow in a southerly direction and with a port side list of approximately 45°.

Figure 5: Picture of the wreck of INGER MARIE  
Source: Swedish Coast Guard

The extent of the damage is not known. That INGER MARIE foundered with a considerable port list within one minute after the collision suggests that the damage was substantial.

Only the starboard side hull and superstructure was visible. Neither the starboard bow nor the side showed any signs of damage above or below the waterline, which means that the substantial part of the damage must have been suffered on the port side.

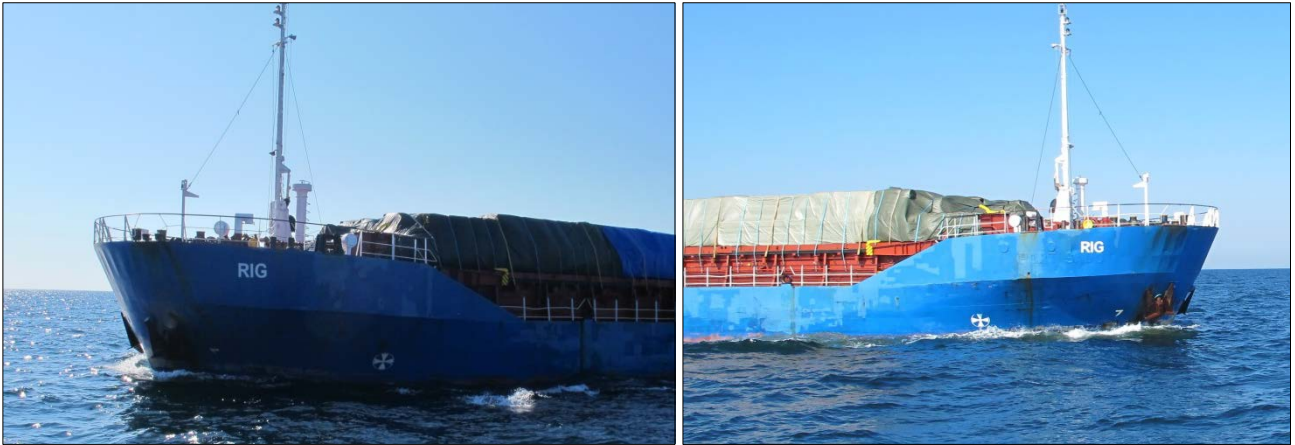
Figure 7: Picture of RIG's bow port and starboard side on the day of the accident  
Source: Swedish Coast Guard

As seen in figure 6 and 7, RIG was almost fully loaded and therefore the anchors were close to the waterline. Traces of red paint were only found on RIG's port bow (figure 8). Whether the marks on the port anchor came from the impact is uncertain. The picture in figure 8 was taken four days after the collision when RIG arrived in port and by then most of the residue from the collision might have been washed away.

The traces of red paint indicate that the impact occurred on the port side of RIG, which is consistent with RIG colliding with INGER MARIE after having initiated a hard starboard turn, while in a forward motion. The port anchor on RIG is likely to have been inflicting substantial damage to INGER MARIE's port side hull resulting in the sudden foundering.

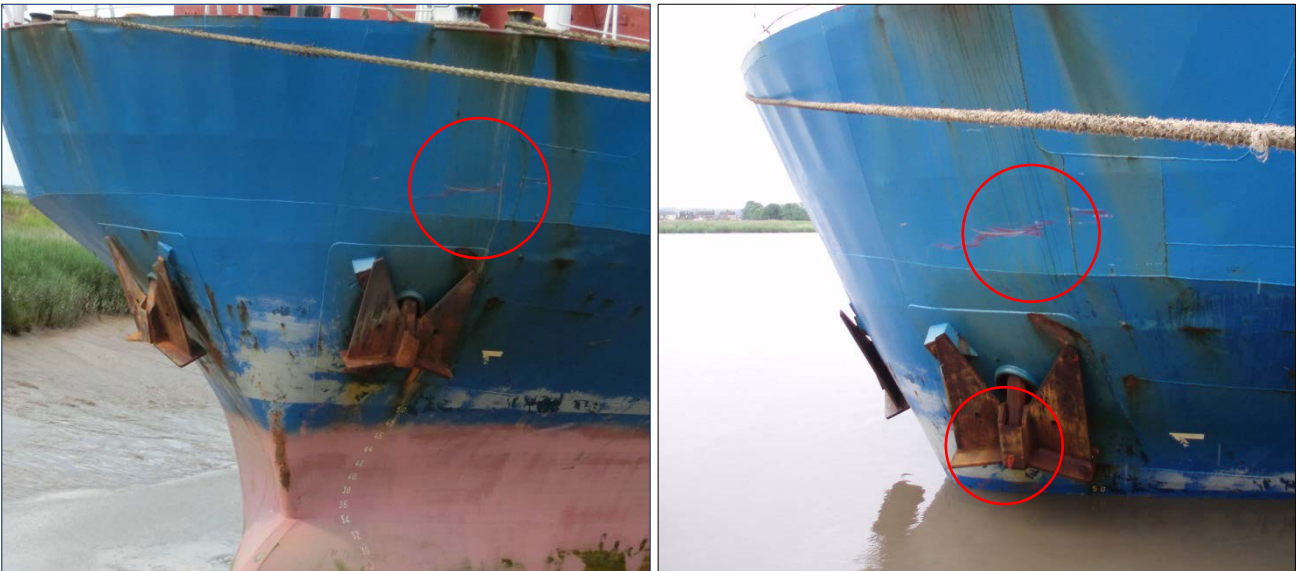
Figure 8: Picture of RIG's bow starboard side taken a few days after the accident  
Source: DMAIB

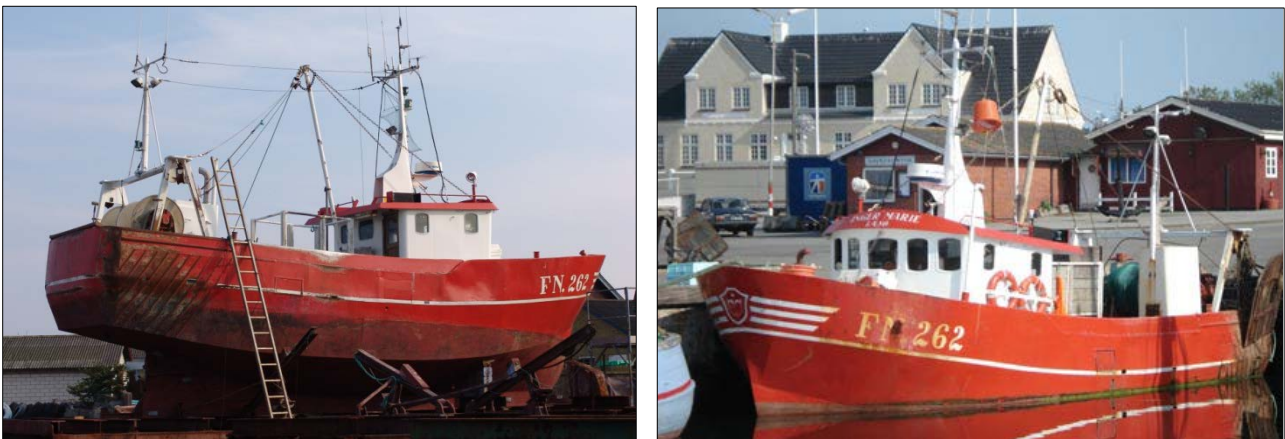
Figure 9: Pictures of INGER MARIE from port side  
Source: G. Vejen. Retrieved from [www.fiskerforum.dk](http://www.fiskerforum.dk)

As seen in figure 9, the skipper would have had a limited view ahead of the vessel's port side while situated aft by the doorway. If the skipper was preoccupied with sorting the catch and the bearing to the RIG was not changing and in a blind sector, then the risk of collision could go unnoticed for an extended period of time. INGER MARIE held a constant course of 245° and speed of 8 knots, which makes it likely that the vessel was underway to its home port of Østerby on the island of Læsø. Considering INGER MARIE's distance from the fishing ground at the time of the collision, the skipper was likely in the process of sorting the catch when the collision occurred.

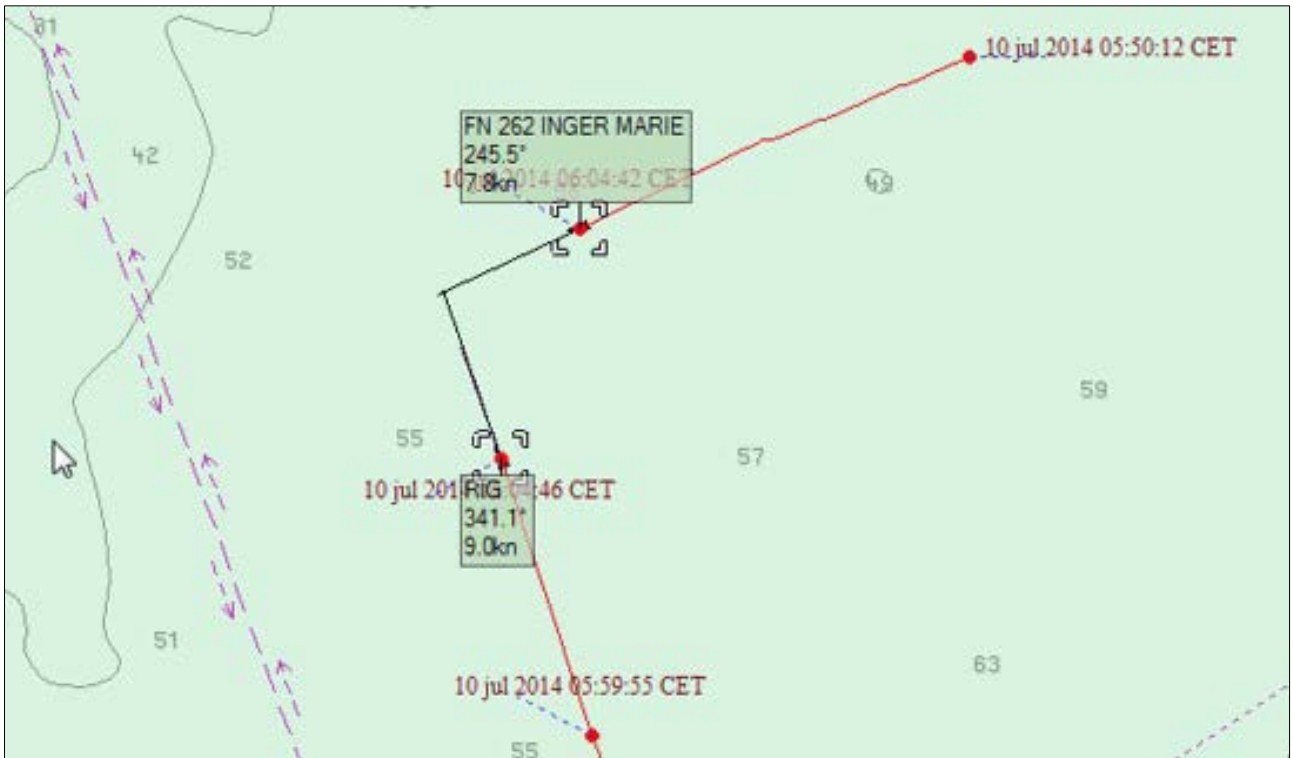
Below in figure 10 are screenshots from the AIS signals from RIG and INGER MARIE on the day of the collision. The vectors on the ships are 3 minutes. INGER MARIE can be seen on a south-westerly course of 246 with a speed over the ground of 7.8 knots, which implies that the vessel was not engaged in fishing, but returning to port after having completed fishing. RIG can be seen on a north-westerly course of 341 with a speed over the ground of 9.0 knots.

Both ships had been on their respective courses for at least 60 minutes before the collision, i.e. for a distance of 8-9 nautical miles. The AIS signal transmitted small variations in the course that did not exceed 2-3 degrees.

The visibility was good and the ships were therefore within sight of each other before the collision with no significant change in bearing.

Figure 10: AIS track from RIG and INGER MARIE few minutes before the collision  
 Source: Danish Maritime Authority

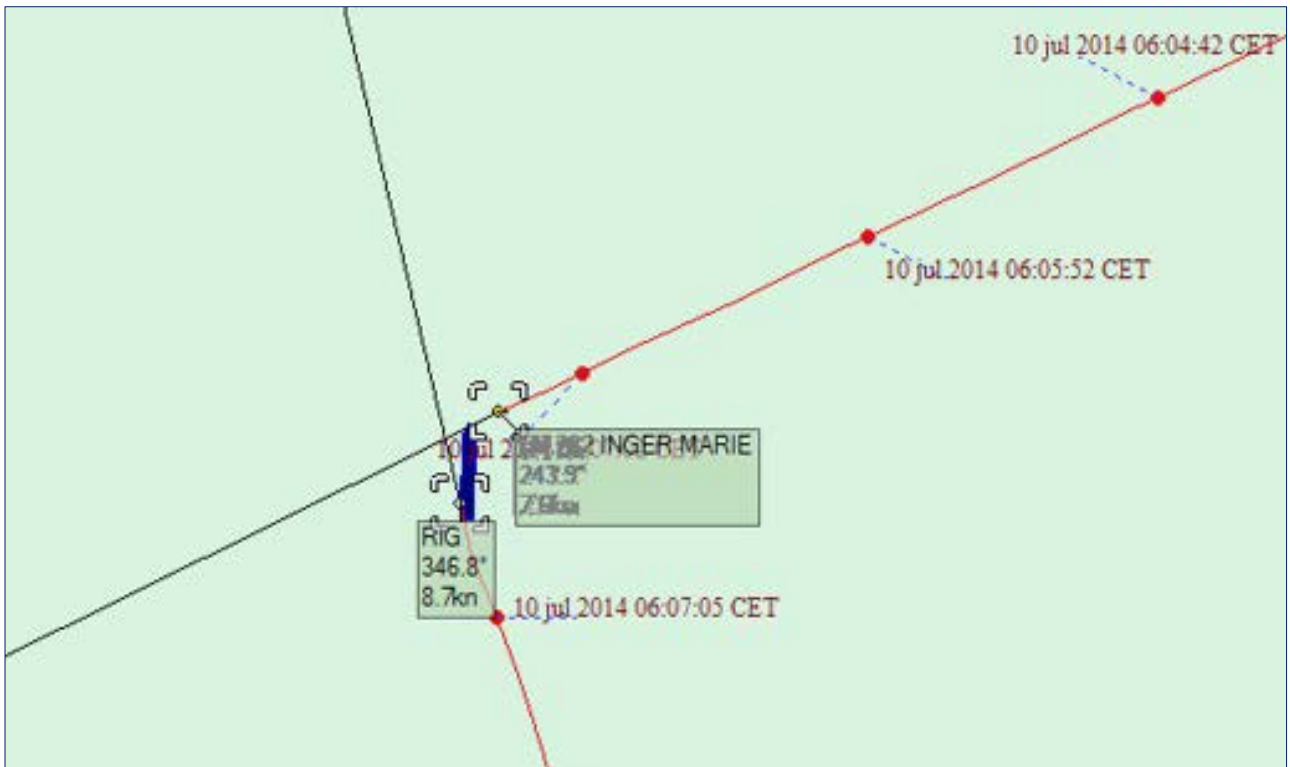
It can be seen in figure 11 below that RIG was in a starboard turn moments before the collision and that INGER MARIE was apparently still on a steady course. Before the turn, the AIS on RIG was transmitting with an update frequency of approximately 10 seconds before the turn. During the turn, the update frequency increased. Therefore, the AIS data is considered a close approximation of the actual situation.

Figure 11: AIS track from RIG and INGER MARIE moments before the collision  
 Source: Danish Maritime Authority
