MARINE ACCIDENT REPORT

March 2015

RIG and INGER MARIE
Collision on 10 July 2014

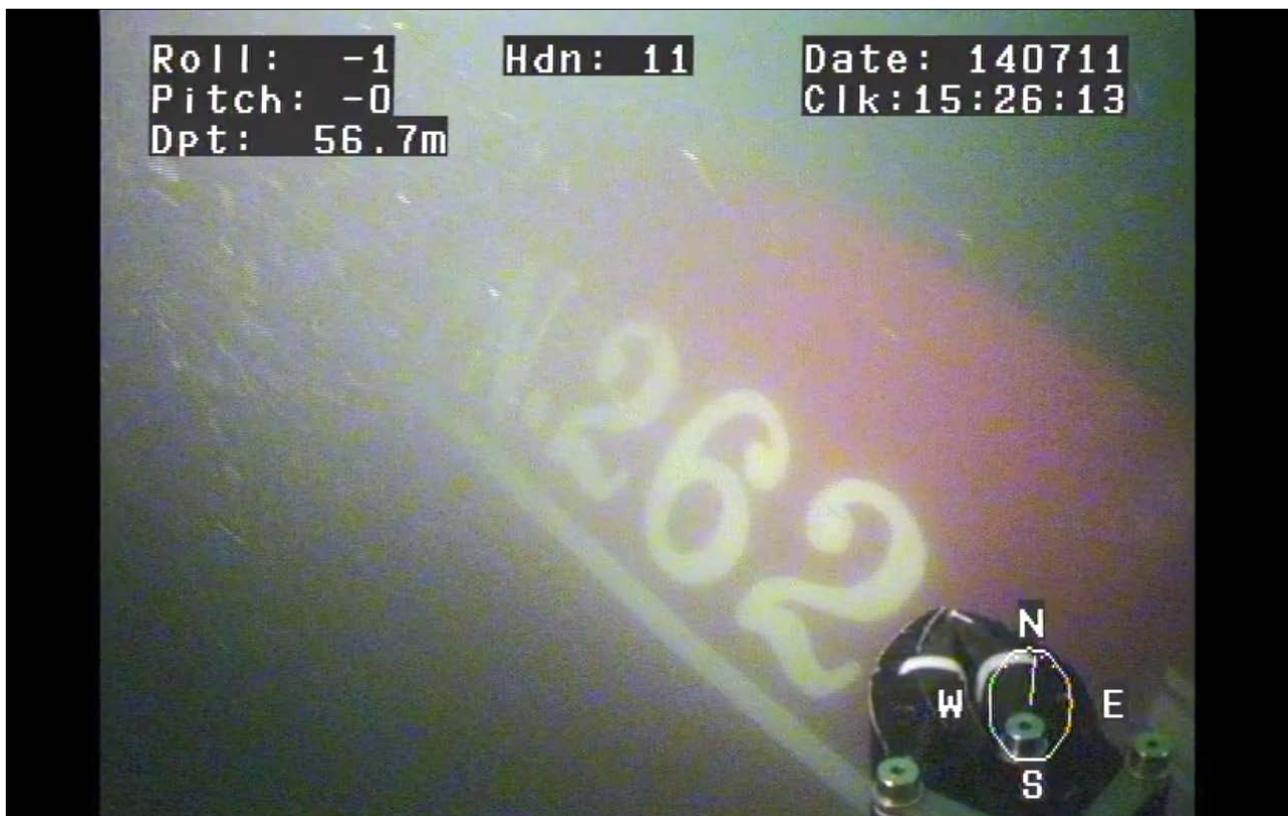
Figure 5: Picture of the wreck of INGER MARIE
Source: Swedish Coast Guard

On 11 July 2014, the Swedish Coast Guard, by the use of an ROV³, located a wreck that was identified as INGER MARIE (figure 5). The vessel was found on a depth of 58 metres, upright with the bow in a southerly direction and with a port side list of approximately 45°.

The extent of the damage is not known. That INGER MARIE foundered with a considerable port list within one minute after the collision suggests that the damage was substantial.

Only the starboard side hull and superstructure was visible. Neither the starboard bow nor the side showed any signs of damage above or below the waterline, which means that the substantial part of the damage must have been suffered on the port side.

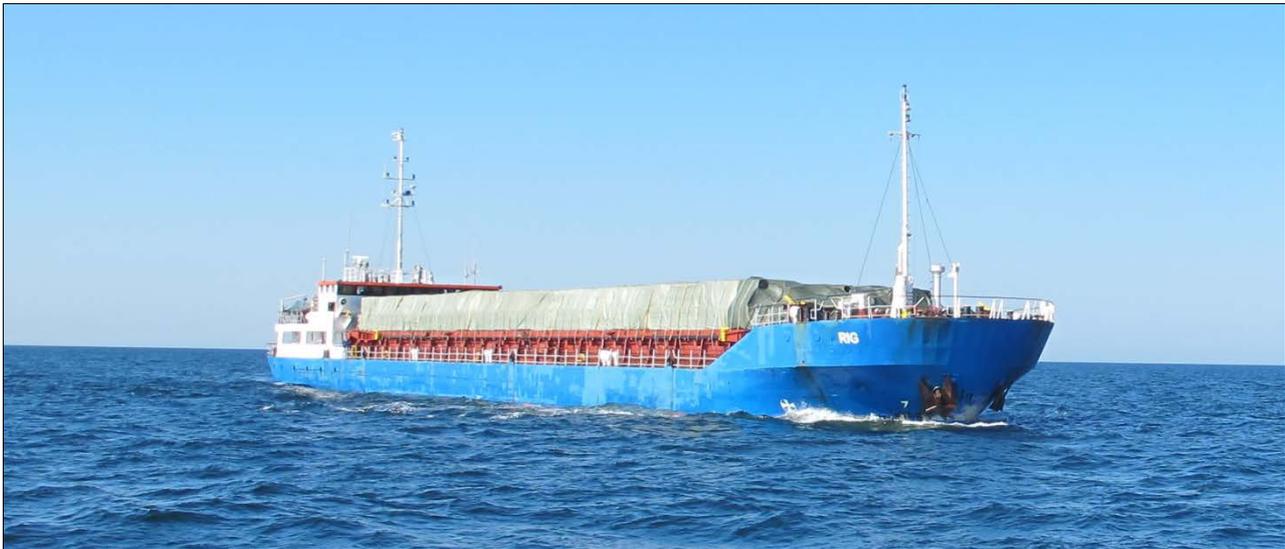
*Figure 6: Picture of RIG's starboard side on the day of the accident
Source: Swedish Coast Guard*

RIG was carrying timber cargo, which in part was stowed on the cargo hold hatches. The cargo did not, however, obstruct the visibility over the bow or the starboard side, while the watchkeeping officer was standing or sitting by the radar on the starboard side. Visibility was to some degree hindered by the relatively small bridge windows and wide frames. The watchkeeping officer might not have been able to see an approaching ship in certain angles on the starboard side if he was not moving around on the bridge and the ship was approaching on a crossing course with no change in bearing.

As seen in figure 6 and 7, RIG was almost fully loaded and therefore the anchors were close to the waterline. Traces of red paint were only found on RIG's port bow (figure 8). Whether the marks on the port anchor came from the impact is uncertain. The picture in figure 8 was taken four days after the collision when RIG arrived in port and by then most of the residue from the collision might have been washed away.

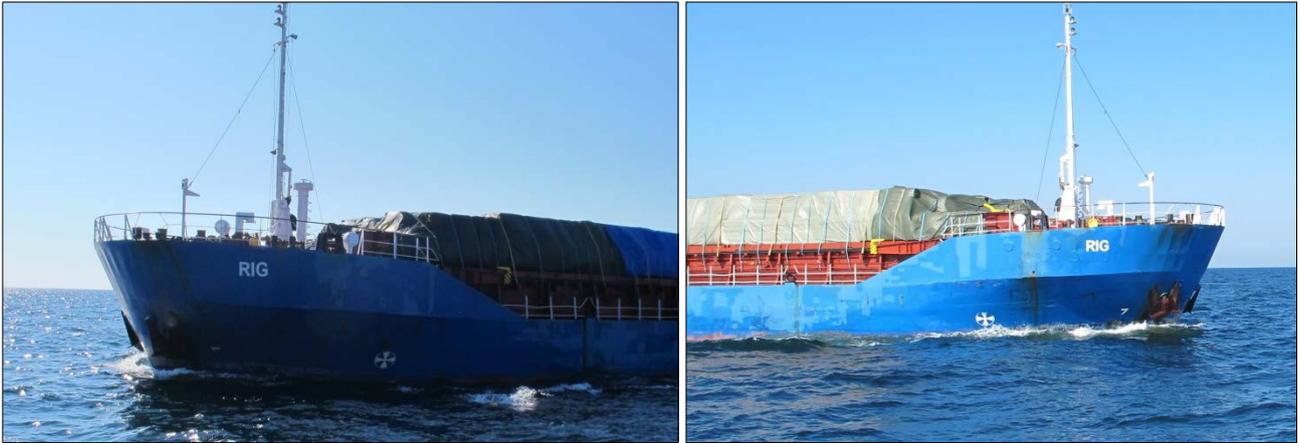
Figure 7: Picture of RIG's bow port and starboard side on the day of the accident
Source: Swedish Coast Guard

The traces of red paint indicate that the impact occurred on the port side of RIG, which is consistent with RIG colliding with INGER MARIE after having initiated a hard starboard turn, while in a forward motion. The port anchor on RIG is likely to have been inflicting substantial damage to INGER MARIE's port side hull resulting in the sudden foundering.

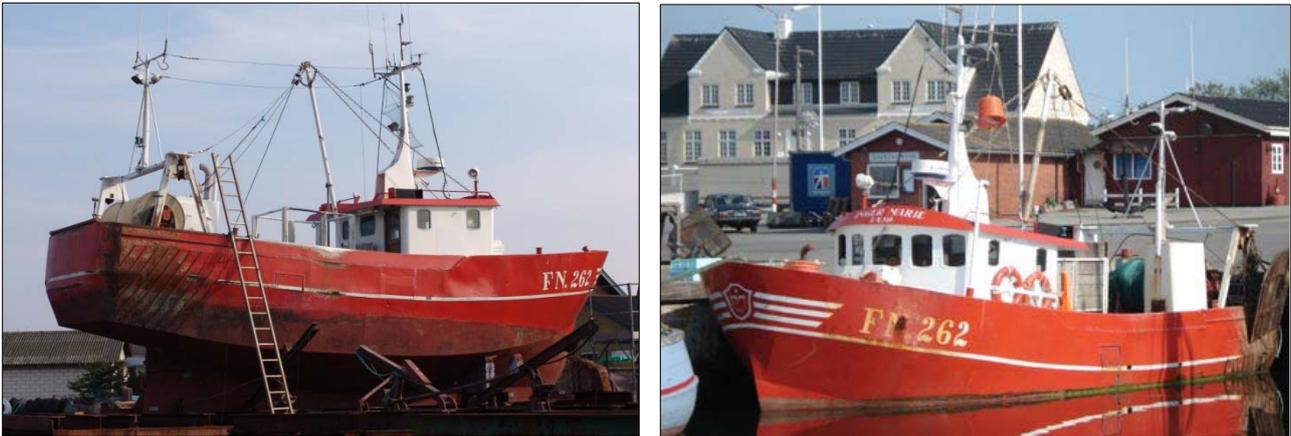
Figure 9: Pictures of INGER MARIE from port side
Source: G. Vejen. Retrieved from www.fiskerforum.dk

As seen in figure 9, the skipper would have had a limited view ahead of the vessel's port side while situated aft by the doorway. If the skipper was preoccupied with sorting the catch and the bearing to the RIG was not changing and in a blind sector, then the risk of collision could go unnoticed for an extended period of time. INGER MARIE held a constant course of 245° and speed of 8 knots, which makes it likely that the vessel was underway to its home port of Østerby on the island of Læsø. Considering INGER MARIE's distance from the fishing ground at the time of the collision, the skipper was likely in the process of sorting the catch when the collision occurred.

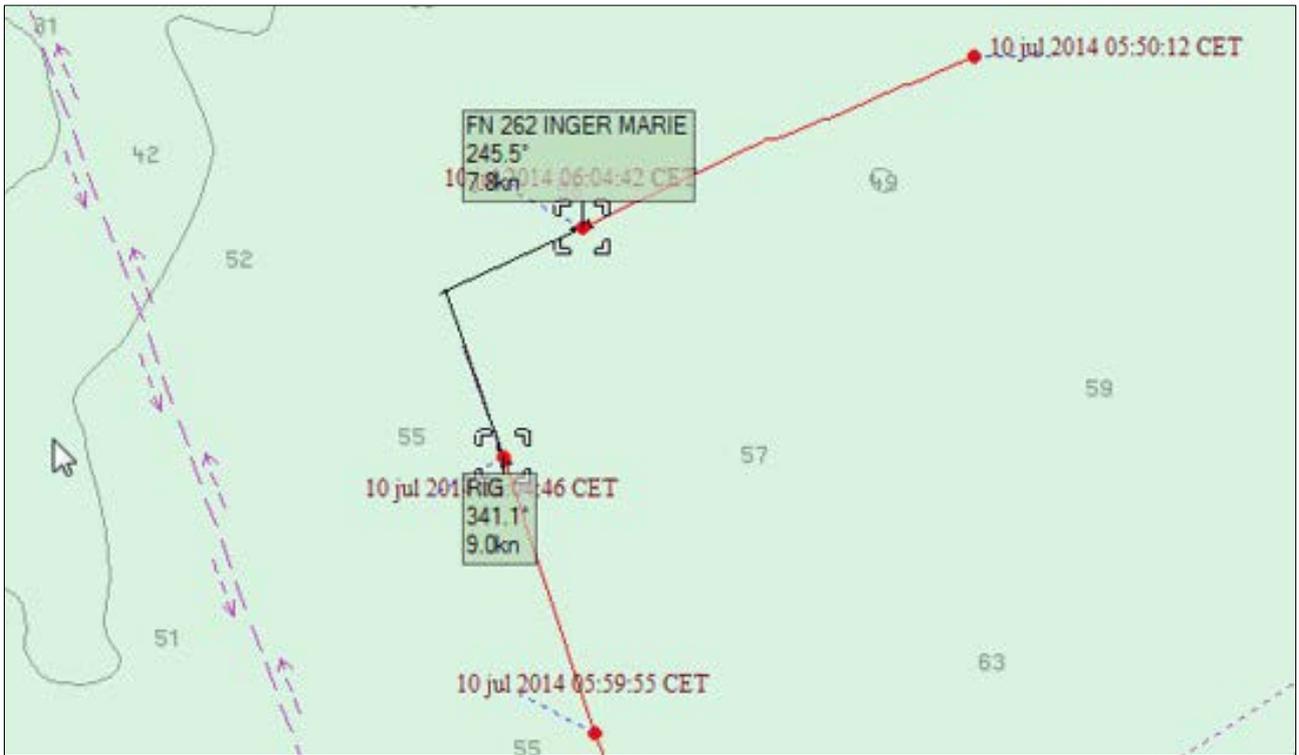
Figure 10: AIS track from RIG and INGER MARIE few minutes before the collision
Source: Danish Maritime Authority

Below in figure 10 are screenshots from the AIS signals from RIG and INGER MARIE on the day of the collision. The vectors on the ships are 3 minutes. INGER MARIE can be seen on a south-westerly course of 246 with a speed over the ground of 7.8 knots, which implies that the vessel was not engaged in fishing, but returning to port after having completed fishing. RIG can be seen on a north-westerly course of 341 with a speed over the ground of 9.0 knots.

Both ships had been on their respective courses for at least 60 minutes before the collision, i.e. for a distance of 8-9 nautical miles. The AIS signal transmitted small variations in the course that did not exceed 2-3 degrees.

The visibility was good and the ships were therefore within sight of each other before the collision with no significant change in bearing.

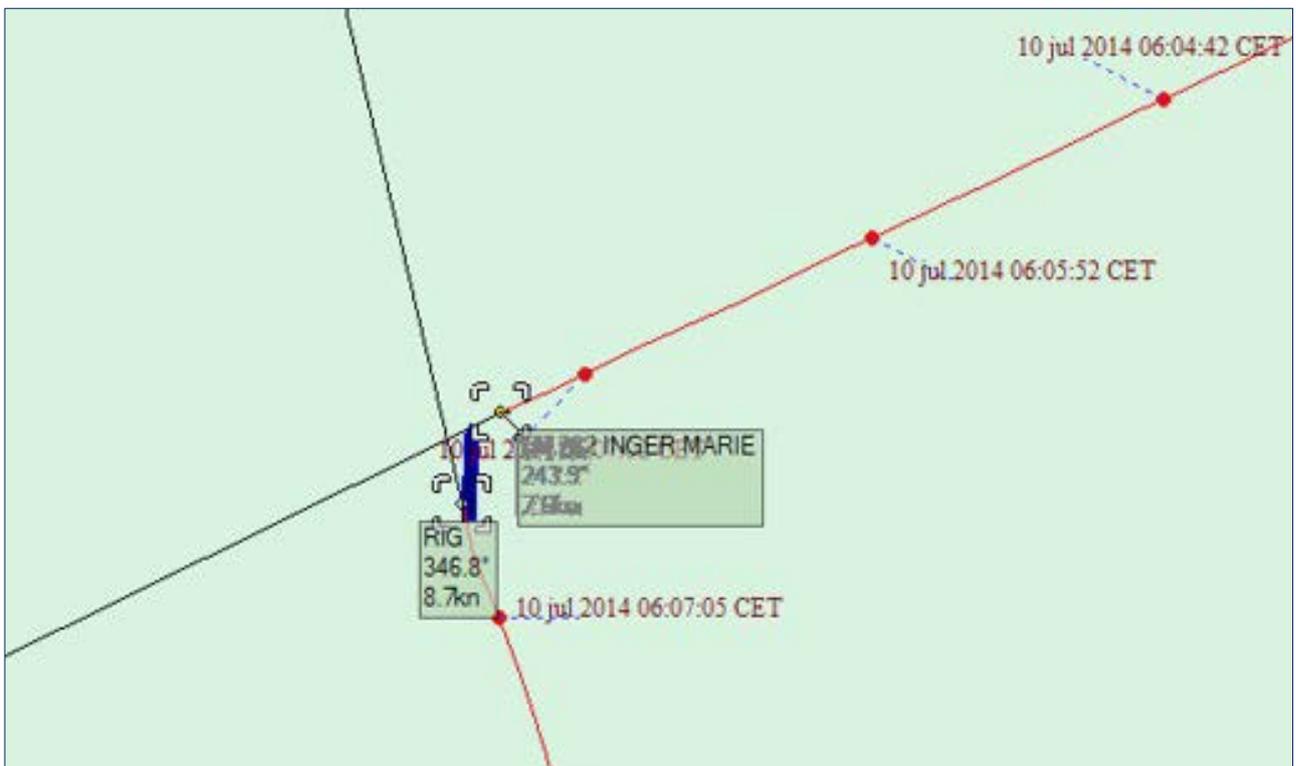
Figure 11: AIS track from RIG and INGER MARIE moments before the collision
Source: Danish Maritime Authority

It can be seen in figure 11 below that RIG was in a starboard turn moments before the collision and that INGER MARIE was apparently still on a steady course. Before the turn, the AIS on RIG was transmitting with an update frequency of approximately 10 seconds before the turn. During the turn, the update frequency increased. Therefore, the AIS data is considered a close approximation of the actual situation.
