MARINE ACCIDENT REPORT

SVENDBORG MÆRSK
Heavy weather damage on 14 February 2014

This marine accident report is issued on 5 September 2014

Case number: 2013010519

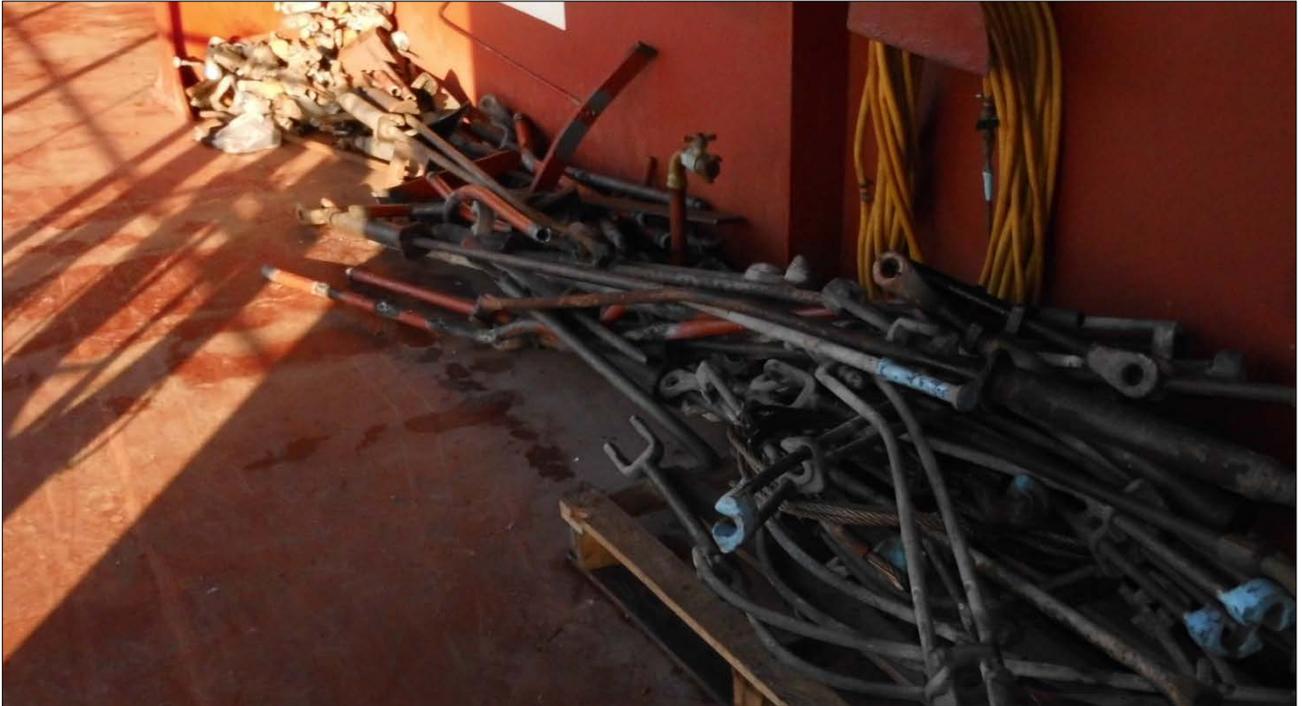
Several pieces of lashing equipment, including FATs, were found damaged as a result of excessive forces induced by the severe rolling of the ship and impact from the seas (figure 6). Some of the lashing rods had failed in their function, indicating that the forces induced on the container stacks during the incident had found their way down to the bottom tiers.

Figure 6: Damaged lashing equipment
Source: Maersk Line A/S

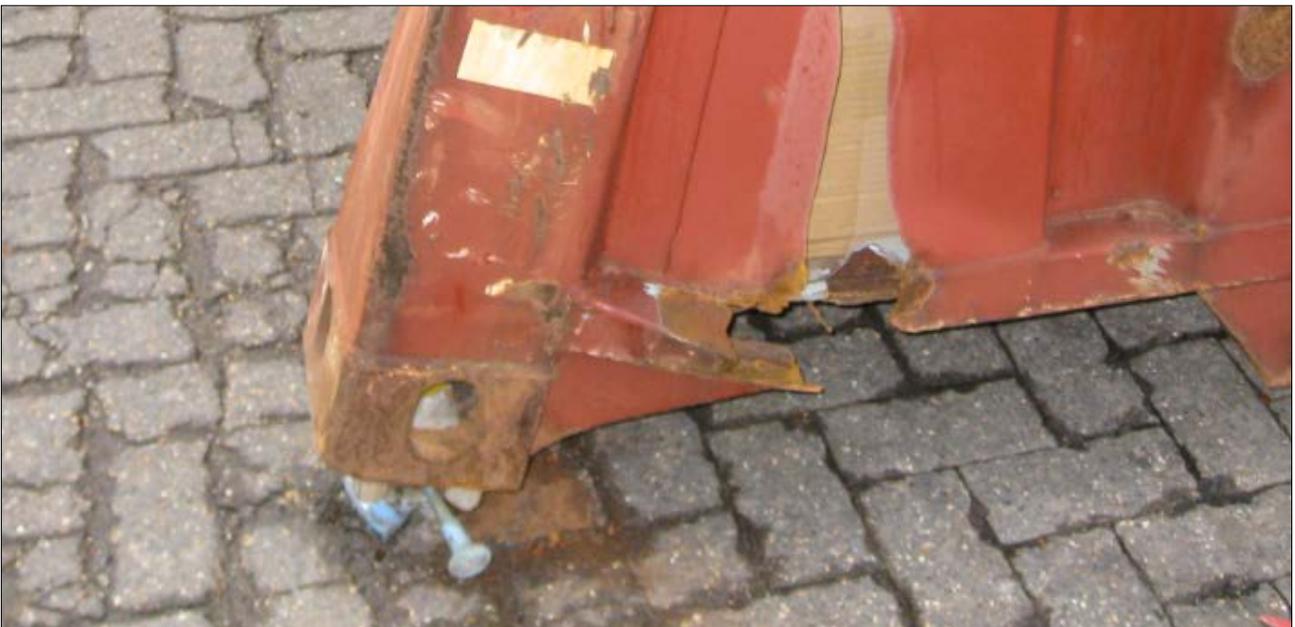
Some containers were found with structural damages confirming that their structural strength was lower than the lashing equipment (figure 7 & 8). The structural strength of the containers and lashing equipment depended on their individual condition and application. Therefore, the finding of damaged lashing equipment *and* containers indicated variations in their structural strength, and/or varying distribution of forces acting on them.

Figure 7: Damaged container
Source: Maersk Line A/S

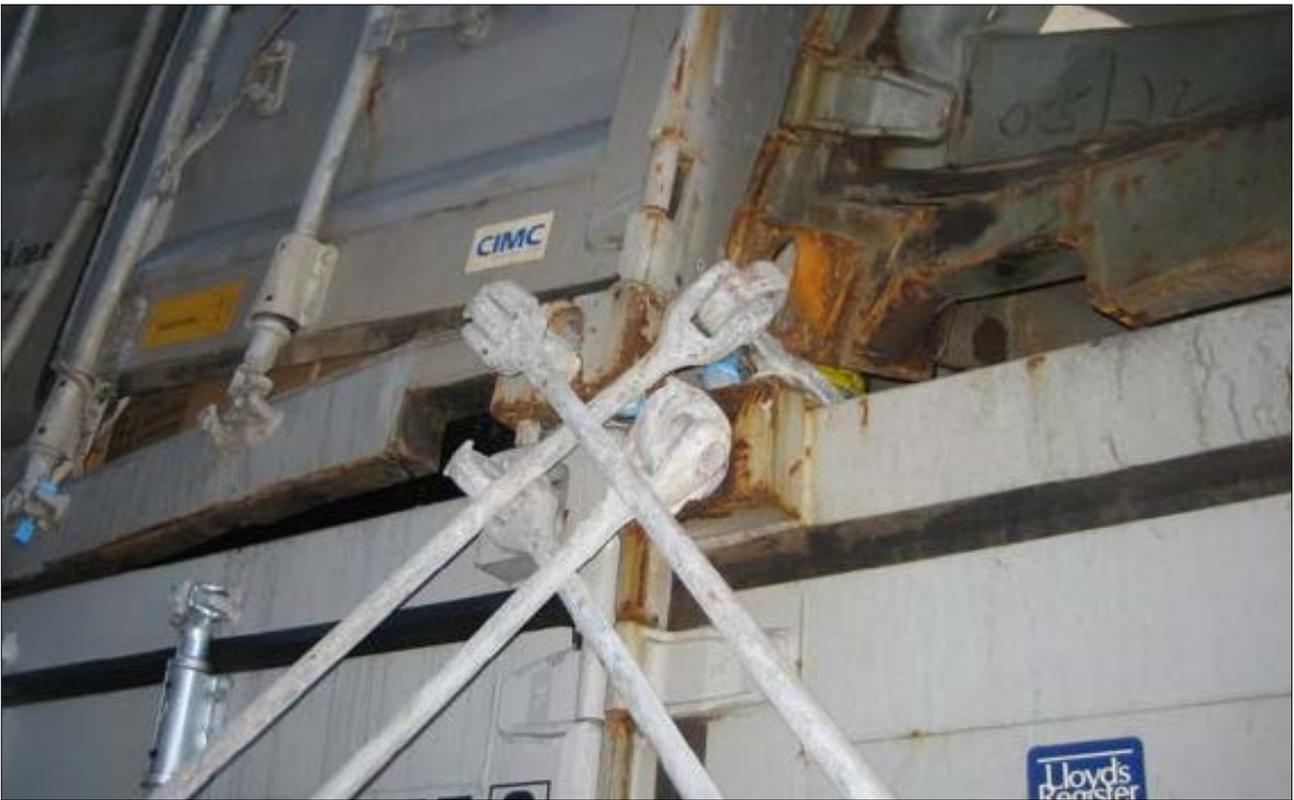
Figure 8: Damaged containers
Source: Maersk Line A/S

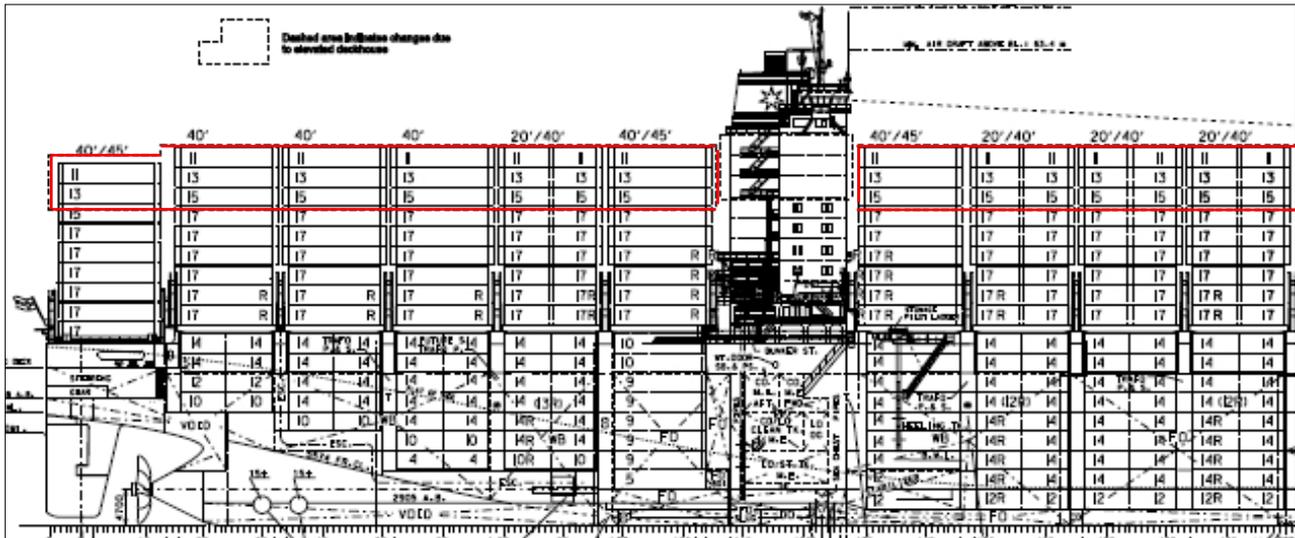
The conversion made it possible to load an increased number of containers on deck by adding two or three layers; enabling stacking up to nine tiers high (figure 9).

Figure 9: Excerpt from general arrangement of SVENDBORG MÆRSK after conversion. Boxed red area shows increase in container capacity.

The ship's robustness to withstand adverse weather conditions without compromising the safety of the cargo had been reduced following the optimization of the cargo capacity.

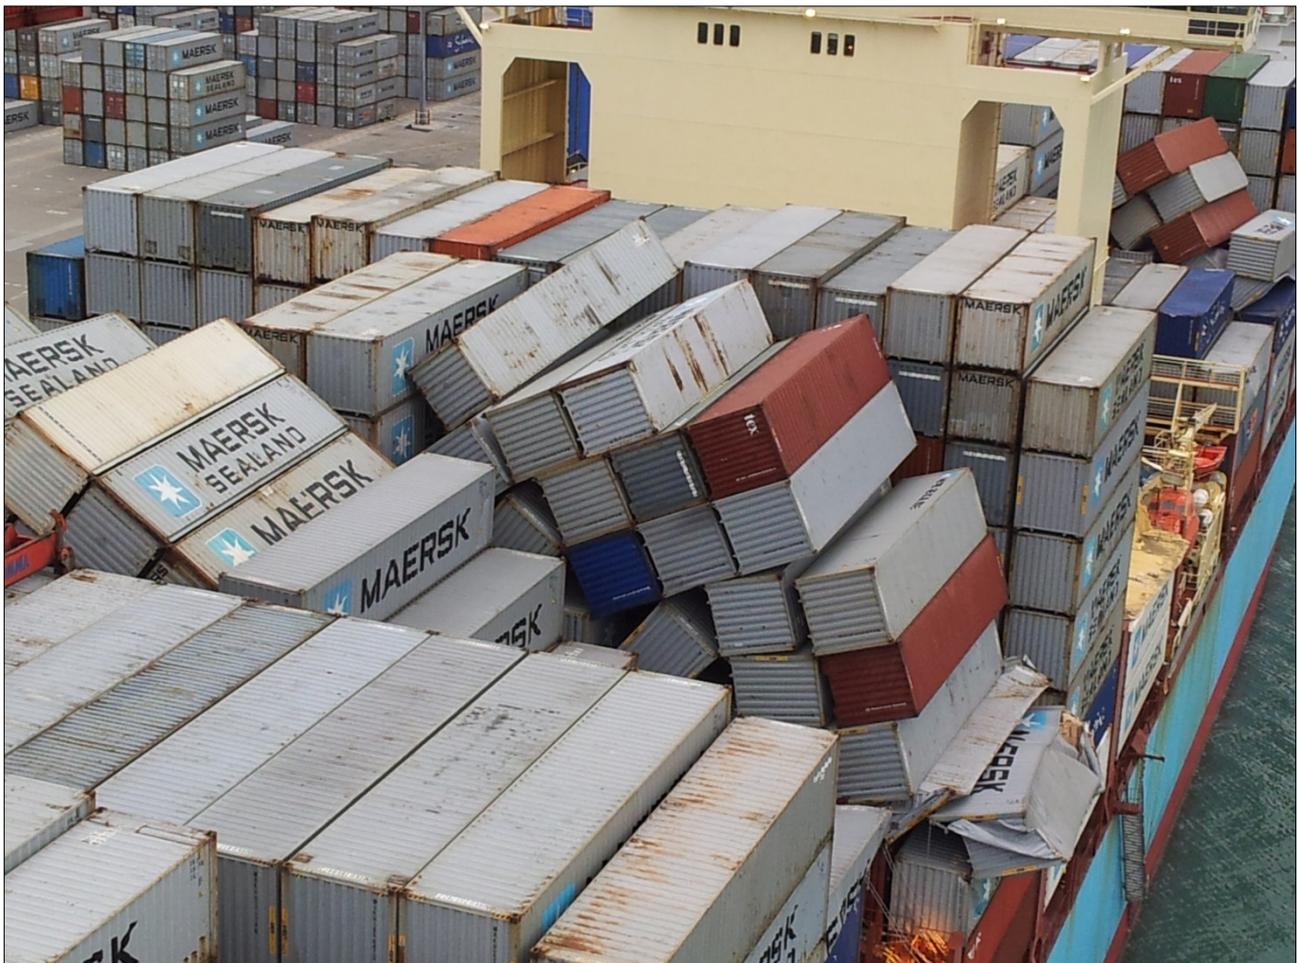
Lashing gear for 600-700 containers was found to have been damaged during the incidents. The counting of the cargo containers showed that 517 units had been lost over board. From the cargo documentation it was established that of these, 75 units contained cargo and the additional 442 units were empty. Another 250 units were found to be damaged (figure 16).

Figure 16: SVENDBORG MAERSK, aft deck at arrival in Malaga
Source: Maersk Line A/S

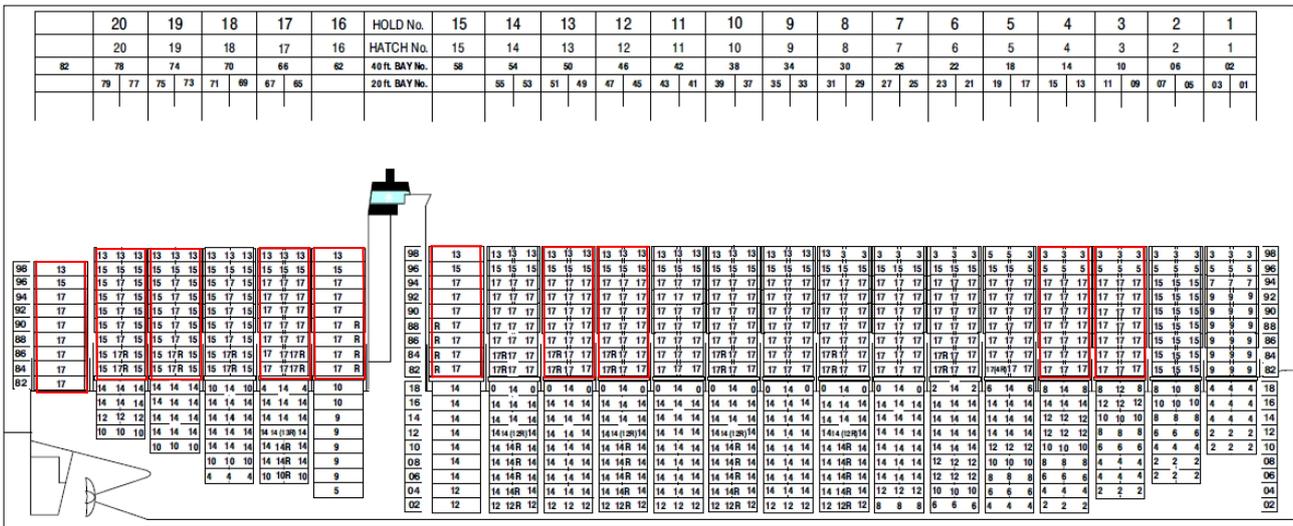
A large number of the lost containers were placed in stacks of eight to nine tiers' height. These comprised bays 46, 50, 58, 62, 74, 78 and 82. Where the containers were stacked seven tiers high, containers were lost over board in some bays. These comprised bays 10, 14 and 66 (Figure 17).

Figure 17: SVENDBORG MÆRSK, bays with lost containers are boxed in red
Source: Maersk Line A/S
