Danish Maritime Accident
Investigation Board

SUMMARY REPORT

September 2014

CHR. HØY
Mooring accident on 5 February 2014

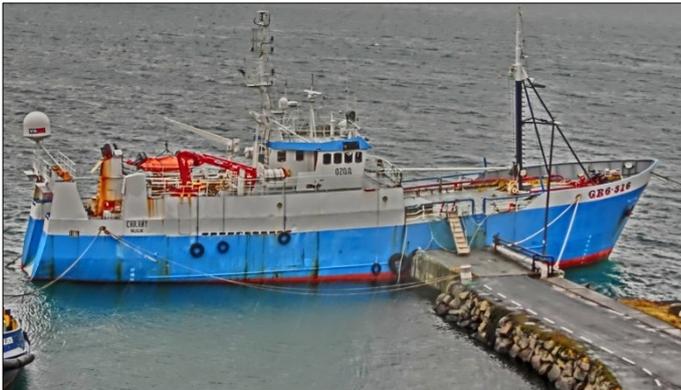
Figure 2: Pier where CHR. HØY was alongside
Source: DMAIB

The berth was shorter than the ship and therefore the mooring lines had to be secured on bollards on the pier and on shore (figure 2). The plan was to approach the pier with the bow first, secure a spring line and use the propulsion and rudder to manoeuvre the ship alongside. Thereafter, the ship was to be moored 1/2 – i.e. by means of one headline and two spring lines. Two of the spring lines (wire ropes) came from the shore side. The ratings were to finish the mooring forward before they secured the moorings aft.

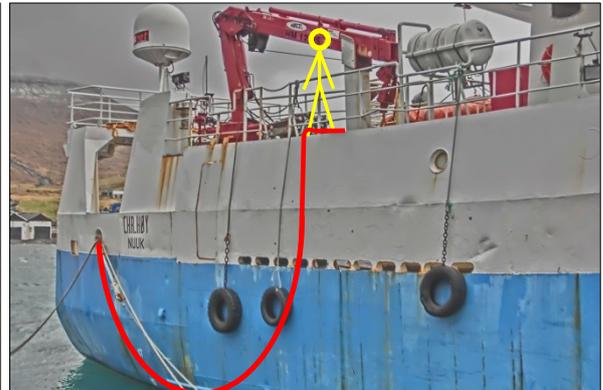
Figure 3: Position of rating and spring line during the accident
Source: DMAIB

The slack of the spring line was therefore brought to the boat deck under the railing (figure 3) by two ratings, where a heaving line was attached to it – while a rating would fasten the spring line onto the bits on the aft deck.

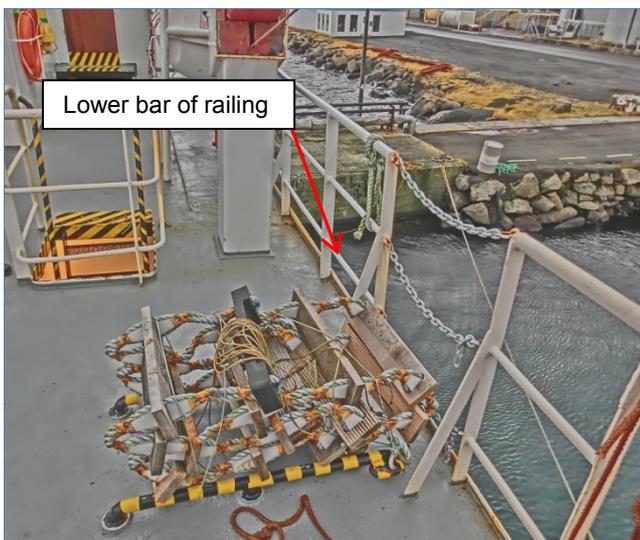
Figures 5 and 6 show the area and position where the rating was positioned as he tried to heave up the slackened mooring rope and prepare the heaving line. The rope was pulled under the lower bar on the railing, and as the rope was piling up on deck, there was little room left for the rating to position himself in such a way that he was clear of the rope if an unexpected event occurred. The rope was heavy and would slide over board if the rating did not hold on to it.

Figure 5: Boat deck where the accident occurred
Source: DMAIB

These circumstances made the rating move the mooring rope to the boat deck and pull the rope up to an area that was neither designed nor suitable for handling mooring ropes – mainly due to the space restriction imposed on the rating unknowingly, making him place himself in a hazardous situation.

After the accident, the operator of the ship has changed the type of mooring ropes used on all ships to a type that is buoyant. Furthermore, folders on safe mooring have been sent to the ships with the aim of changing the risk assessments made in connection with mooring operations.

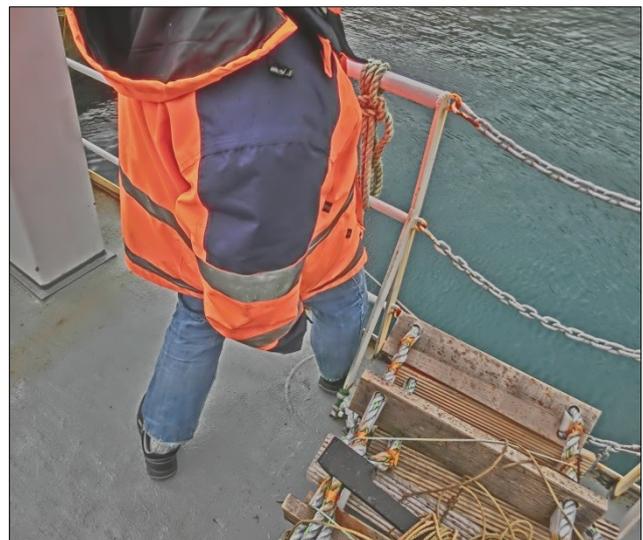
As the rope was caught by the propeller and tightened, his leg was trapped under the bar of the railing as shown on figure 6.

Figure 6: Approximate position of rating
Source: DMAIB

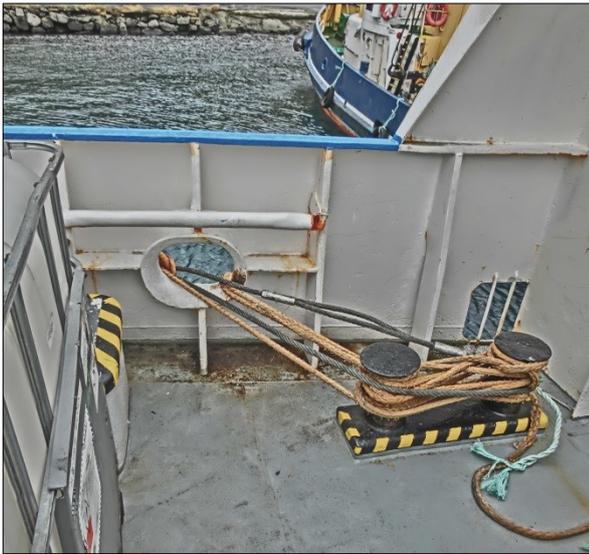
The rope stored on the aft deck was accidentally slacked out of the aft fairlead (figure 4) enabling the rope to sink and drift into the rotating propeller. The rating who was standing on the aft deck was occupied by another task and therefore did not notice the rope sliding out of the fairlead and into the water.

Figure 4: Mooring bitts on aft deck
Source: DMAIB

Different types of mooring ropes were available, some of which were buoyant and some of which were not. In addition, wires from shore side with rope tails were used as seen on figure 4 above.

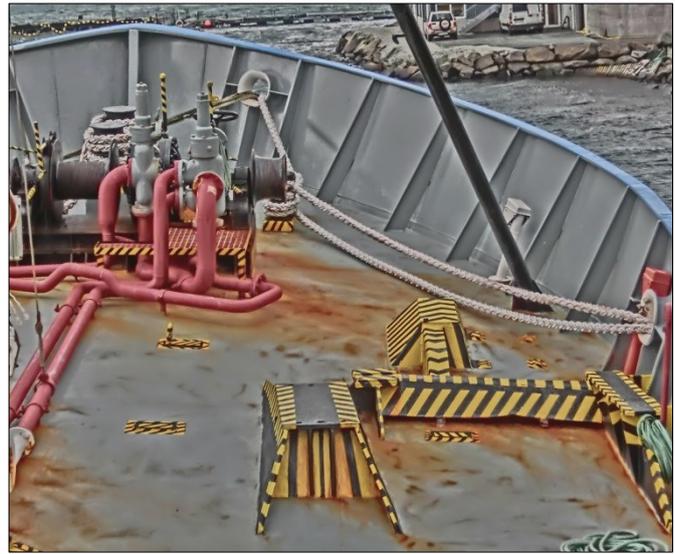
CHR. HØY was built as a stern trawler in 1974 and had been refitted to serve as a guard ship and tender ship in 2012. The mooring arrangements had not been modified and consisted of one combined mooring and anchor winch on the foredeck and mooring bits on the aft part of the ship (figures 4 and 5). There were no mooring winches on the aft deck.

Figure 5: Mooring arrangement on foredeck
Source: DMAIB
