Danish Maritime Accident
Investigation Board

MARINE ACCIDENT REPORT

June 2014

URD
Fire on 4 March 2014

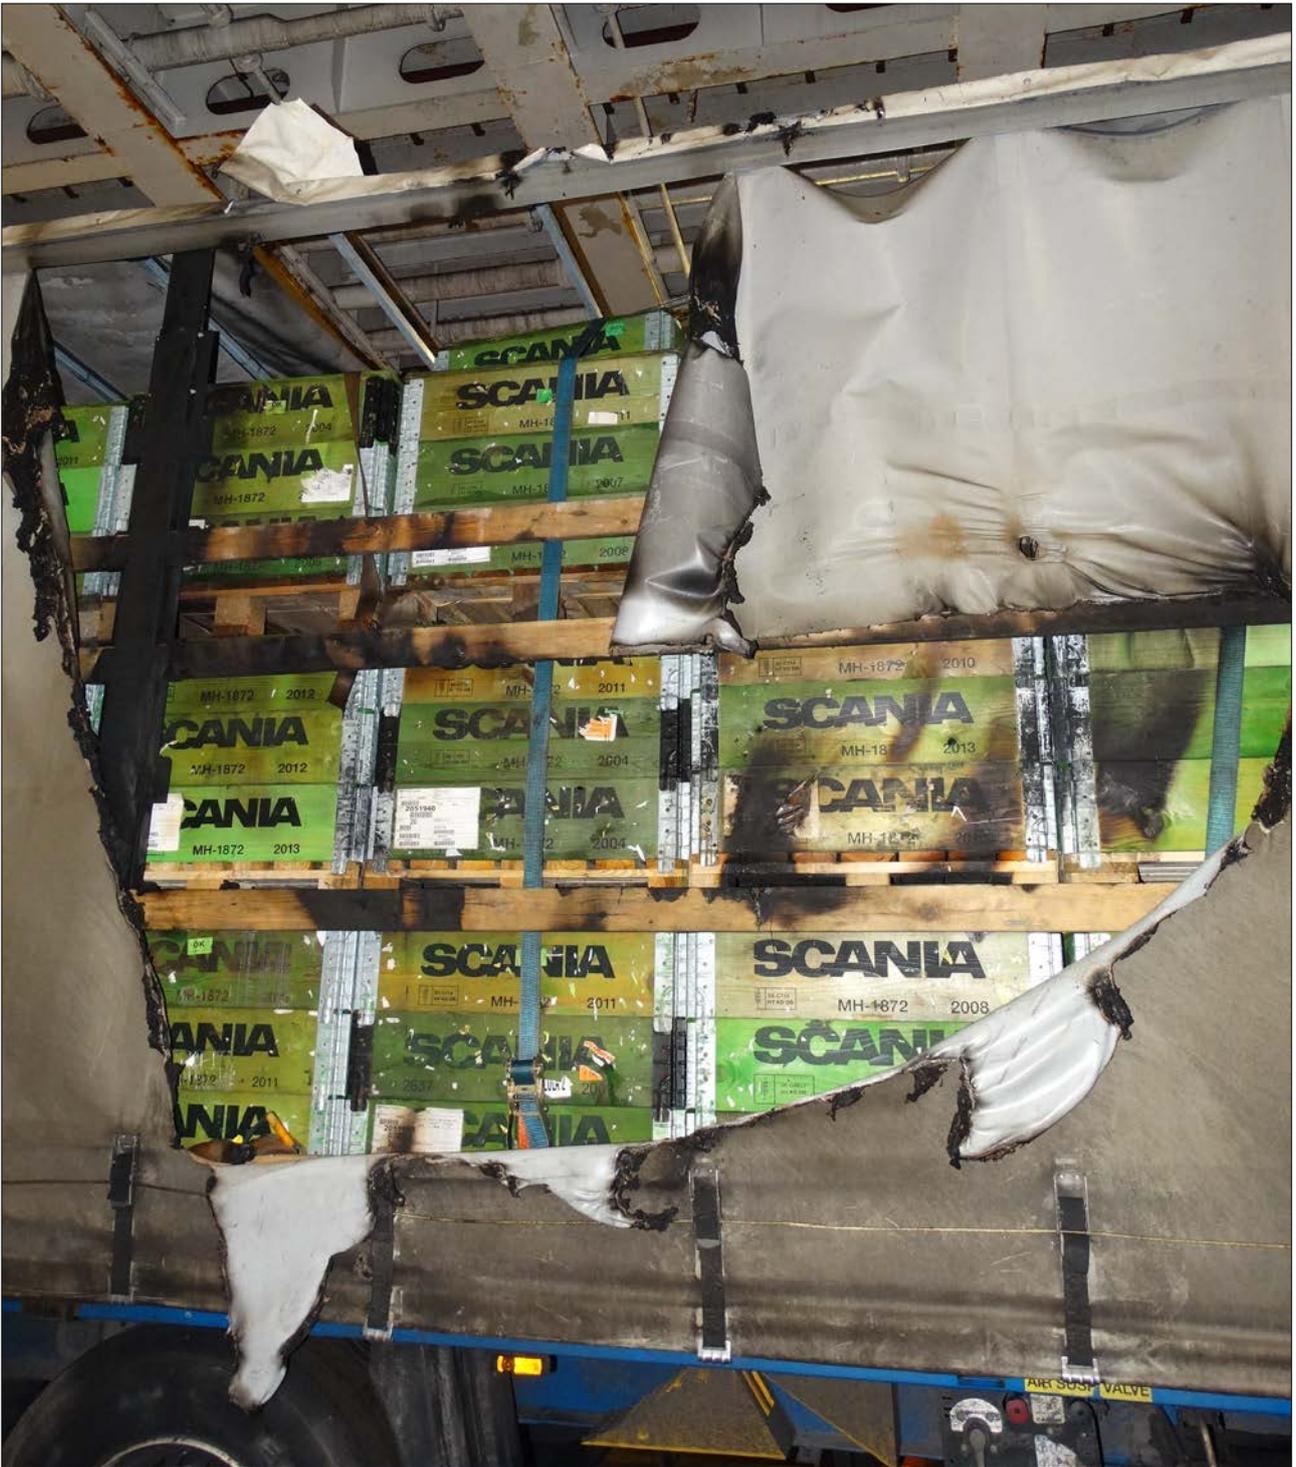
At 0808, the 2nd engineer informed the master that the fire had been extinguished (figure 5). However, it was decided to station a fire watch on the car deck for the rest of the crossing.

Figure 5: Burnt lorry. Picture taken after arrival in port
Source: Stena Line

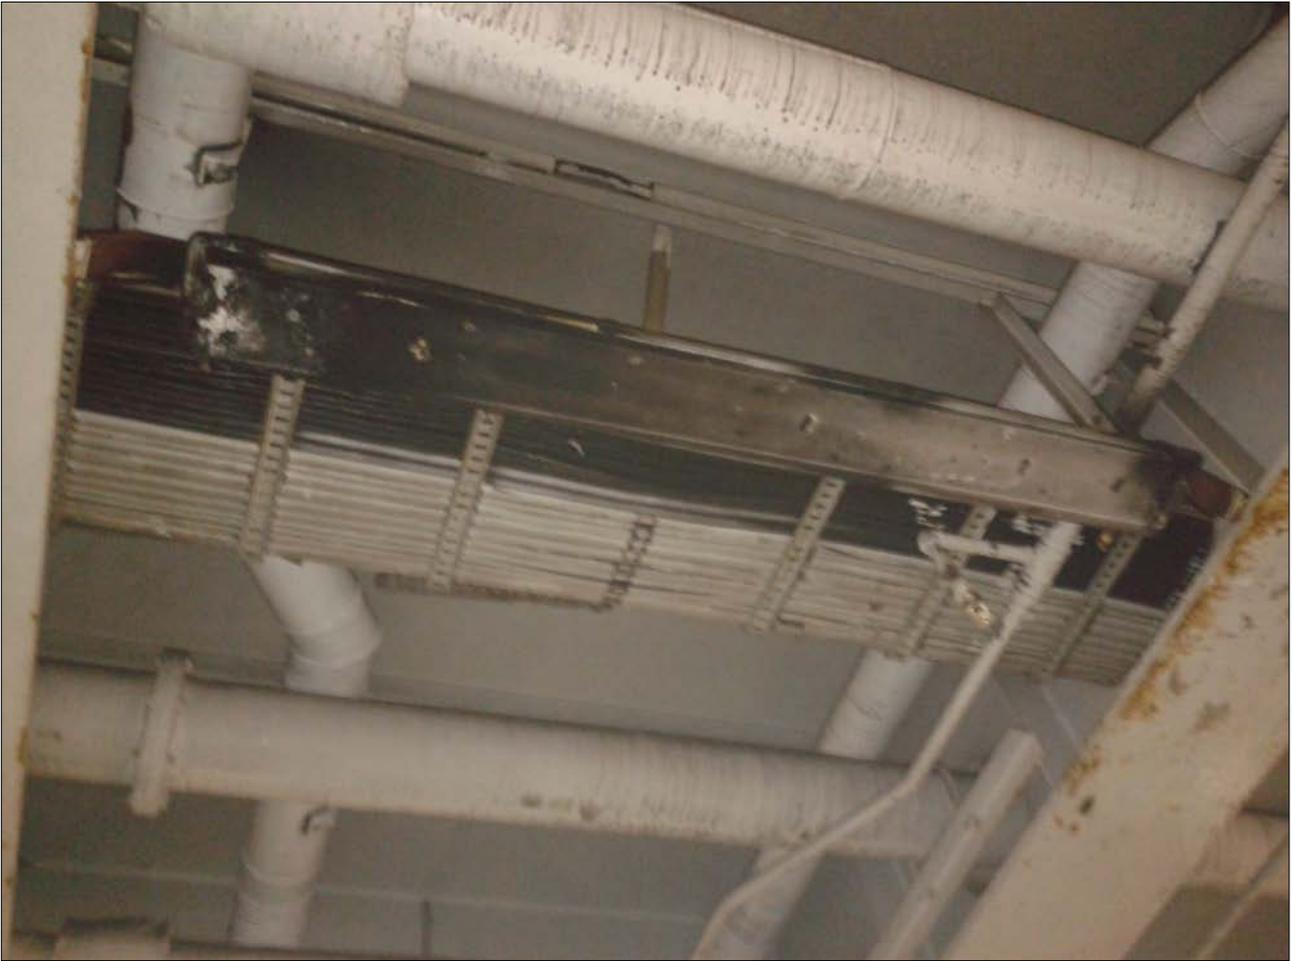
During the discovery and subsequent extinction of the fire, its origin was uncertain. Afterwards, the crew discovered that the fire had originated in a fluorescent light fixture installed on the main car deck (figure 6).

Figure 6: Light fixture where the fire originated on the main car deck
Source: Stena Line

The cause of the fire was a malfunction in a fluorescent light fixture that made the diffuser catch fire. At some point, the diffuser got detached from the light fixture and landed on the tarpaulin of the lorry situated underneath. The tarpaulin caught fire and flames and smoke developed.

A humid and saline atmosphere inside the light fixture is likely to have caused an expedited poor electrical connection resulting in arcing, thus igniting the fire. It has not been possible to establish the level of protection against ingress of water into the burnt light fixture due to its condition.

The fire on board URD originated in a malfunctioning fluorescent light fixture on the main car deck. A combination of age, poor capsuling and a subsequent humid and saline atmosphere inside the fluorescent light fixture is likely to have caused poor electrical connections that resulted in arcing. The diffuser caught fire, parted from the fixture and landed on and ignited the tarpaulin on the lorry situated below.

The fire originated in a fluorescent light fixture. The burned fixture and a randomly chosen fixture from the car deck showed clear signs of deterioration caused by ageing and exposure to an unfavourable environment. On this background DMAIB recommends the company that all fixtures installed on the ship's car decks are subject to an examination to ascertain the need for repair or replacement.

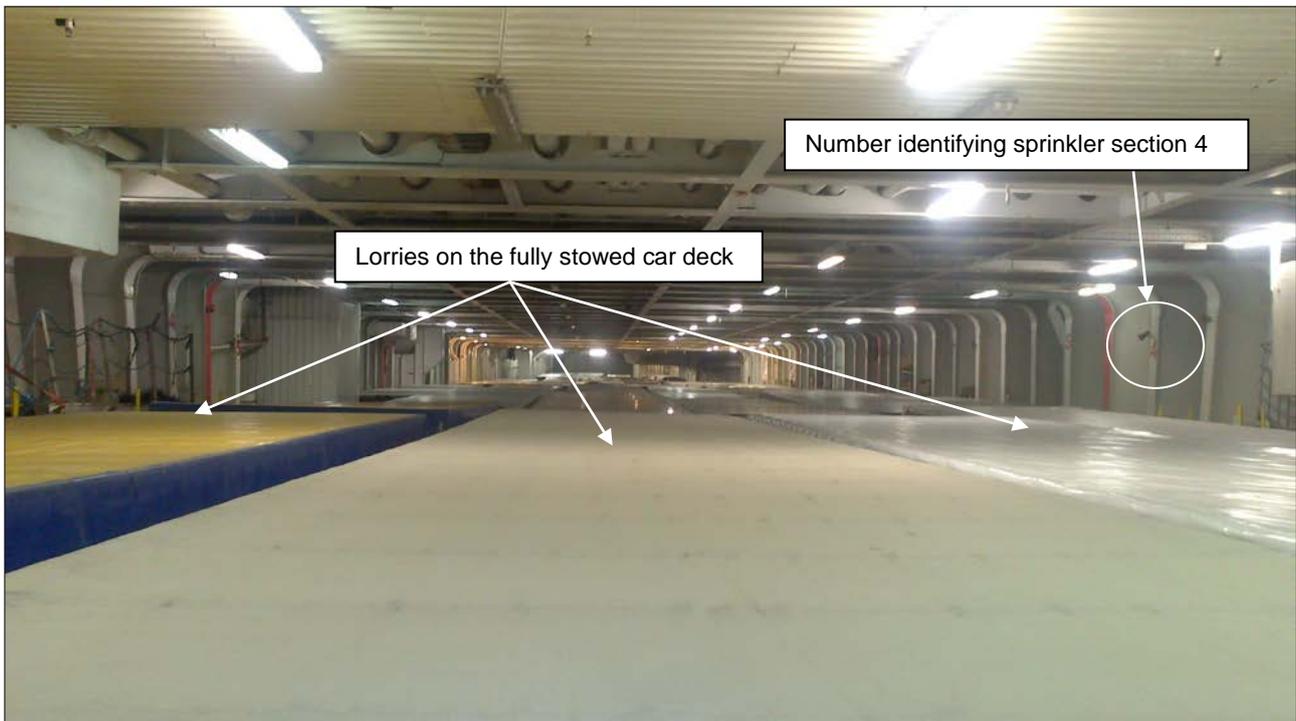
As smoke developed, it gathered underneath the deck above, limiting the visibility between the deck above and the top of the lorries. This made it difficult to identify the individual sprinkler sections as they were marked with numbers on the frames on the ship's sides (figures 9 & 10).

Figure 9: Identification of sprinkler sections on the full main car deck on board URD
Source: Stena Line

As smoke gathered on the car deck, it was difficult to visually identify in which sprinkler section the burning lorry was situated. It required particular knowledge of the car deck to know what section valve to operate on the sprinkler system as there were no intuitive aids available for crew support in this situation.

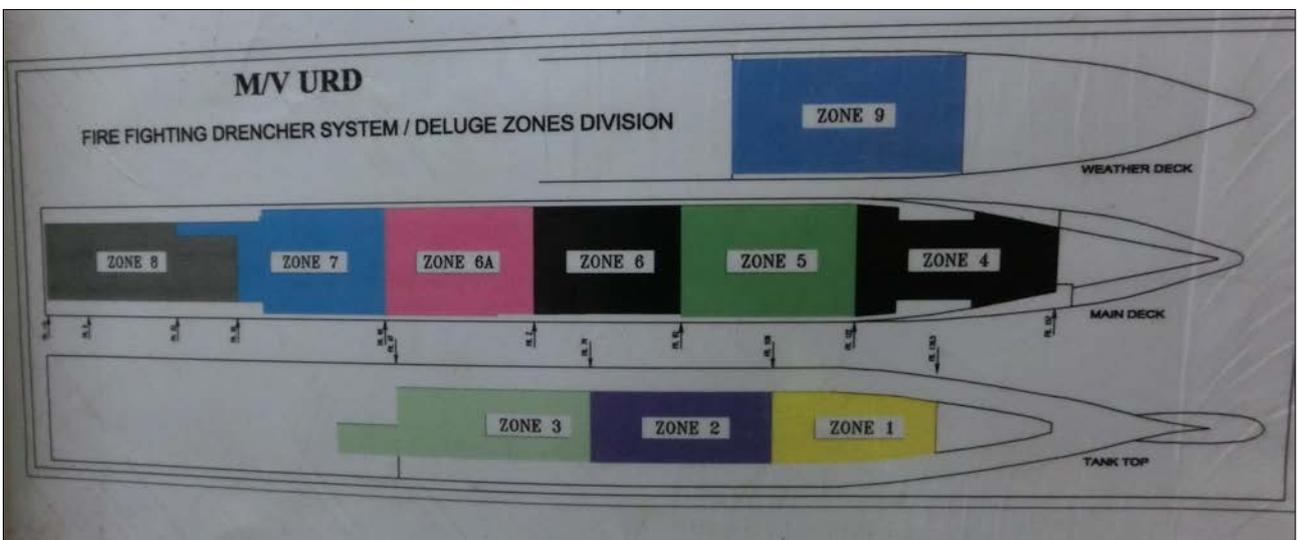
A drawing inside the sprinkler control station described the sprinkler sections on a model of the ship in the *opposite* direction relative to the point of view of the observer. This could cause confusion about the operation of the sprinkler system (figure 11).

Figure 11: Diagram of the vessel in the reverse direction relative to the viewer
Source: DMAIB

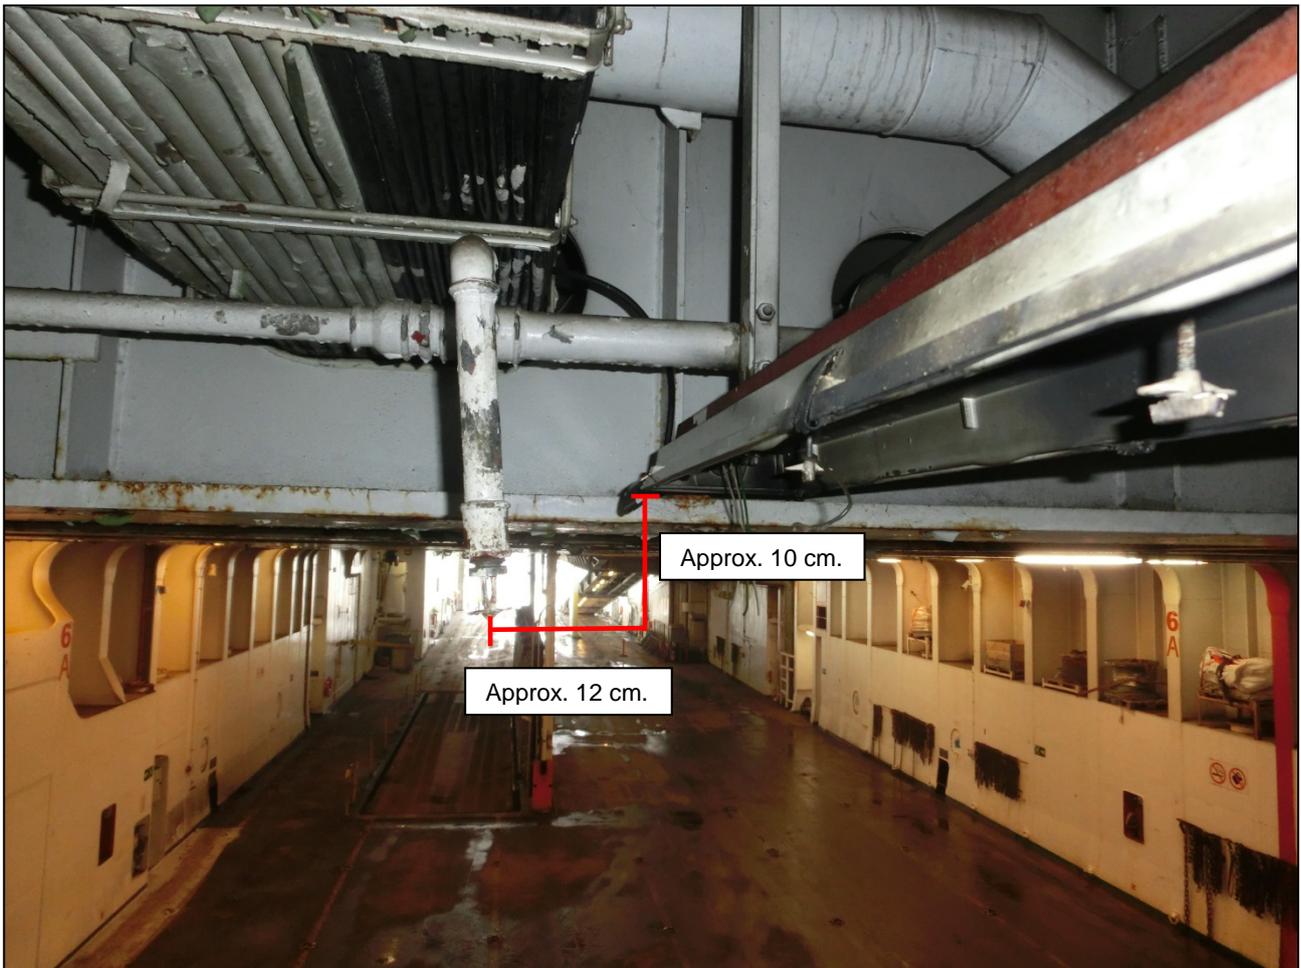
The fixture is likely to have been fitted in 1995. Several of the fixtures, including the burnt one, were placed in close proximity to the car deck sprinkler system; sprinkler heads (figure 13).

Figure 13: Sprinkler head proximity to burnt fluorescent light fixture
Source: DMAIB

The close proximity of the burnt fixture to a sprinkler head that was tested regularly may have contributed to the existence of the excessive humid and saline atmosphere inside the light fixture.

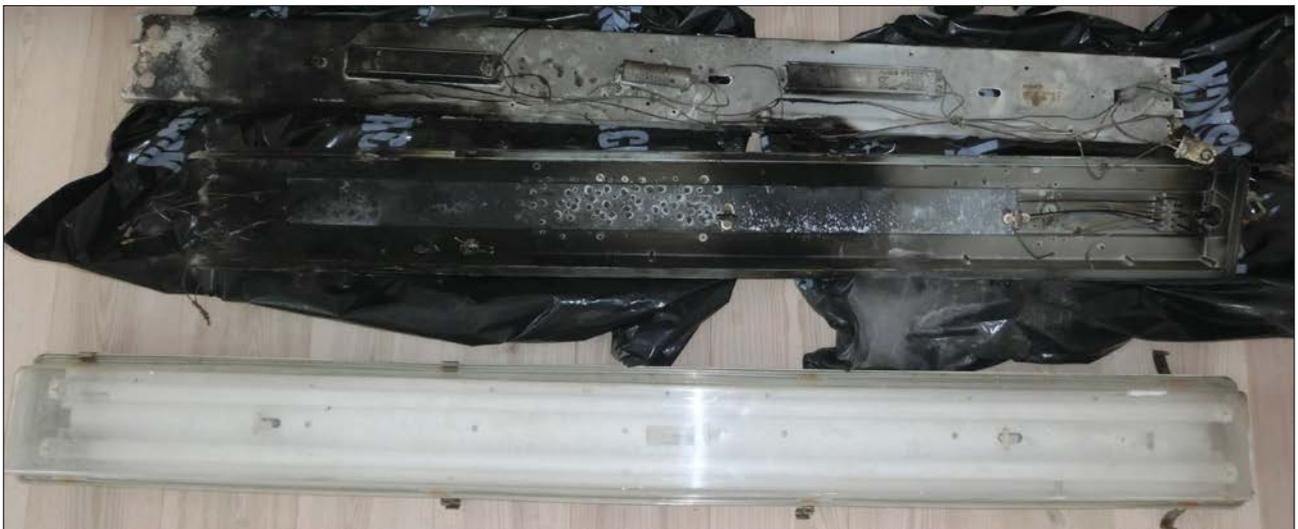
Examination of a similar intact reference light fixture (figure 14) from the main car deck on URD showed that the original ingress protection level was badly deteriorated and that water could penetrate through the bolting of the fixture on its back side. The original protection level was estimated to have been equivalent to IP 44, but was not marked on the fixture.

Figure 14: The burnt light fixture next to an intact light fixture from URD
Source: DMAIB

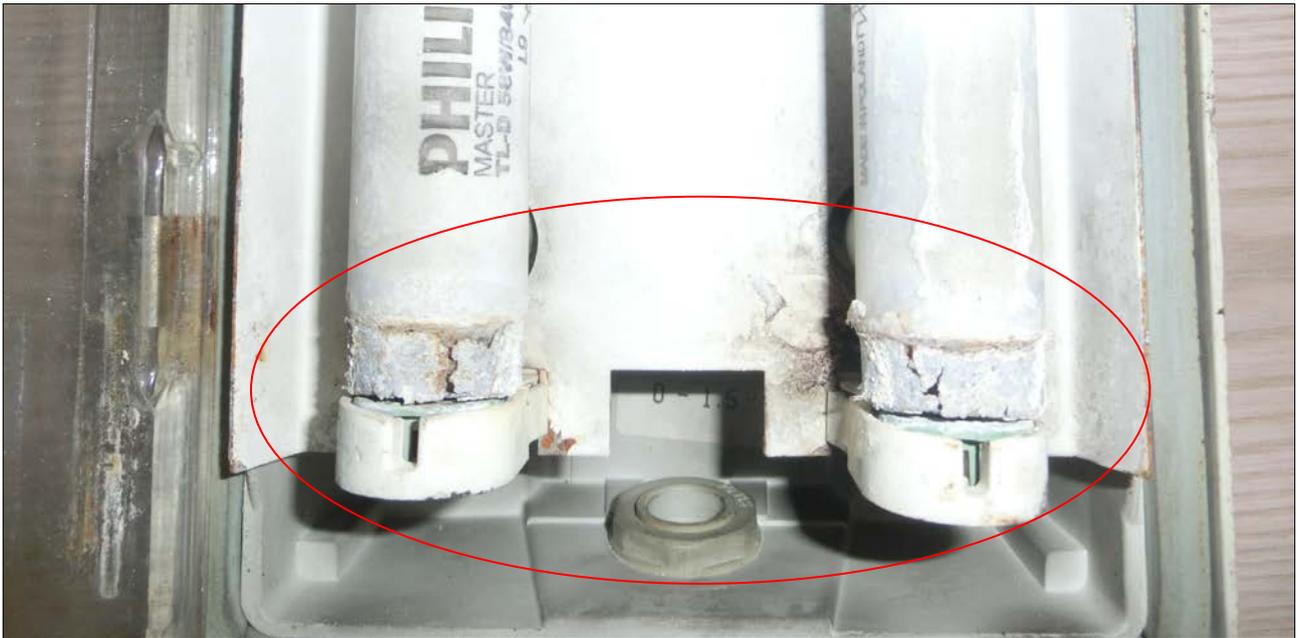
The reference light fixture showed evidence of corrosive impact and salt deposits at the ends of the light tubes (figure 15).

Figure 15: Intact light fixture from URD suffering from heavy corrosive impact
Source: DMAIB

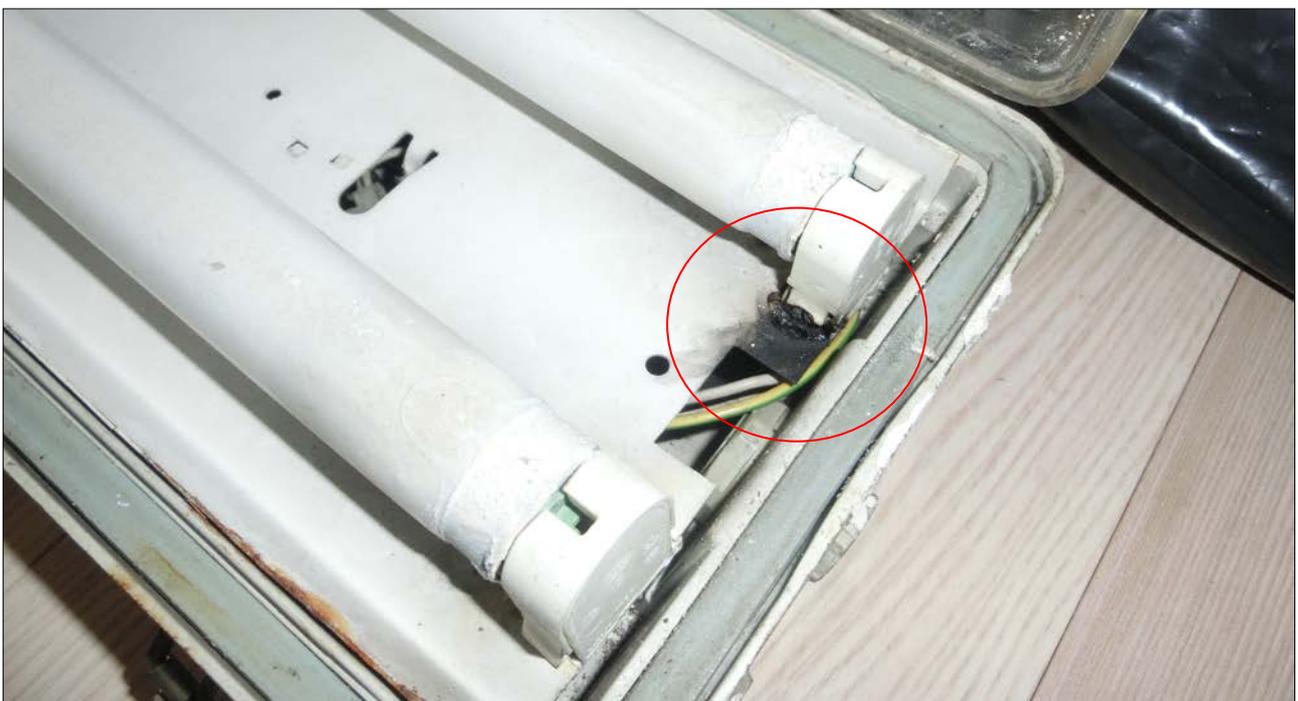
Furthermore, one socket showed clear signs of burning of the plastic shielding (figure 16), which could be determined to be the result of arcing between the socket's electrical connections and the metal mounting plate inside the fixture leading a voltage of 1000-1500 volts induced by the ballast. The metal mounting plate had carbon deposits originating from arcing during unsuccessful attempts to start burned out light tubes.

Figure 16: Intact light fixture from URD with burn marks in one socket
Source: DMAIB

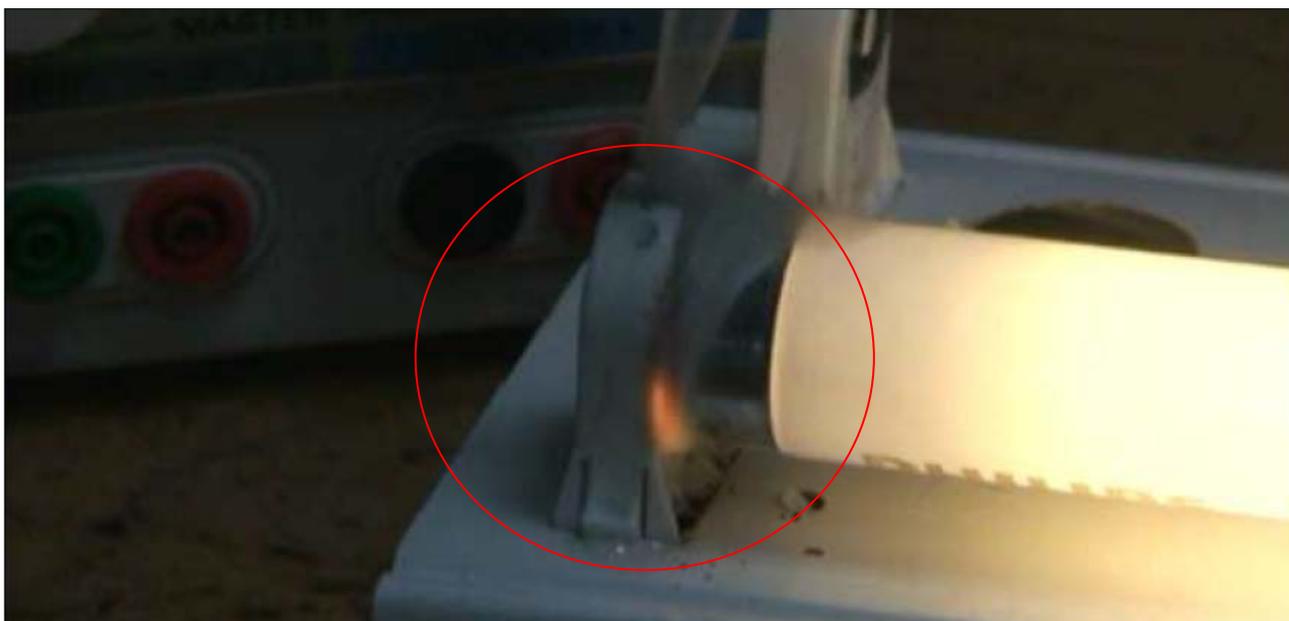
Attention should be drawn to the potential hazards associated with fluorescent lights. The DMAIB has previously experienced that fluorescent light fixtures have been the origin of on-board fires. Tests made during investigations of the serious fires on board HERCULES² and UILOQ³ have proved the possibility of arcing in sockets in fluorescent light fixtures due to bad electrical connections (figure 17). The type of electrical circuit found in these light fixtures was, however, different.

Figure 17: Arching in socket on light fixture from UILOQ during tests made in 2009
Source: Danish Institute of Fire and Security Technology (DBI)
