Danish Maritime Accident
Investigation Board

MARINE ACCIDENT REPORT

January 2014

DART
Grounding on 1 August 2013

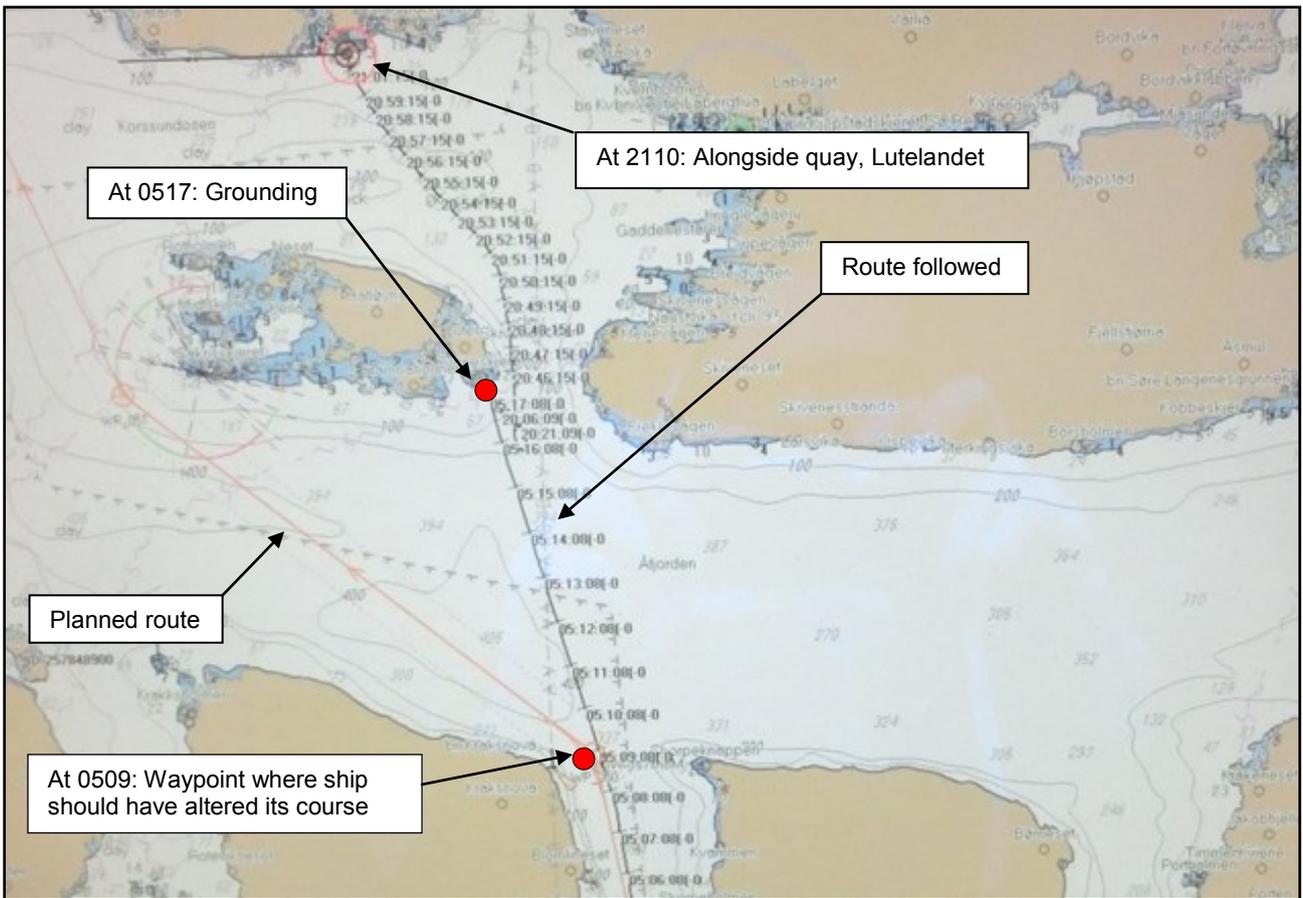
The voyage continued as planned until 0507, whereafter the mate could not remember anything until the ship went aground at 0517. The picture from the ship's ECDIS (figure 3, page 8) shows that the mate had not altered the course at the waypoint passed at 0509. Instead it proceeded on the original course until the ship went aground on the Groeneskjeret at 0517. The mate immediately woke up at the sound of the ship's contact with the rock and set the pitch of the screw at zero. The AB who was keeping the watch on board the ship and the master were both present on the bridge one minute after the grounding.

Figure 3: Picture from EDCIS. The red track shows the planned route, while the black track shows the route followed. Source: The Danish Maritime Accident Investigation Board

DART grounded after the watchkeeping mate had fallen asleep immediately before a waypoint. Since the ship did not alter its course, it deviated from the planned route and went aground.

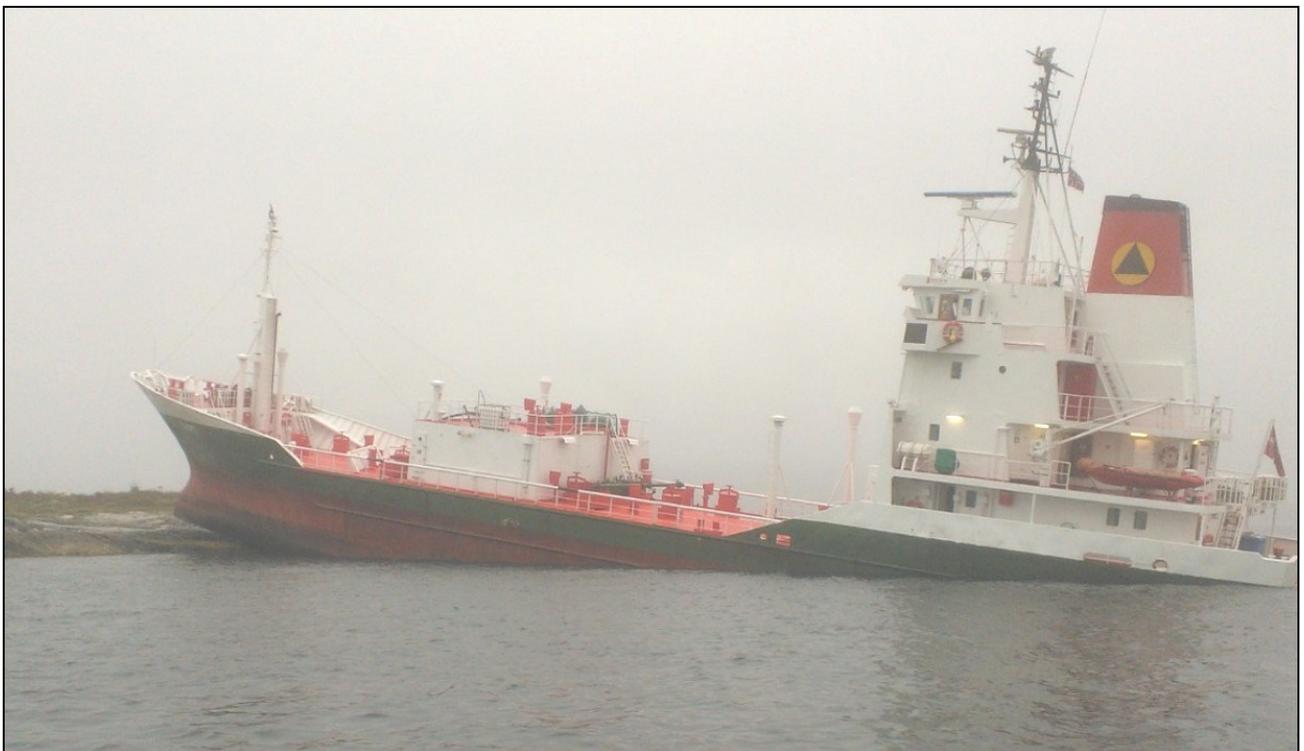
Figure 4: Grounding on the Groeneskjeret Photo: Maritime Management ApS

The ratings and the chief engineer found a minor crack between the bow thruster room and the forepeak, but no additional damages or leakages. It was ascertained that the ship was standing very firmly on the ground. At 0630, the main engine was stopped.

The ship's crew inspected the ship for any leakages and sounded the tanks once again. No major leakage was found, but a small amount of water was seeping through the crack between the forepeak tank and the bow thruster room. The water ingress was estimated to 200 litres an hour.

The crack between the forepeak and the bow thruster room did not result in ingress of water, but the master decided to stabilize it before the tugs tried to get DART off the ground. He arranged for a shipment of cement to be transported to the ship from Florø, and the chief engineer and an AB managed to close the crack by means of foam rubber, cement and a plate. The intention was to minimize the risk of water ingress when the ship was pulled off the ground.

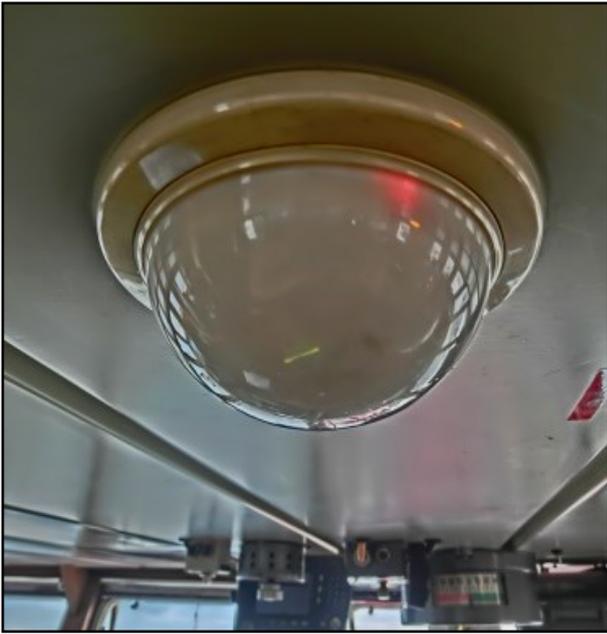
The functioning of the bridge watch alarm fitted on DART was such that a sensor would register any movements on the bridge (figure 5, page 11). For each movement registered by the sensor, a watch would start counting down from five minutes. If no movement was registered during these five minutes, a high tone would sound. The alarm was audible in the master's cabin and, furthermore, throughout most of the accommodation.

The bridge watch alarm did not sound prior to the grounding of DART though the mate had been asleep for appr. 10 minutes. The reason for this was probably that the movement sensor was located too close to the chair in which the mate was sitting (figure 7, page 11). This meant that very small movements by the sleeping mate were registered and that the bridge watch alarm, therefore, started counting from the start. The crew on board DART did not realize that there was a problem with the bridge watch alarm prior to the grounding.

Figure 5: Movement sensor
Source: Danish Maritime Accident Investigation Board

The bridge watch alarm did not react when the mate was sleeping. The movement sensor has probably registered minor movements by the mate and, thereby, reset itself. The on-board crew did not realize that the bridge watch alarm did not function as intended. In addition, the alarm was a passive measure that did not require intentional action to be de-activated. The design of the bridge watch alarm meant that it was possible to test it only while the ship was at speed and in case of lacking movements on the bridge. Therefore, the routine test of the bridge watch alarm before departure did not reveal the inappropriate location of the sensor in the specific case.

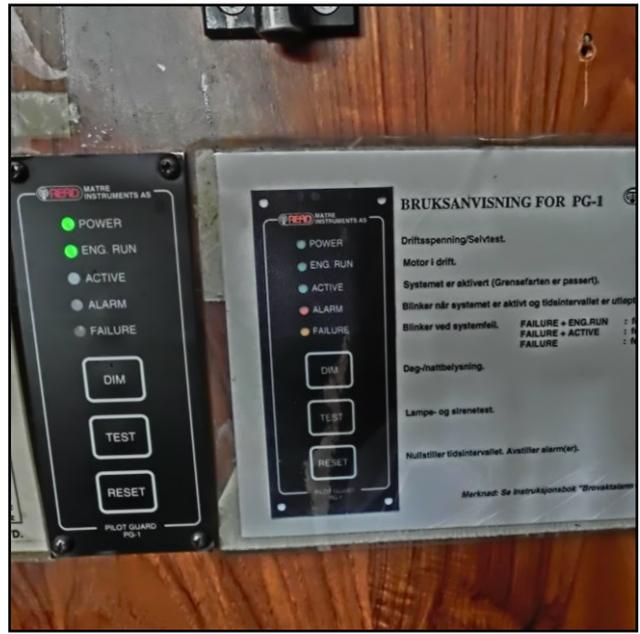
It was possible to switch on and off the bridge watch alarm by means of a control device on the bridge (figure 6, page 11). However, the crew never turned off the alarm since it would automatically become active when the engine was running and the ship was at speed.

Figure 6: Control device for the bridge watch alarm
Source: Danish Maritime Accident Investigation Board

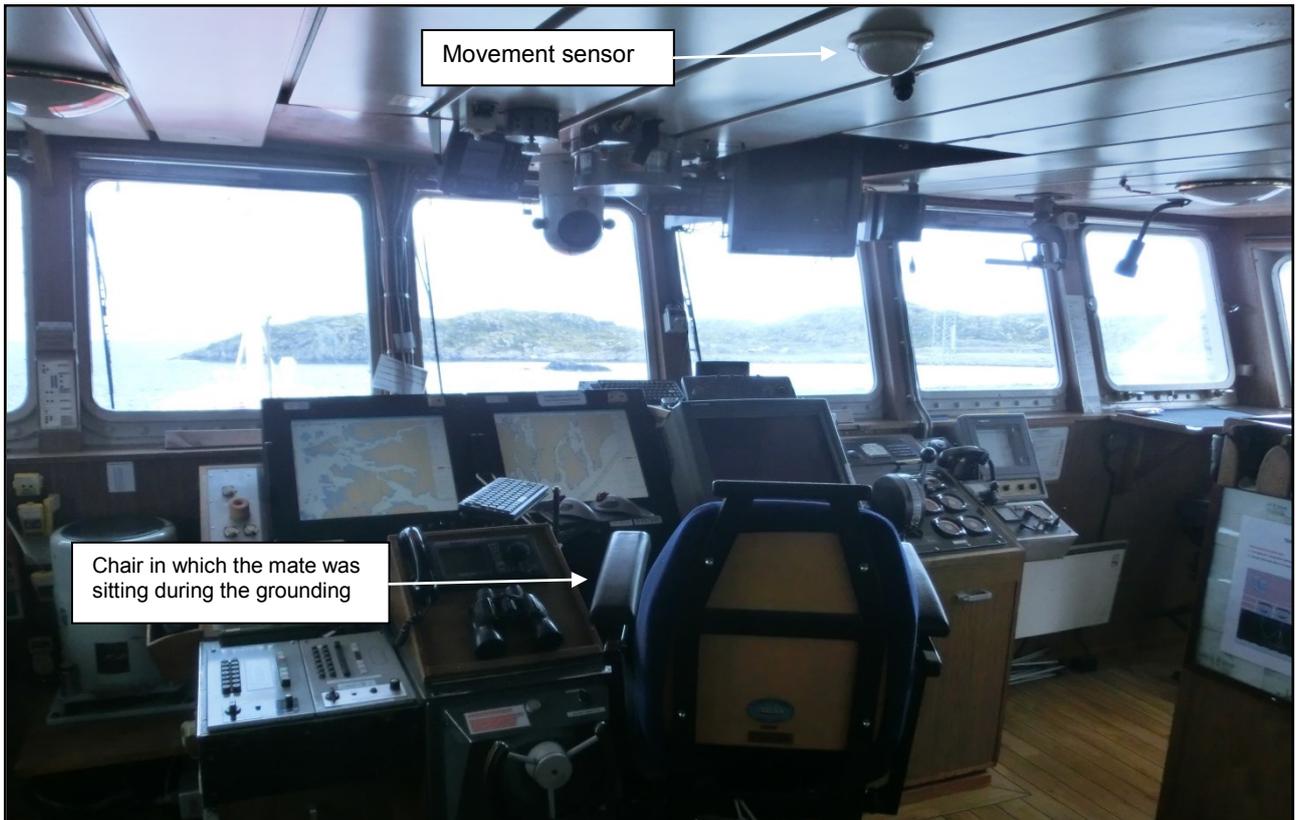
Figure 7: The location of the movement sensor in relation to the chair in which the mate was sitting during the grounding
Source: Danish Maritime Accident Investigation Board
