MARINE ACCIDENT REPORT

SPRING GLORY / JOSEPHINE MÆRSK

Collision on 5 June 2012

This marine accident report is issued on 3 May 2013

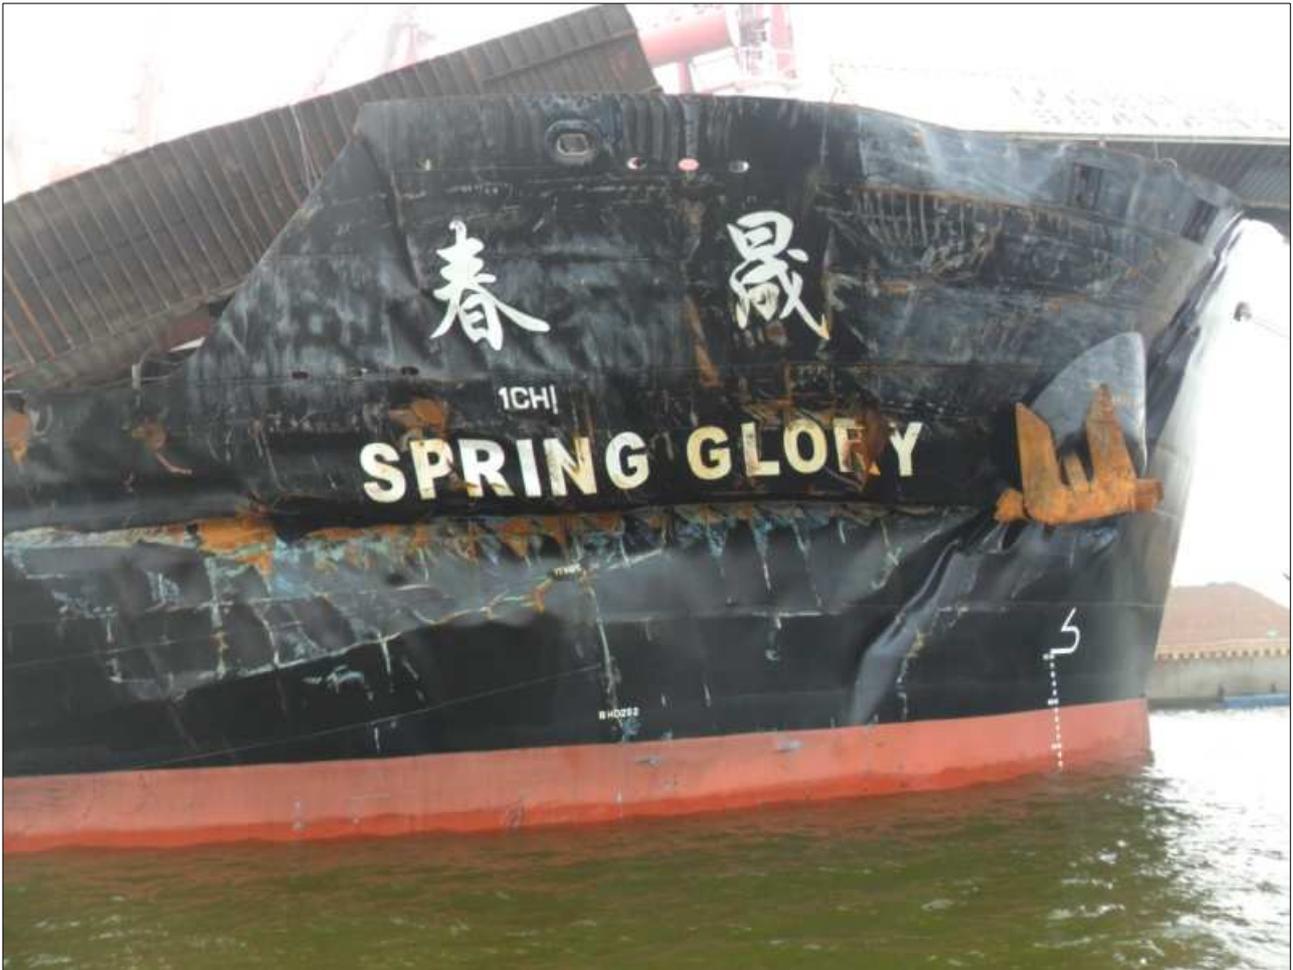
Figure 10: Damage to SPRING GLORY
Source: Jiangsu Huaxi Ship Management Co., Ltd.

Meanwhile, the master ordered other crew to wait at the muster station. Later, it was reported that no oil spill or water ingress was found. The starboard side of the collision bulkhead was slightly deformed and there was a crack 4-5 metres above the waterline.

The shell plating located on the starboard bow, topside tank and internal structures and affiliated equipments and combination ladders, etc. sustained contact damage.

The starboard side frames, beams, hull and deck of the forecastle, bosun-store on the main deck of the fore part of no.1 hatch were slightly deformed and dented from frame no. 263 to no. 241 and about 4 metres above the waterline. The starboard anchor and chain pipe were deformed. The starboard side of the collision bulkhead was slightly deformed. The frames and hull were slightly deformed and dented from frame no.116 to no.119 and about 5 metres above the waterline to deck. The starboard side pilot combination ladder was deformed. A hole was made in the void tank starboard side and 5 metres above the waterline, size about 1.4 x 0.5 metres. Three holes were made in the starboard side of no.1 TWB.TK(S), all about 5 metres above the waterline, size about 0.1 x 0.05 metres (frames nos. 248 to 249), 0.2 x 0.1 metres (frames nos. 248 to 247), 0.3 x 0.5 metres (frames nos. 241 to 242). Photos of some of the damage to SPRING GLORY are shown in figures 10 and 11 on the next page.

On 6 and 7 June 2012, the crew temporarily repaired the damages and lashed the two containers. The master then decided to proceed to the discharge port after having made a risk assessment. On 7 June at 1616 hours, SPRING GLORY resumed its voyage.

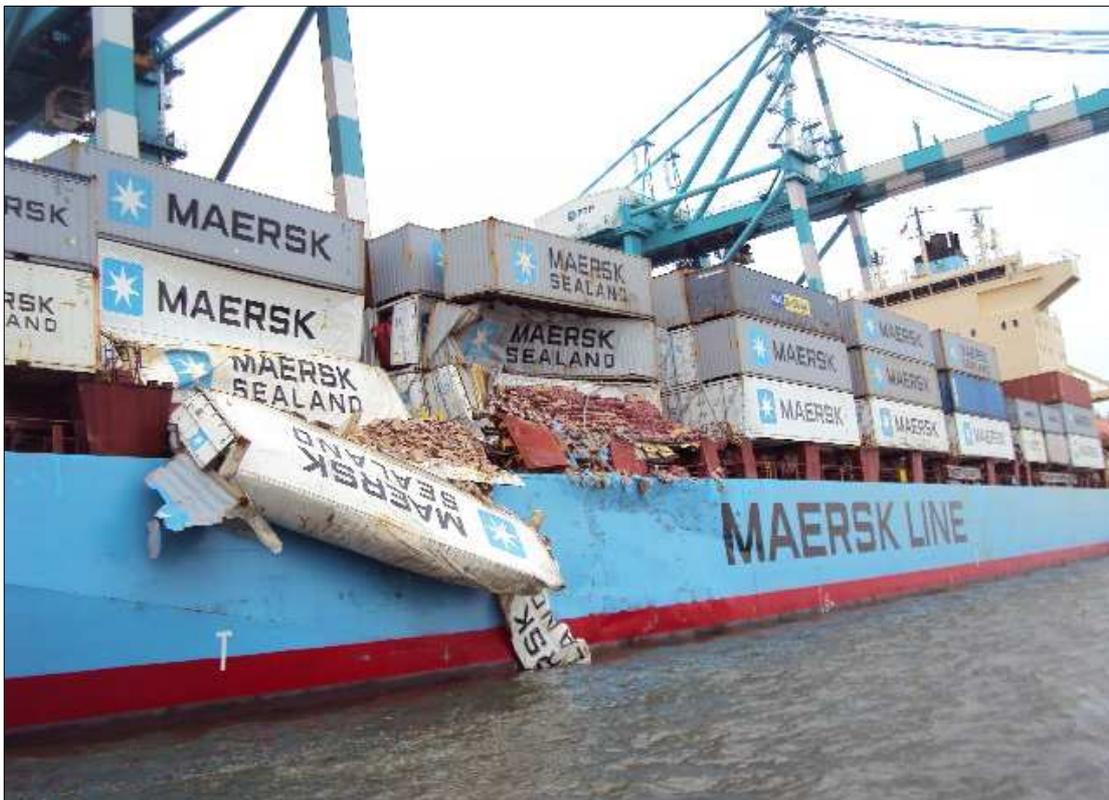
Figure 20: Damage to JOSEPHINE MÆRSK
Source: Maersk Line

There was extensive damage around bays 16 and 20 with damage to several containers and loss of six containers, two of which landed on the forecastle of SPRING GLORY, indentation of the ship's side and hatch coamings and damage to hatch covers and indentation of the ship's side on the port quarter.

The majority of the damaged containers contained frozen meet which soon began to rot and decompose after having been exposed to the ambient temperature.
