Danish Maritime Accident
Investigation Board

MARINE ACCIDENT REPORT

April 2013

SKULD
Contact damage on 28 June 2012

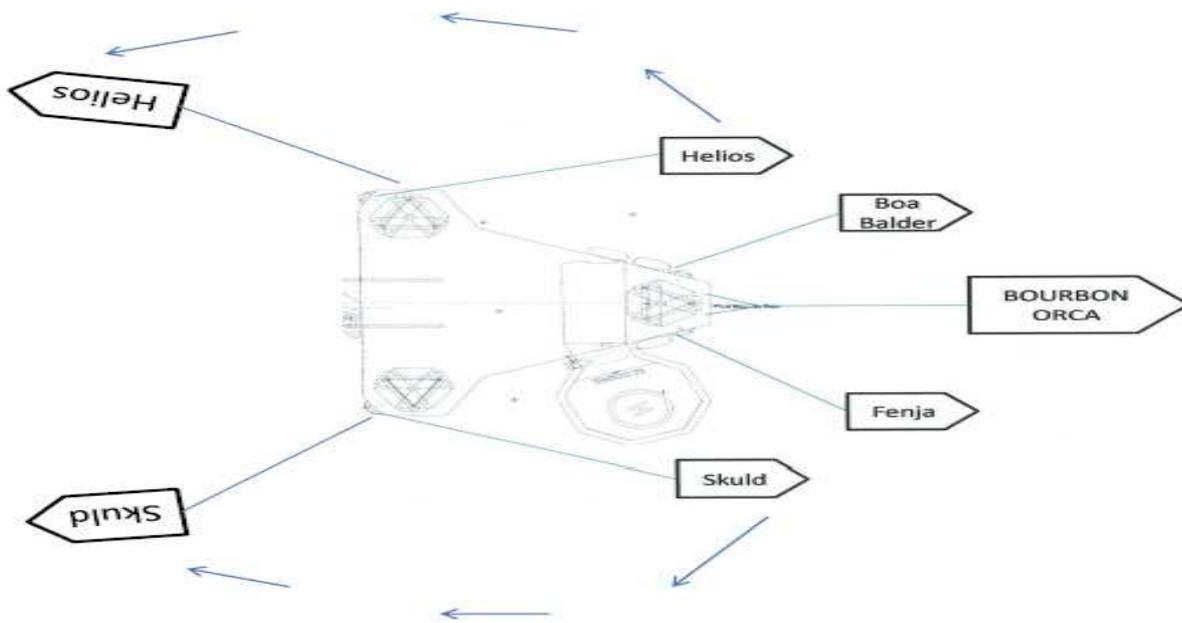
Figure 5: Intended manoeuvre when instructing SKULD and SVITZER HELIOS to change position in the tow
Source: Lead pilot / Danpilot

When SKULD tried to execute this instruction, the port side azimuth was set to giving thrust to port and the starboard azimuth was kept giving thrust aft. Thrusting to port moved the stern of the vessel to starboard thereby initiating a fast movement to port. The crew on board SKULD immediately realized the mistake, but due to the speed of the movement to port and the time it would take to turn the azimuth thrusters, they could not stop the movement towards the rig. When swinging towards the rig, the crew on board SKULD registered that they would pass very close to ENSCO 72's helicopter platform, which was level with SKULD's bridge. In an attempt to pass forward of the helicopter platform, the crew increased the power of the azimuth thrusters. The crew on the bridge of SKULD estimated that the vessel cleared the helicopter platform by approximately 1 metre. However, the increased power also increased the severity of the collision. As seen in figure 6 below, when colliding SKULD hit the rig on the starboard forward side of ENSCO 72.

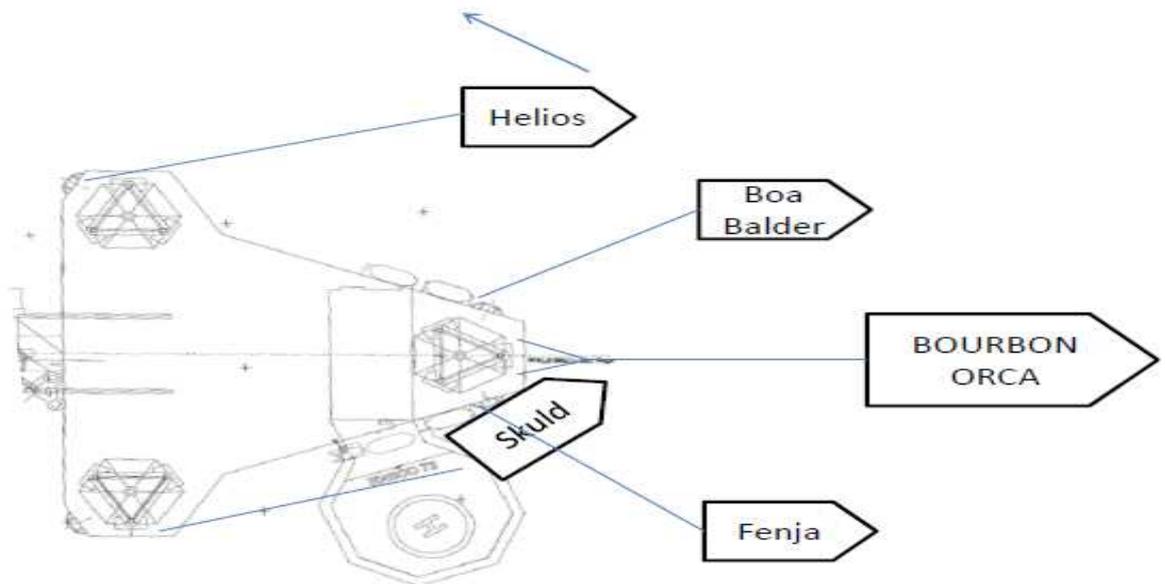
When colliding SKULD was trapped along the starboard, forward corner of the rig as seen in figure 6 and 7 below. When the two vessels collided, the other vessels in the tow put their engines to zero pitch (stop). Initially SKULD was not able to manoeuvre clear of the rig, but as the forward speed of the rig was reduced, it became possible for SKULD to manoeuvre free of its position alongside the rig and fall down to the intended position aft of the rig.

Figure 6: SKULD when colliding and caught alongside ENSCO 72
 Source: Lead pilot / Danpilot

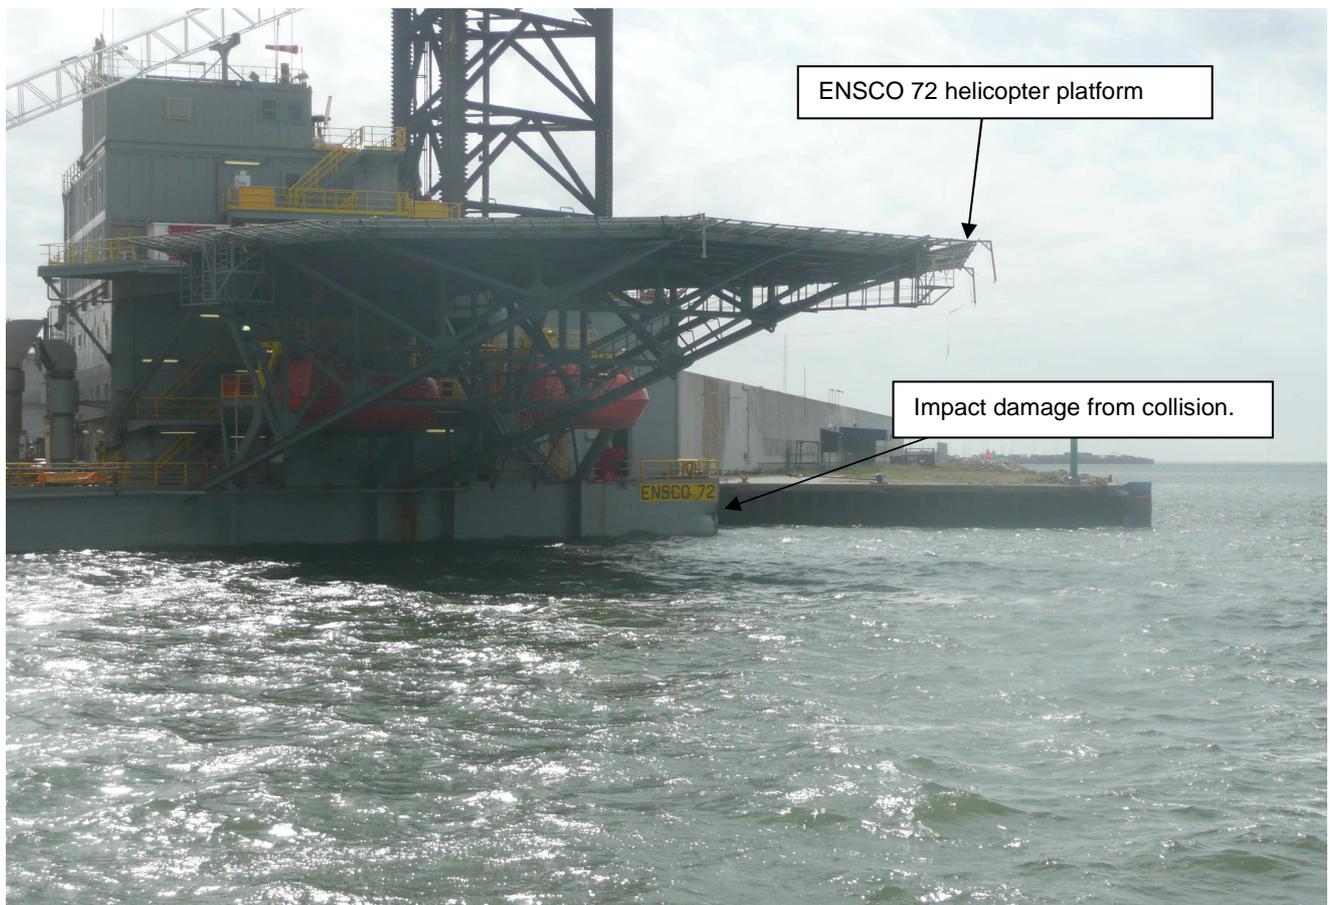
Figure 7: Collision area of ENSCO 72
 Source: DMAIB

As seen on figure 7 above the collision caused damage to ENSCO 72 above the waterline. Additionally, below the waterline the collision caused a leak to a water ballast tank.

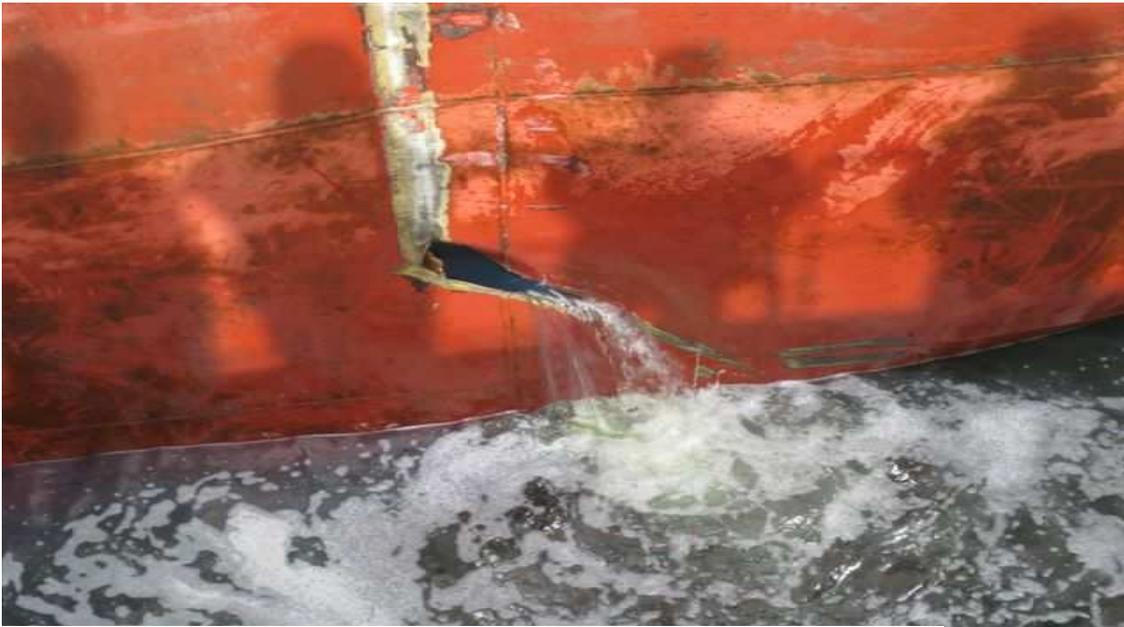
The collision with ENSCO 72 caused an approximately 30 cm x 40 cm hole in SKULD's port side below the waterline. The damage is seen in figure 6 below. The hole involved the port side wing tank and tank no 2, which were both fuel oil tanks. Additionally, from the wing tank, a part of the hole, approximately 5 cm x 10 cm in size, gave the water free access to the engine room. The main damage is shown on figure 8 below.

Figure 8: The damage to SKULD's port side
Source: Svitzer.

At the time of the collision, the fuel oil tanks contained approximately 25 m³ of diesel oil. From these tanks it is estimated that between 1 m³ to 5 m³ diesel oil leaked to the water following the collision. Due to the light nature of the diesel oil, it was not possible to pump the diesel oil from the water surface. Instead it is estimated that the diesel oil evaporated from the surface within the first few days after the accident.

The water ingress in the engine room caused the auxiliary engines 1 and 2 to shut down. The main switchboard therefore lost its power supply which led to the loss of directional control of the azimuth stern drives and all other equipment not supplied by the emergency switchboard.

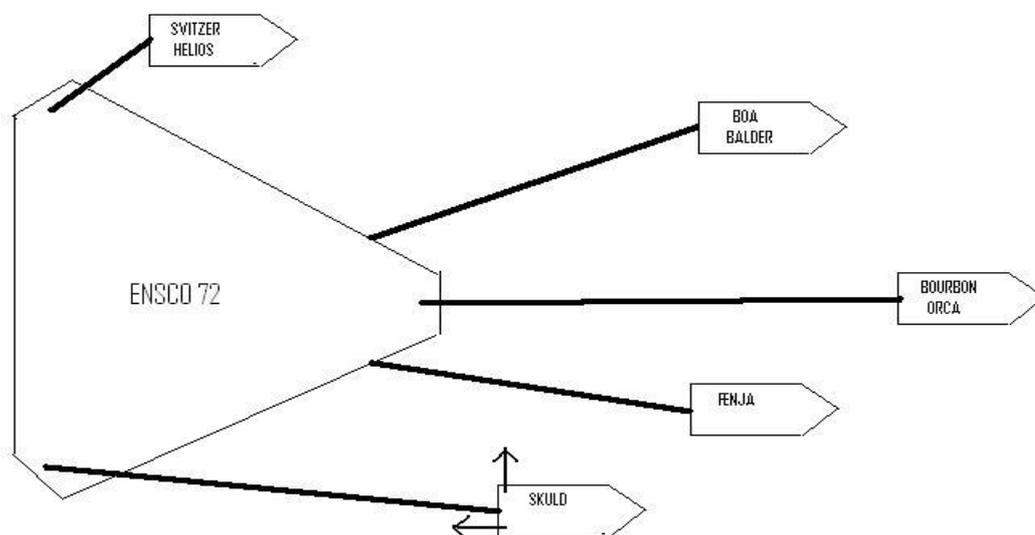
When SKULD was instructed to change position in the tow by moving aft of the rig, the master, who was manoeuvring throughout the manoeuvres close to and when in Grådyb, gave the thrust orders to the azimuth thrusters as seen in figure 9 below. The port azimuth was set to thrust to port. The starboard azimuth was set to maintain thrust directly aft. The thrust to port pushed the stern to starboard thereby initiating a port turn that developed very fast until colliding with ENSCO 72.

However, it was also immediately apparent that SKULD's bridge and accommodation were in danger of hitting the rig's helicopter platform. Therefore, instead of positioning the thrusters in an attempt to stop the turn to port, the master instinctively chose to direct all the available thrust aft in an attempt to pass forward of the helicopter platform.

Figure 9: Thrust orders given when changing position to aft of the rig
Source: Master SKULD / Svitzer (Drawing by DMAIB)

It is the assessment of the investigation board that the most probable cause for the wrong manoeuvre being initiated was the master in the deciding seconds when initiating the manoeuvre instinctively reacting as if the tug was working over the bow as was the most common operational pattern for the vessel.
