Danish Maritime Accident
Investigation Board

MARINE ACCIDENT REPORT

NICOLAI MAERSK
Fatal accident to seafarer on 26 April 2012

This marine accident report is issued on 4 February 2013

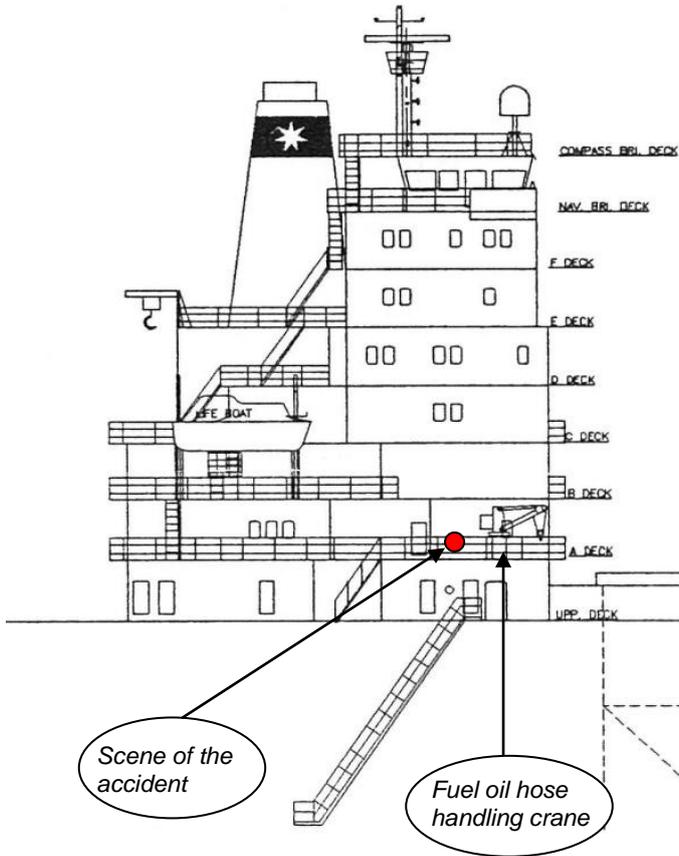
Figure 3: Location of the fuel oil hose handling crane and scene of the accident

NICOLAI MAERSK is equipped with two cranes intended for hoisting fuel oil bunkering hoses and lifting Suez boats. The cranes are placed on the A deck just above the gangway on each side of the ship. Figure 3 to the left shows the location of the crane and the scene of the accident.

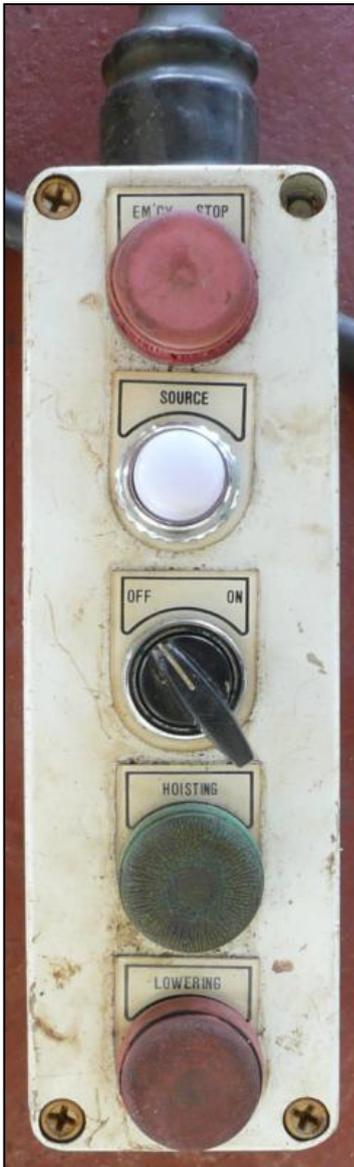
Figure 6: The control box

In figure 6 to the left, the control box is shown.

When the crane had been used, it was common practice to activate the emergency stop in order to make sure that the power was off when the crane was not supposed to be used.

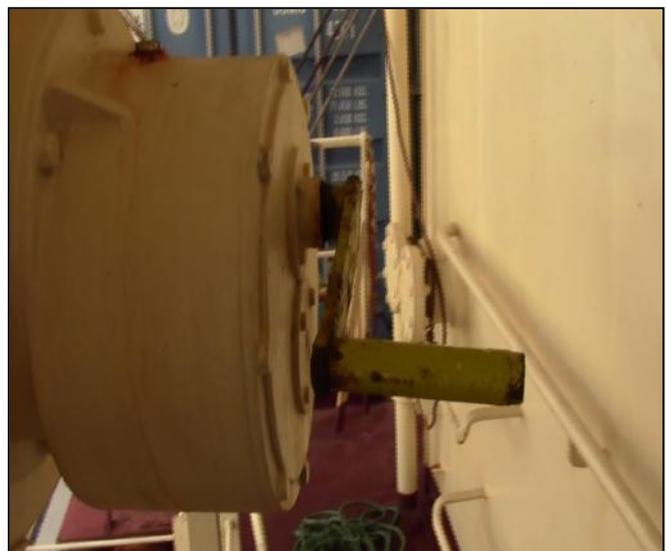
Figure 7: The emergency crank mounted on the rotor shaft
Source: Danish Maritime Accident Investigation board

Figure 7 shows the crank used for emergency operation mounted on the rotor shaft.

In case of power failure or if otherwise needed, it is possible to operate the crane manually. This is done by mounting a crank on the rotor shaft of the electric motor. The shaft is without gear and driven by the electric motor.

The emergency crank was mounted on the end of the rotor shaft and it was possible to lower and hoist the hook by means of the crank only when the automatic mechanical safe brake was loosened. It was observed that it was possible to wriggle the crank when mounted and pressed against the shaft as much as possible. When mounted, the crank could hold its position on the rotor shaft.

When the emergency crank is mounted and the lowering function on the control box is activated, the crank will instantly start rotating at a speed of 1,770 revolutions per minute. The crank handle will then move at a speed of approximately 186 km/hour based on a radius of 28 cm from the crank shaft to the handle. The crank has a weight of 3.2 kg. As the crank does not fit tight on the shaft end, but is able to wriggle, it could be hurled off within a very short moment after activating the lowering function, thus hitting and causing fatal injury to the 2nd engineer.

- Fleet wide crane survey to be carried out and assessed for further required actions.
- Interlocks to be built in on fuel oil hose handling and Suez boat cranes not equipped with such to secure that the crane cannot be operated electrically if the manual hoisting crank is used. Installation of interlock switches has been completed on the company's N-class series.
- Cranks and handles to be duly marked in order to avoid similar incidents.
- Review introduction / familiarization procedures and check lists.
- Review procedures / work instructions in the RDRM-system (Repair design requisition and maintenance system) and GSMS (Global Ship Management System).

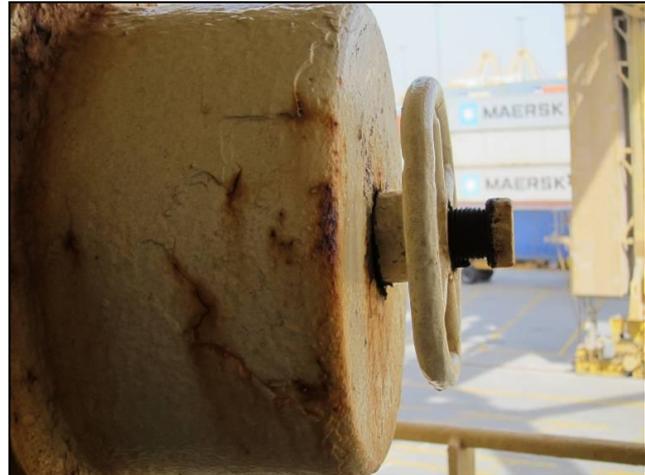
Figure 8: Hand wheel for manual operation of the brake
Source: Danish Maritime Accident Investigation board

The crane is fitted with an automatic mechanical safe brake. The hand wheel for the brake is shown in figure 8. The brake declutches when power is connected and the hoisting or lowering function is activated. When the power is off, it is necessary to loosen the brake manually by turning a handwheel on the crane.

When the automatic mechanical safe brake has been loosened, it is possible to lower and hoist by hand.

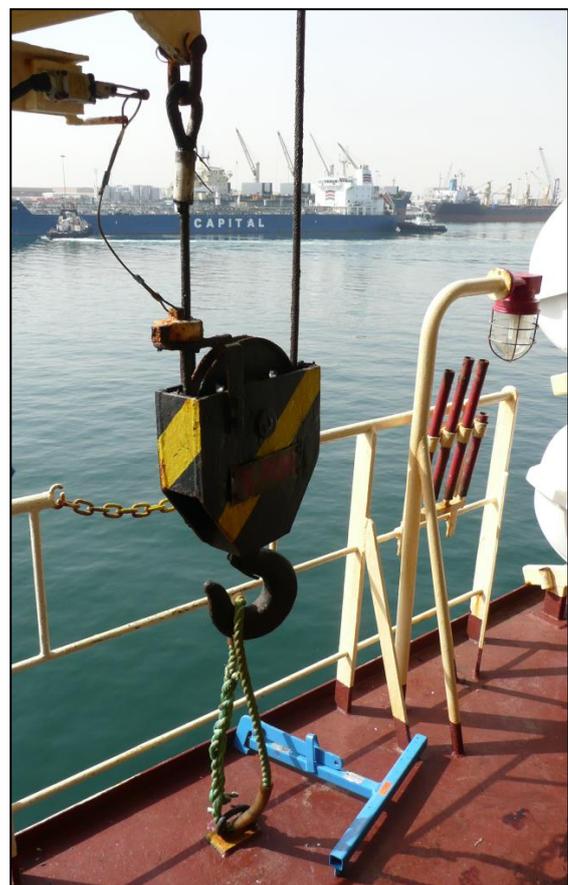
Figure 9: The hook, its lashing and the drum lifter
Source: Danish Maritime Accident Investigation board

In order to tighten the lashing, it was common practice to deactivate the limit switch manually and then carefully hoist the hook with small jerks until the lashing was tight.

Figure 9 shows the hook and the lashing. In the figure, the lashing is not tightened, but has a little slack caused by the lowering of the hook at the time of the accident.

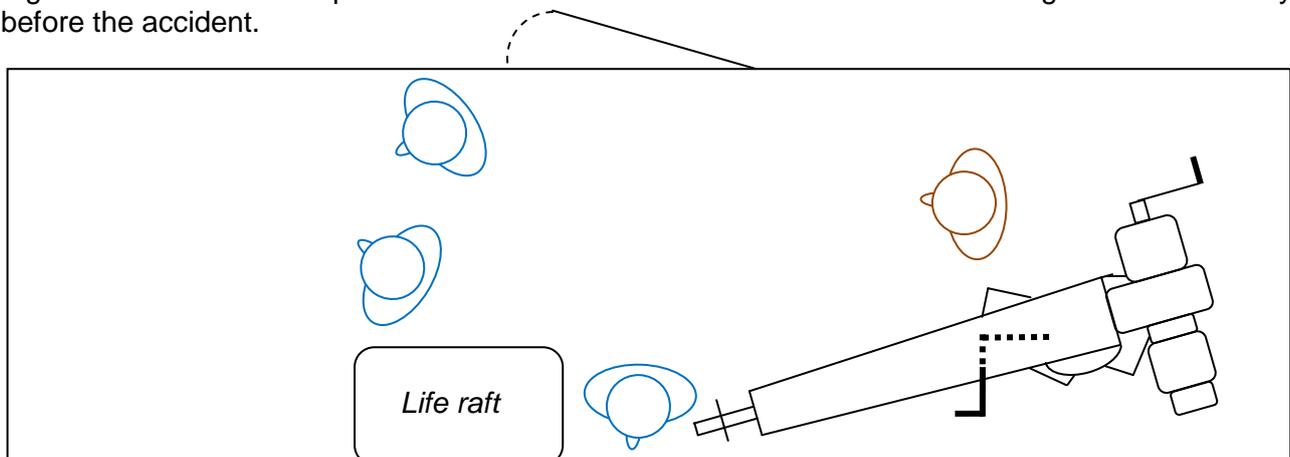
Figure 10: The scene of the accident before the accident
Source: Danish Maritime Accident Investigation board

Figure 10 illustrates the positions of the three crew members and the 2nd engineer immediately before the accident.

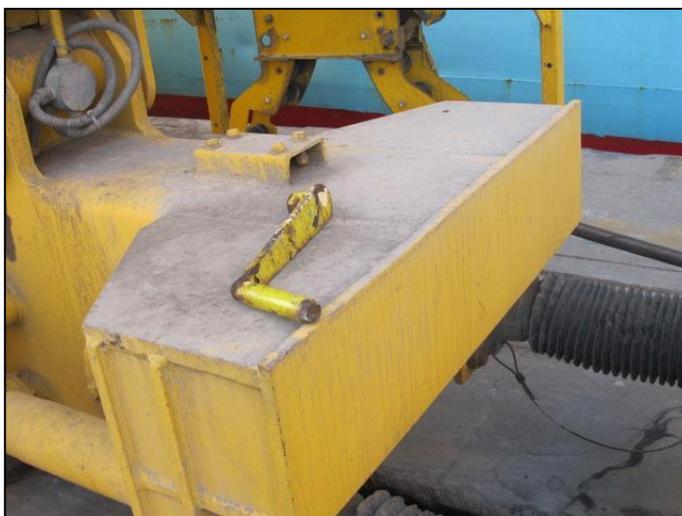
Figure 11: The crank on the buggy of the container crane
Source: Moller – Maersk A/S

The crank and debris from the 2nd engineer's hearing aid were found on the quay aft of crane. The crank was found at a horizontal distance from the scene of the accident of about 50 metres. It was initially found by a stevedore on the rails used by the container cranes and thereafter placed on the buggy of one of the container cranes. Figure 11 shows the crank on the buggy where it was found later approximately one hour after the accident by a crew member who brought it on board.

Based on knowledge of the speed of the rotation and the dimension of the handle it is possible to calculate the speed of the handle in the rotation. The speed was 158 km/h. There were no traces of blood on the crank.

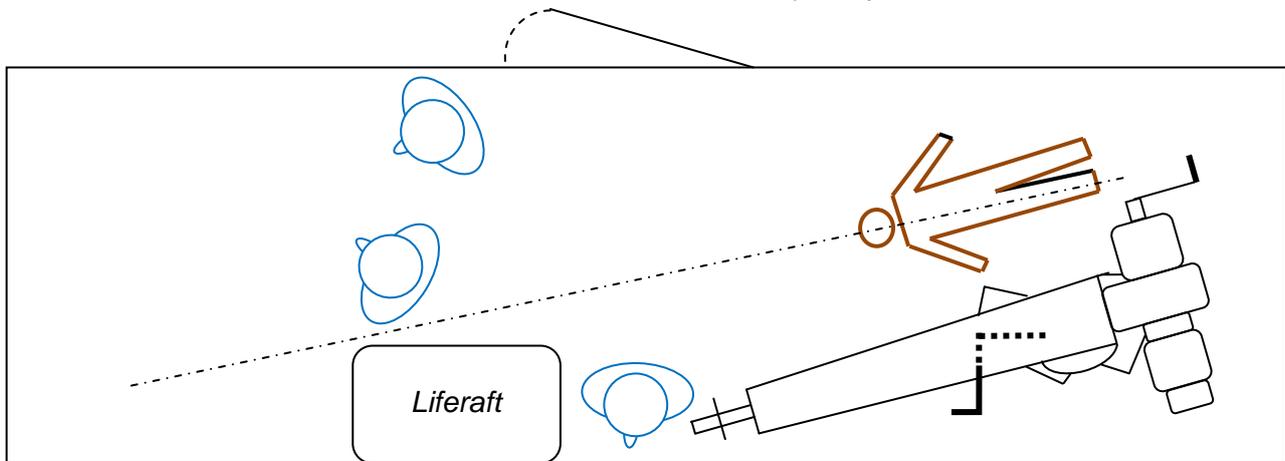
Figure 12: The scene of the accident after the accident
Source: Danish Maritime Accident Investigation Board

Figure 12 below shows the position of the three crewmembers and the 2nd engineer immediately after the accident. The dotted line indicates the estimated trajectory of the crank.

The crank and debris from the 2nd engineer's hearing aid were found on the quay aft of crane. The crank was found at a horizontal distance from the scene of the accident of about 50 metres.

Blood stains in different places on the crane and in adjacent areas on the A deck prove that the 2nd engineer was standing at a short distance aft of where the emergency operation crank was mounted on the crane, but not close enough to be hit by the crank if it was mounted on the shaft. When he was struck by the heavy crank, his feet were pushed backwards giving the position shown in figure 12.
