# MARINE ACCIDENT REPORT

**MAERSK CHAMPION**  
**Fire in accommodation on 9 January 2012**

**This marine accident report is issued on 1 November 2012**

**Case number: 201200421**

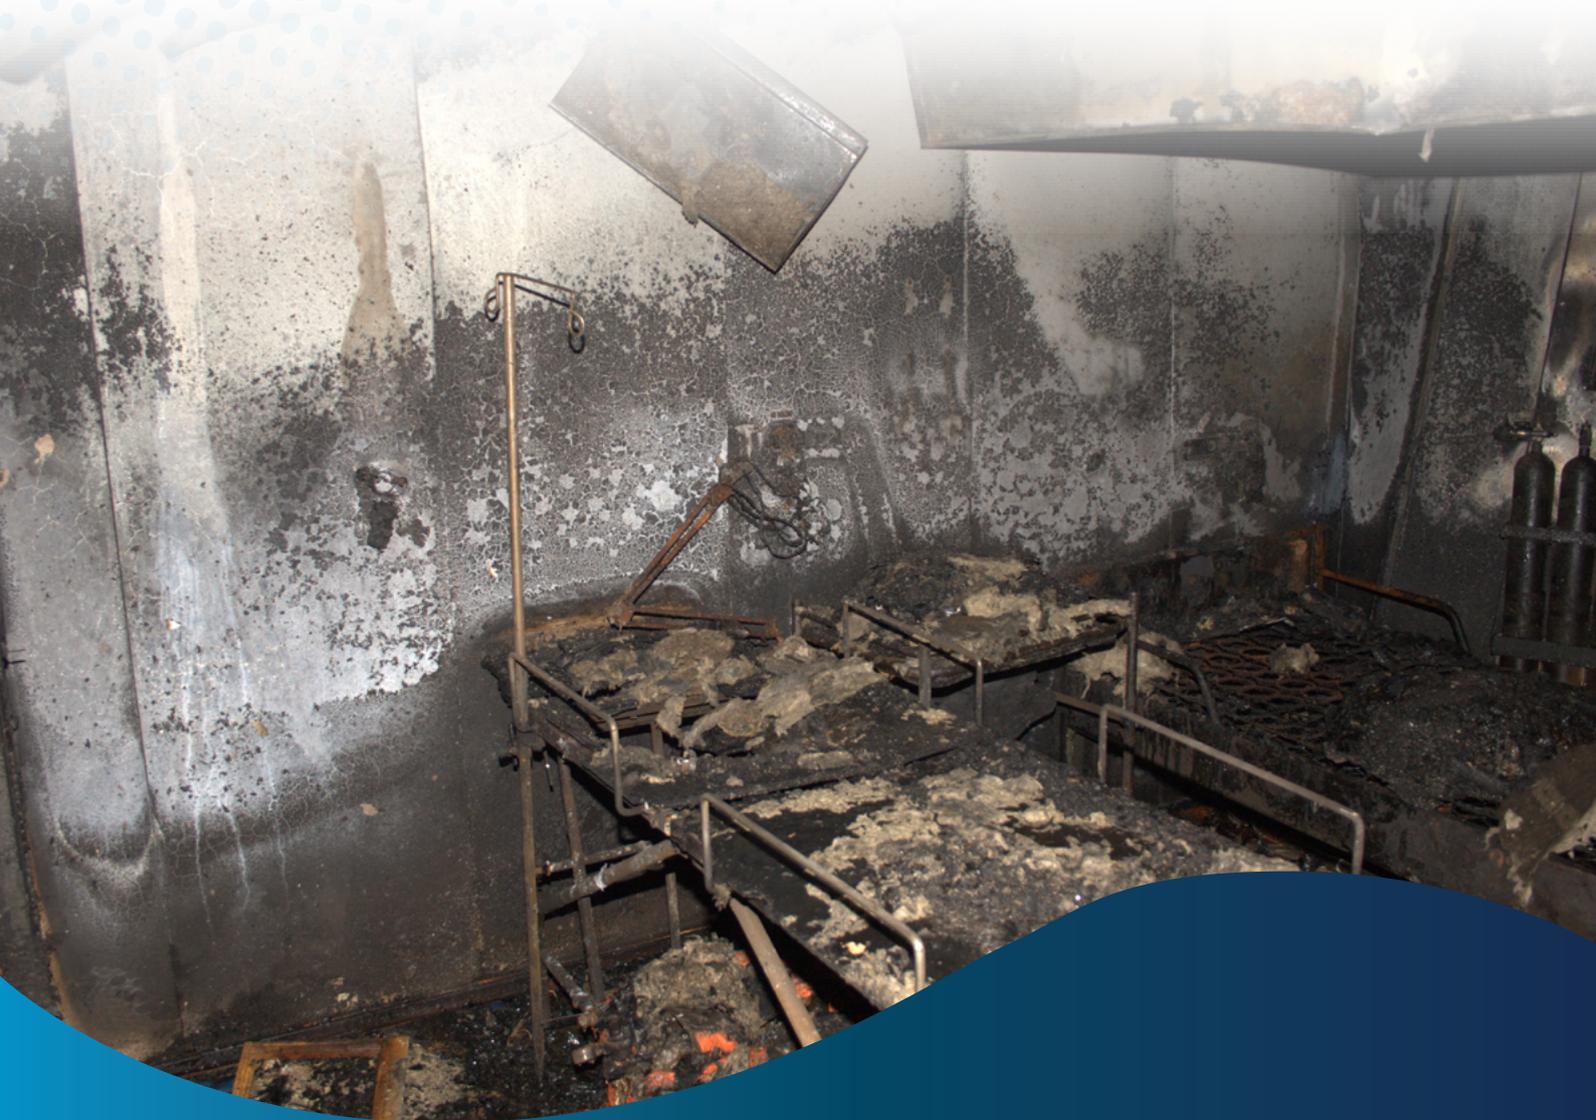
**Front page: The ship's hospital after the fire**

The ship's hospital burned out and the adjoining corridor, TV/recreation room, mess room and duty mess was also damaged as a result of the fire. The fire and smoke damages to the ship's interior were severe.

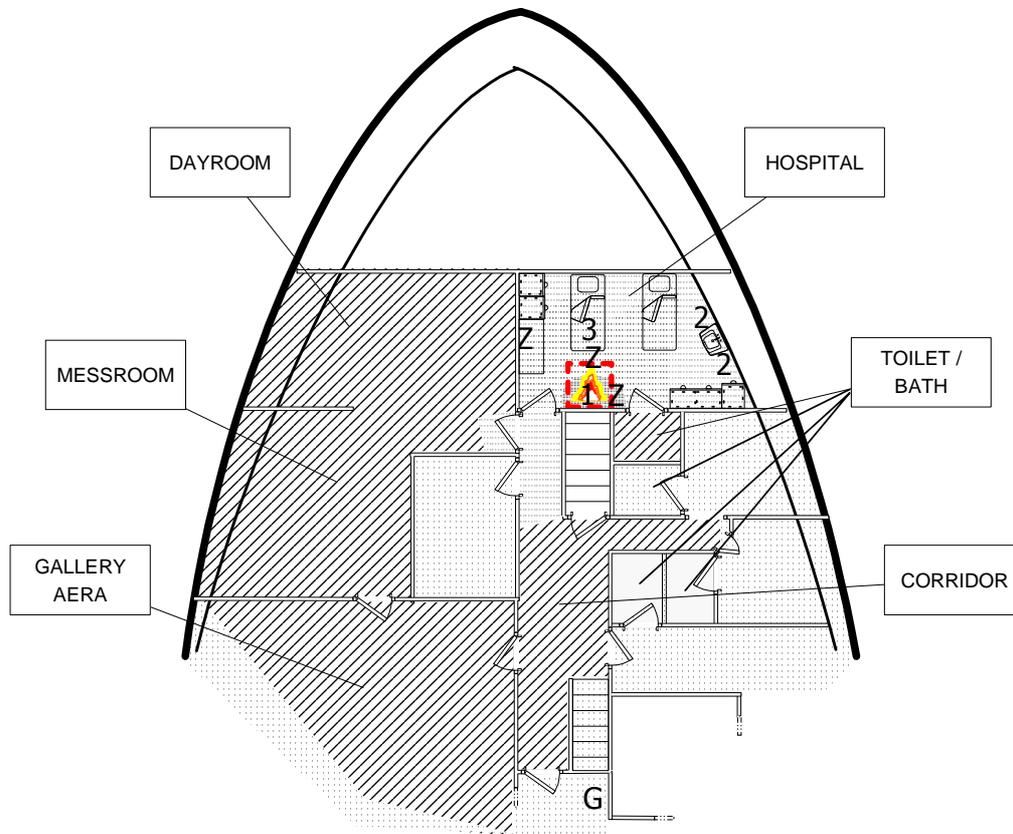
Figure 4: Arrangement of compartments in accommodation on main deck  
 Source: The Danish Institute of Fire and Security Technology

At noon, during lunch approximately at 1155, a boom was suddenly heard in the mess room adjacent to the hospital and the bulkhead between the dayroom and the hospital seemed to move slightly (see sketch on figure 4 on page 9).

- G CIRCUIT BREAKER BOX
- Z MARKS AFTER SHORT CIRCUIT
- 1 BOX WITH OLD MEDICINE ETC
- 2 OXYGEN CYLINDERS
- 3 OXYGEN CYLINDERS IN BAG UNDER THE BED
-

HOTBED AREA
-

BURNING IN THE FLOOR
-

HEAVY FIRE DAMAGED
-

FIRE DAMAGED
-

EXCESSIVE SMOKE DAMAGE
-

SMOKE DAMAGE

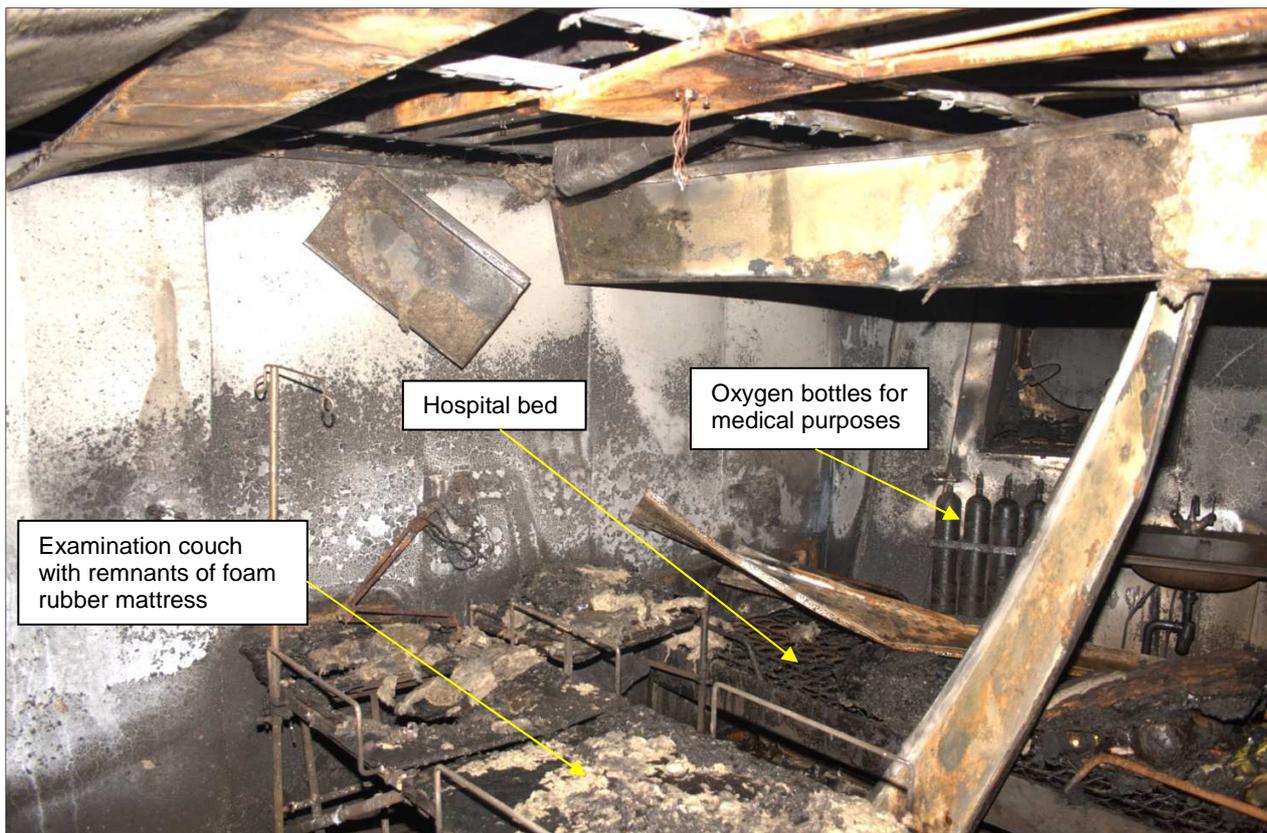
The hospital burned out and the adjoining corridor, day room, mess room and duty mess was also damaged as a result of the fire. In total the fire and smoke damage to the ship's interior was severe. Fire damages in the accommodation are shown on figure 5, 6, 7 and 8.

Figure 5: Ship's hospital after the fire  
Source: Danish Institute of Fire and Security Technology

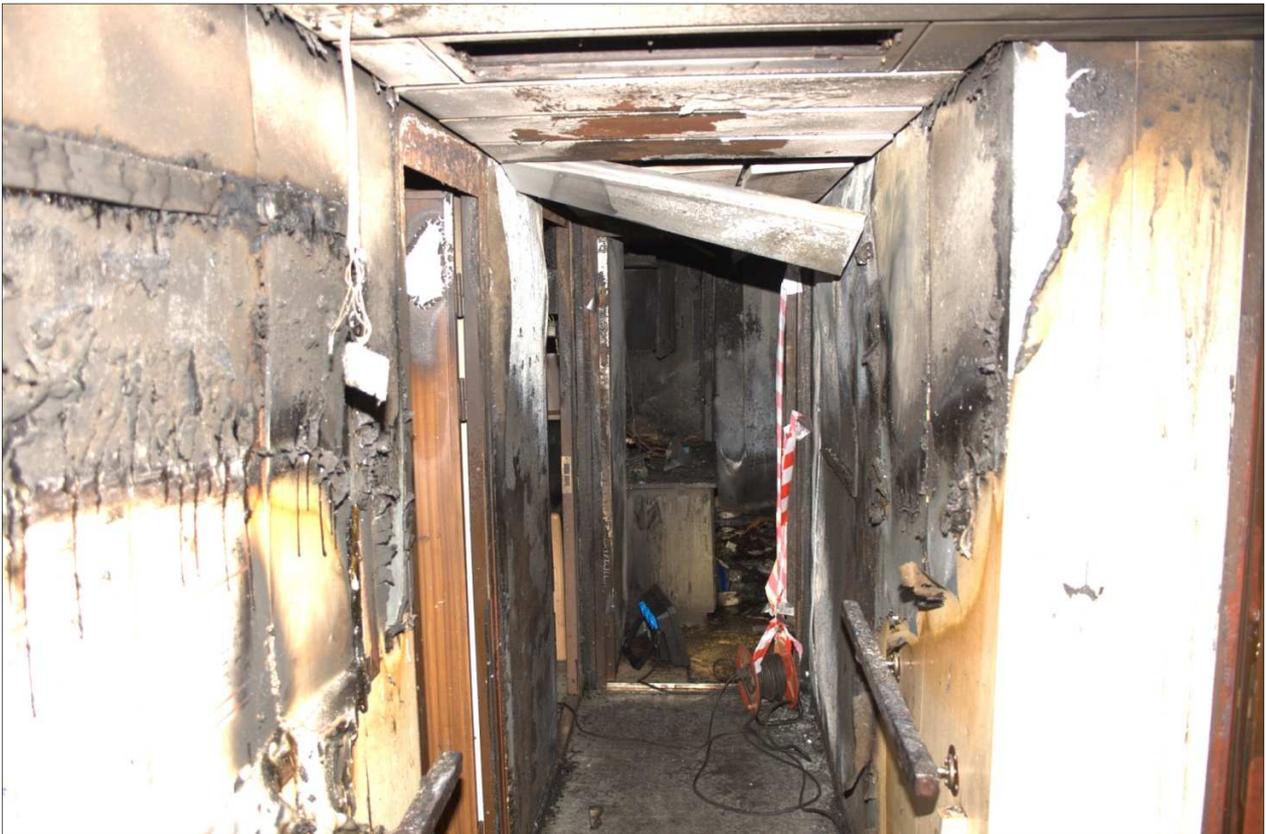
Figure 6: The corridor viewed from aft towards the open door of the ship's hospital  
Source: Danish Institute of Fire and Security Technology

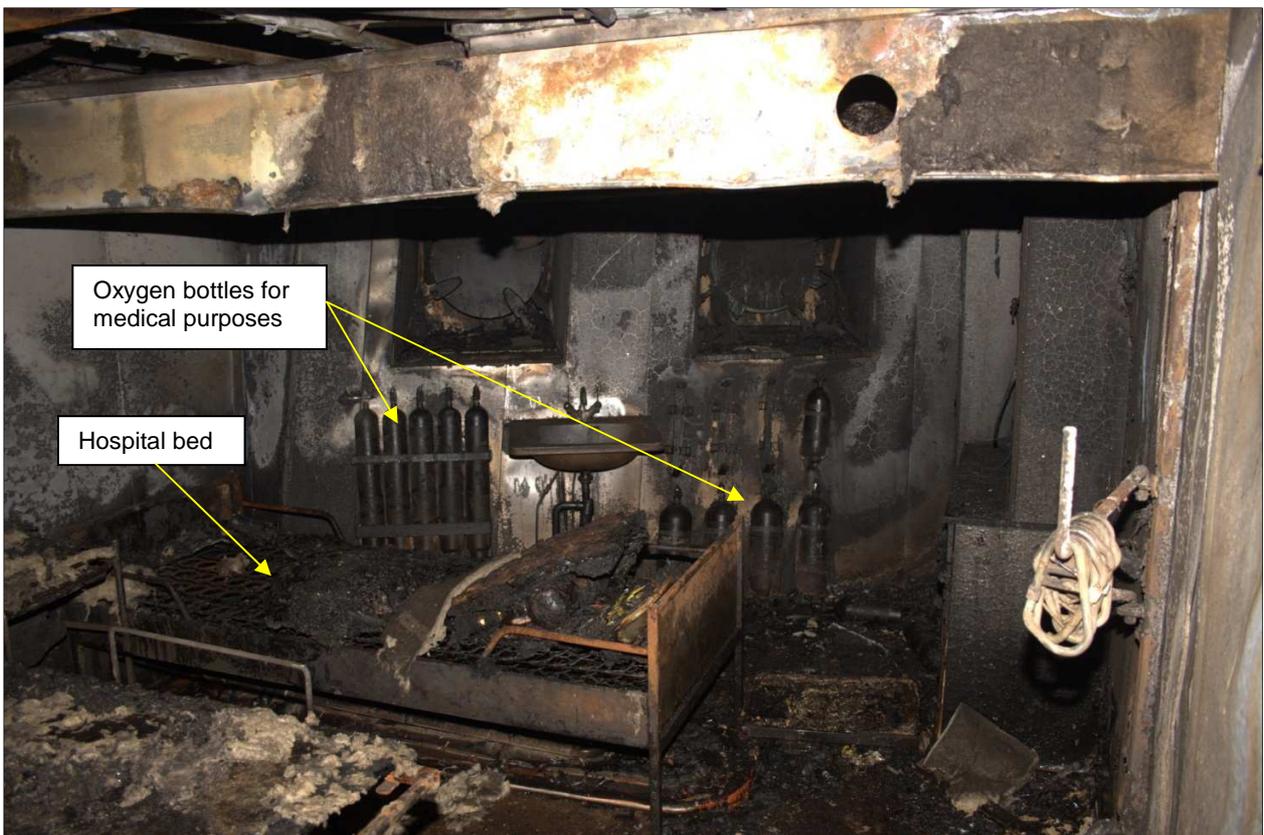
Figure 7: Ship's hospital after the fire  
Source: Danish Institute of Fire and Security Technology

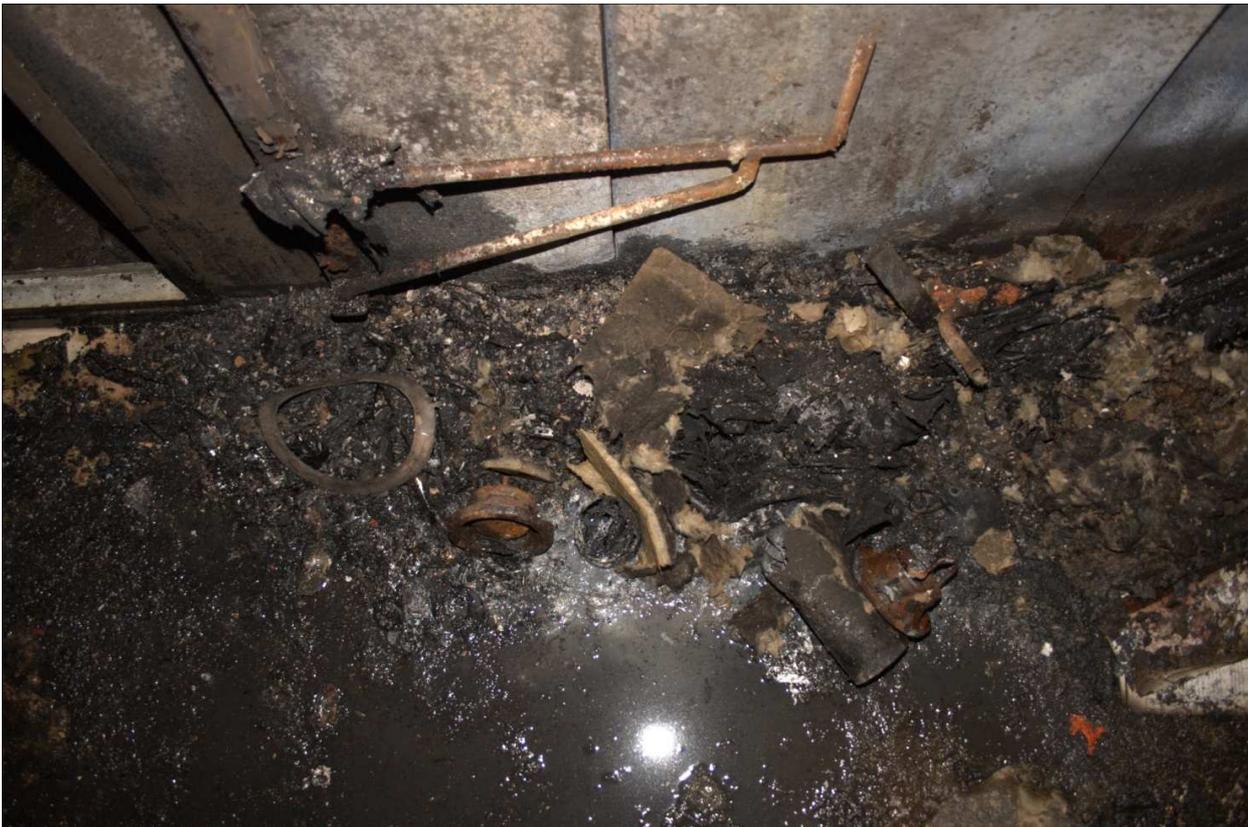
*Figure 8: Site and residues from the plastic box with outdated medicine and chemicals after the fire  
Source: Danish Institute of Fire and Security Technology*

It was found that the fire had occurred in the plastic box placed in the ship's hospital used to contain medicine and chemical residues.

The cause of the fire was with high probability determined to be self ignition by a chemical reaction between chlorine-containing granules and other chemical substances in the plastic box with medicine and chemical residues that was located in the ship's hospital.

However, the cause of the fire was, with high probability, self ignition by a chemical reaction between chemical substances from liquid insecticide and chlorine-containing granules contained in the plastic box.

The shipping company has initiated that an internal procedure for handling and storage of paints and chemicals containing hazardous substances will be amended to include the requirement for a specific risk assessment for storage taking the various risks into consideration.

The shipping company has initiated that internal guidelines for storage of expired medicine are being developed.

The shipping company has initiated that a fleet information notice is distributed to the fleet to share the immediate learning regarding storage of expired medicine and chemicals.
