MARINE ACCIDENT REPORT

CARISMA
Fatal accident to seafarer on 26 January

Joint investigation report by the coast State of Denmark and the flag State of Finland in accordance with the IMO Casualty Investigation Code (resolution MSC.255(84)).

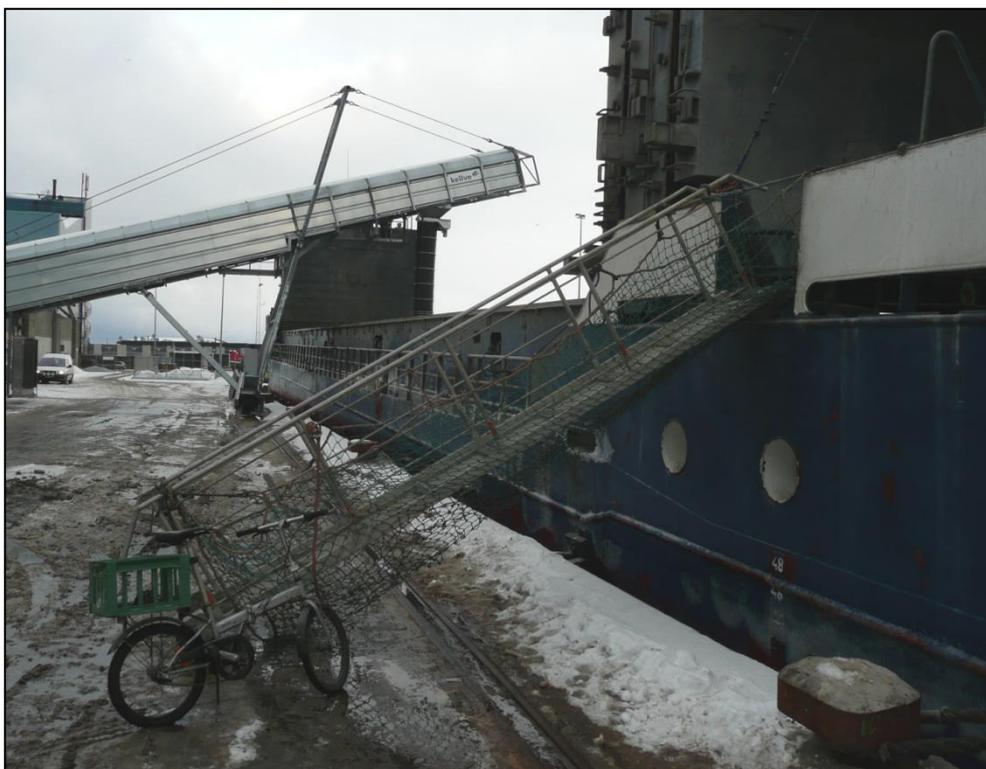
Figure 2: The gangway
Source: Danish Maritime Accident Investigation Board

CARISMA is equipped with an aluminium gangway. It is placed on the deck near to where it is to be rigged. The gangway consists of a footbridge, stanchions, hand rails and ropes. Under the gangway a net is rigged. See figure 2. When it is dark, the gangway is illuminated.

On board CARISMA, the gangway was not used consistently for a number of reasons where it could not be rigged.

After the accident the ship has been equipped with a new gangway that can be rigged parallel to the ship's side.

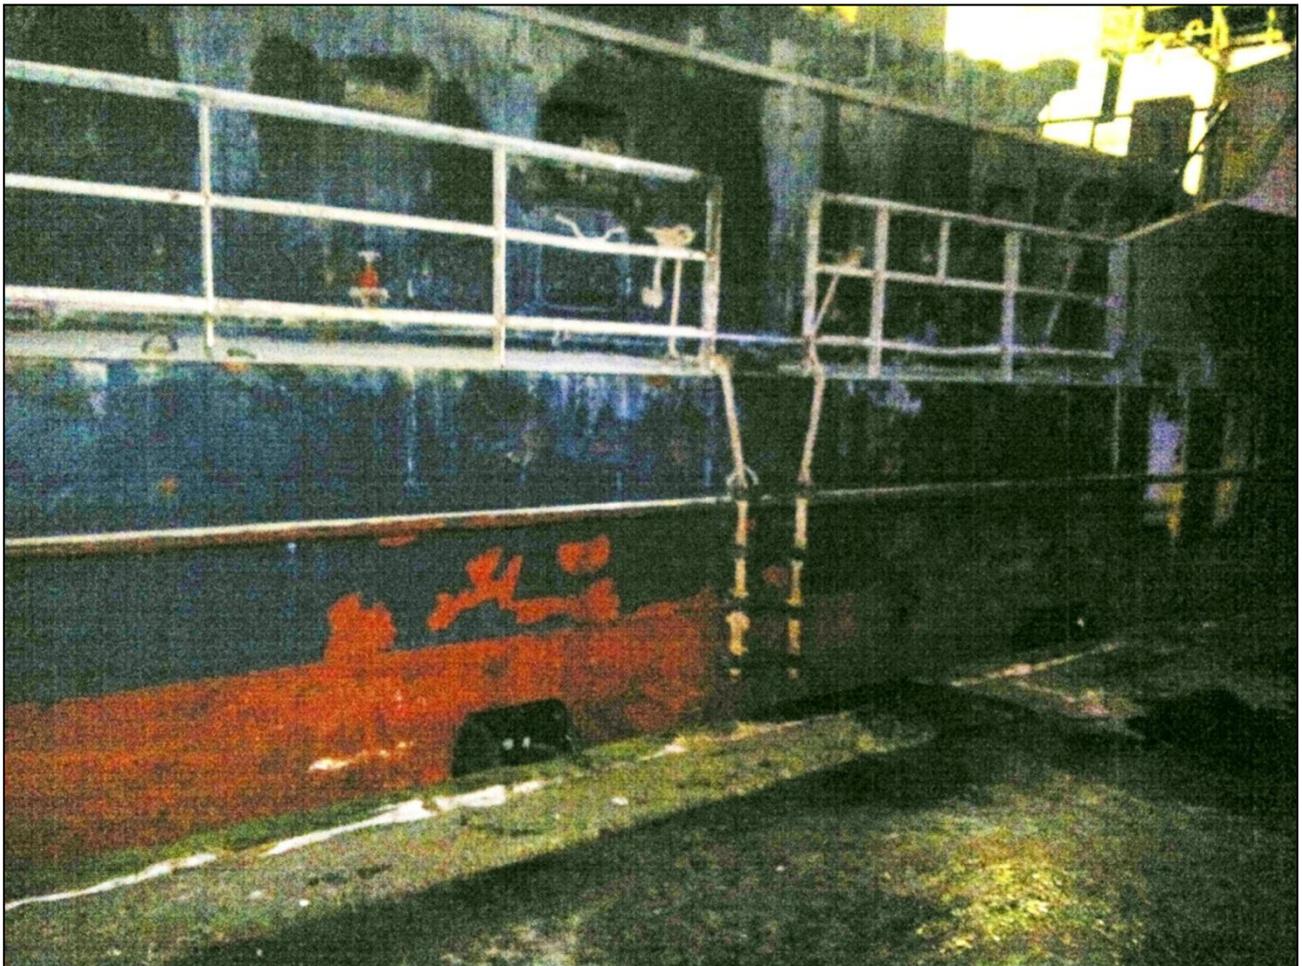
*Figure 3: The pilot ladder rigged at the ship's side
Source: Bornholm's Police*

On board CARISMA there was a short ladder for embarkation and disembarkation of pilots. It consisted of two ropes with steps in between. There were four steps on the ladder. The distance between the steps was 40 centimetres, making the section with steps 1.20 metres long. The pilot ladder was frequently used when the gangway was not rigged for the above-mentioned reasons.

When the pilot ladder was used, it was rigged in an opening in the railing. The two ropes of the ladder were tied to stanchions in the railing, making it easy to climb down the ladder.

The picture below shows how the pilot ladder was rigged. The picture does not show the position of the ladder at the time of the accident as it had been moved before the picture was taken.

Due to the discharge of ballast, the ship had decreased its draught by approximately one meter. The steps of the pilot ladder were therefore one meter higher above the quay than when the crew members left the ship.

Half an hour after arrival, the crew members rigged the pilot ladder and left the ship. At that time the discharge of ballast had just begun. When the seaman returned to the ship, the steps of the pilot ladder had been raised one meter due to discharge of ballast. For this reason and because the distance between the quay side and the ship's side was 80 centimetres, it became considerably more difficult to step onto the pilot ladder.

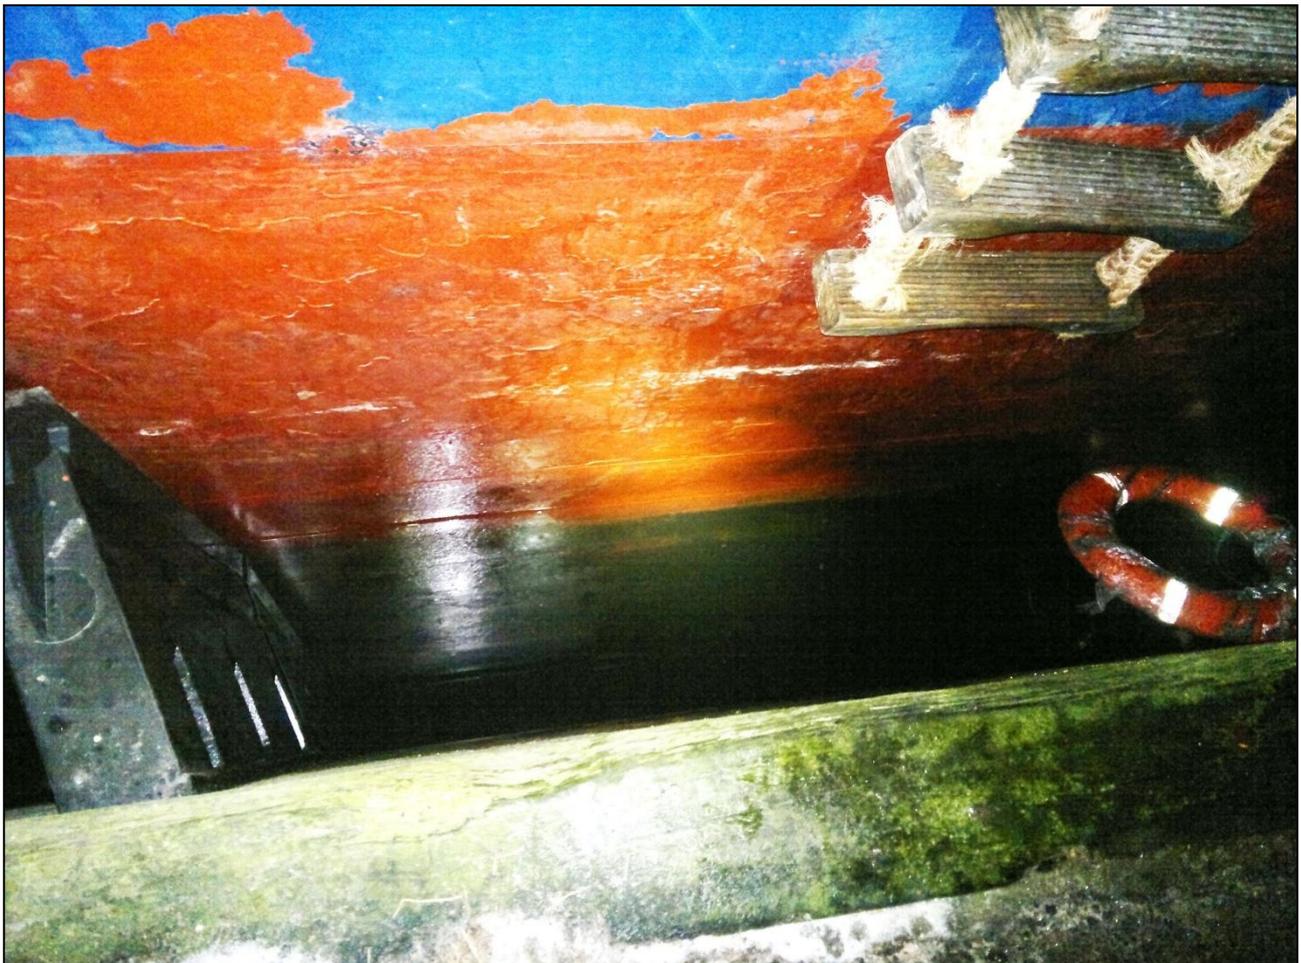
Figure 4: The gap between the ship's side and the quay
Source: Bornholm's Police

The figure below shows the gap between the ship's side and the quay. The picture does not reflect the correct position of the pilot ladder as it had been adjusted after the accident and before the picture was taken.

The distance between the ship's side and the quay was about 80 centimetres and the gap was limited by two vertical rubber fenders. The distance between the fenders is 3 metres. The fenders reached from the edge of the quay and some distance below the surface of the water. From the edge of the quay to the water there was about 1.5 metres.

Because of below-zero temperatures, the quay was slippery due to ice.

On the day of the accident, the temperature was below the freezing point. This circumstance made the quay slippery as it was covered with patches of ice. This may have caused the seaman to slip and fall into the water while attempting to use the pilot ladder to embark the ship.

The use of the pilot ladder instead of the gangway had over time resulted in a non-realized increase of risks; risks such as slippery quay surfaces, variable distances between the quay and ship's side, and the changed position of the pilot ladder due to changes in the displacement.
