# MARINE ACCIDENT REPORT

**ORANESS**

**Accident to seafarer on 10 November 2011**

**This marine accident report is issued on 10 April 2012**

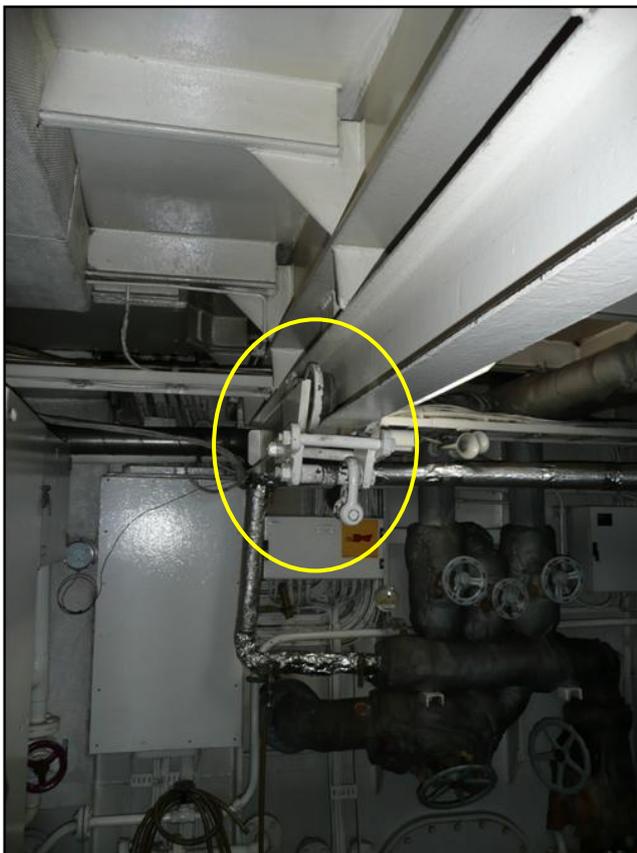
*Figure 3 showing the H-beam and the roller with shackle to carry the crane*

In order to lift the cylinder top it is necessary to use a portable electrical crane. The crane runs on an H-beam mounted in the ceiling of the engine room and going along the length of the engine room.

After having shackled the crane to a runner on the H-beam, the crane is positioned by dragging it in the longitudinal direction.

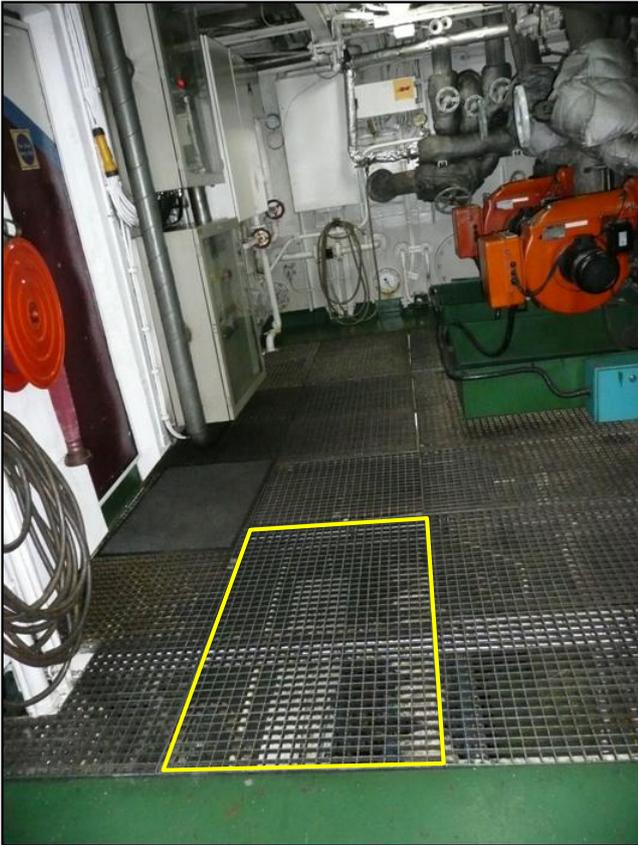
In order to lift a cylinder head, it is necessary to remove sufficient grating on the deck above the cylinder top.

*Figure 4 showing the section of grating to be removed*

Before dismantling the damaged cylinder head, two sections of grating were removed. No protective measures were taken to prevent falling into the opening in the deck.

On board ORANESS, a system of sceptres and hand ropes has been produced making it possible to shield and fence openings in the upper deck in the engine room when sections of grating are removed.

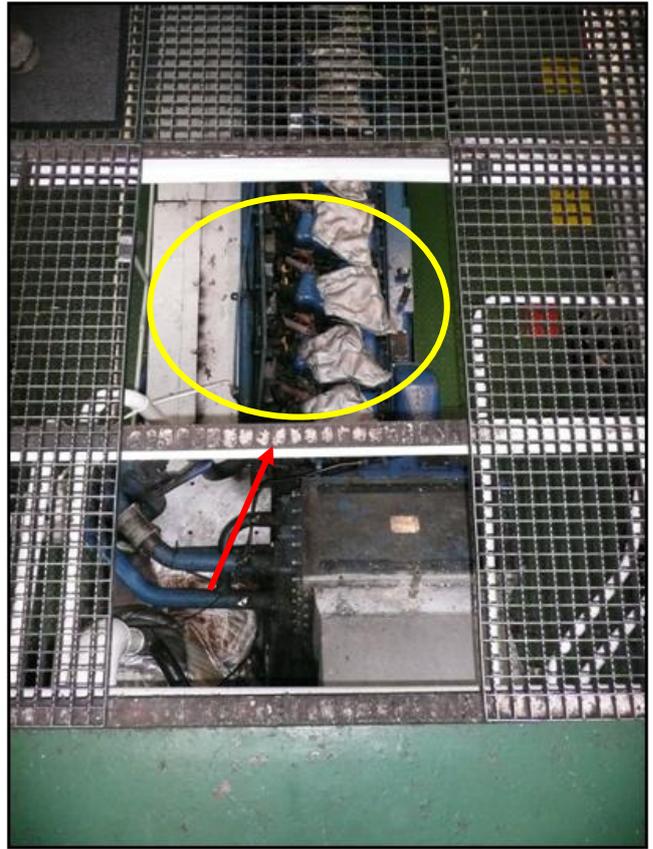
*Figure 5 showing the opening the ship's assistant fell through and the beam he hit in the fall*

Suddenly the ship's assistant fell through the opening where the grating had been removed. In the fall, he hit a stringer with his chest. He landed on top of the main engine after a fall of approximately 2.5 metres face down on his hands and knees. Thereafter, he fell from the top of the engine and on to the floor plates. He was wearing working clothes and safety shoes, but no safety helmet.

*It is the assessment of the Investigation Board that, due to the fact that the ship's assistant was performing a routine task, he was inattentive of the danger of falling to a lower level. Because the opening in the deck was not fenced or shielded, he fell through it.*

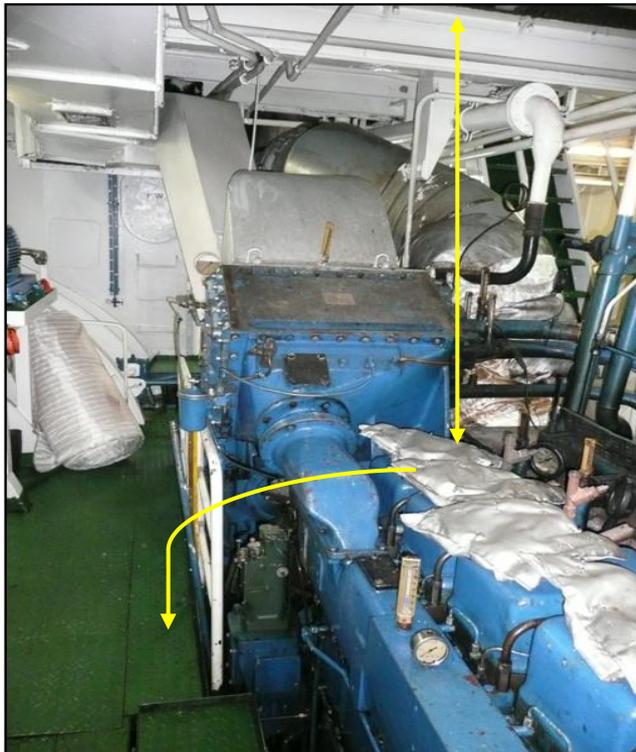
*Figure 6 showing the path the ship's assistant fell*

After dismantling the cylinder head, the ship's assistant went one deck up to drag the crane forward to position it above the damaged cylinder. It is very likely that he had his back to the opening while dragging. When reaching the opening in the deck, he fell into it, hit a stringer and landed on top of the main engine.
