**MARINE ACCIDENT REPORT
DIVISION FOR INVESTIGATION OF MARITIME ACCIDENTS**

**MAERSK LANCER
Accident to seafarer
13 November 2010**

The casualty report has been issued on 6th September 2011

Case: 201012662

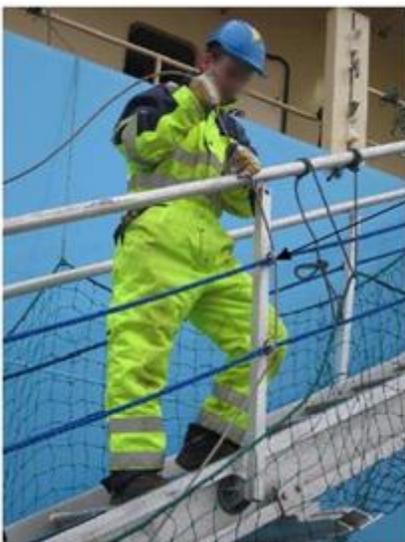
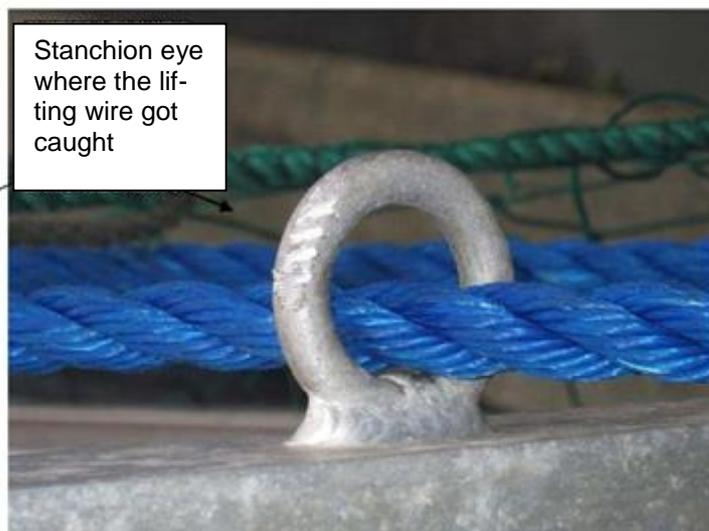
The reason for this was that the lifting wire had caught an eye on one of the stanchions preventing the handrail from falling down in stowage position. The lifting wire was caught approximately half-way up the gangway.

The problem with the lifting wire getting stuck on an eye on a stanchion has occurred frequently on MAERSK LANCER and is well known in other supply vessels in the company's fleet using the same gangway system. The problem is usually solved without any problems.

It is the assessment of the Division for Investigation of Maritime Accidents that the well known problem with the lifting wire getting caught on an eye of one of the station was not solved and thus was a contributing factor to the accident.

It is the assessment of the Division for Investigation of Maritime Accidents that the lifting wire getting stuck in a stanchion on the gangway caused disturbance and made it necessary to derogate from normal procedures and thus was a contributing factor to the accident.

The shipping company is recommended to look into the well known problem with the lifting wire getting caught on the stanchions when taking in the gangway.

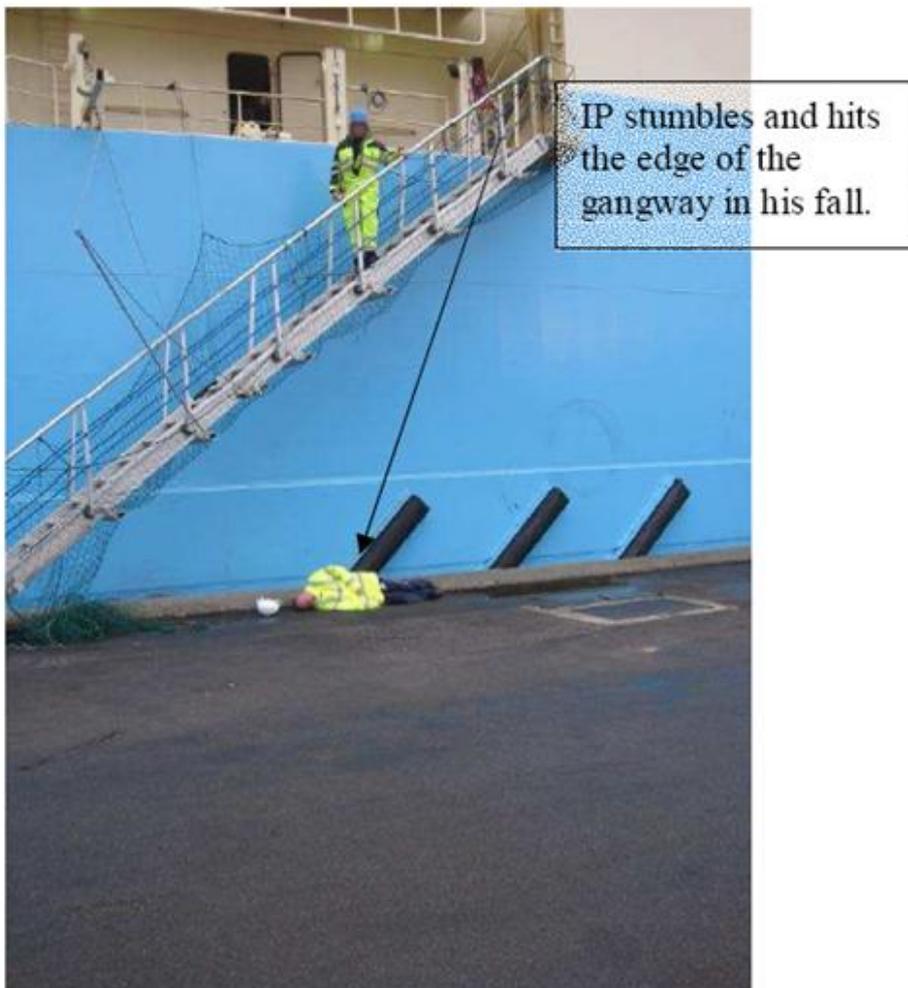
The IP stepped out on the gangway facing aft and looking down. He went some steps down the gangway and pulled the handrail forth and back. Simultaneously the watch keeping ship's assistant pushed the lifting wire. At the same moment as the watch keeping ship's assistant managed to clear the lifting wire from the eye on the stanchion, the handrail fell down in stowage position with a sudden movement. The IP did not let go of the rail and was probably pulled forward and he lost his balance and stumbled off the gangway on the side facing the pier. In the fall he hit the gangway.

He fell to the pier and landed on his right-hand side close to the edge of the pier. The distance he fell was approximately 5 metres.

Figurants showing the position of the falling IP

When the lifting wire was loosened, the handrail fell down with a sudden movement. This caused the IP to lose his balance and stumble off the gangway. The handrail fell down because the pin holding the handrail in the upright position was removed.

It is the assessment of the Division for Investigation of Maritime Accidents that the removal of the pin holding the handrail in an upright position before the problem with the lifting wire was solved was a contributing factor to the accident.

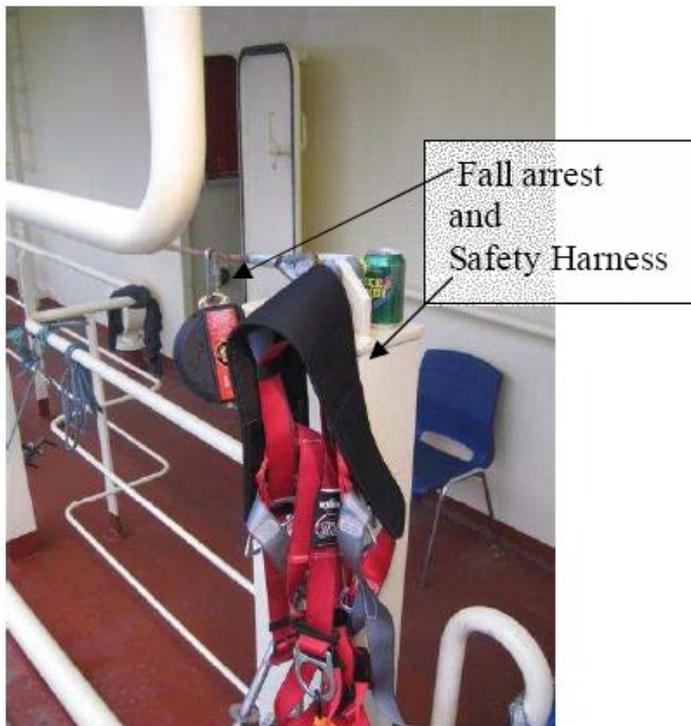
The winch used to lift the gangway is operated from the deck. Therefore he did not wear a safety harness when operating the winch as there was no call for it.
