**MARINE ACCIDENT REPORT**

**ATHENA  
Fire  
27 October 2010**

Danish Maritime Accident Investigation Board,

**Case: 201012017**

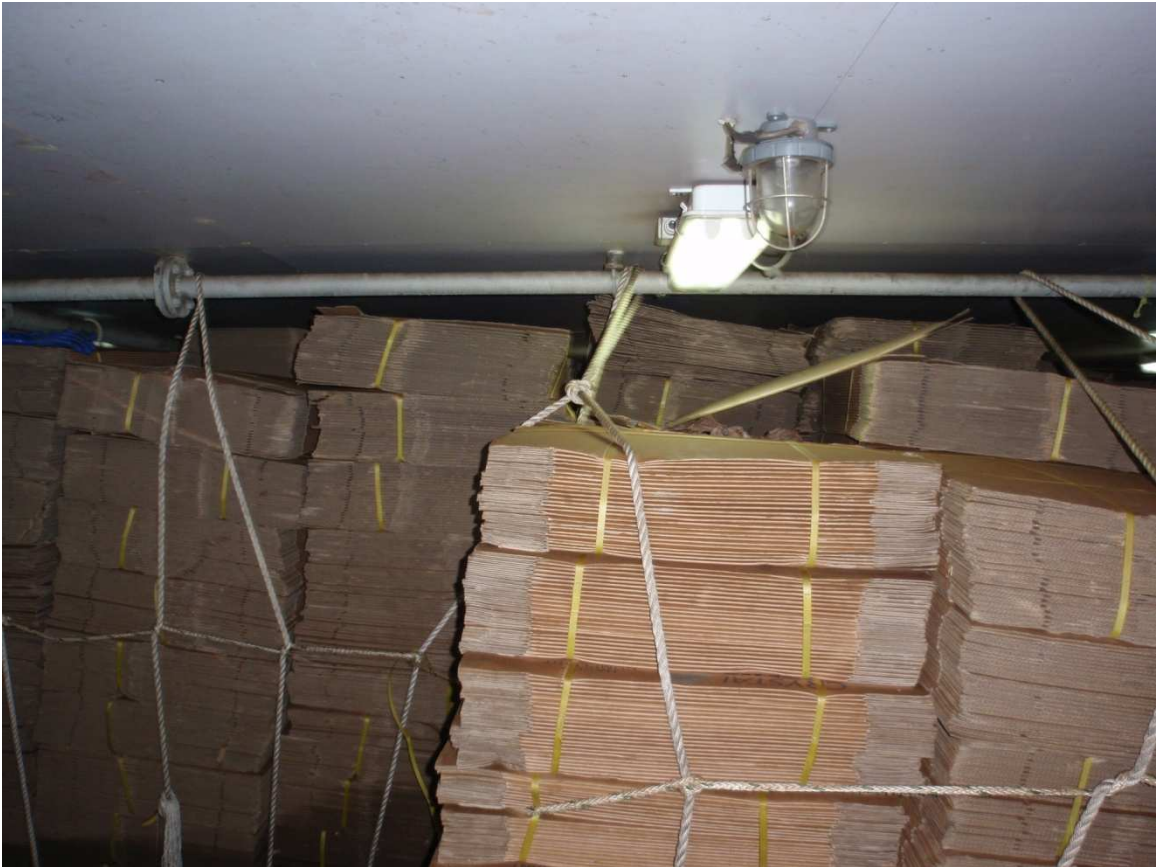
As experienced in severe fires in the same ship and a sister ship in 2007, the cardboard packaging was recognized by the owners and by the ship's crew and officers as a highly combustible material.

Stowage of corrugated cardboard packaging

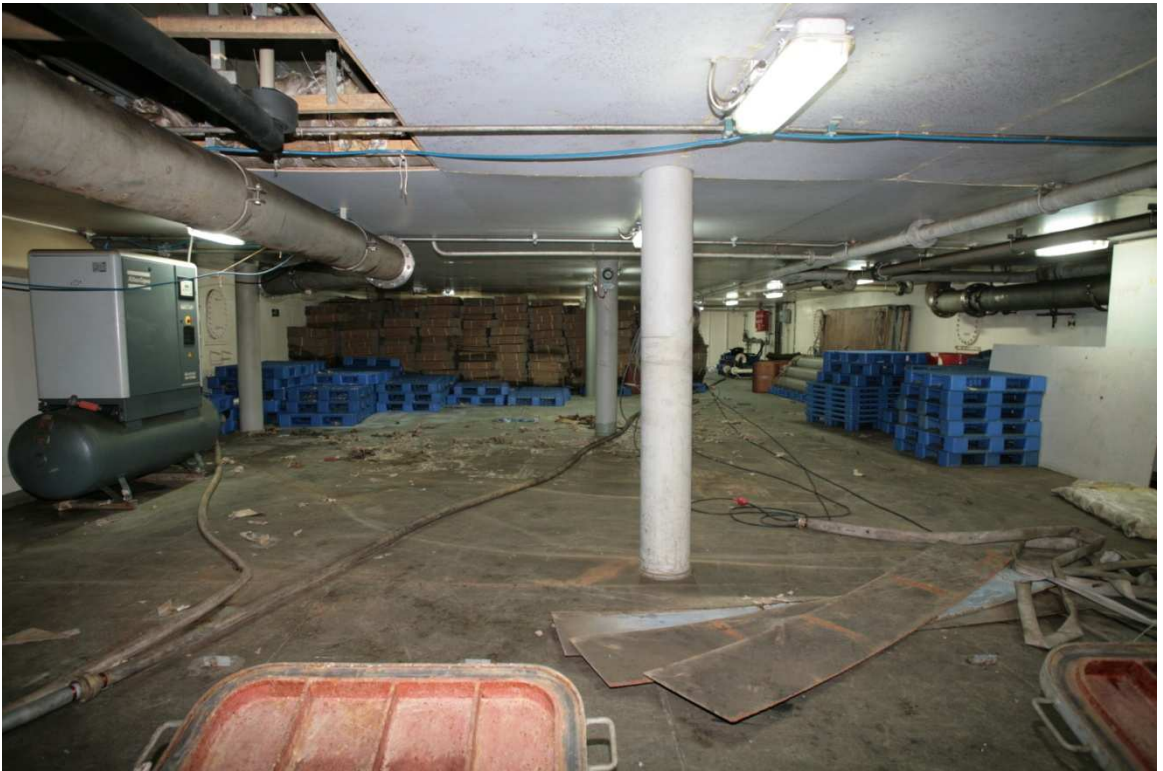
Cardboard packaging in the aft part of the space aft of the cargo hold on the 1<sup>st</sup> deck

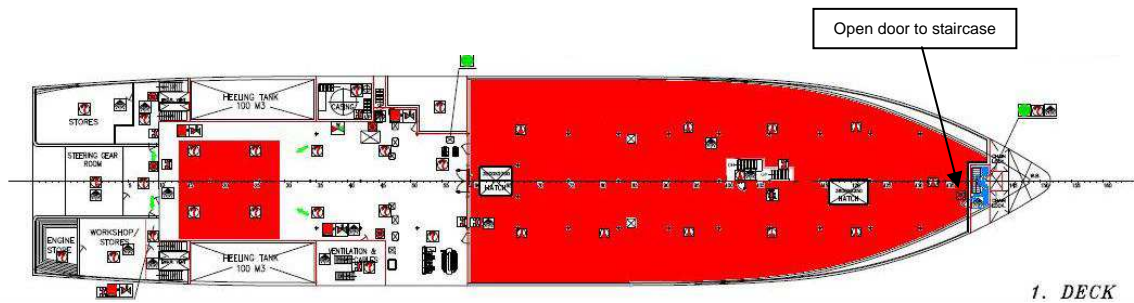
Red areas show storage of corrugated cardboard packaging on the 1<sup>st</sup> deck

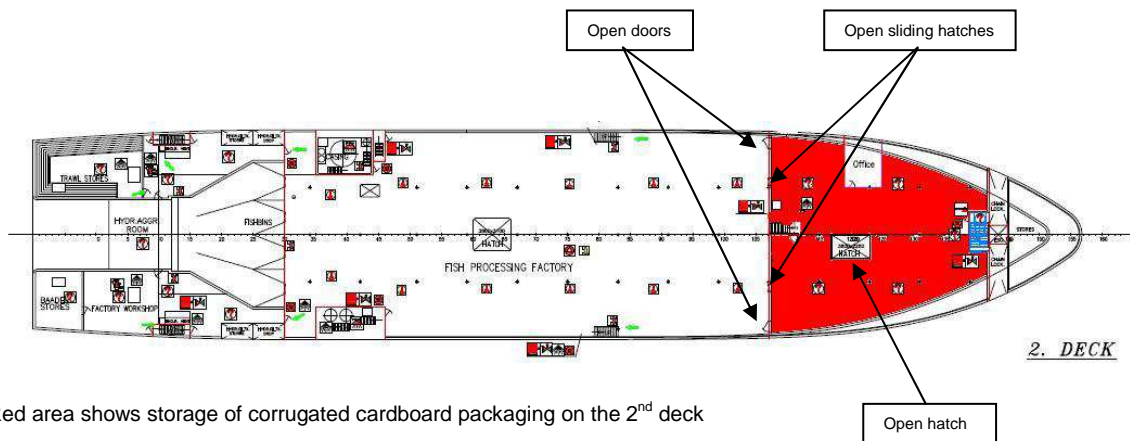
Red area shows storage of corrugated cardboard packaging on the 2<sup>nd</sup> deck

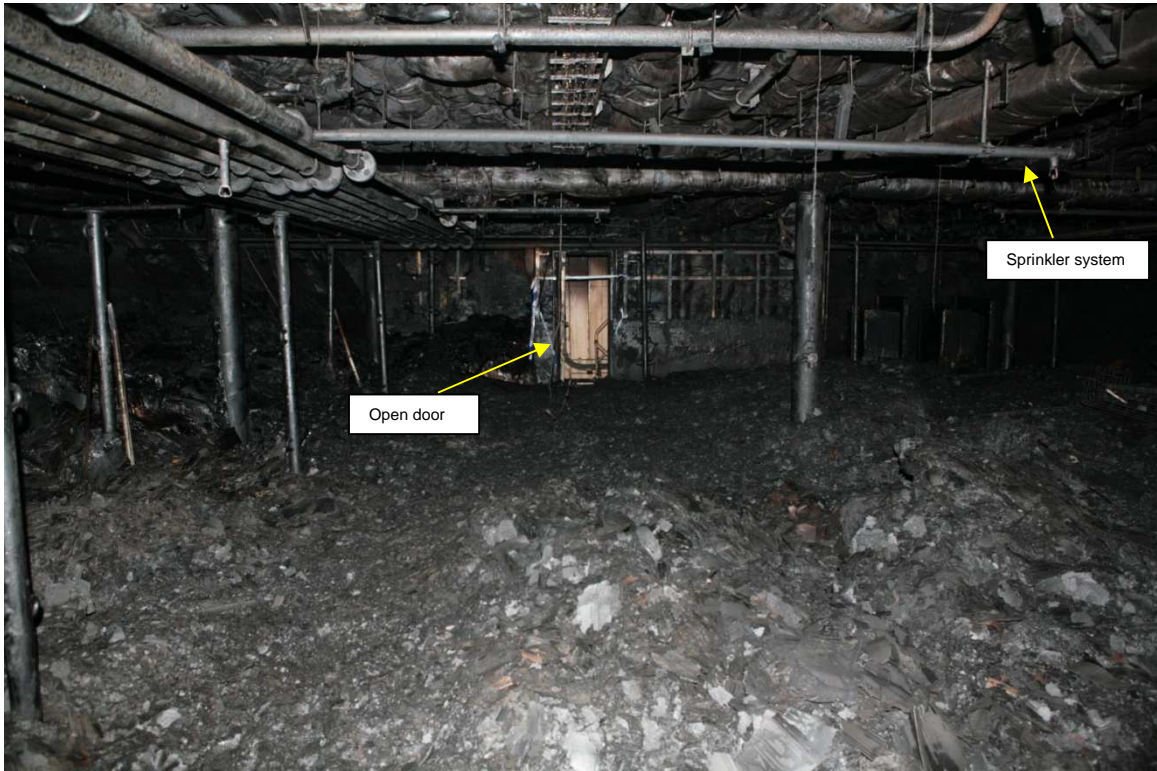
Open door in front of cargo hold on the 1<sup>st</sup> deck

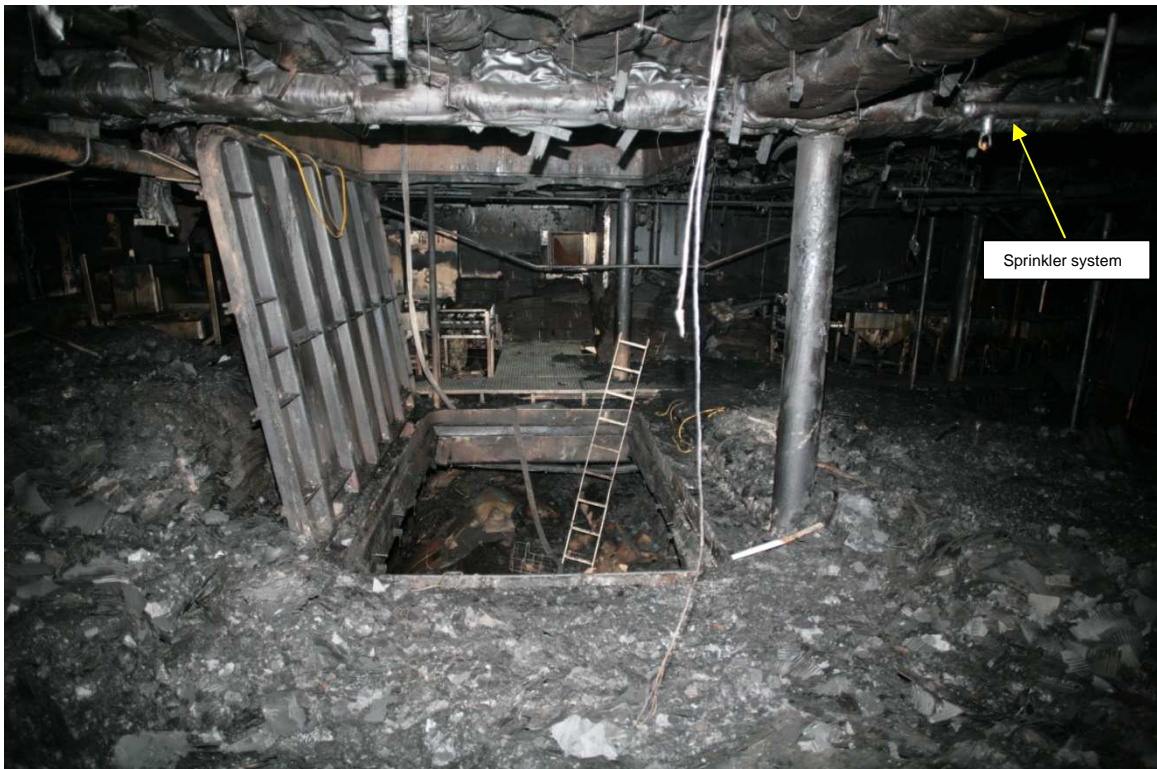
- *an early and effective containment of the initial fire in the cargo hold on the 1<sup>st</sup> deck was made impossible because of the open hatch on the 2<sup>nd</sup> deck (6.2);*

During the passage from the Faroe Islands, the fore hatch on the 2<sup>nd</sup> deck was kept open because the crew had transferred corrugated packaging material from the freezer hold on the 1<sup>st</sup> deck to the packing room on the 2<sup>nd</sup> deck. This open hatch caused the fire to spread rapidly from the freezer hold on the 1<sup>st</sup> deck to the packing room on the 2<sup>nd</sup> deck.

Open hatch on the 2<sup>nd</sup> deck, packing room

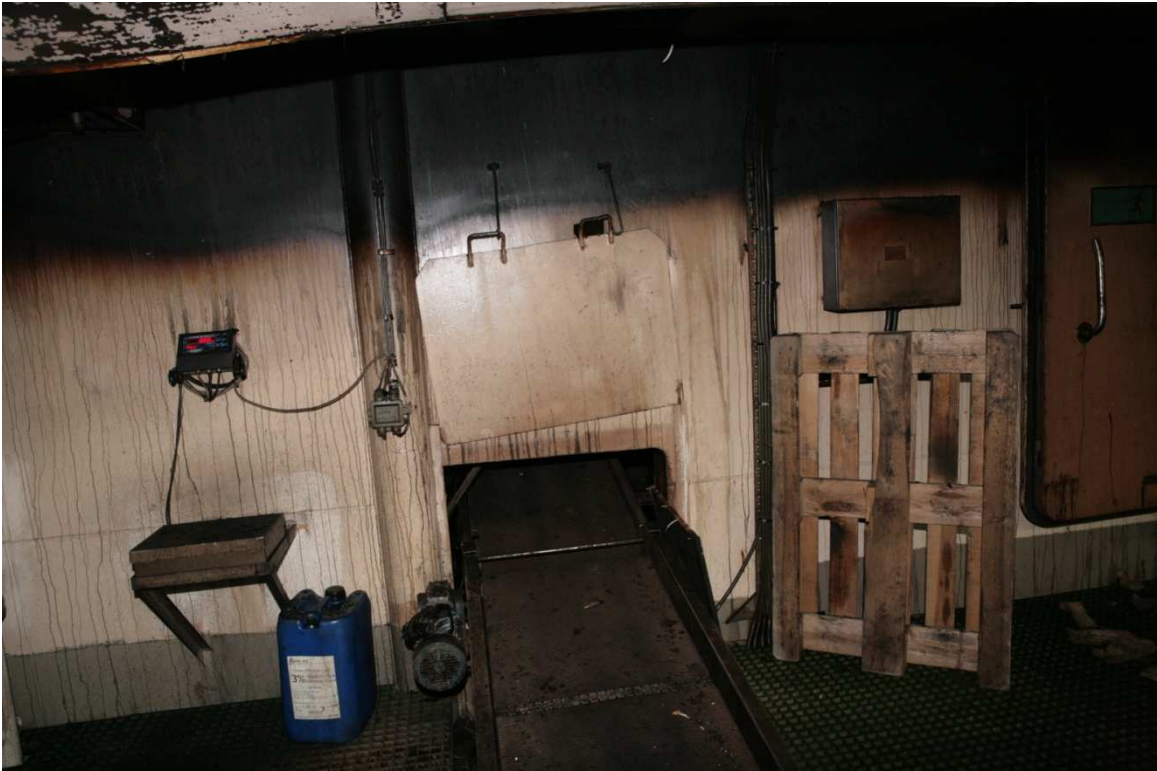
Two sliding hatches in the bulkhead between the packing room on the 2<sup>nd</sup> deck and the processing area on the same deck were open. Two doors in the same bulkhead were kept open, one in the port side and one in the starboard side.

At first, the open sliding hatches and doors meant that the fire was supplied with air from the adjacent spaces and later that heat and smoke spread to the processing area and via the staircase also to the ship's accommodation.

Open sliding hatch viewed from the processing area

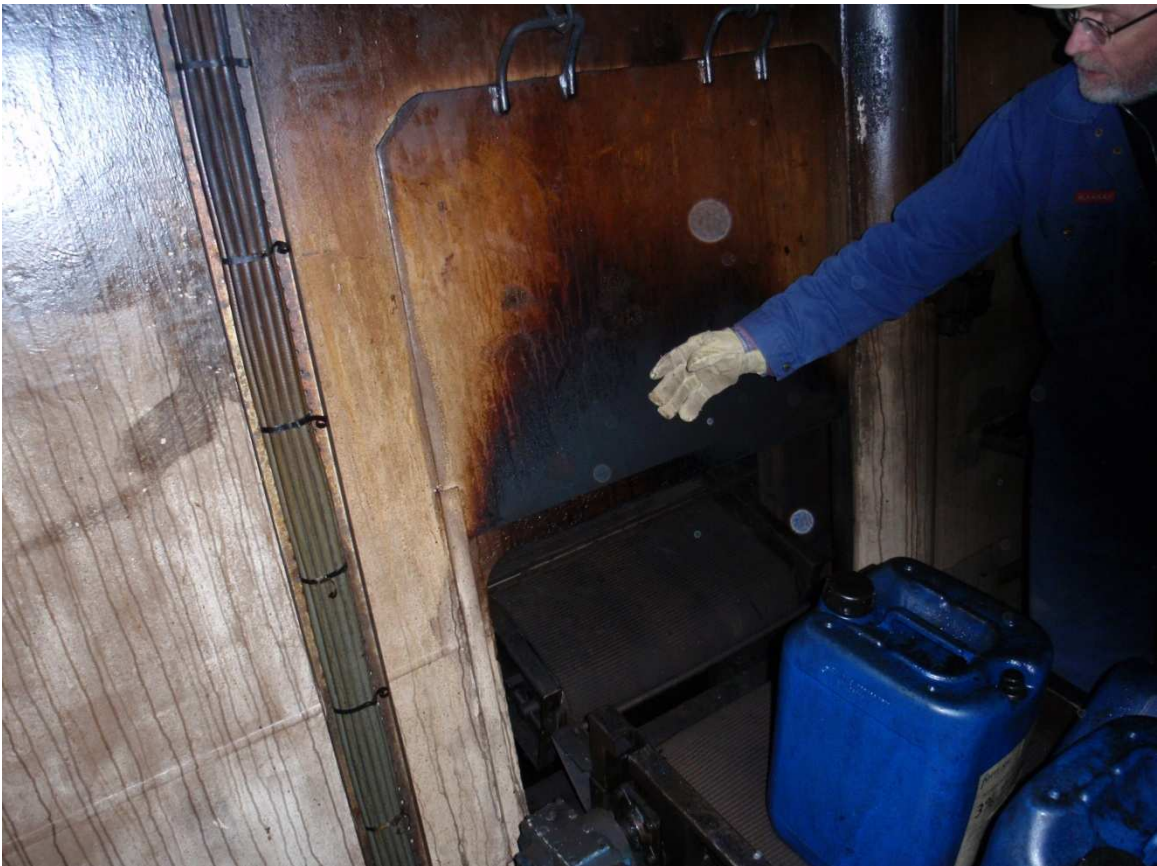
Open sliding hatch viewed from the processing area

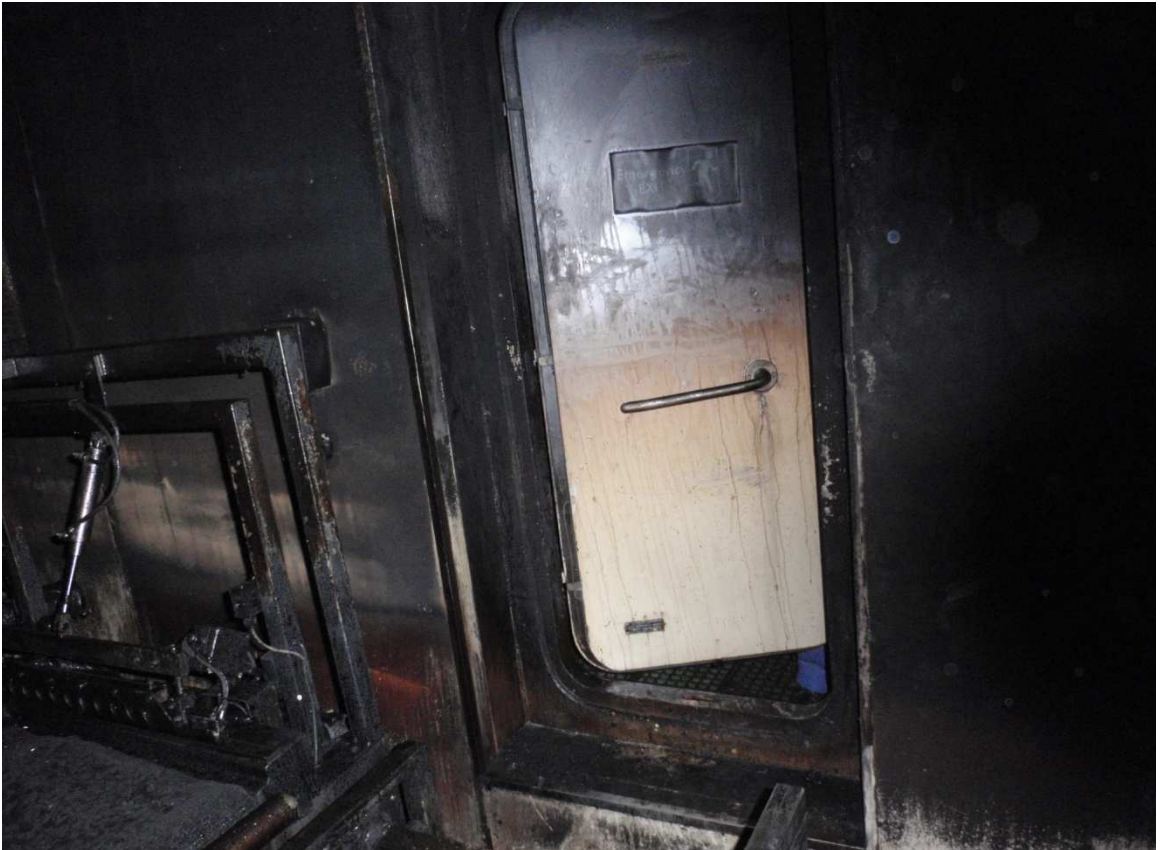
Port side door in bulkhead between processing area and packing room on the 2nd deck (open during fire)  
Photo: The Investigation Board

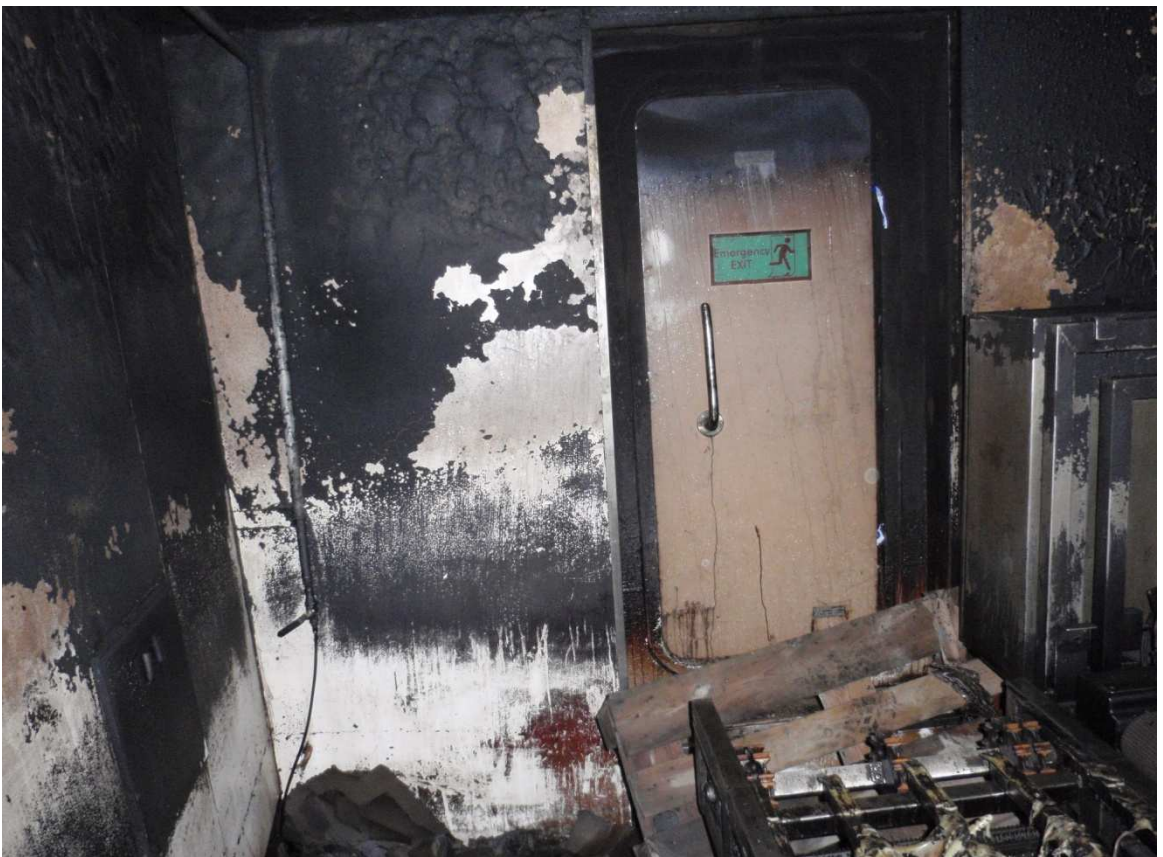
Door in the starboard side of bulkhead between processing area and packing room on the 2nd deck (open during fire)  
Photo: The Investigation Board

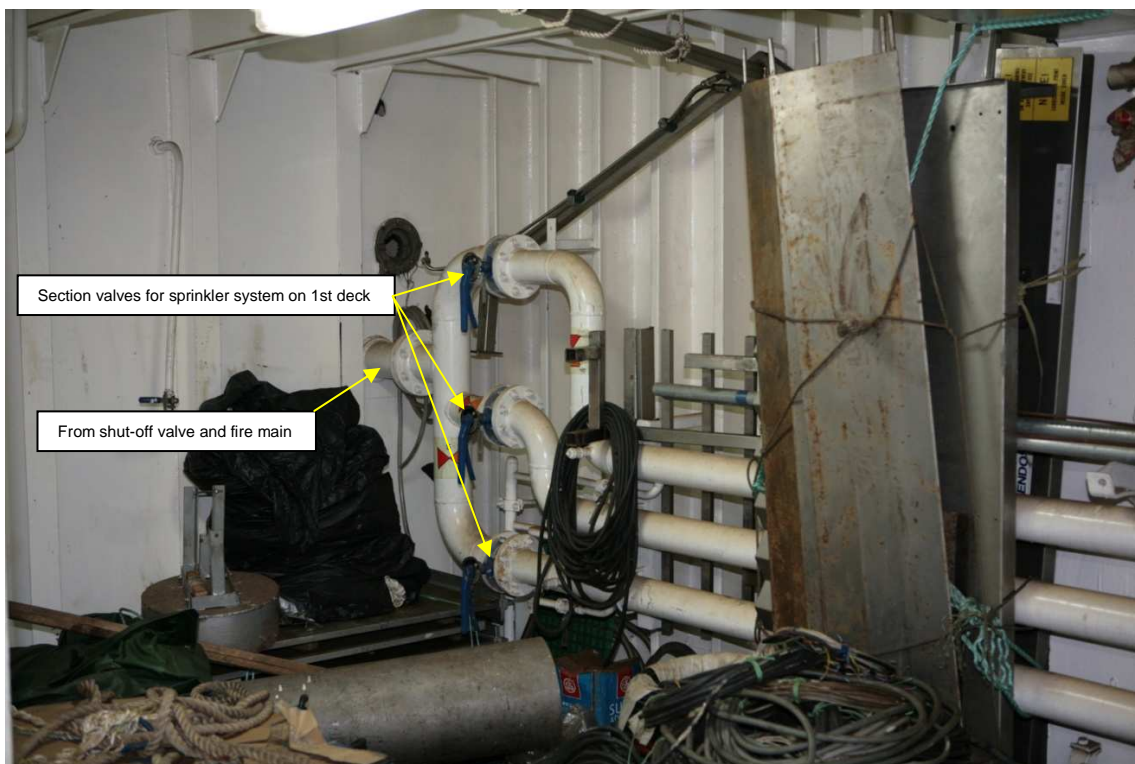
- *the arrangement of the section valves for the sprinkler system was inappropriate with regard to easy accessibility from open deck (6.3);*
- *the effective closing of doors, hatches, fire flaps, etc. from open deck to the ship's interior and cooling of deck and surfaces by the use of fire hoses implied a containment of the fire in the ship's cargo hold on the 1<sup>st</sup> deck and in the packing room on the 2<sup>nd</sup> deck. Eventually, the open doors and sliding hatches caused severe soot and smoke damage to the ship's interior (6.3);*

The sprinkler system in the cargo hold on the 1<sup>st</sup> deck consisted of three sections, each section to be manually operated by a butterfly valve in a storeroom located on the port side aft of and adjacent to the cargo hold. A shut-off valve to isolate the sprinkler system from the fire main was installed in the port engine room casing aft of and adjacent to the storeroom.

Sprinkler system's section valves for sprinkler on the 1st deck

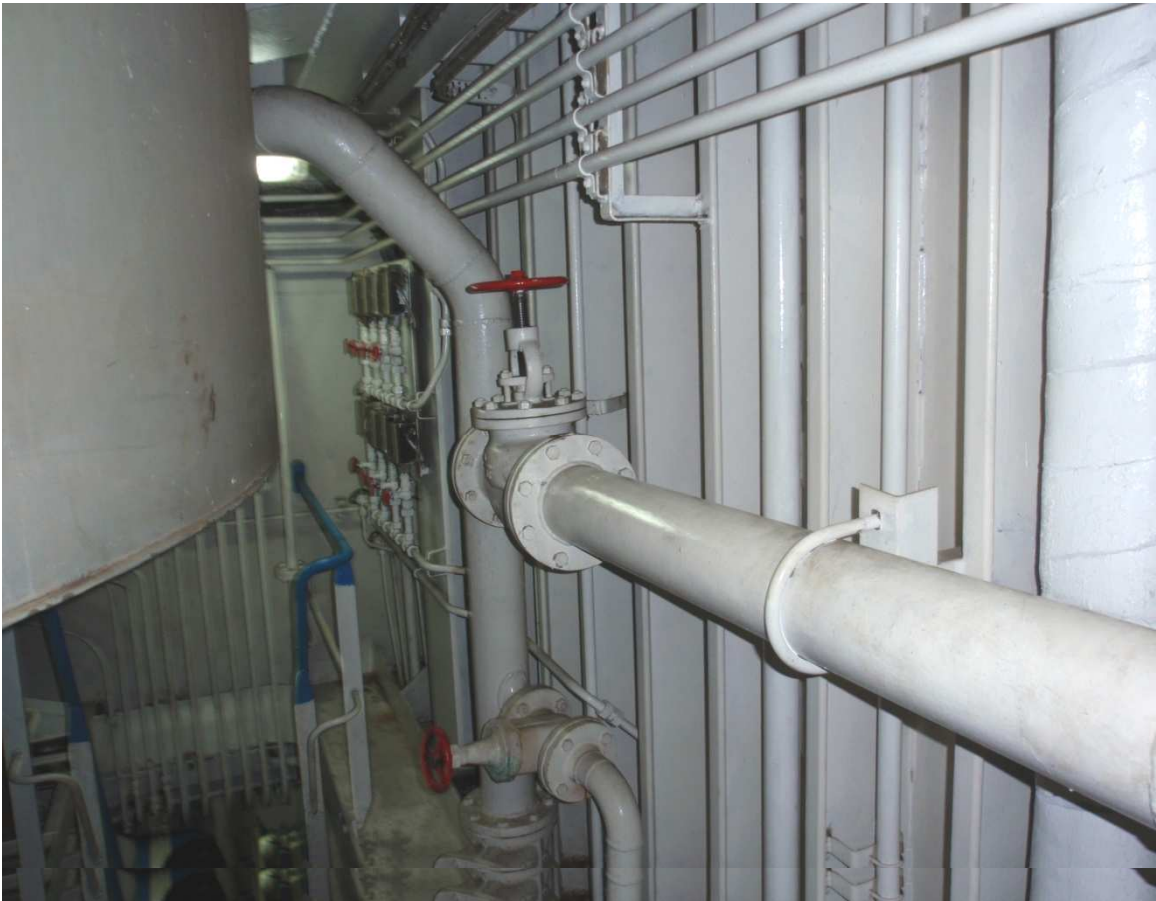
Sprinkler system's shut-off and isolating valve for sprinkler sections on the 1st deck

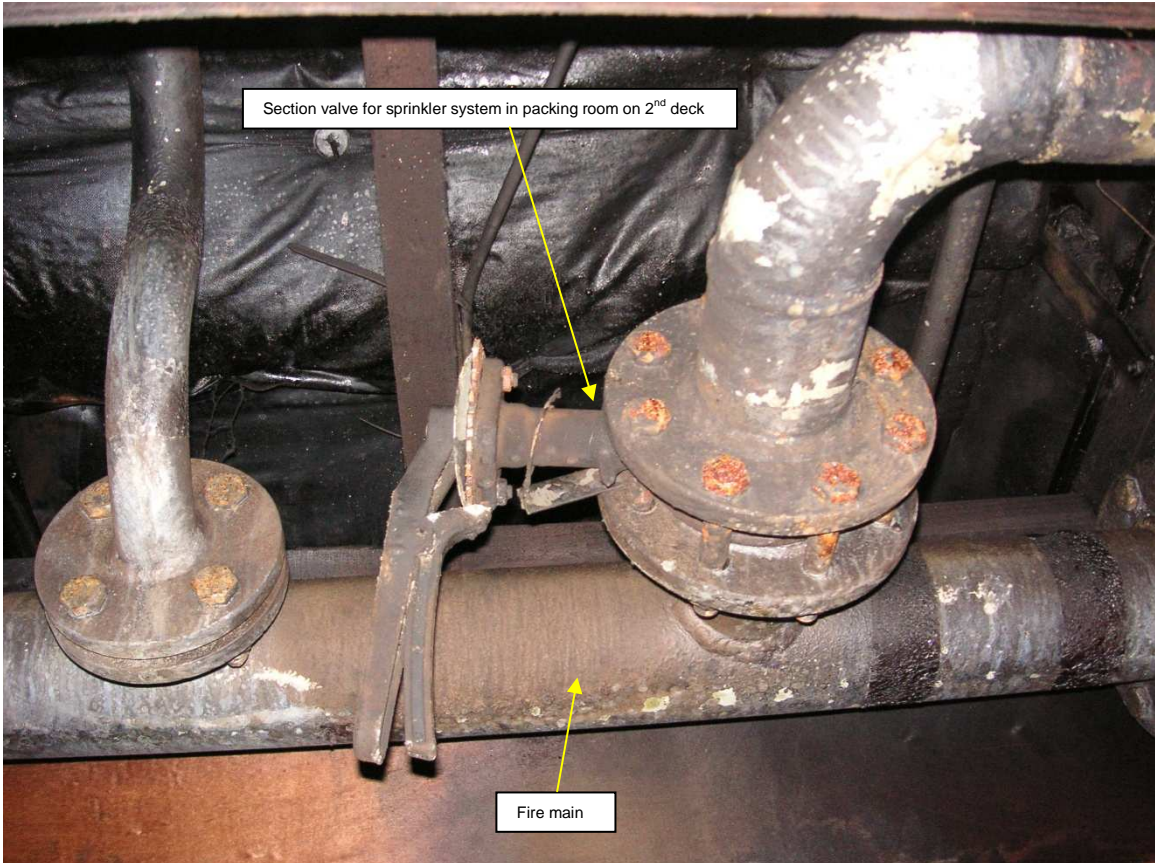
The sprinkler system in the packing room on the 2<sup>nd</sup> deck consisted of two sections, each section to be manually operated by a butterfly valve located behind a trapdoor in the ceiling plate in the processing area adjacent to the bulkhead between the packing room and the processing area. No shut-off valve had been installed to isolate these sections of the sprinkler system. Thus, these section valves were constantly pressurized by the fire main.

Section valve for sprinkler system in packing room on the 2<sup>nd</sup> deck, situated above ceiling plates

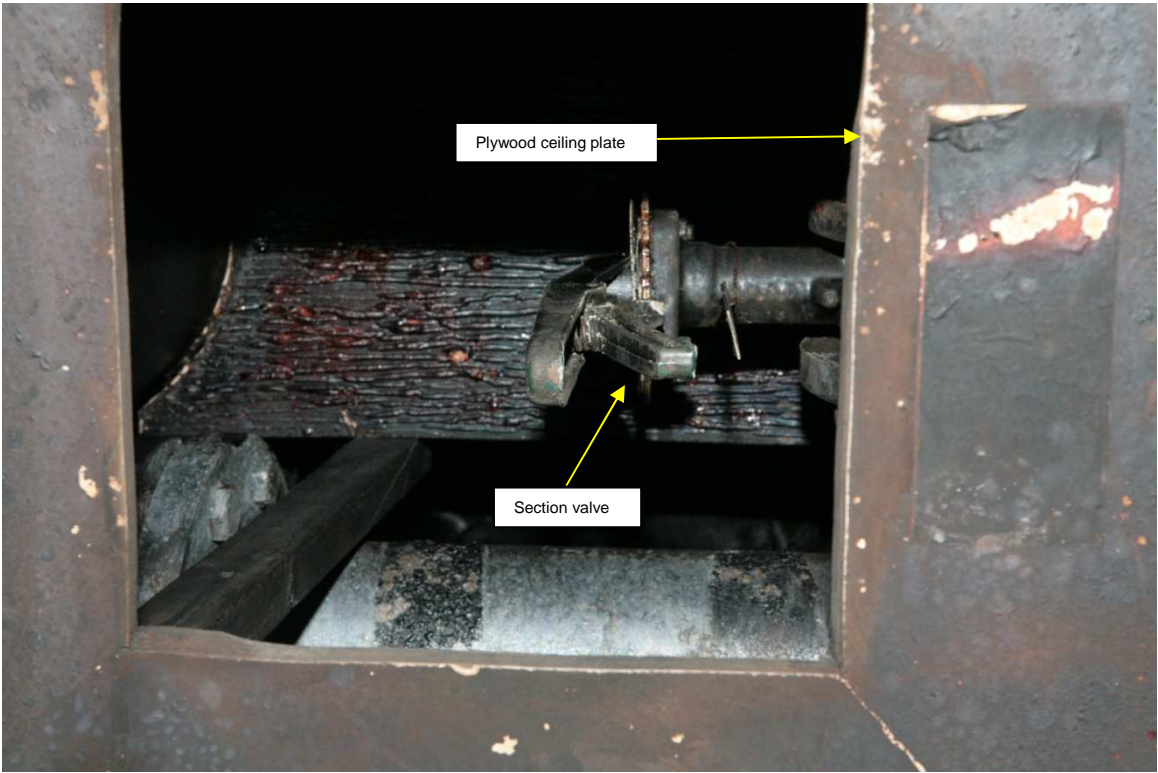
Section valve for sprinkler system in packing room on the 2<sup>nd</sup> deck

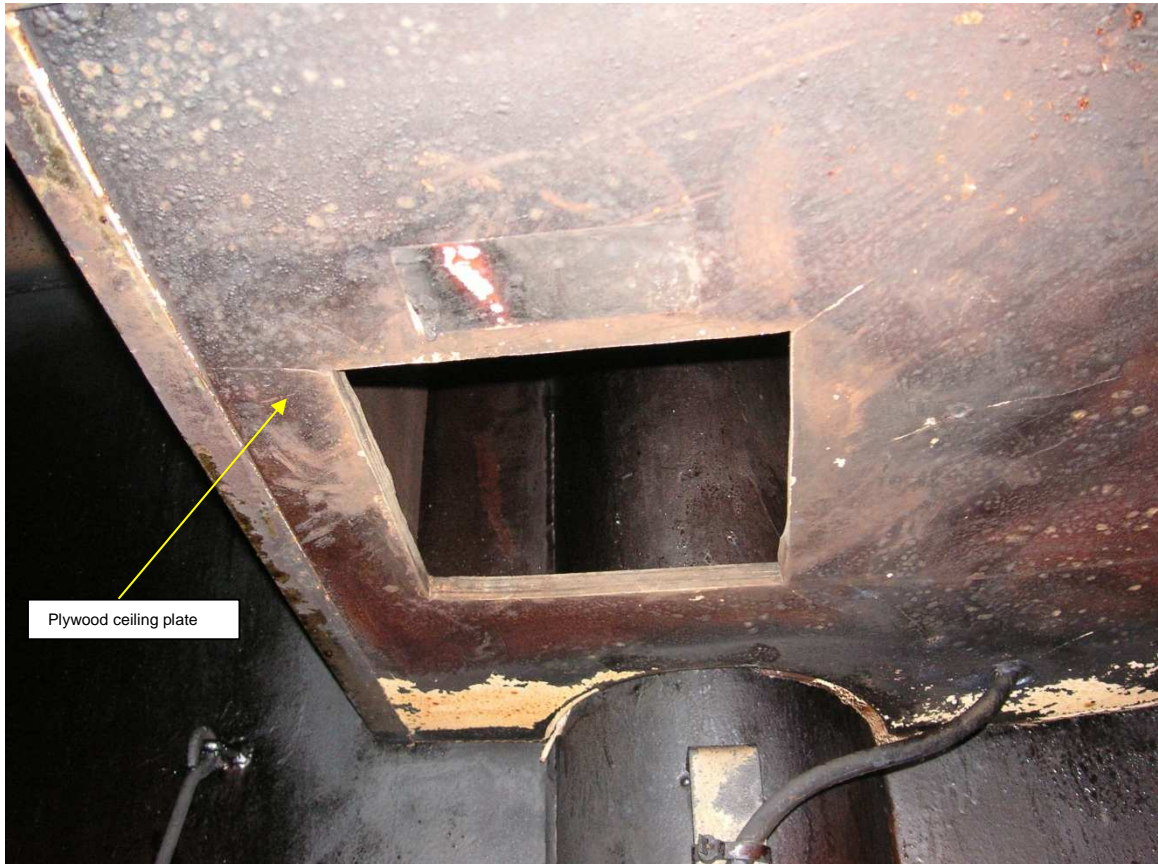
Ceiling plate and opening for operation of section valve for sprinkler system in packing room on the 2<sup>nd</sup> deck

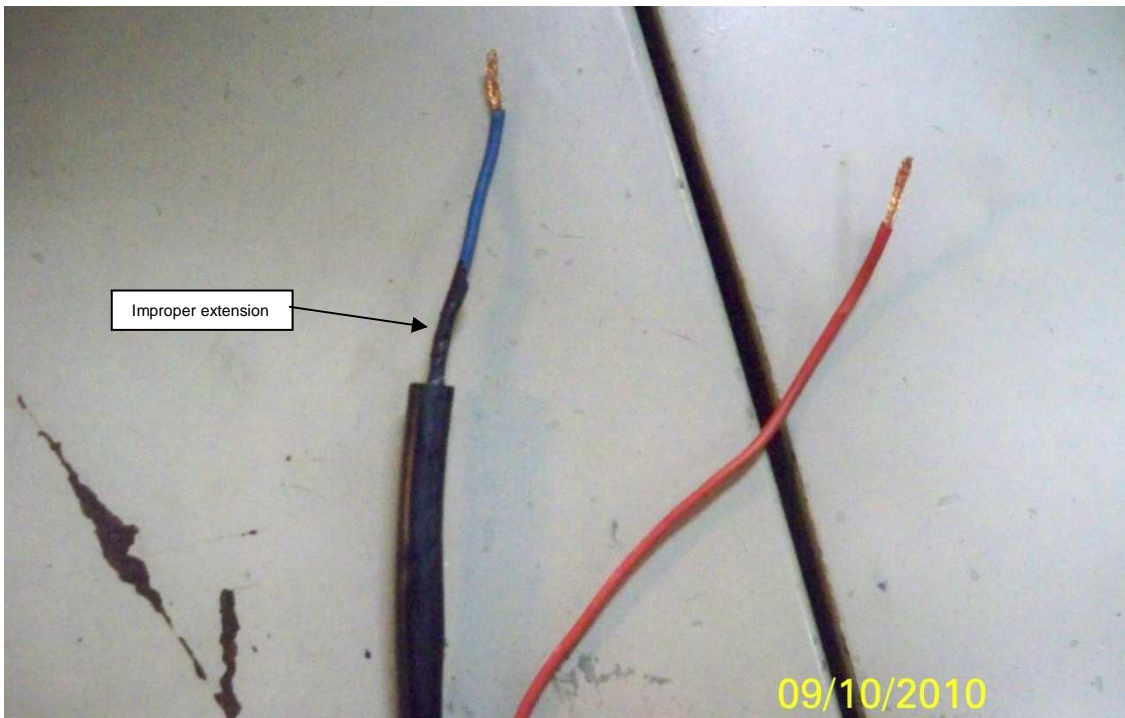
Crew members have stated that the electrical installations in the processing area, cargo holds and the accommodation made at the reconstruction were flawed in several respects, necessitating a long series of repairs by the ship's own electricians after the ship had left the shipyard.

Electric cable with an improper extension of wire

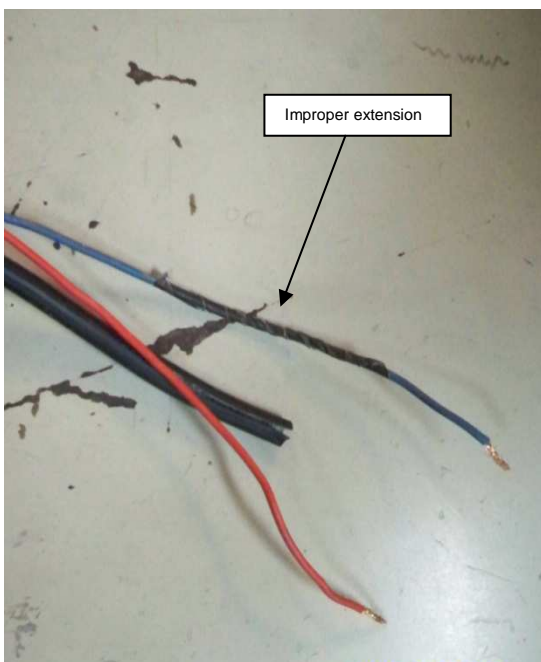
Electric cable with an improper extension of wire

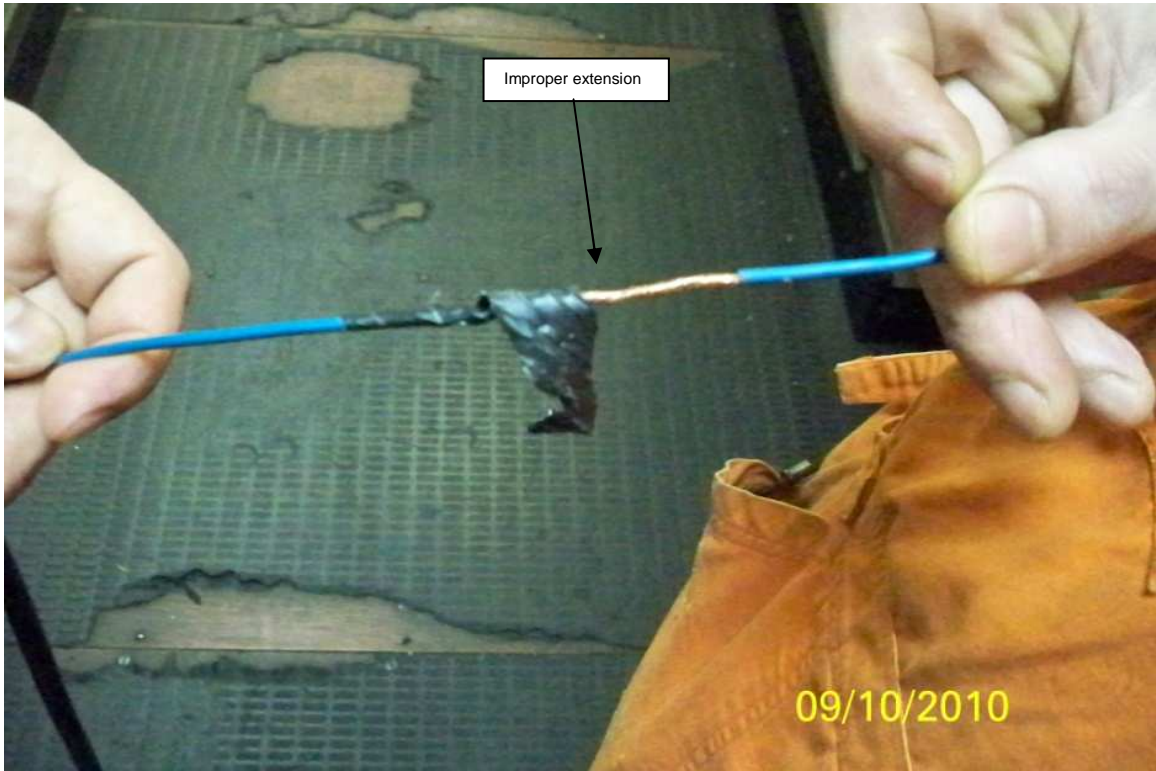
Electric cable with an improper extension of wire

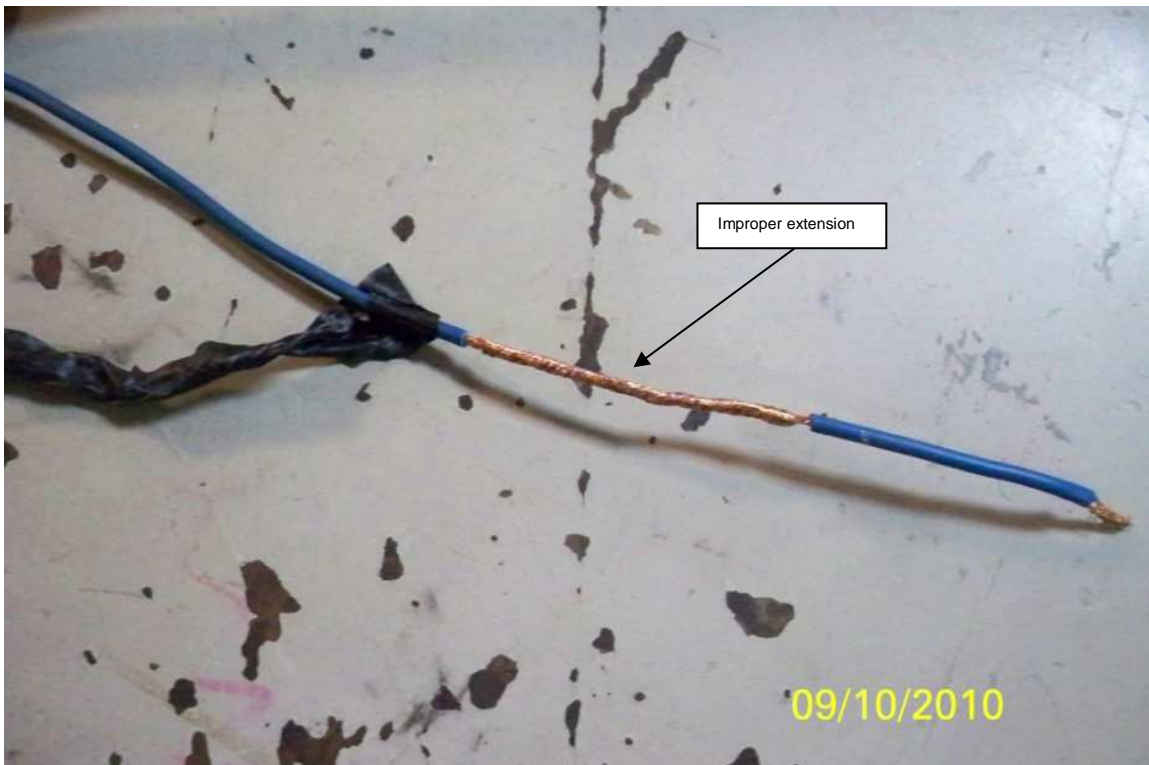
Electric cable with an improper extension of wire

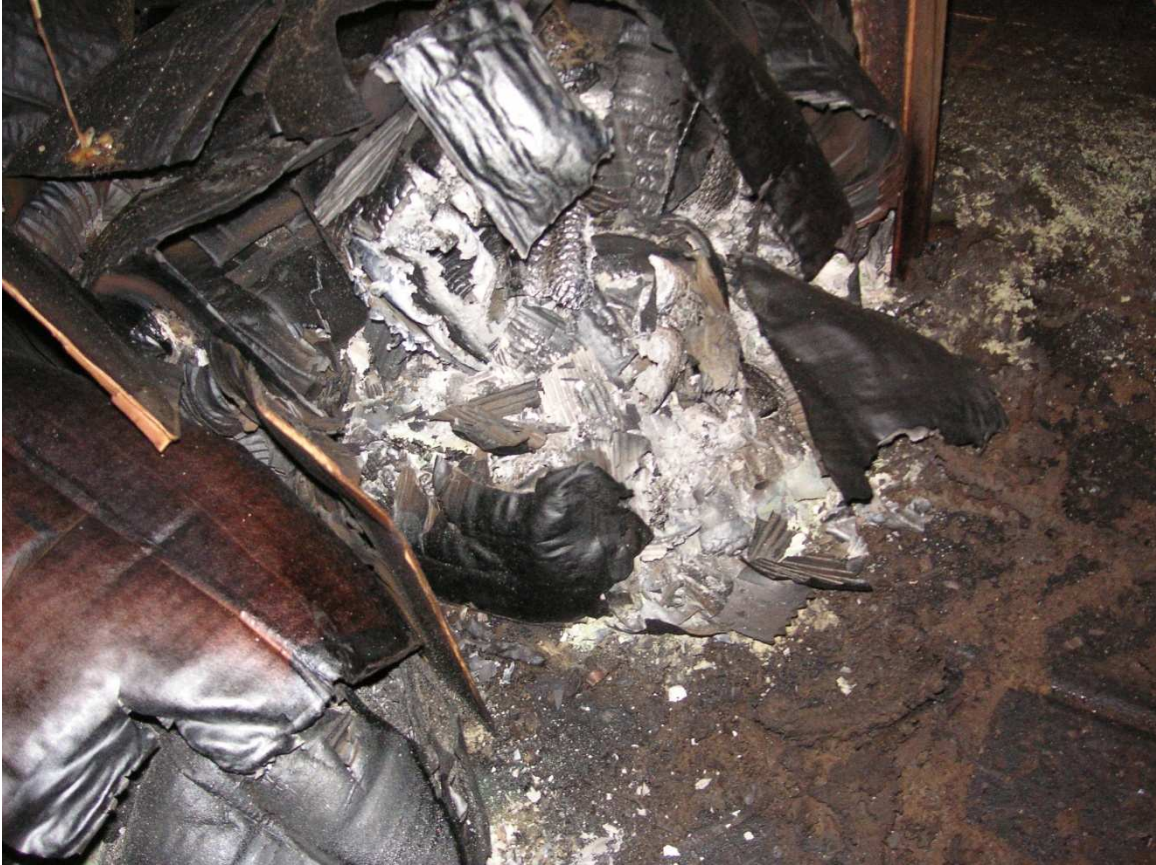
A storeroom in the accommodation on the trawl deck was damaged by an isolated fire in combustible material standing on or near the steel shelves. The steel shelves welded to the deck were exposed to heat conduction from the fire in the packing room on the 2<sup>nd</sup> deck below. Thus, the shelving system's steel structure had become so hot that it could ignite combustible materials. The fire had extinguished itself, probably due to a lack of oxygen.

Storeroom in accommodation on trawl deck

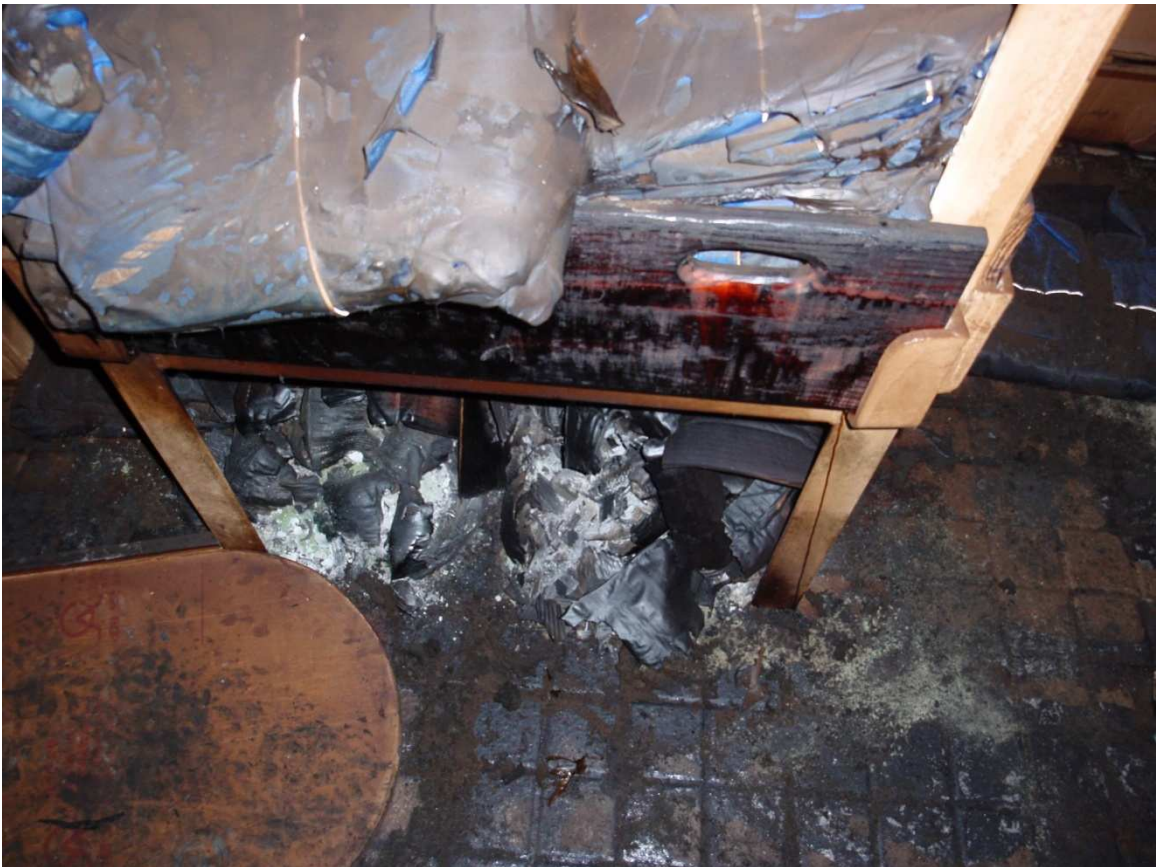
Storeroom in accommodation on trawl deck

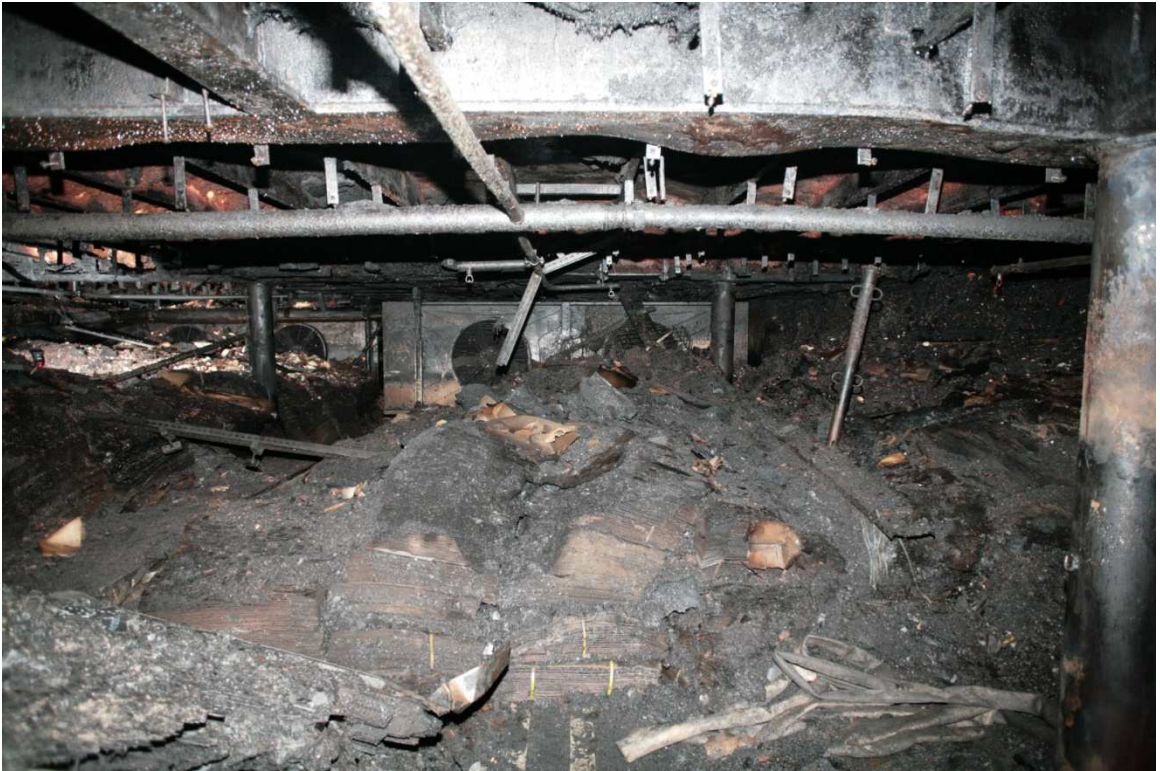
The fire caused severe fire damage to the ship's interior in the freezer hold on the 1<sup>st</sup> deck and in the packing room on the 2<sup>nd</sup> deck. Furthermore, the fire caused severe smoke and soot damage to the processing area on the 1<sup>st</sup> deck and to the entire accommodation.

Forepart of packing room on the 2<sup>nd</sup> deck

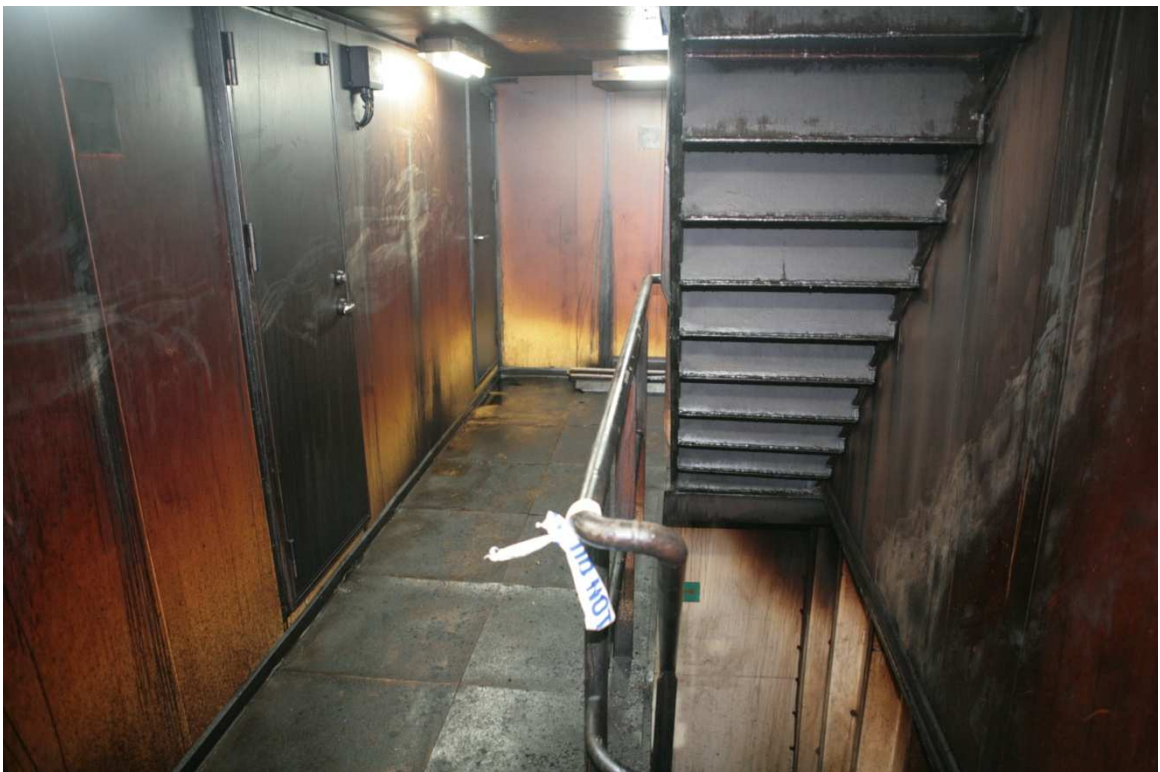
Soot damage to the accommodation
