**MARINE ACCIDENT REPORT**

**ATHENA  
Fire  
27 October 2010**

Danish Maritime Accident Investigation Board,

**Case: 201012017**

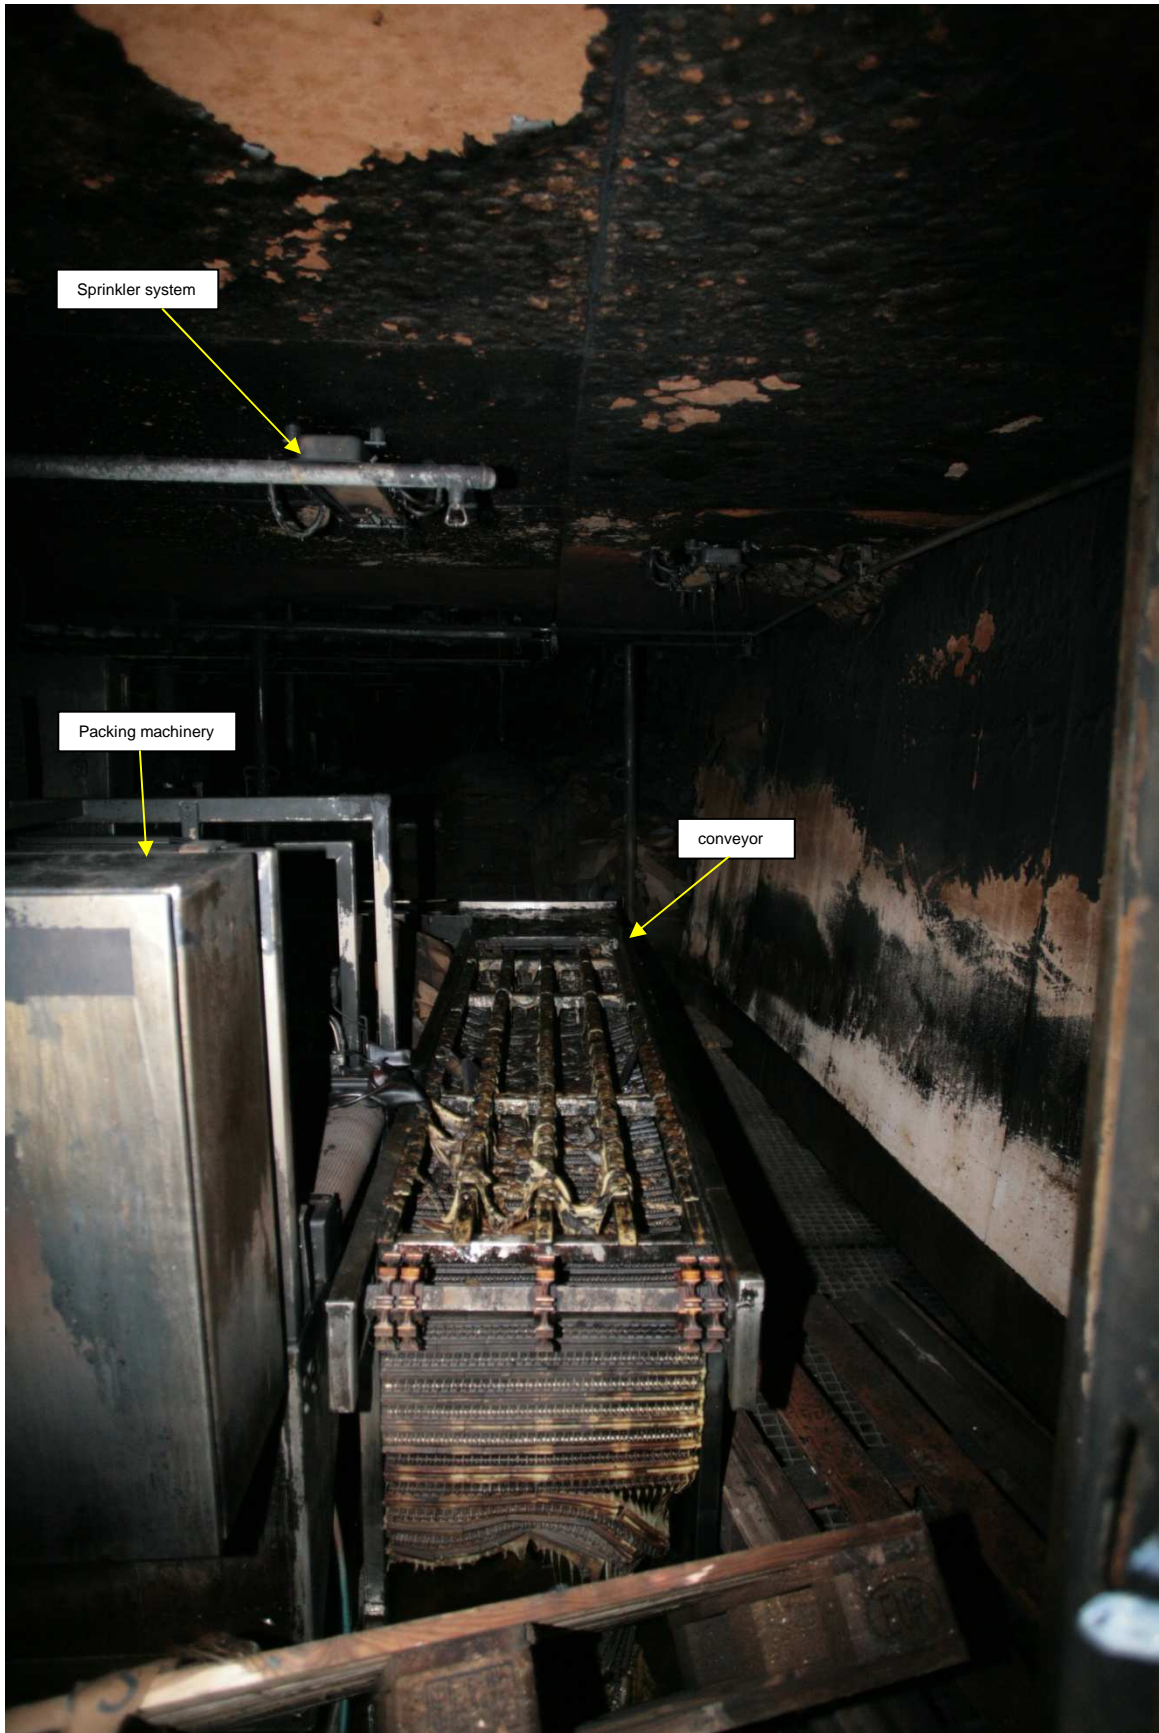
Aft part of the packing room

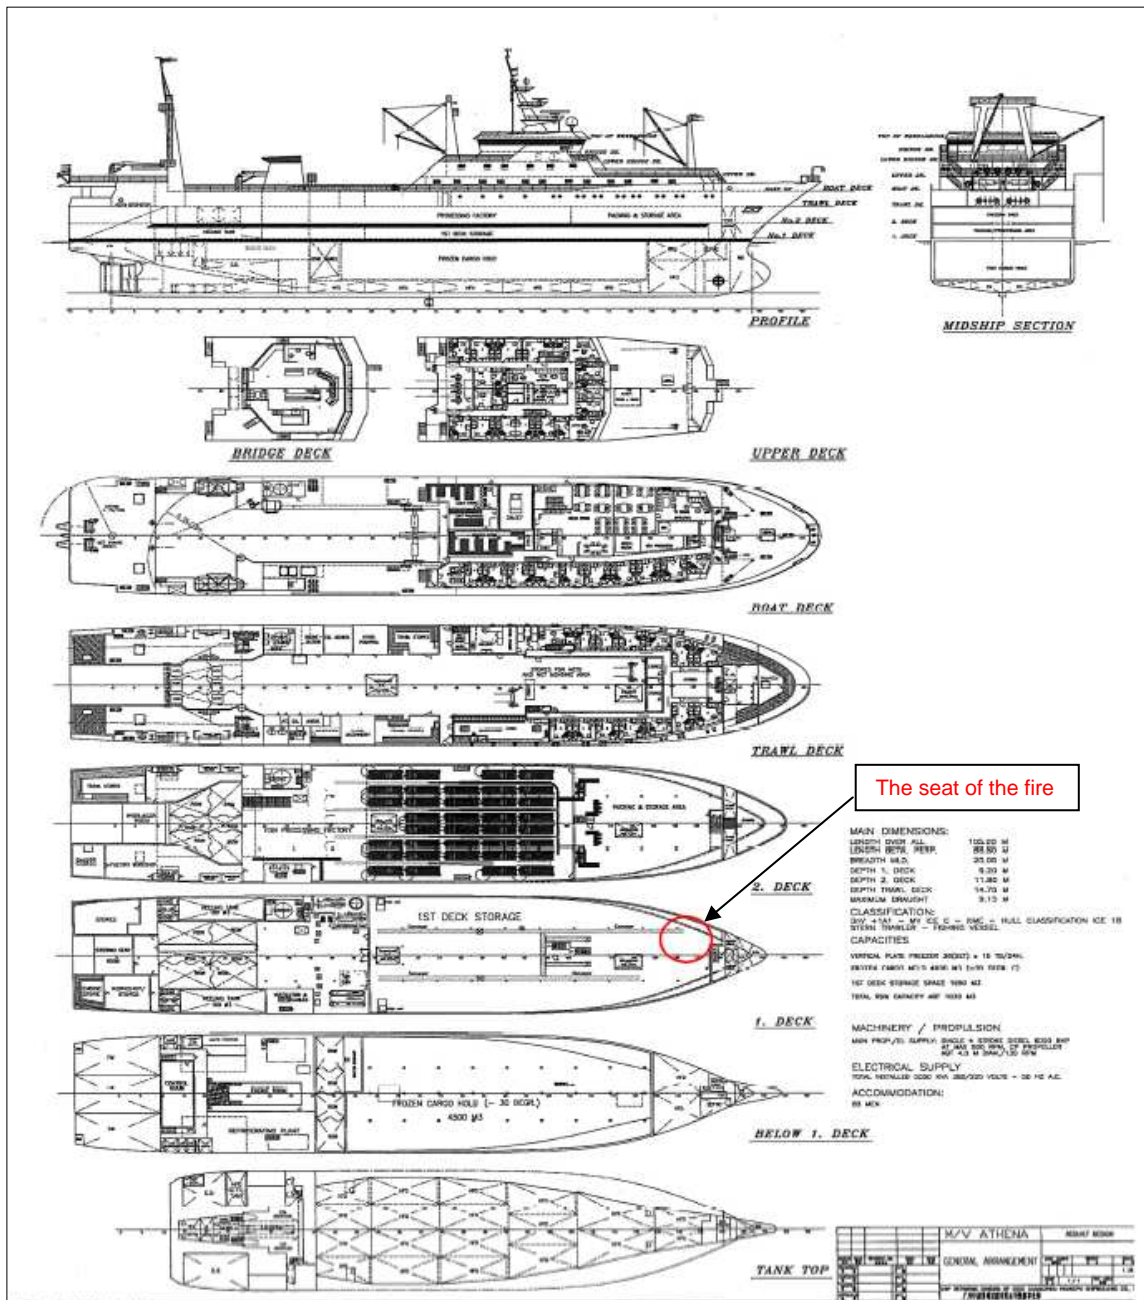
The seat of the fire shown on General Arrangement

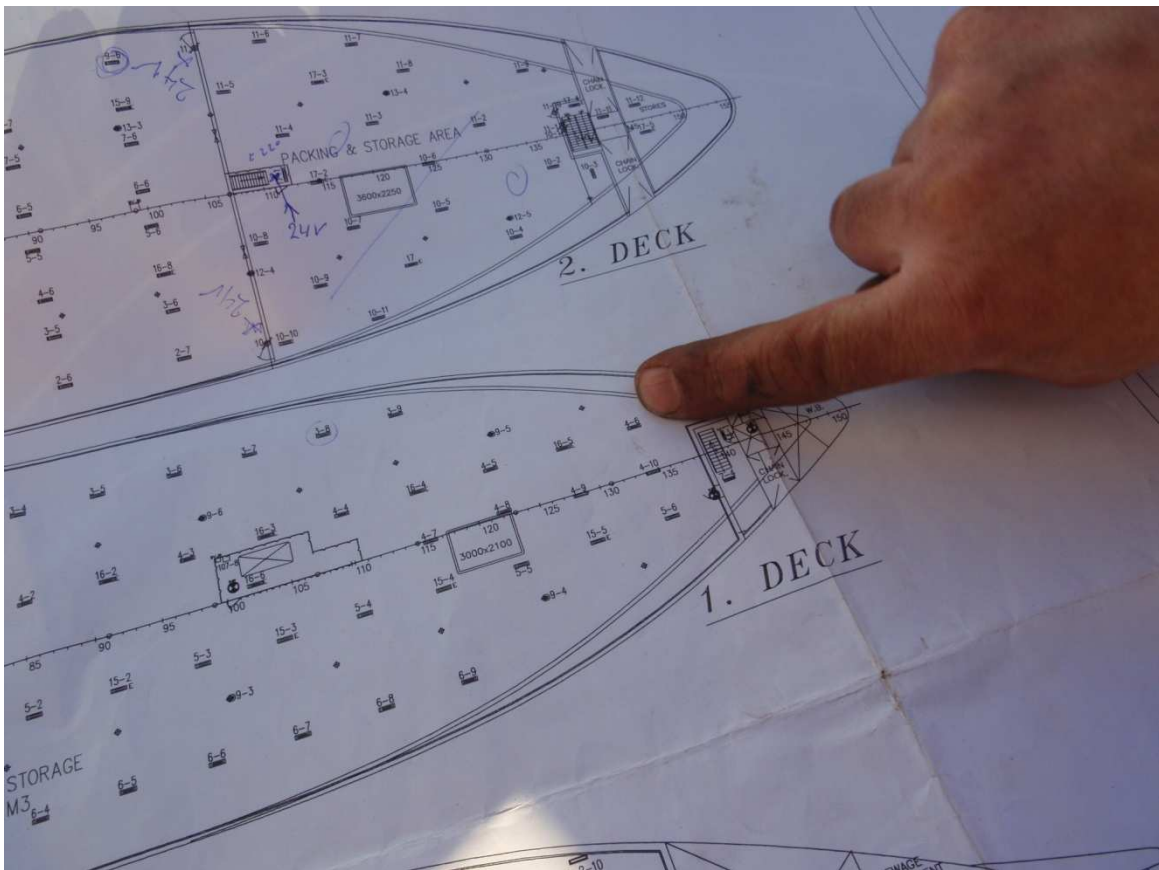
A fluorescent lamp fixture installed in the fore part on the port side of the freezer hold on the 1<sup>st</sup> deck was found to have a hole of approx. 16 x 8 mm in the housing, which was made of approx. 1 mm steel plate. The hole was created by melting as a result of electric arcs.

The seat of the fire, 1<sup>st</sup> deck forepart, the fluorescent tube fixture

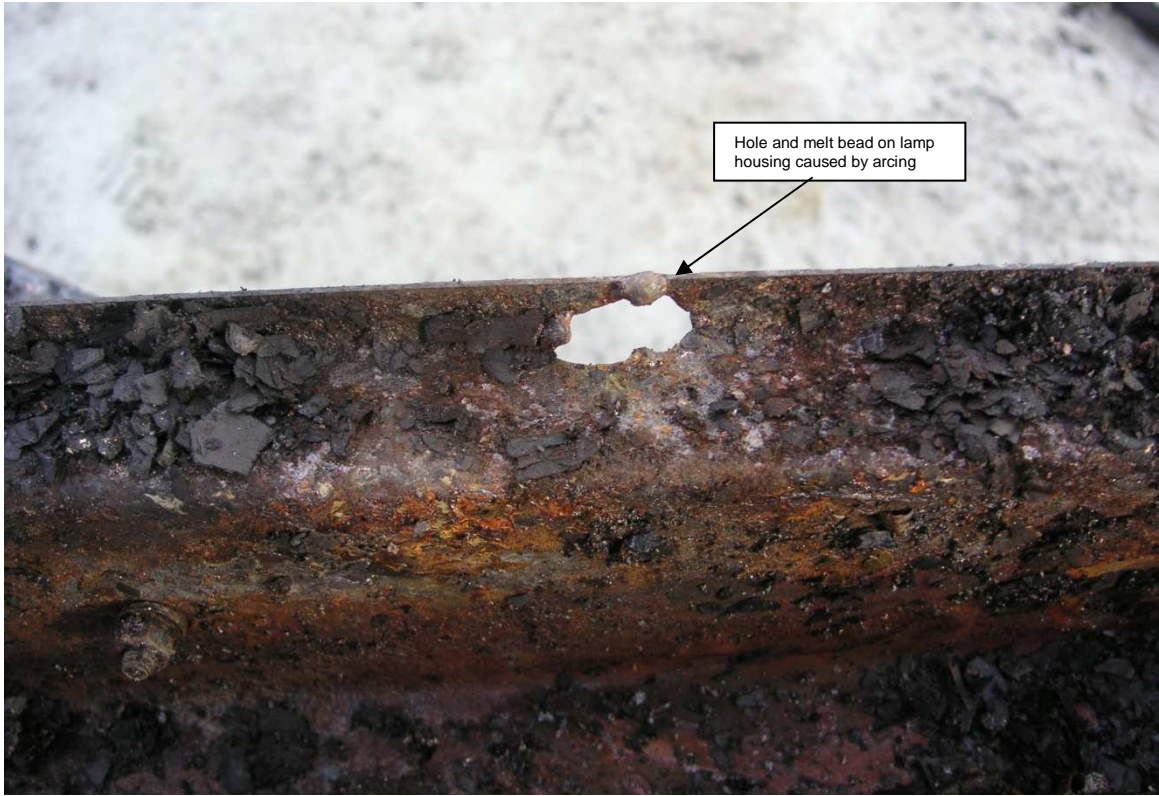
Damage to housing for fluorescent lamp fitting, caused by electric arcing

*The Investigation Board assesses that the fire originated from electrical arcs of a short circuit at a three-wire cable and a fluorescent lamp fitting. The character of the burnt hole in the lamp housing leads to the assumption that there has been a phase to phase contact near the housing of the lamp fitting, or alternatively a phase to earth contact at this point and another phase to earth fault somewhere else in the system that could not be determined.*

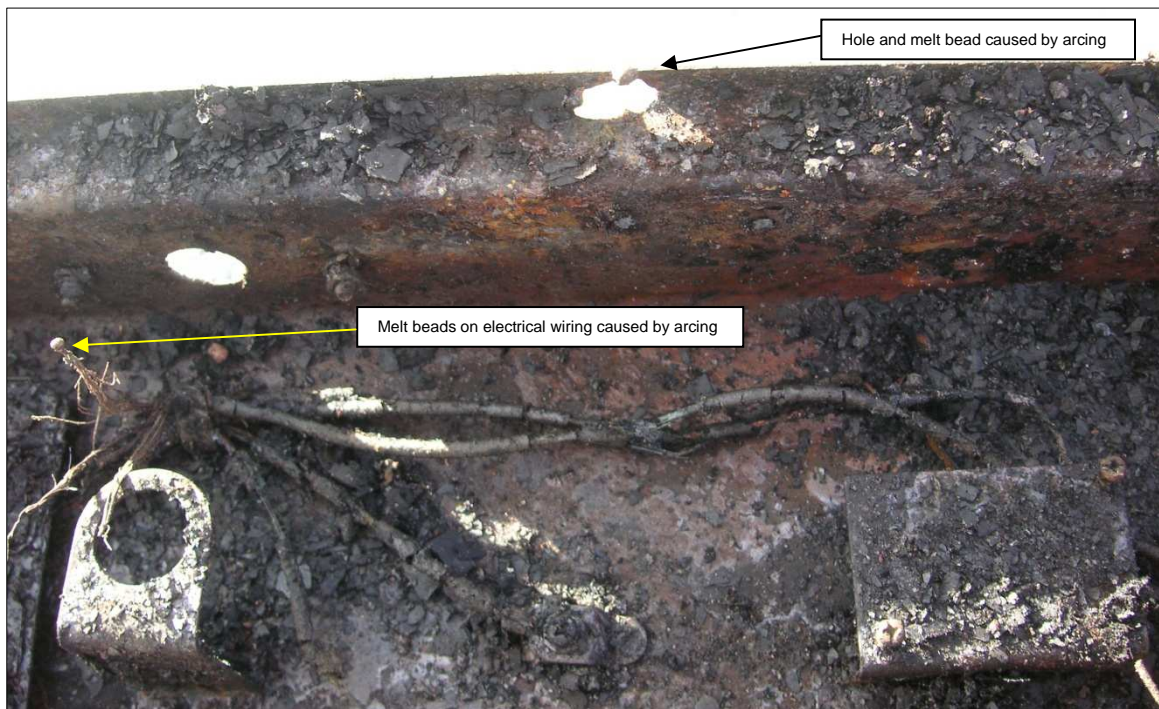
Thus, according to the team from the National Centre of Forensic Services, Crimescene Unit, Fire Investigation Section and the Danish Institute of Fire and Security Technology, the fire was most likely caused by arcs from a short circuit between a fluorescent tube fixture and a three-wire electrical cable for that fixture.

Damage to fluorescent lamp fitting, caused by electric arcing

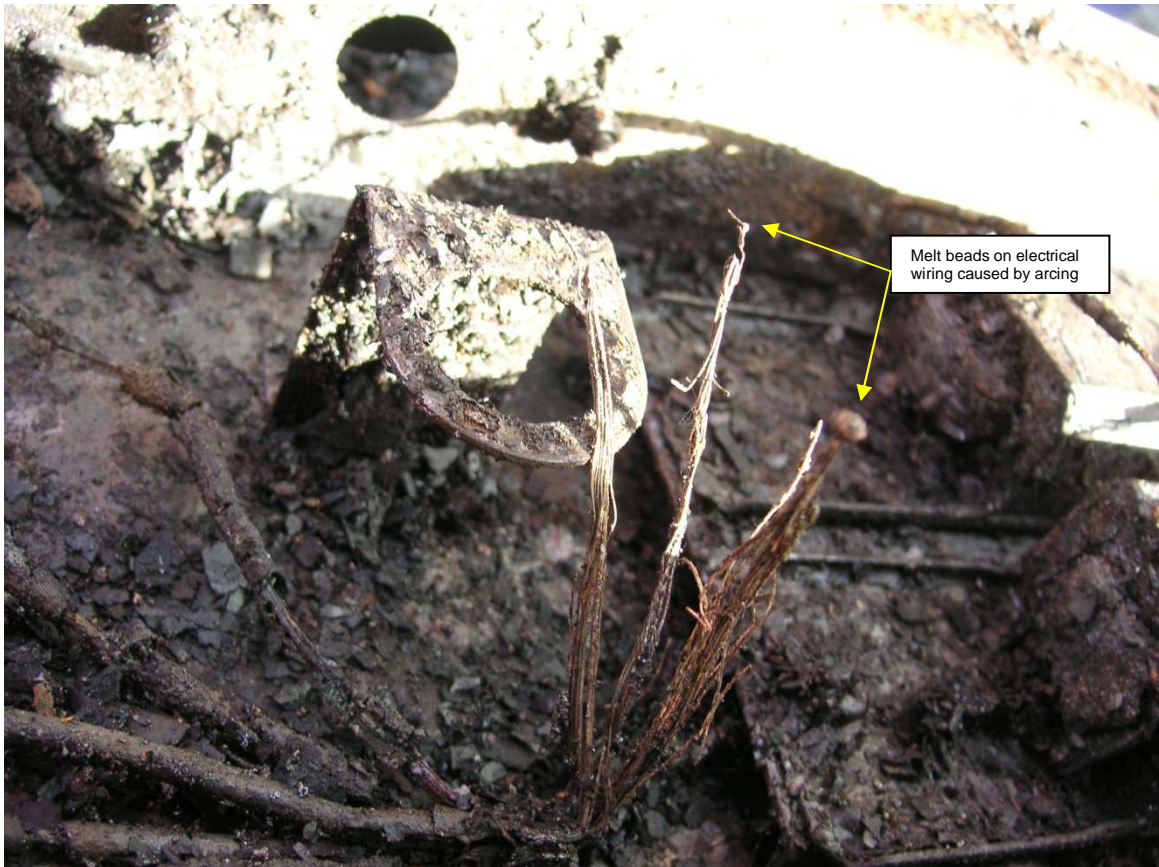
Melt beads on wiring in fluorescent tube fixture caused by arcing

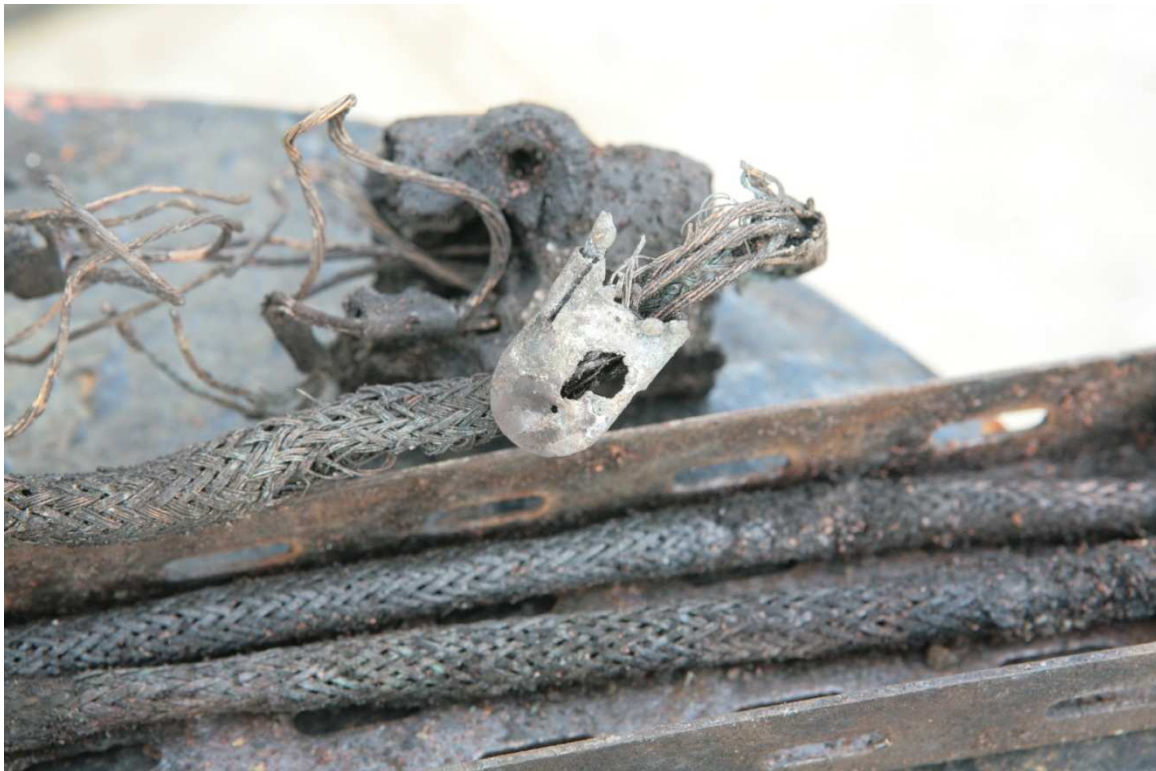
On each side of the housing, there was a junction box with a cable entry at each end in which cables were connected with wires from the fixture. In the cable leading to the fixture, there was damage to the cable metal braid, and the cable identification marking had partly melted away.

Damage to cable metal braid and cable identification marking caused by arcing

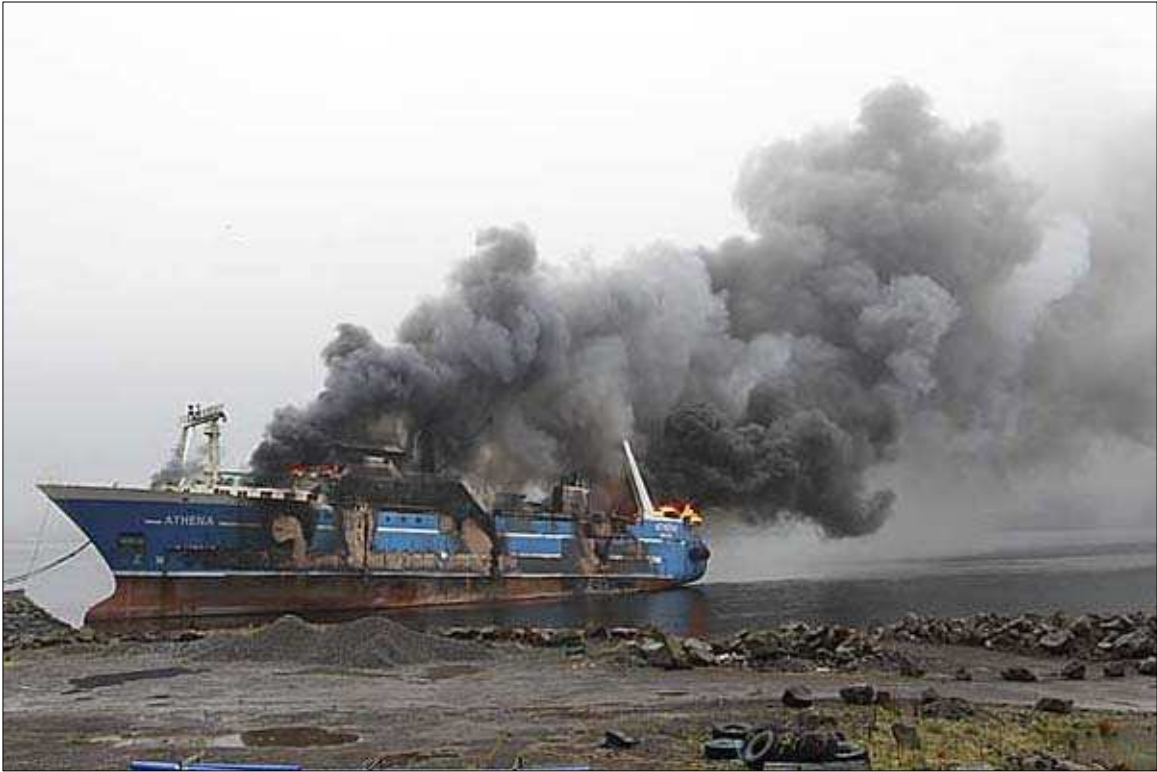
This fire was caused by chemical processes in the two-component insulation and is not subject to an investigation by this Investigation Board. It led to the total loss of the ship.

ATHENA on fire on 9 May 2011 at the Faroe Islands
