MARINE ACCIDENT REPORT

MAERSK TENDER
Fatal diving accident on 24 July
2010

The report has been issued on: 19 October 2011.

Case: 201008713

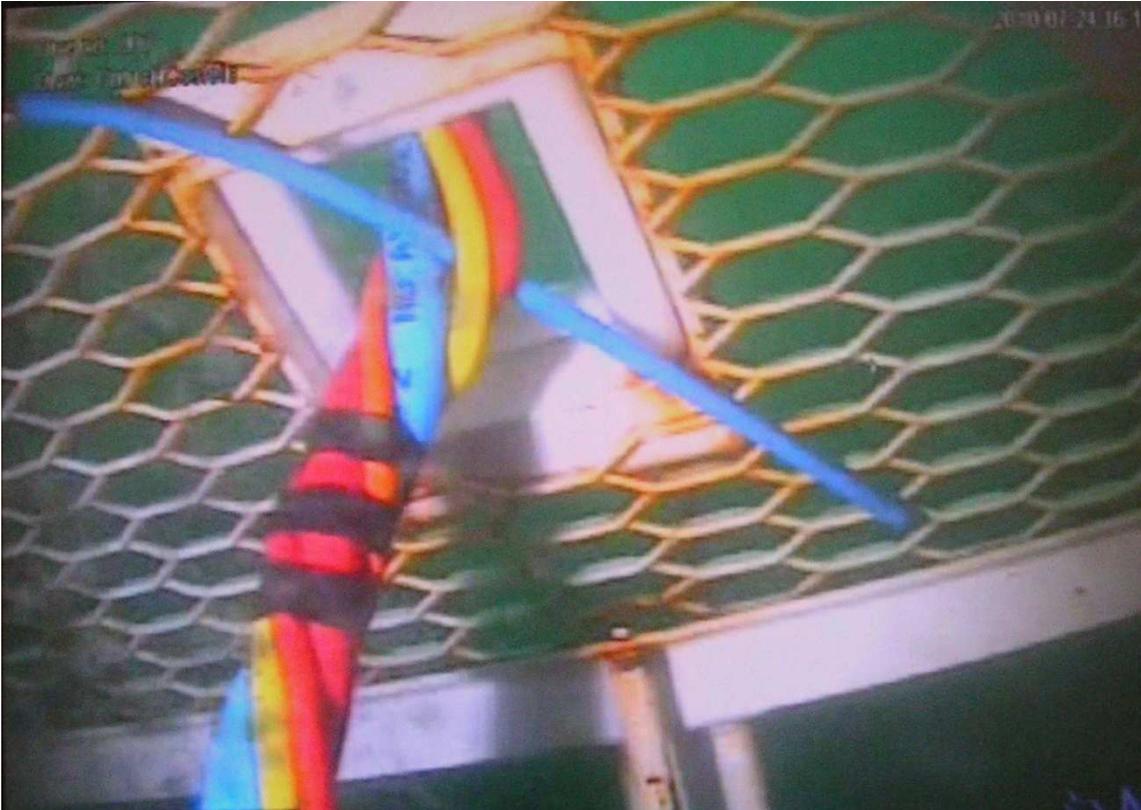
At 16:14:40, the umbilical began providing resistance to being hauled towards the basket and the diver pulled hard at it, still holding the locking pin in his hand.

The locking pin in the umbilical before being removed by the diver

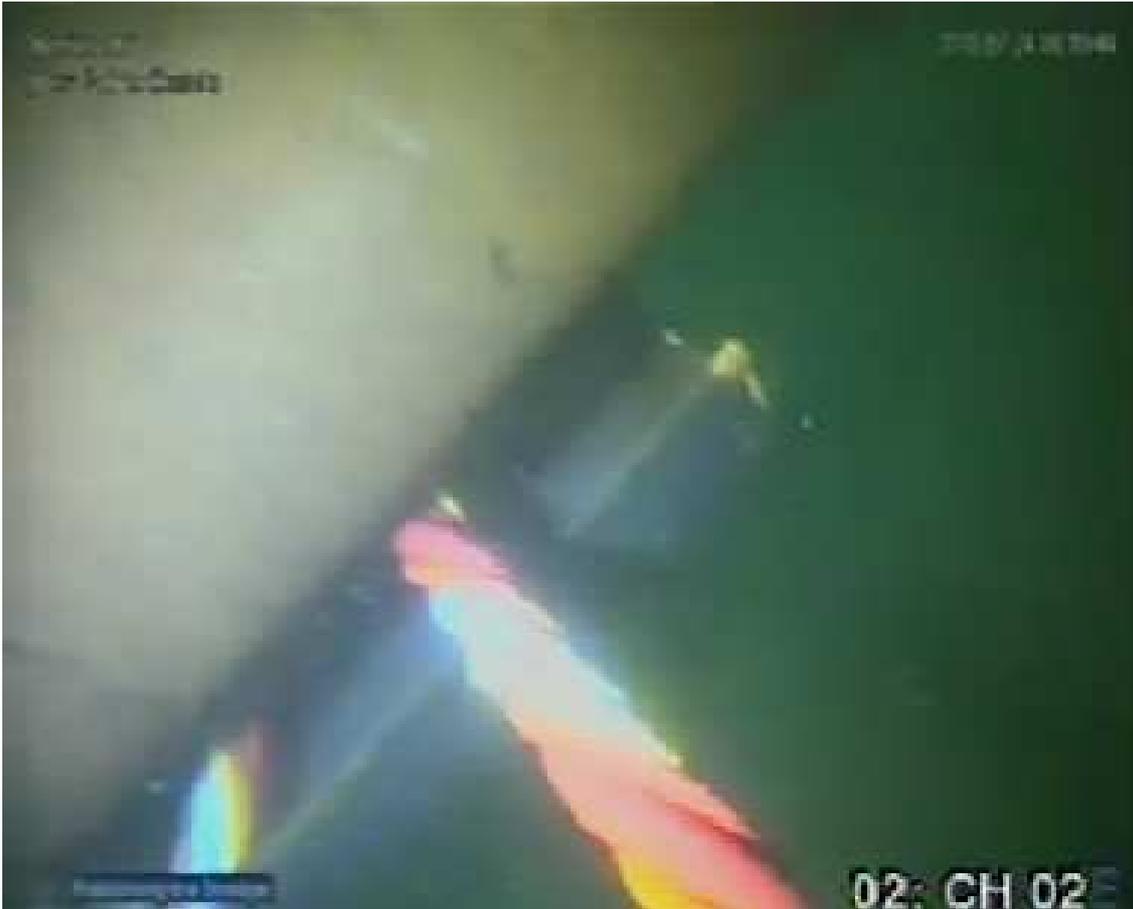
Umbilical trapped and squeezed between dredger pipe and H-girders.

He followed the umbilical 10-12 metres for approximately 10 seconds until he reached the dredger pipe. At the dredger pipe, he found the umbilical entangled making a loop between the dredger pipe and the upper end of the two H-girders hanging in shackles below the dredger pipe (see picture above).

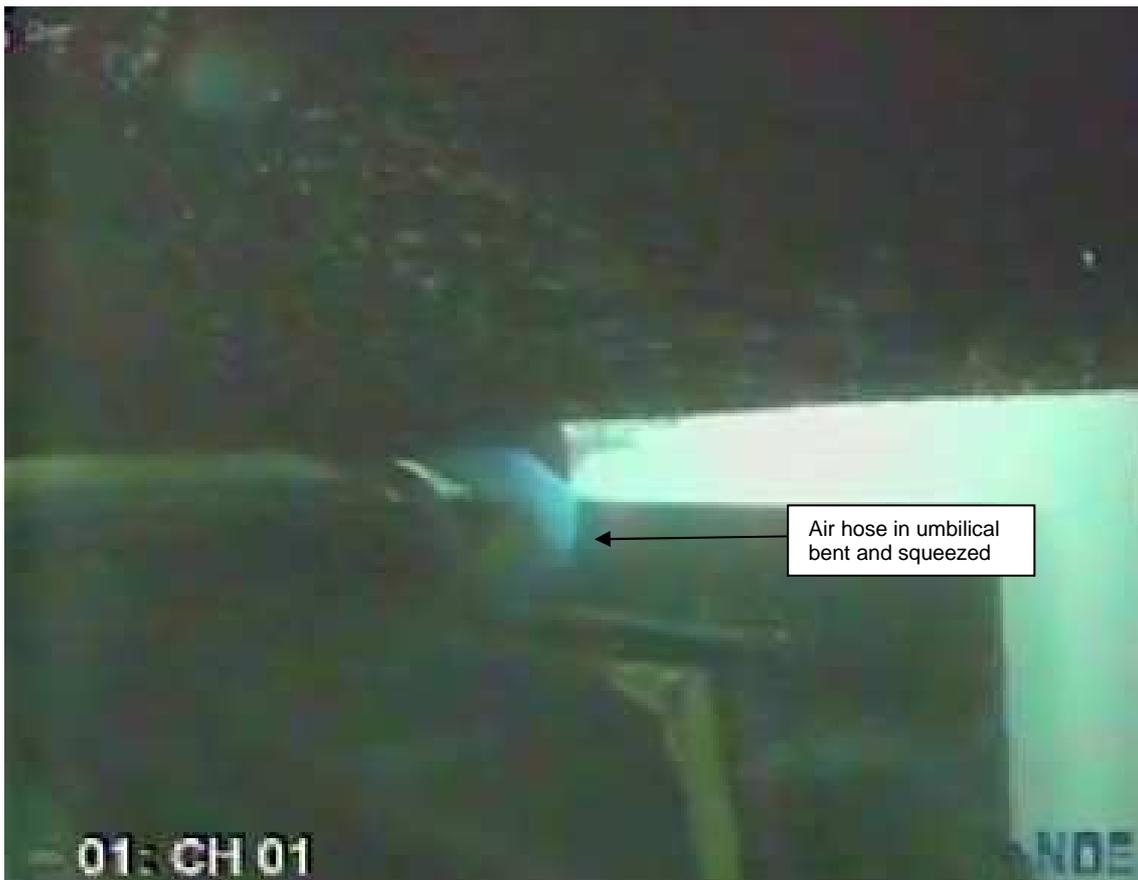
The air hose of the umbilical squeezed between dredger pipe and H-girders. Photos: screen shot from DVR recorder

At 16:25:57, the standby diver reached and grabbed the umbilical that was entangled between the dredger pipe and H-girders. He tried to loosen the umbilical by hand and shouted repeatedly during the following 20 seconds to the diving supervisor to lift the dredger pipe.

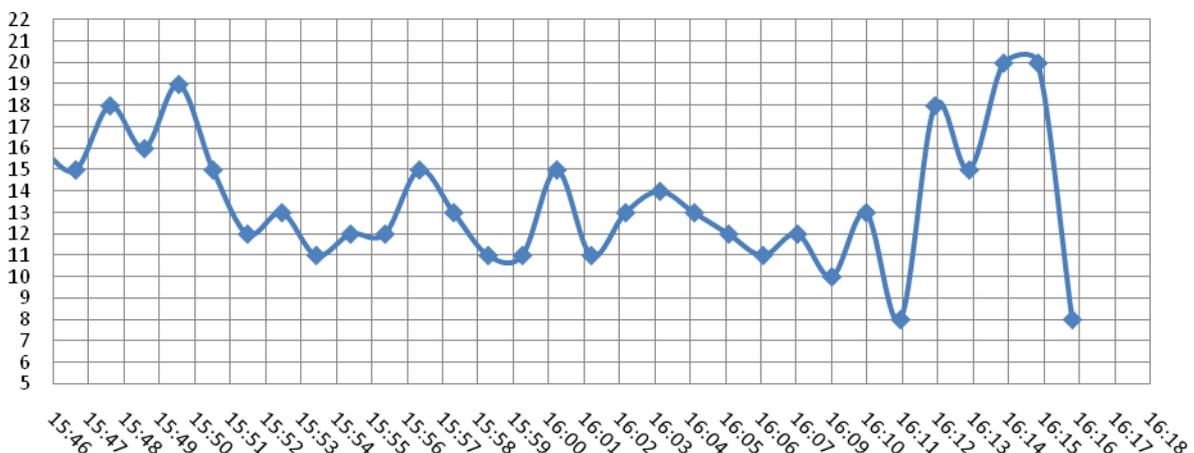
- *the diver's increase of breaths after having passed the dredger pipe on his way back to the diving basket was caused by an emerging shortage of air supply which in turn was caused by the squeezed umbilical (6.1).*

While he was working on the seabed, from approximately 15:52 until approximately 16:11, his breath varied between 10 and 15 per minute. This can be interpreted as a sign of good physical fitness.

When the diver began following his umbilical back to his basket from approximately 16:12, his breath increased remarkably until 16:16 (see graph).

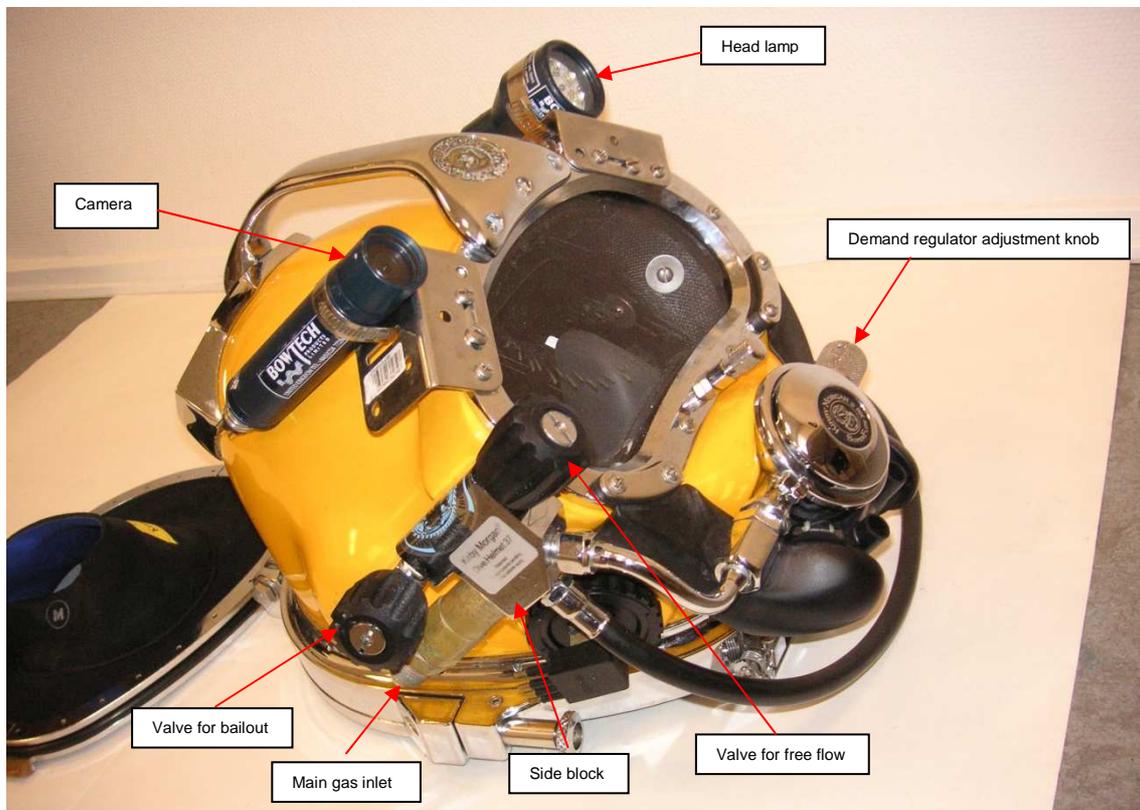
The dive helmet.

The examination revealed no defects in the helmet's air distribution system. When the demand regulator was examined, the regulator adjustment knob was found approximately in the middle position. Six turns on the knob were needed to set it for maximum breath resistance and eight and a half turns were needed to set it for minimum breath resistance. No statements indicate that the setting of the adjustment knob had been touched after the accident.

At the request of the Investigation Division, the dive helmet was examined by the Diving School of the Royal Danish Navy to establish the condition of its communication system. The examination revealed that the microphone and earphone wiring was made of a non-original terminal strip but the connection was correct.

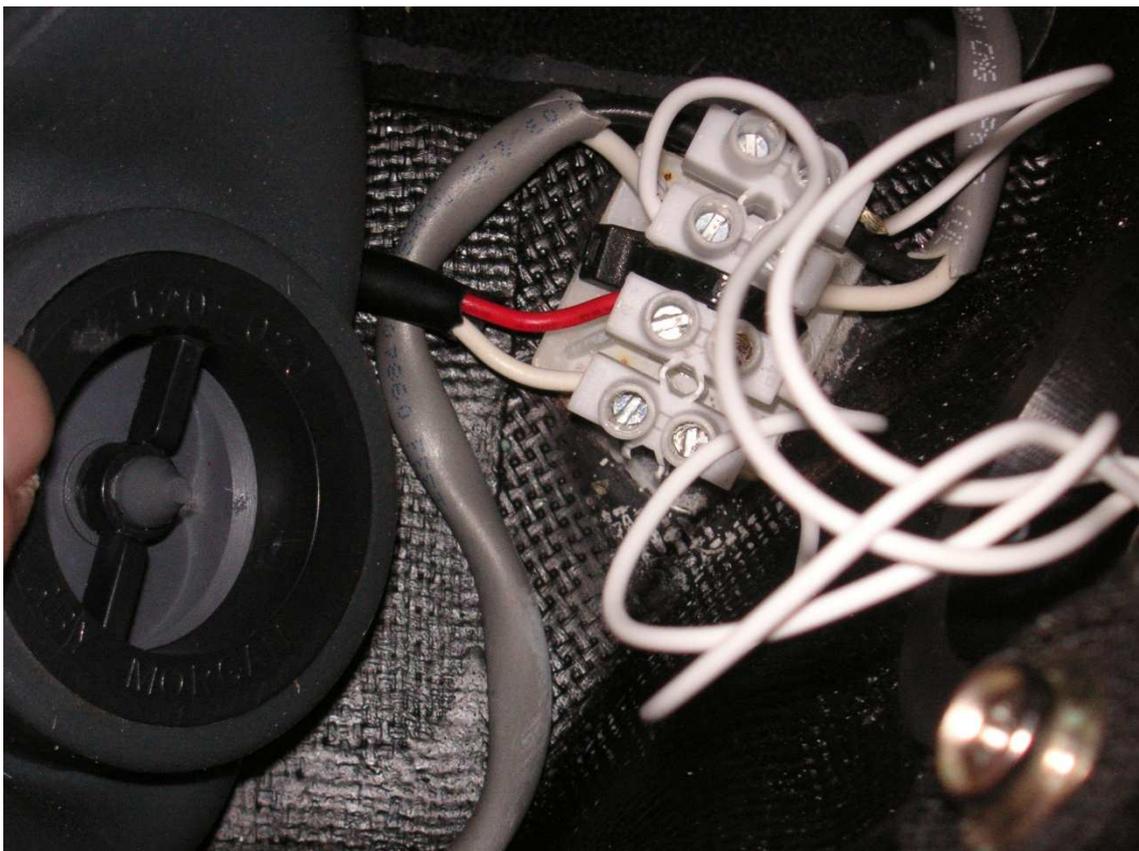
6. With a wrongly connected 4-wire system (where the microphone is connected to the earphone wires and the earphones are connected to the microphone wires), the problem starts when the diver has put his hat liner on and then puts on the helmet. When he is still on the surface the communication can be perceived as a bit unclear but still ok for both the diver when spoken to by the dive control (supervisor) and vice versa.

When the diver then goes below the surface, the problem occurs to its full magnitude. The diver must try to hear what is communicated to him through the microphone (which is placed in the nasal mask) and the supervisor must try to hear what the diver says through the earphones which are covered by the hat liner.

Wiring of the ear and head phones in the dive helmet.

The malfunctioning communication system was caused by wrongly conducted repair work on dive helmets and an inadequate test procedure.
