Danish Maritime Accident Investigation Board

MARINE ACCIDENT REPORT
December 2013

EMMA MÆRSK

Flooding of engine room on 1 February 2013

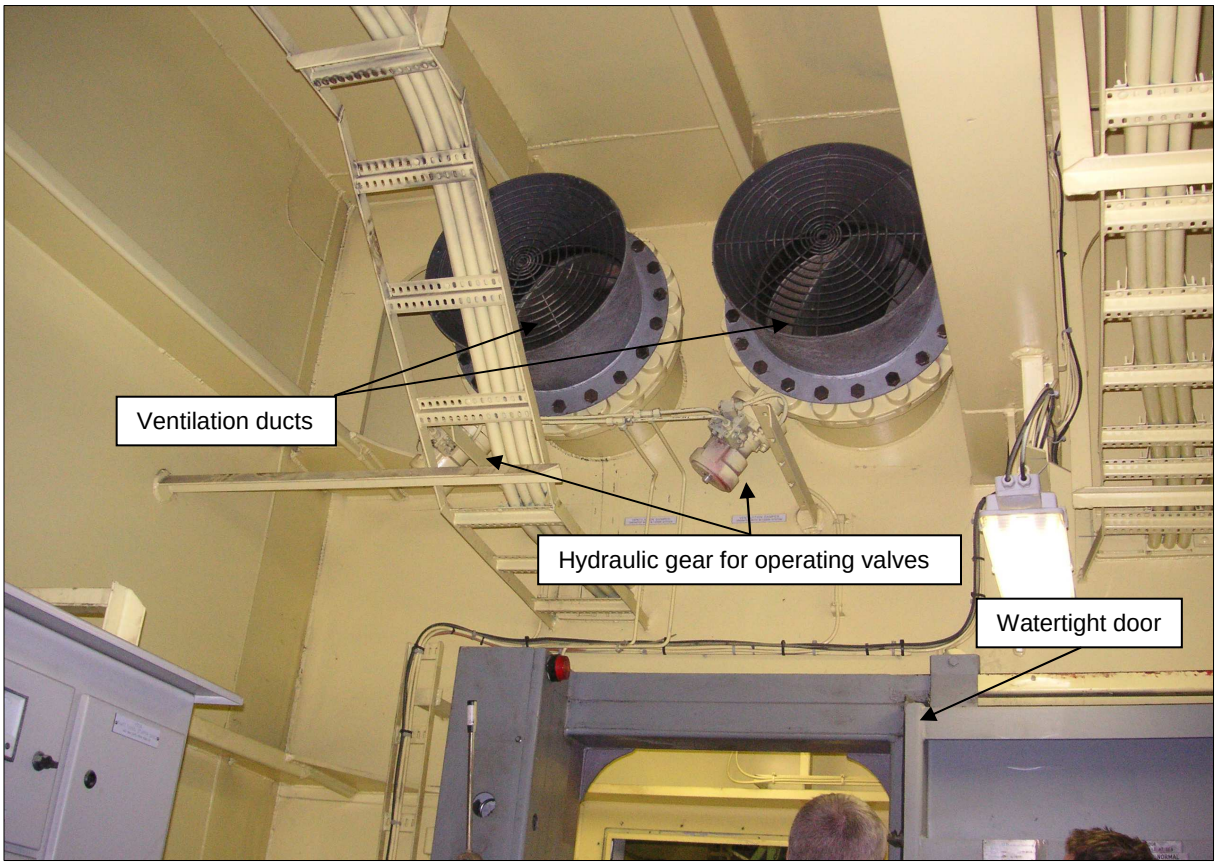
Figures 12: Hydraulically operated valves in ventilation ducts passing through the watertight bulkhead above the watertight door in a sister ship, viewed from the shaft tunnel
Source: DMAIB

Above the watertight door, there were two air ducts each of 600 mm diameter that went through the bulkhead for ventilation of the shaft tunnel. For each air duct there was a hydraulically operated valve fitted at the aft side of the bulkhead. The valves were remotely operated from the engine control room and the ship control centre at the deck office. They could not be operated locally. The position of the air ducts in the watertight bulkhead is shown on figure 12 on page 15.

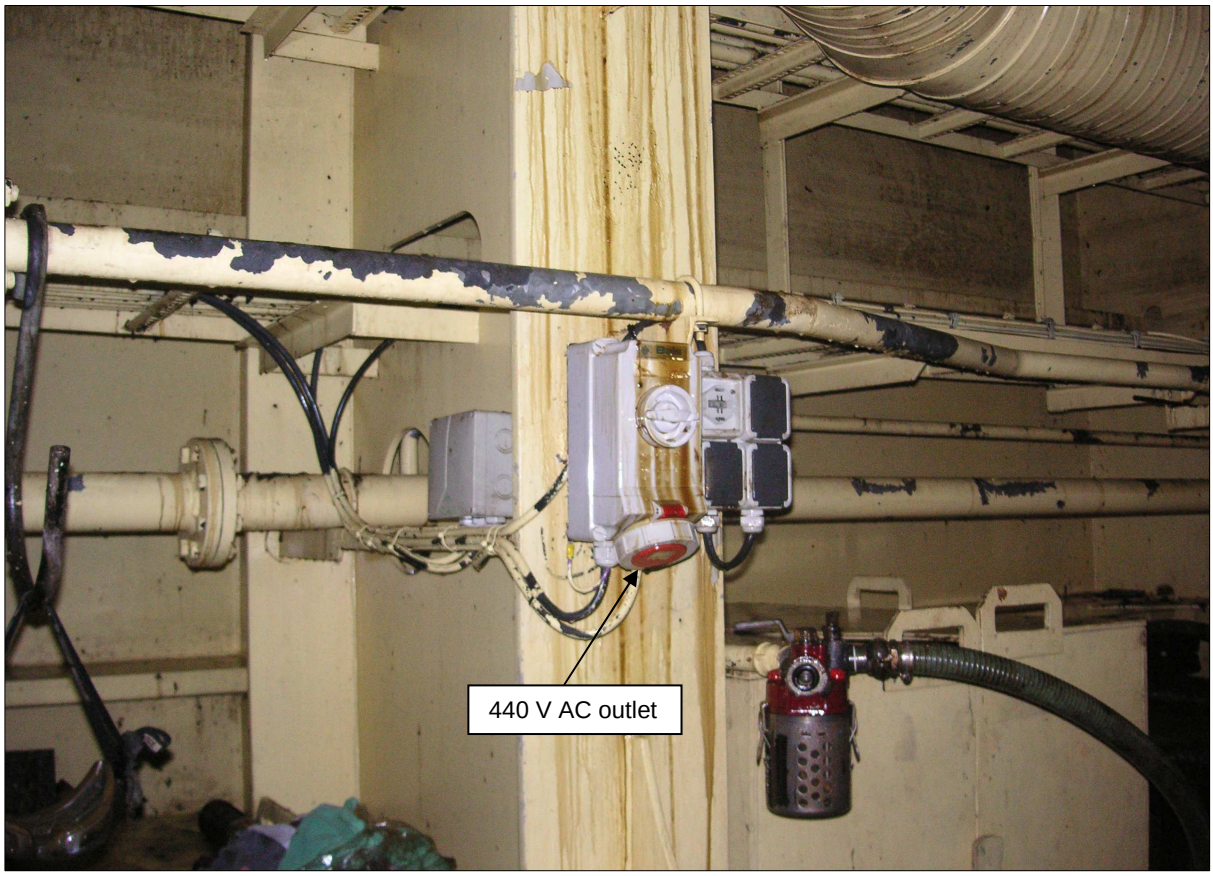
At about 2205 hours, a 3rd engineer, who was standing at the aft part of the main engine watching the situation develop, became aware that water unexpectedly began flowing from a 440 volt AC outlet at the port side of the engine room some five or six metres from the watertight bulkhead (figure 15 below).

Figure 15: 440 volt AC outlet from which seawater began flowing out
Source: DMAIB

As the 3rd engineer investigated this unexpected scenario, he heard a sudden blast and saw one of four cable penetration sealings in the watertight bulkhead give way to the water pressure followed by a massive ingress of seawater. A few moments later, the other three cable penetration sealings also failed which resulted in an even larger ingress of water into the engine room.

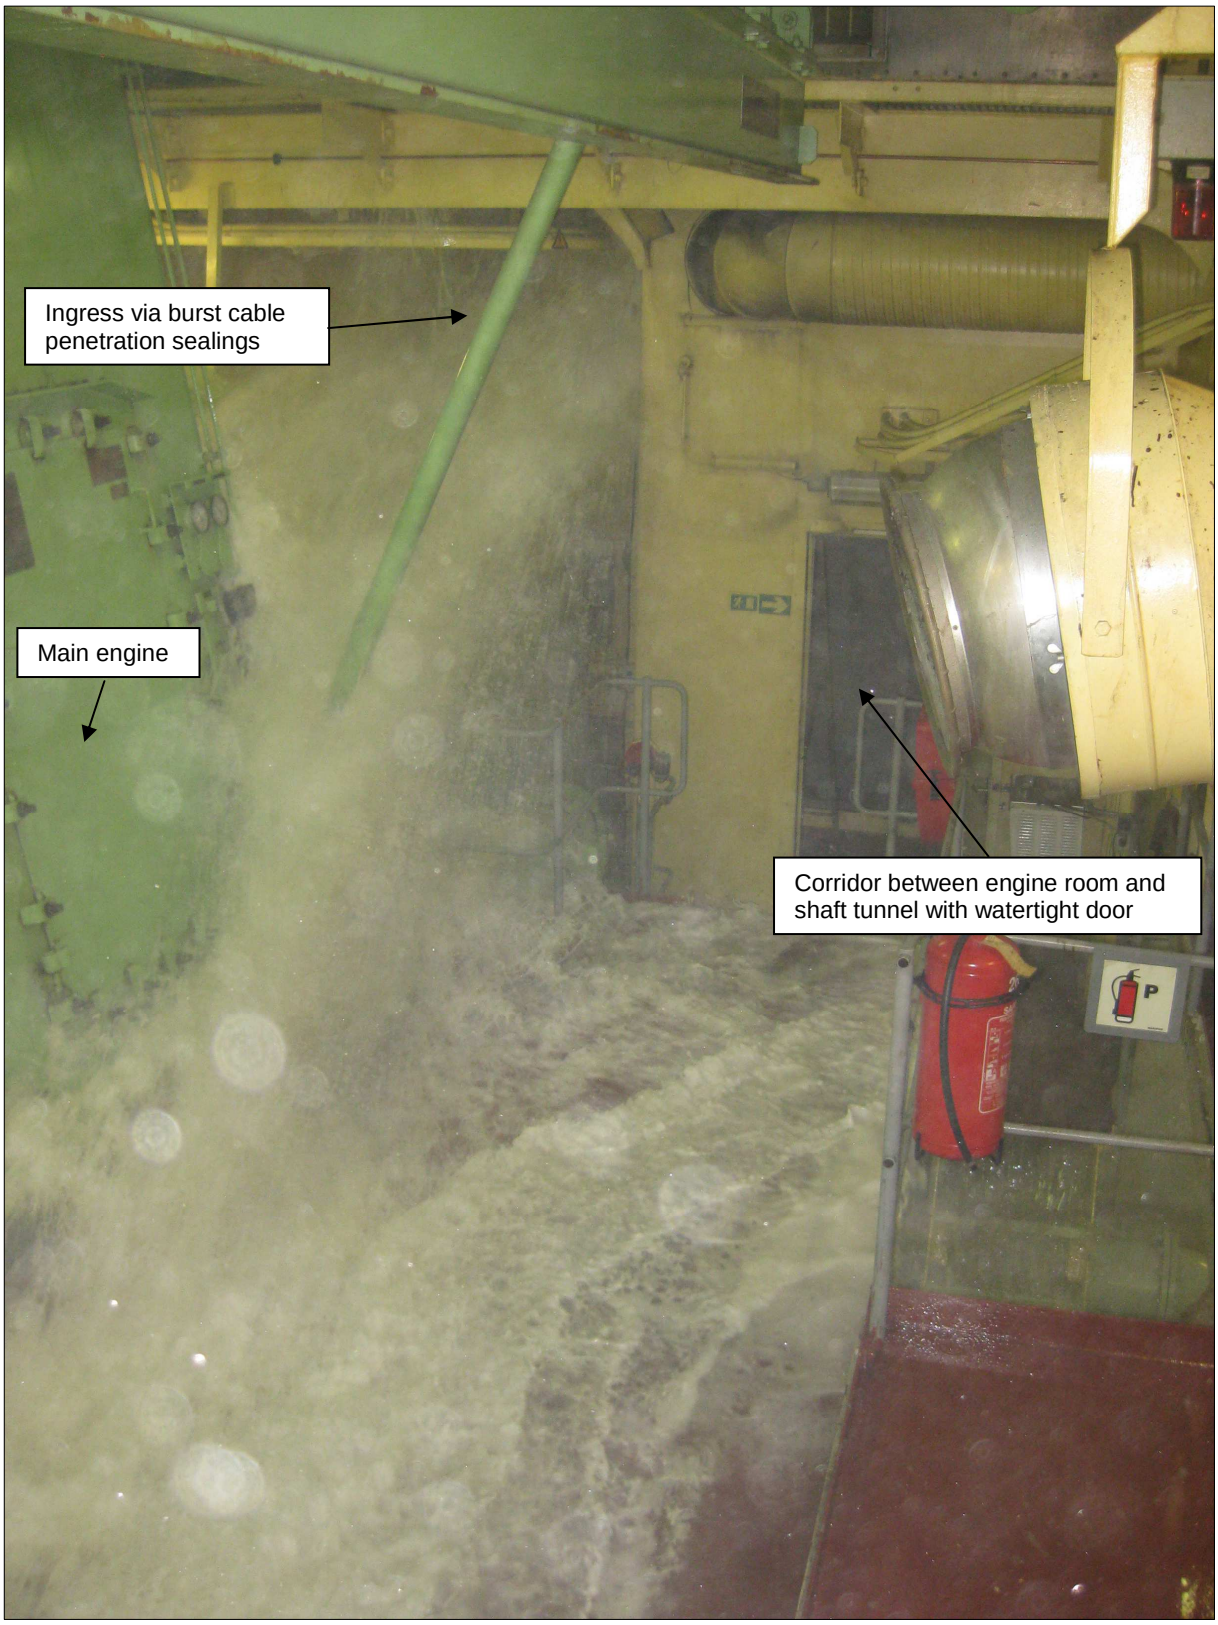
Figure 17: Seawater ingress from propeller shaft tunnel into the main engine room via burst cable penetration sealings in the watertight bulkhead, viewed from the port side of the engine room
Source: Maersk Line

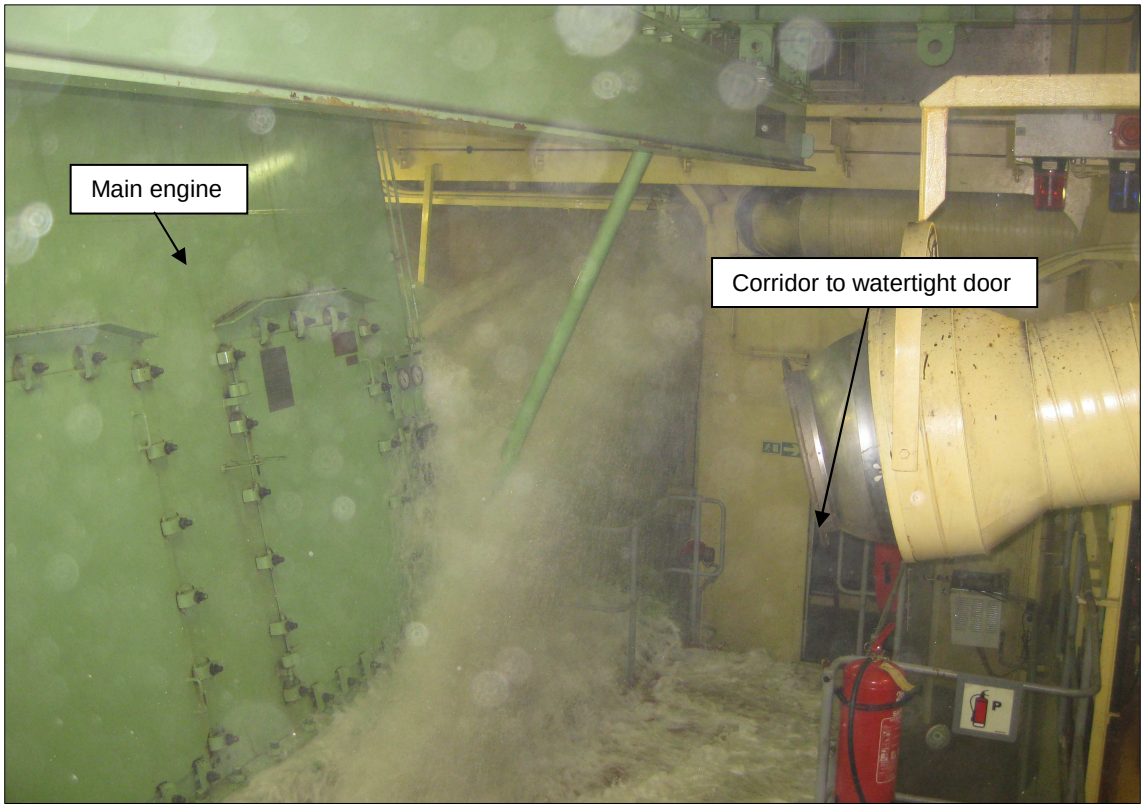
Figure 18: Seawater ingress from propeller shaft tunnel into the main engine room via burst cable penetration sealings in the watertight bulkhead, viewed from the port side of the engine room
Source: Maersk Line

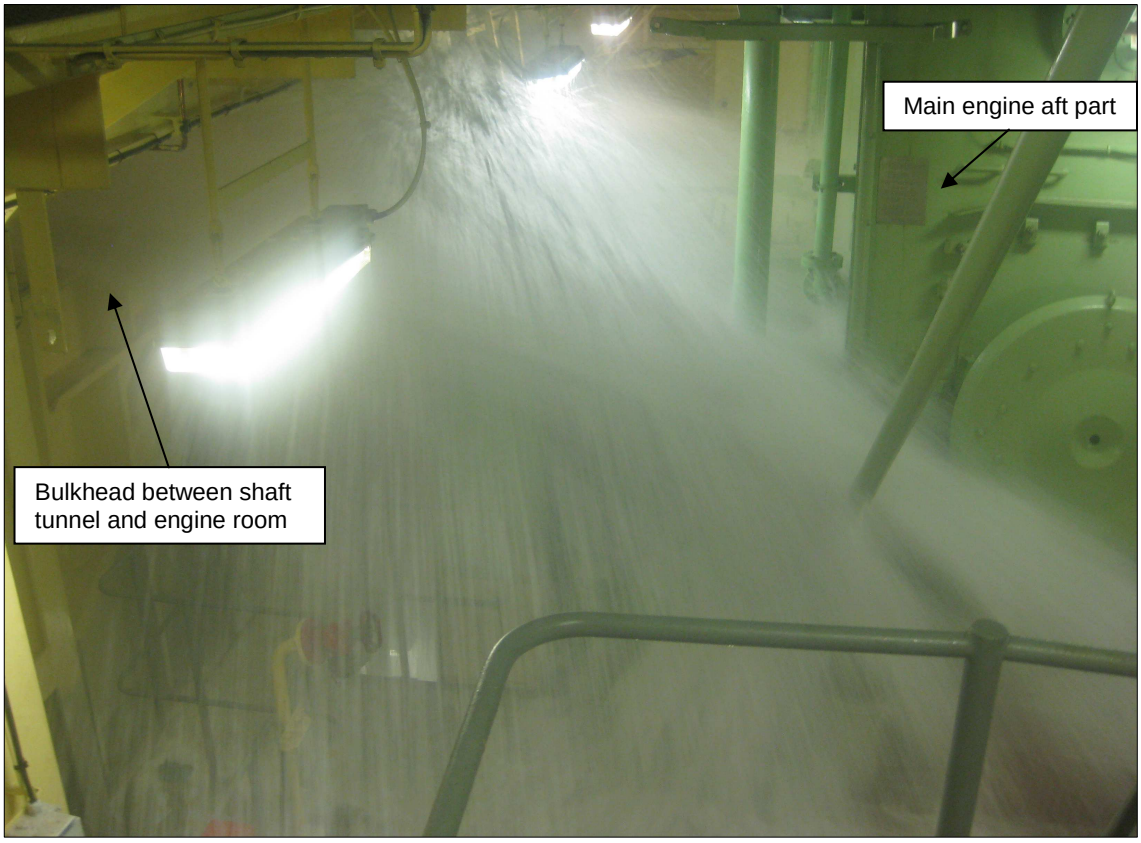
Figure 19: Seawater ingress from propeller shaft tunnel into the main engine room via burst cable penetration sealings in the watertight bulkhead, viewed from the starboard side of the engine room
Source: Maersk Line

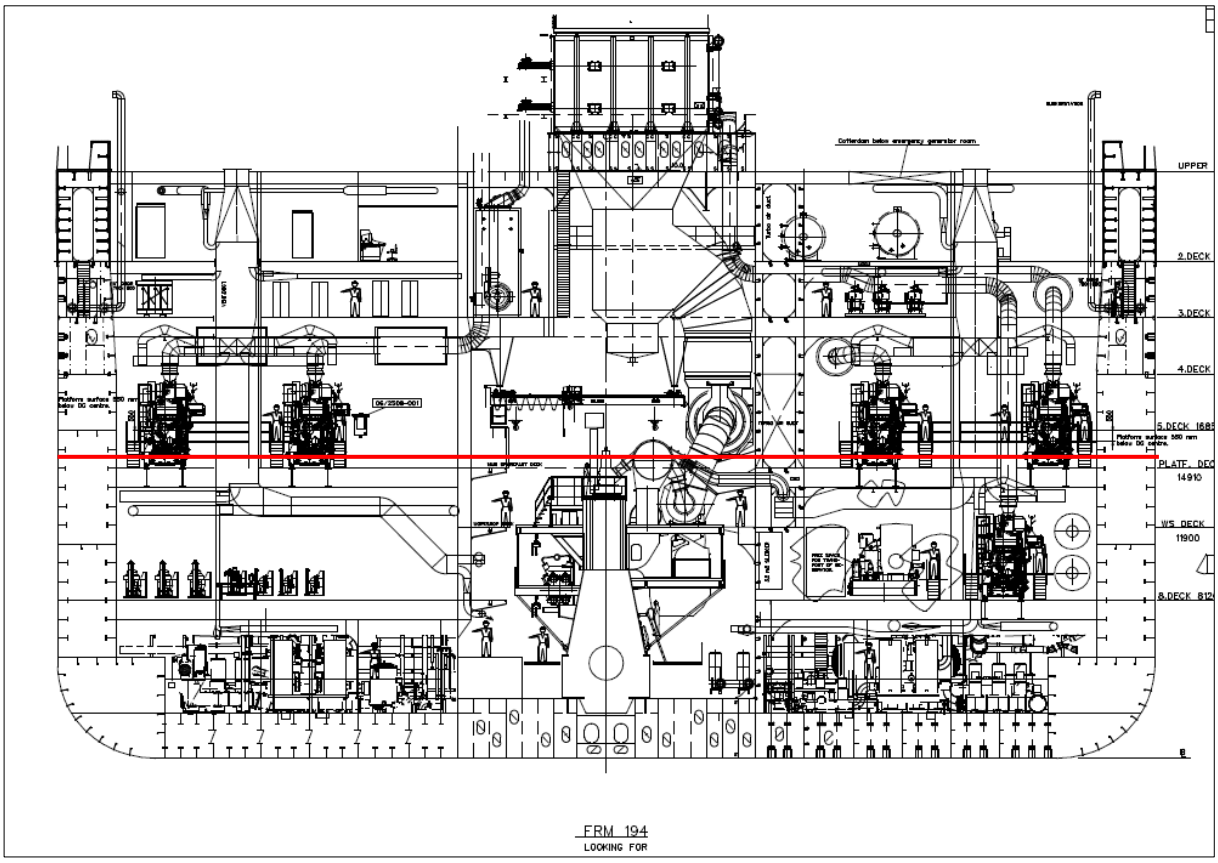
Figure 22: Transverse section of the engine room with a red line indicating the maximum water level
Source: Maersk Line

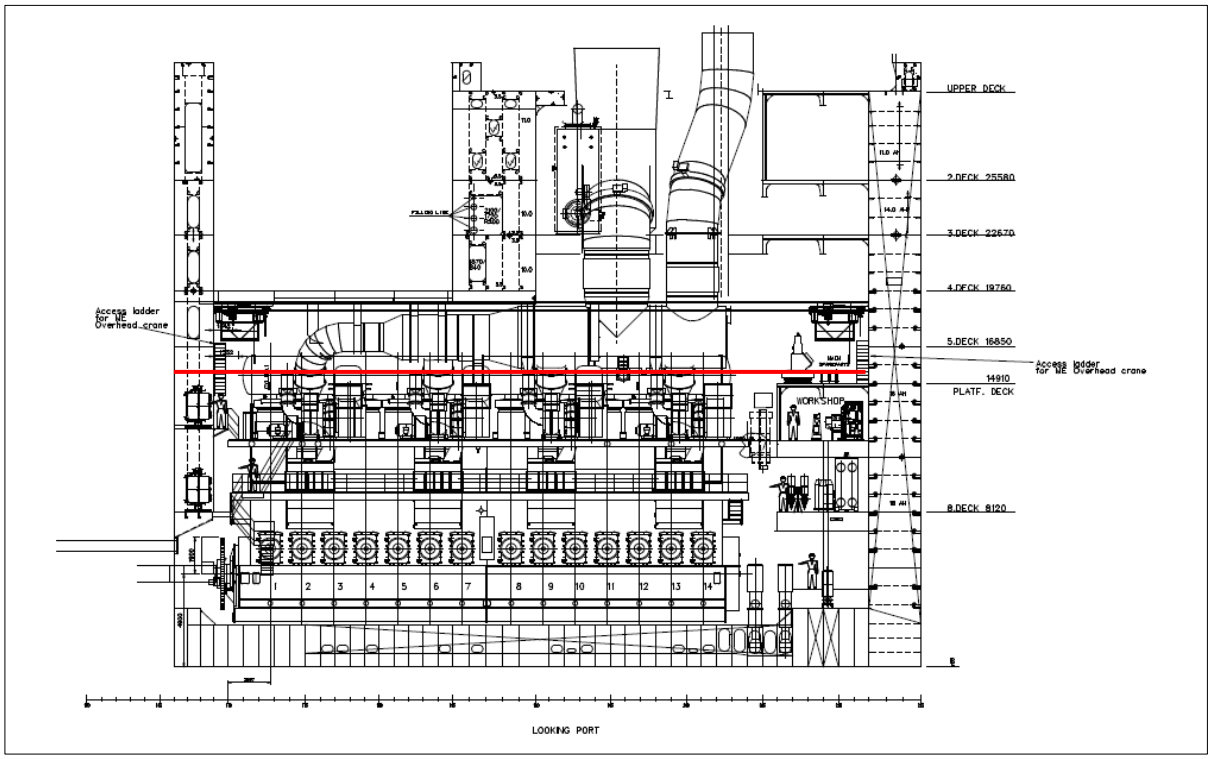
Figure 23: Longitudinal section of the engine room with a red line indicating the maximum water level
Source: Maersk Line

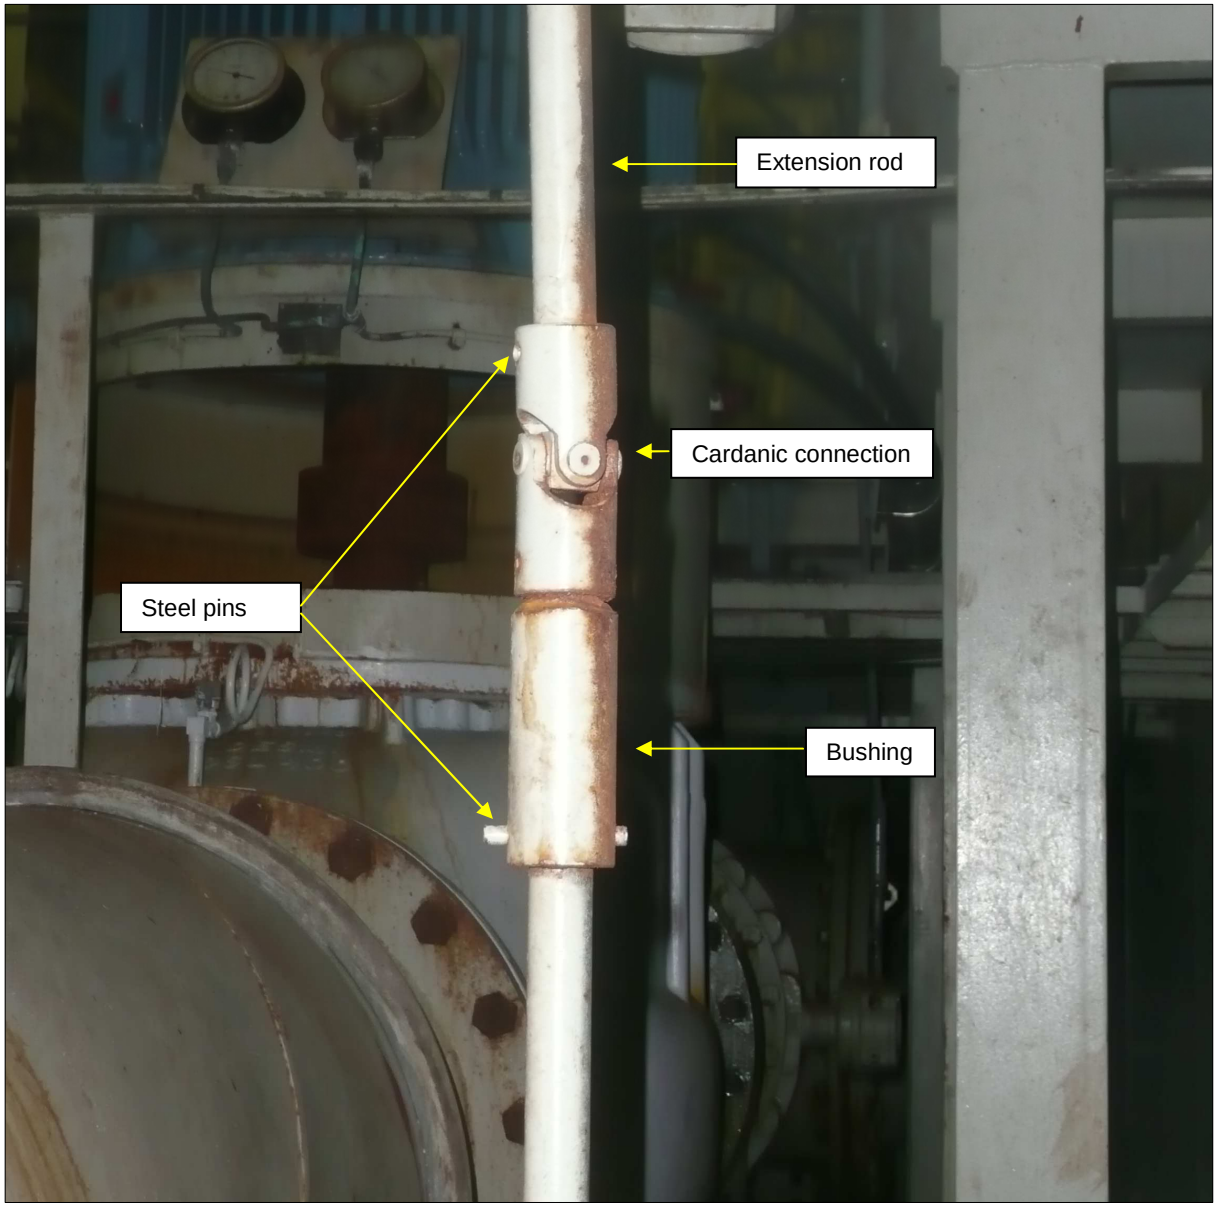
The emergency bilge suction valve provides direct suction from the engine room tank top. The opening of the suction valve was supposed to be carried out manually by a large handwheel just above the floor plate (figure 28 on page 28). The suction valve was situated just above the tank top and its spindle was connected to the handwheel by an extension rod (figure 29 on page 28) fitted to the valve spindle by a cardanic connection, the bushing of which was locked to the rod with steel pins (figure 27 below).

When operating the handwheel, a steel pin broke and the handwheel could not be used. The engineer then crawled under the floor plates and used a wrench to open the valve while standing on the tank top in water to the knees.

Figure 27: Extension rod with a cardanic connection fitted with a bushing and steel pins, in a sister ship and of the same type and principles as in EMMA MÆRSK
Source: DMAIB

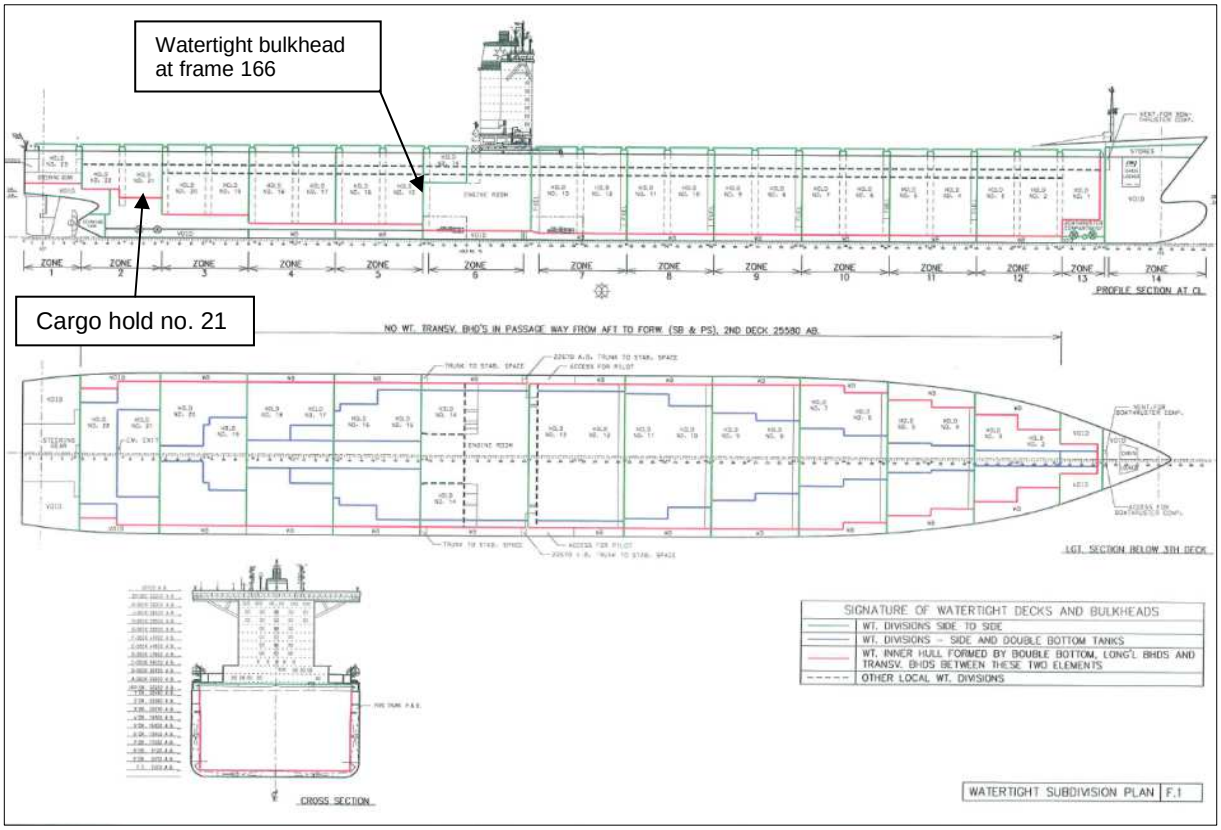
The bulkhead between the engine room and the shaft tunnel, situated at frame no. 166, was designed, constructed, approved and relied on as a watertight bulkhead (figures 30 and 31 on page 30).

This bulkhead had not been constructed to meet the ship's damage stability conditions, but rather to limit the needed capacity of the CO_2 fire extinguishing plant. It was not compulsory according to SOLAS regulations.

Even though not prescribed and necessitated by the ship's damage stability conditions, the bulkhead's watertight integrity was a major factor for the ship's damage stability. And in case of a leakage into the compartments aft of the engine room, the intactness of this watertight bulkhead was of the utmost importance to the ship's ability to operate.

Figure 30: The ship's watertight subdivision and watertight bulkhead at frame No. 166
Source: The ship's damage stability booklet

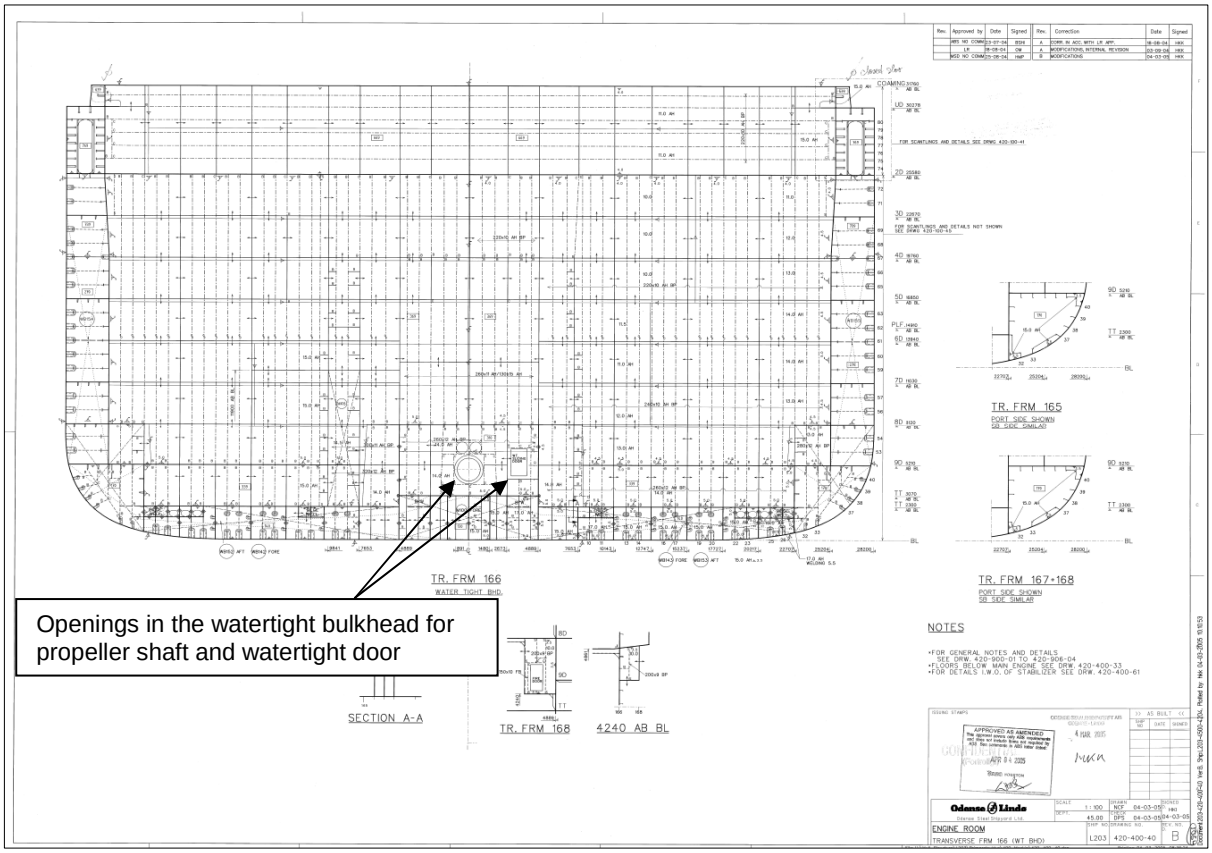
There were six cable penetrations in the watertight bulkhead: Four for electric high voltage power supply for the shaft motors, and two for other purposes, one of which above and one of which below the watertight door. These cable penetrations are dealt with separately in the next section.

Figure 31: Watertight bulkhead at frame No. 166 viewed from fore
Source: ABS

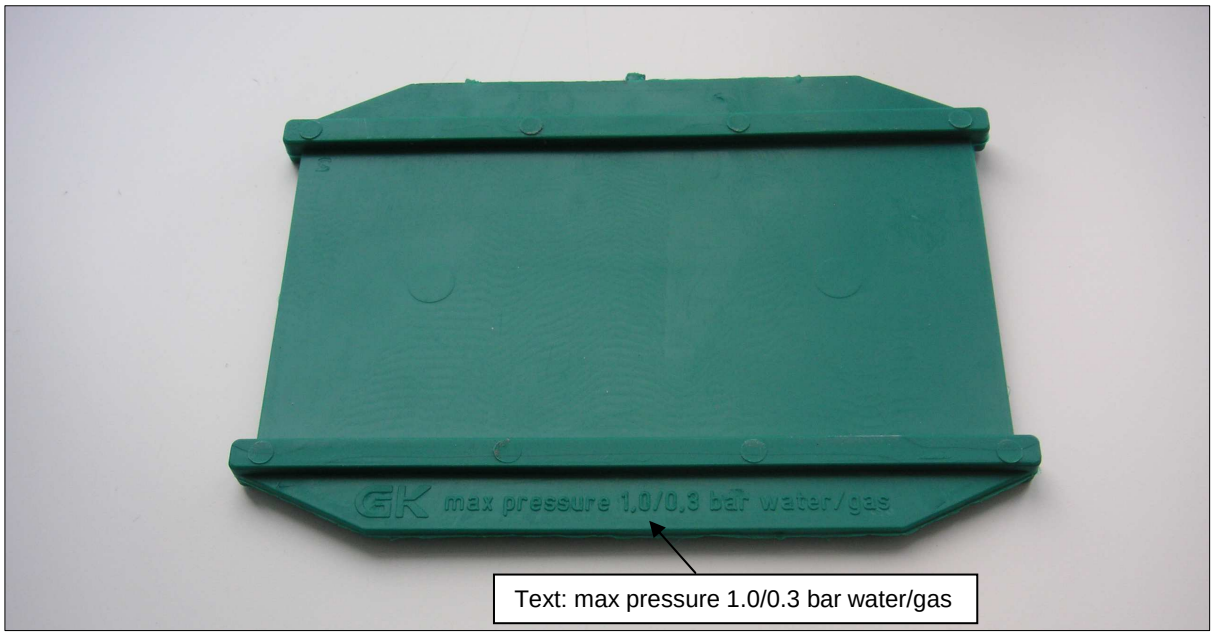
The stay plates are made of plastic material (elastomer), galvanized steel or stainless steel (figures 34 and 36 on page 33). It should be noted that the plastic stay plates mounted in EMMA MÆRSK were not marked with any maximum pressure.

Cable penetrations with plastic stay plates had been approved by class in fire rated class "A" bulkheads and decks in accordance with test results, but had not been approved in watertight bulkheads and decks.

Figure 34: Stay plate of plastic (elastomer) for "GK Packing System"
Source: DMAIB

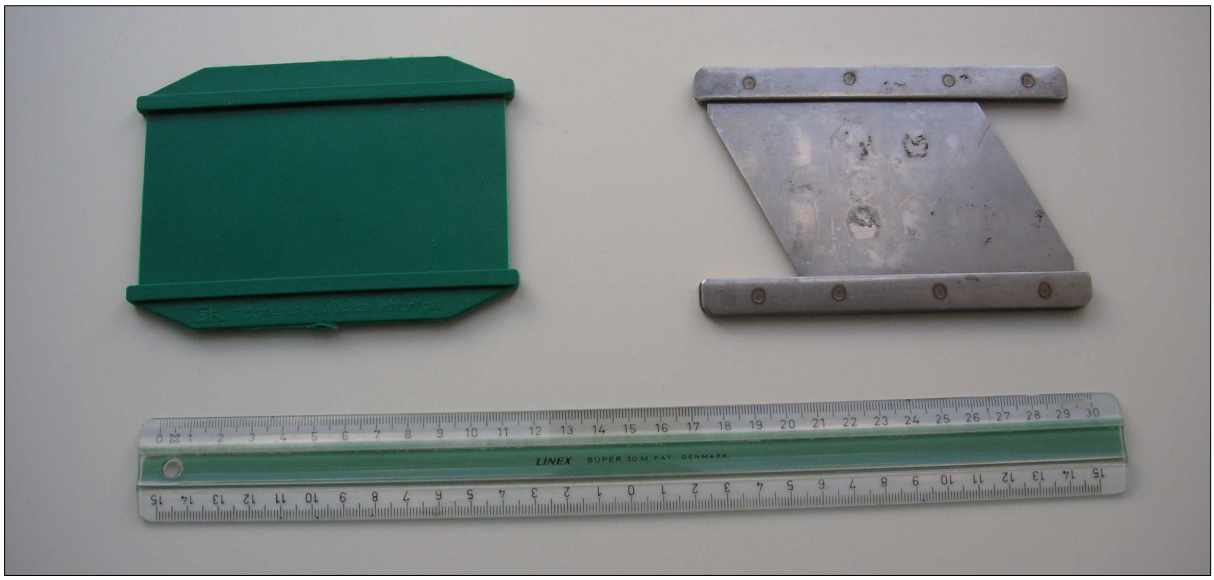
According to the manufacturer's product recommendations, cable penetrations with metal stay plates were tested to a water pressure of 5.5 bar and a gas pressure of 0.3 bar, while plastic stay plates were limited to 1 bar and 0.3 bar, respectively.

Figure 35: Stay plates of plastic (elastomer) and stainless steel for "GK Packing System"
Source: DMAIB

Cable penetrations were primarily fitted with plastic stay plates instead of stainless steel plates because they were easier to install and were less costly. The four high-voltage cable penetrations located above the propeller shaft in the watertight bulkhead at frame 166 were all fitted with stay plates of plastic. Another cable penetration located in the same bulkhead and below the floor plates was fitted with a stay plate of stainless steel.

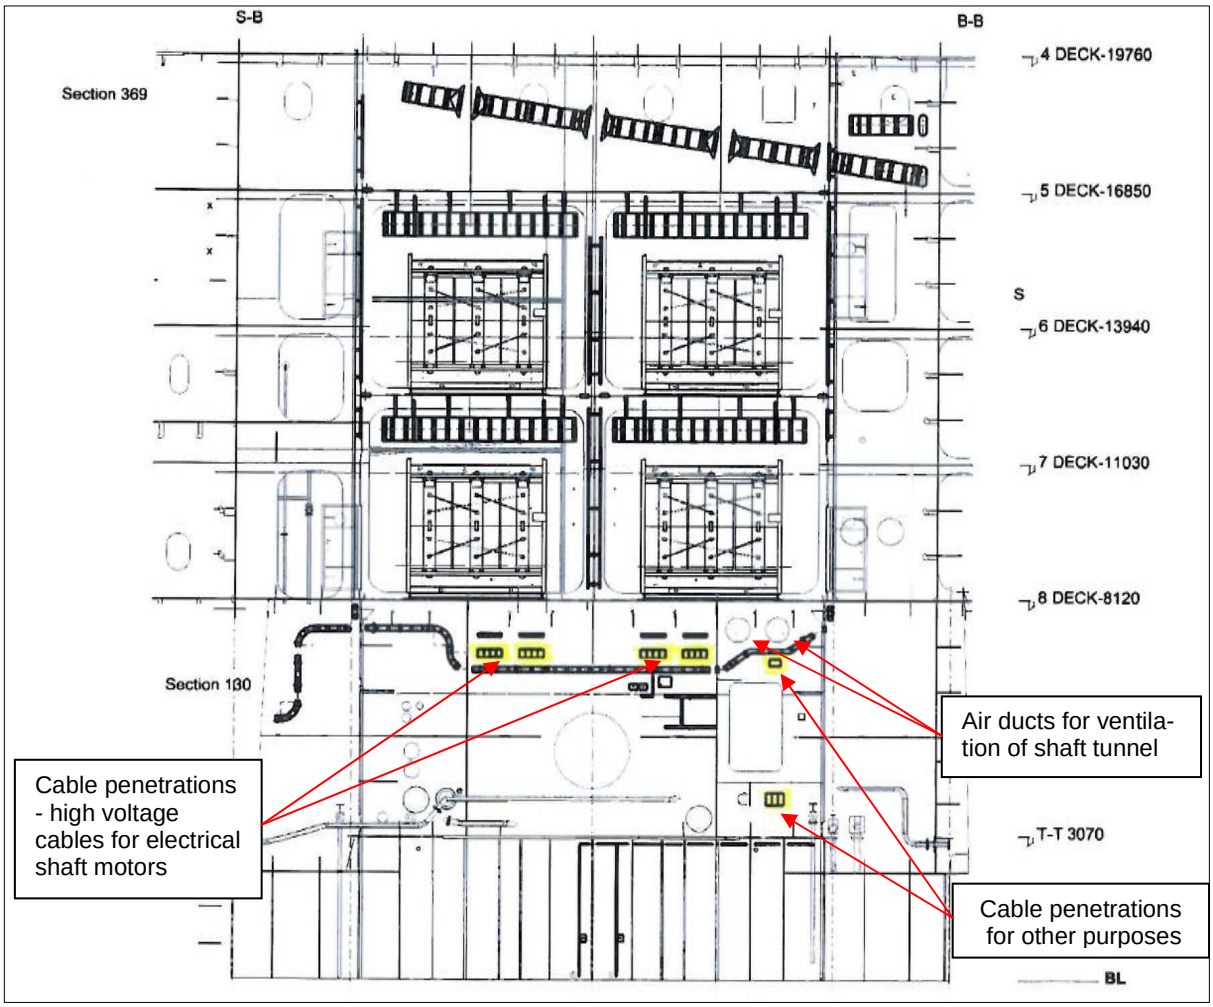
When the four high voltage cable penetration sealings collapsed, the ship’s draught was about 16 metres. The high voltage cable penetrations in the watertight bulkhead were situated about seven metres above the ship’s basis line. Thus, the cable penetrations collapsed at a hydrostatic water pressure corresponding to the maximum water column of appr. nine metres equal to appr. 0.9 bar.

Figure 36: Detail of watertight bulkhead at frame No. 166 transverse section viewed from forward
Source: The ship’s damage stability booklet

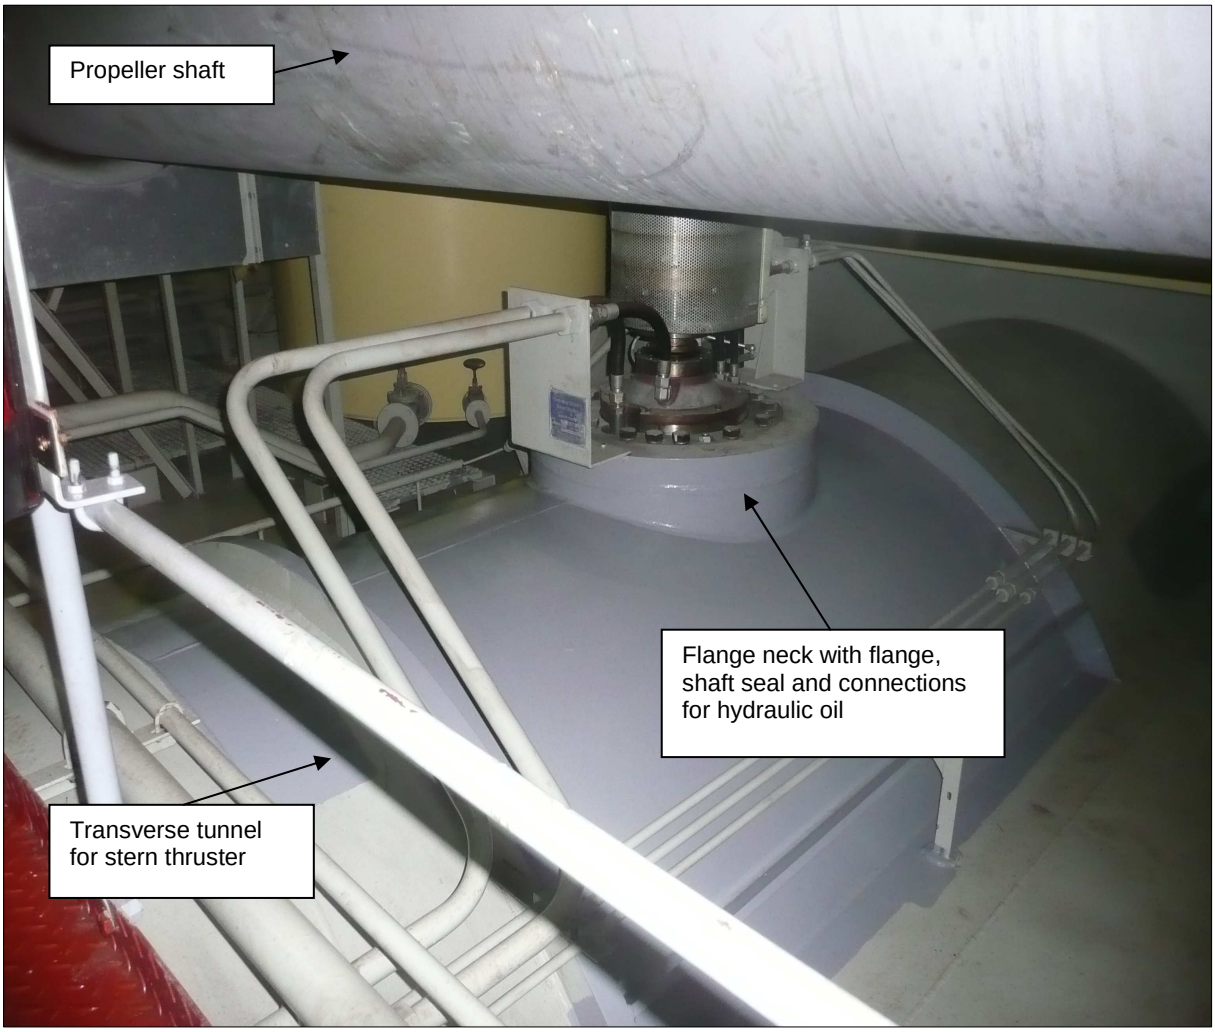
The 2nd engineer tried to get close to the leakage in an attempt to ascertain its origin and came as close as 1.5 – 2 metres from where he could see a dark area at the flange neck around the vertical shaft of the stern thruster. He realized that there was nothing to be done to stop the ingress and hurried back towards the engine control room and joined the chief engineer and the duty 3rd engineer at the system control computer on the 8th deck near the elevator.

Figure 40: Stern thruster tunnel with flange neck, flange, shaft seal and hydraulic connections in the shaft tunnel of a sister ship
Source: DMAIB

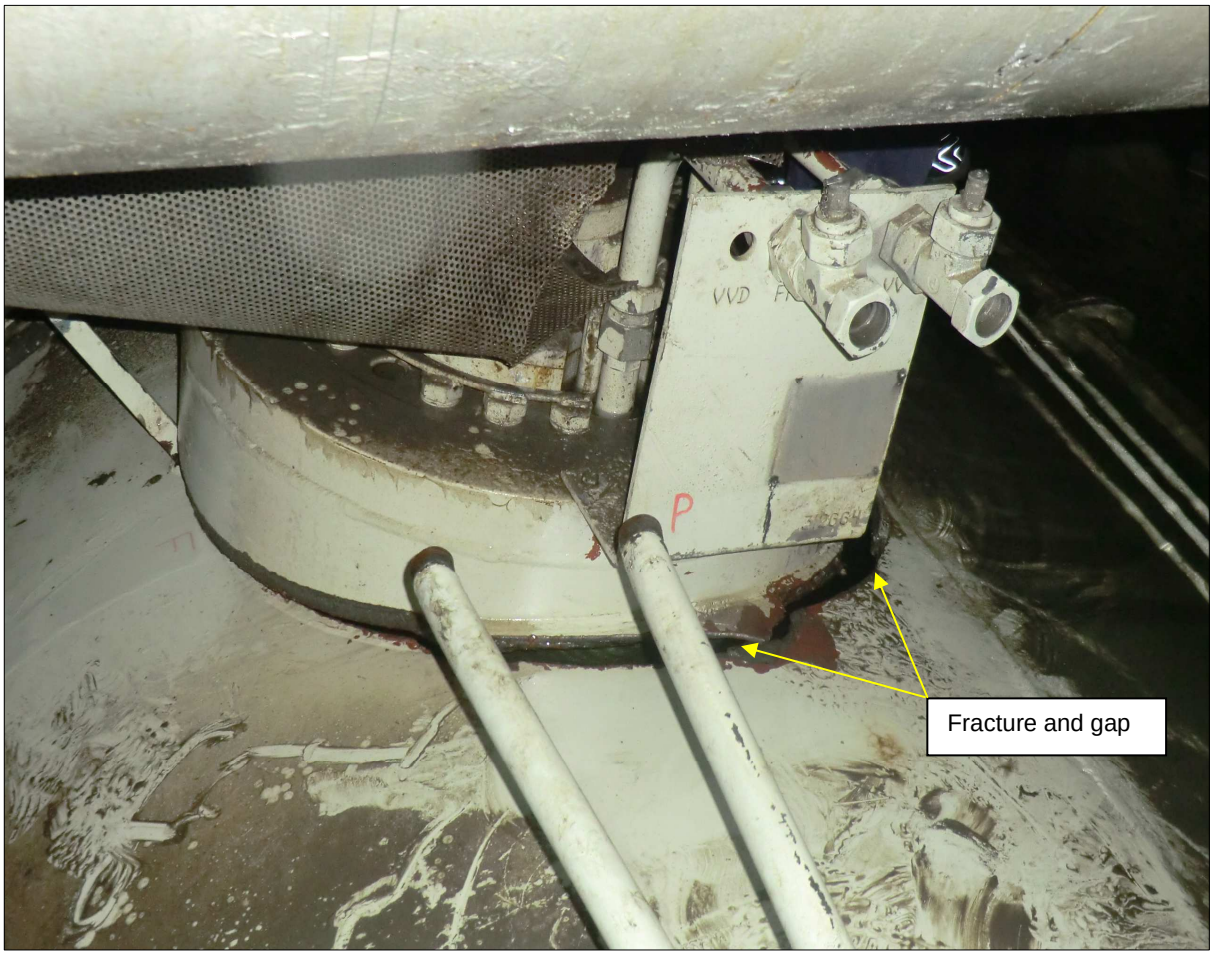
Figure 41: Breakage at the flange neck to the transverse stern thruster tunnel
Source: Maersk Line

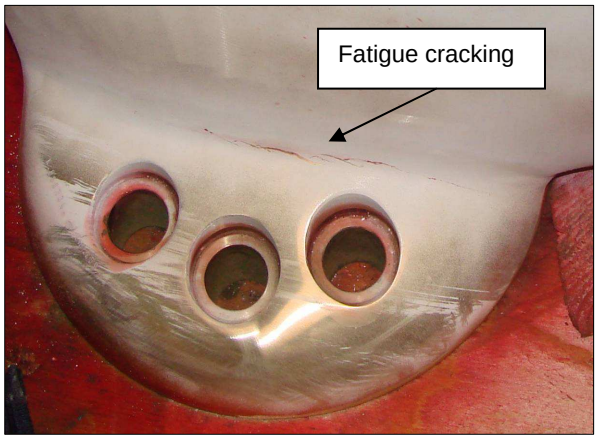
It was found that the three remaining original blades had cracked in way of the transition between the propeller blade and base. All cracks had occurred on the same side, i.e. the side pointing away from the thruster drive. Thus, all eight original propeller blades from the stern thrusters of EMMA MÆRSK had experienced fatigue cracking. All fatigue cracking had the same pattern and appeared at the same area of the propeller blades (figures 47 and 48 below and figure 59 on page 43).

Figures 47: Crack indication on front side of blade 1 on the aft stern thruster
Source: Force Technology

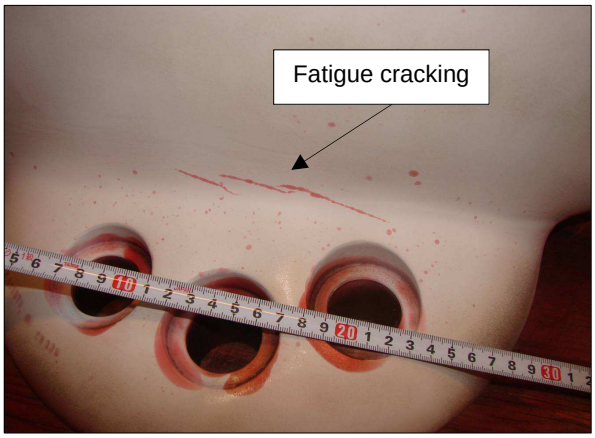
Figure 48: Crack indication on front side of blade 3 on the aft stern thruster
Source: Force Technology

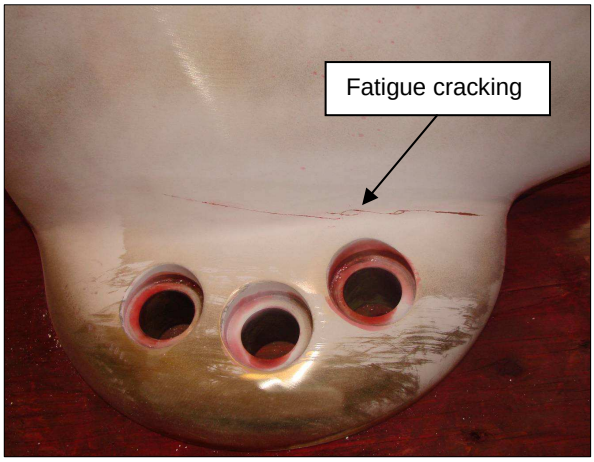
Figure 49: Crack indication on front side of blade 4 on the aft stern thruster
Source: Force Technology

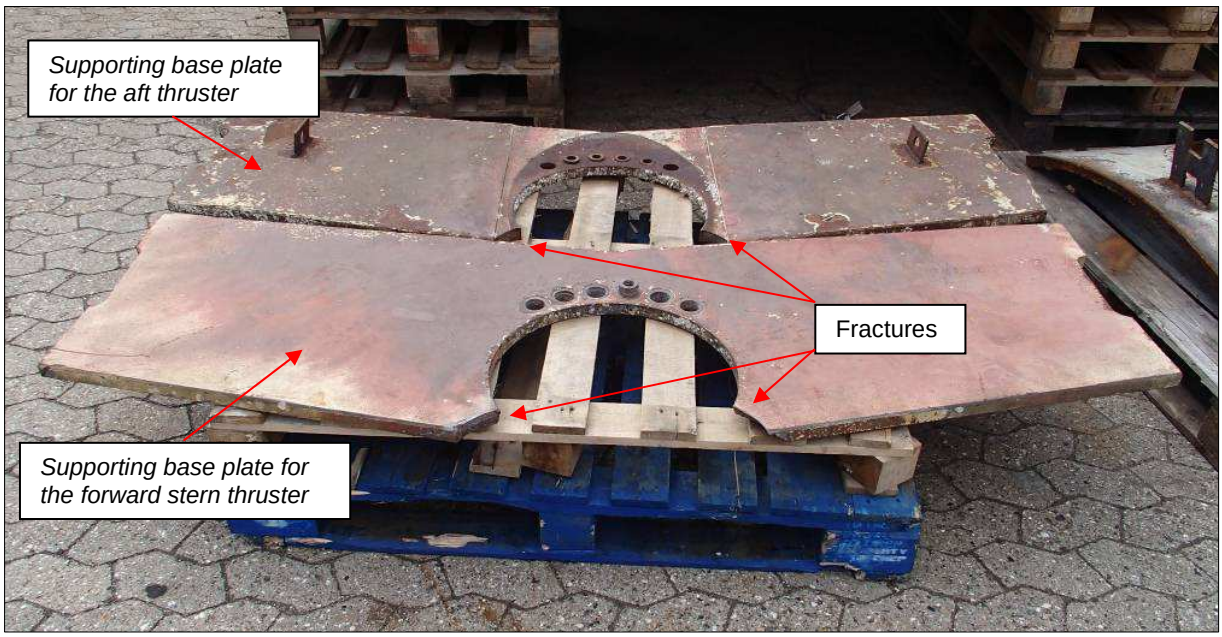
The supporting plate of the forward stern thruster had actually broken in three places, one of which was through a bolt hole (figure 52 on page 47). Four out of five fractures of the supporting base plates were of the same pattern, going from one corner of the base plate where a notch in the transition between the machined part and the non-machined part of the plate meets the outside corner, very much like the result of a notch effect (figures 53 and 54 on page 48).

Figure 51: Broken supporting base plates for the forward and the aft stern thruster
Source: Force Technology

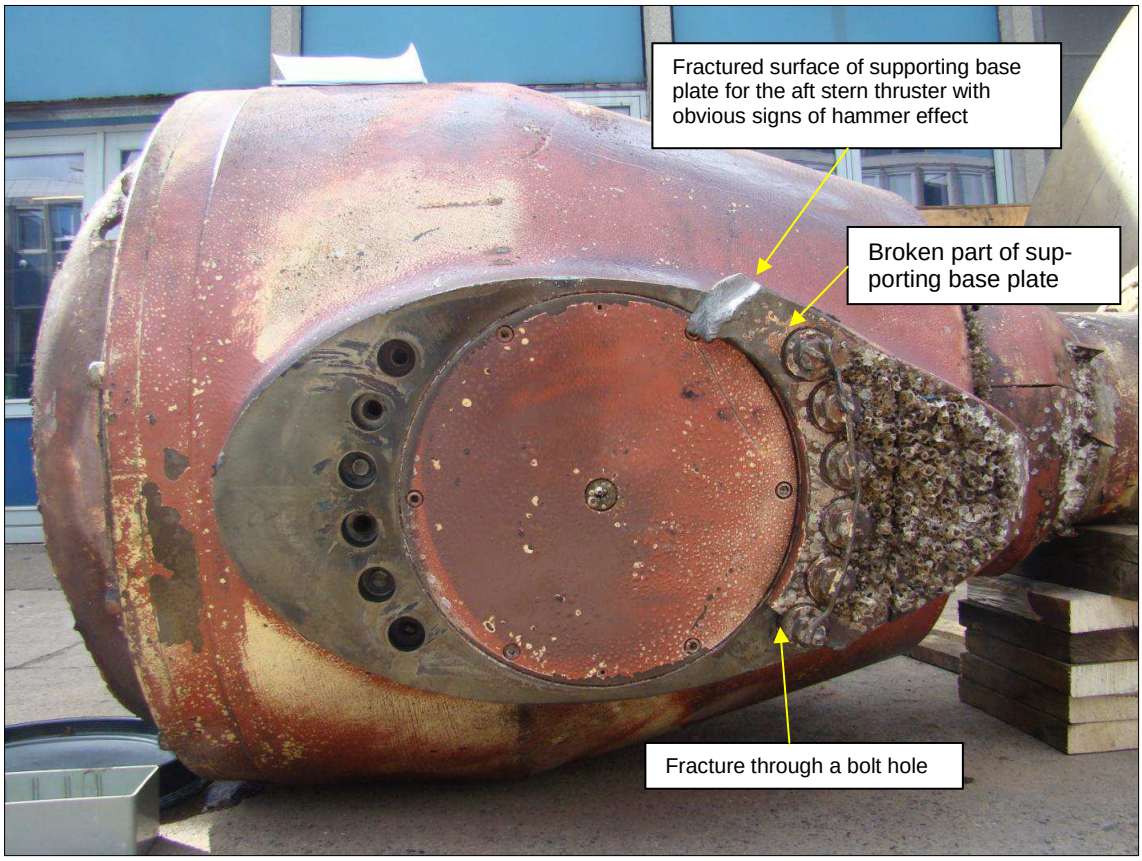
Figure 52: Bottom side of the damaged forward stern thruster with the broken part of the supporting base plate
Source: Maersk Line

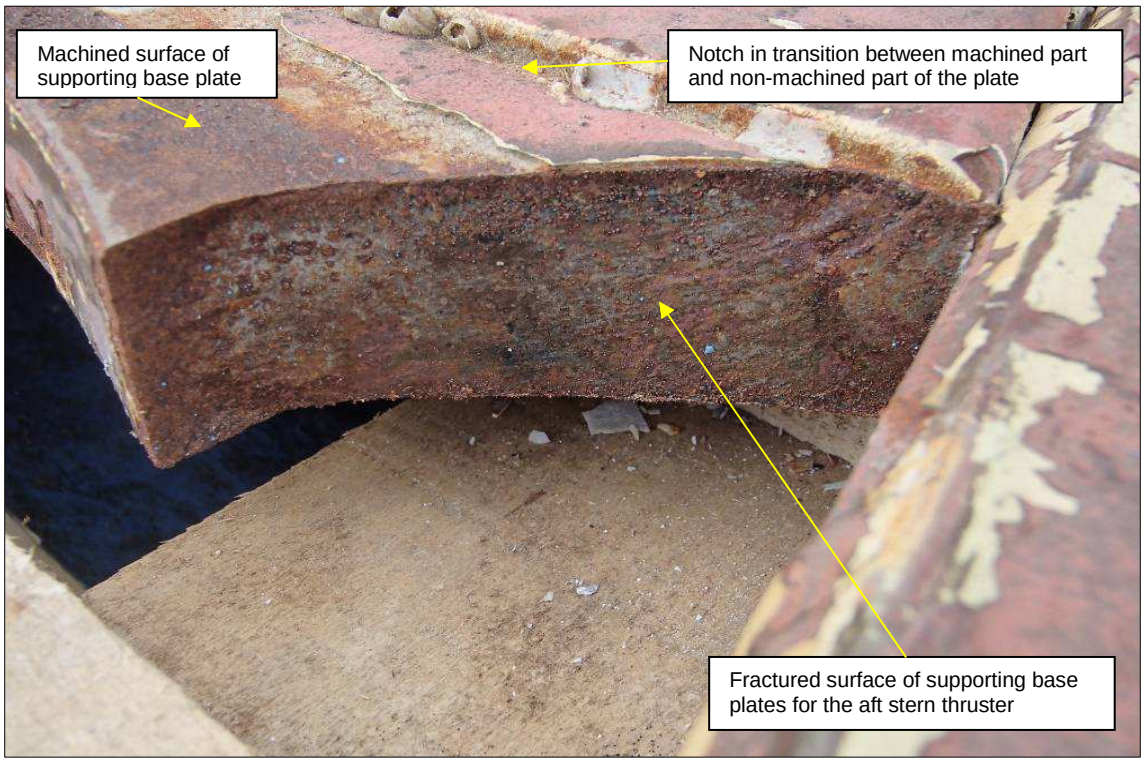
Figure 53: Fracture of supporting base plate for the aft stern thruster
Source: Force Technology
