STONE I

Marine accident report on loss of control

4 JANUARY 2020

The report is issued on 16 September 2020.

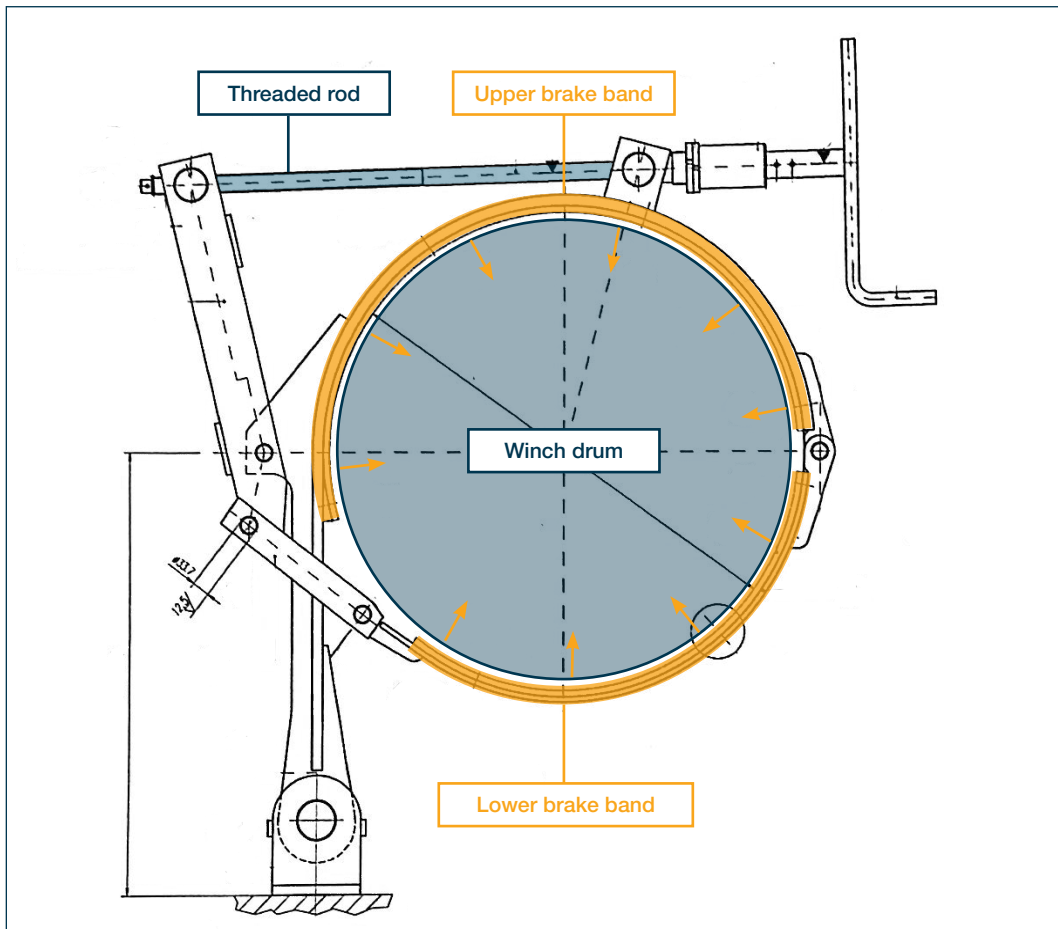
Figure 8: Basic drawing of mooring winch
Source: Zenith Gemi Isletmeciligi AS / DMAIB

The hand wheel was connected to a threaded rod that drew the upper and lower halves of the brake band together (figure 8), which brought the brake band into contact with the brake drum. Brake setting indicator nuts for the spring load were fitted on the rod close to the hand wheel, visually indicating whether the brake had been properly calibrated. Paint markings on the threaded rod indicated how much the brake had been tensioned (figure 9). These visual cues had the purpose of enabling the crew to determine, whether the brakes were properly tensioned. The paint marking on the threaded rod indicated two turns on the rod. Hence, the visual indicators made it readily visible for the deck crew to determine if the brakes were sufficiently applied.

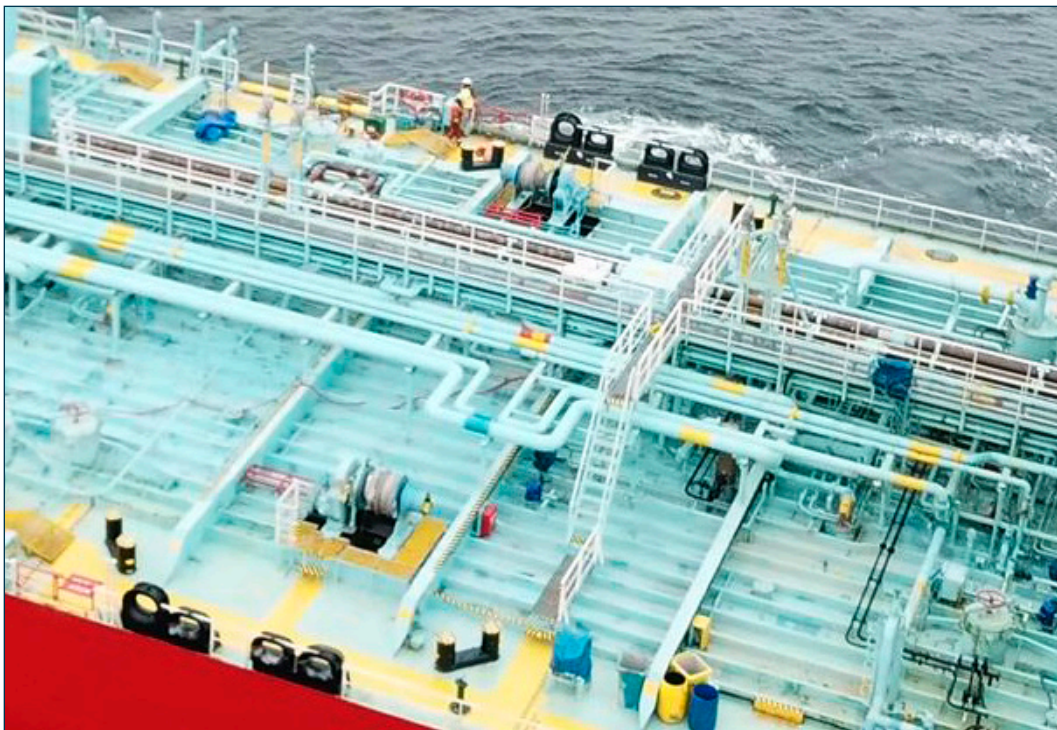
Figure 15: Mooring arrangement on the main deck
Source: DMAIB

The two mooring stations on the main deck had a similar layout. On each of the mooring stations, the mooring fittings comprised two single split drums, fairleads and bollards. The winches were located on each side of the ship and had one designated fairlead in each side of the ship. The bollards also had designated fairleads in each side. It was not possible to use the bollards for loose mooring lines, as there were no aligned winches to tighten the lines (figure 15, next page).

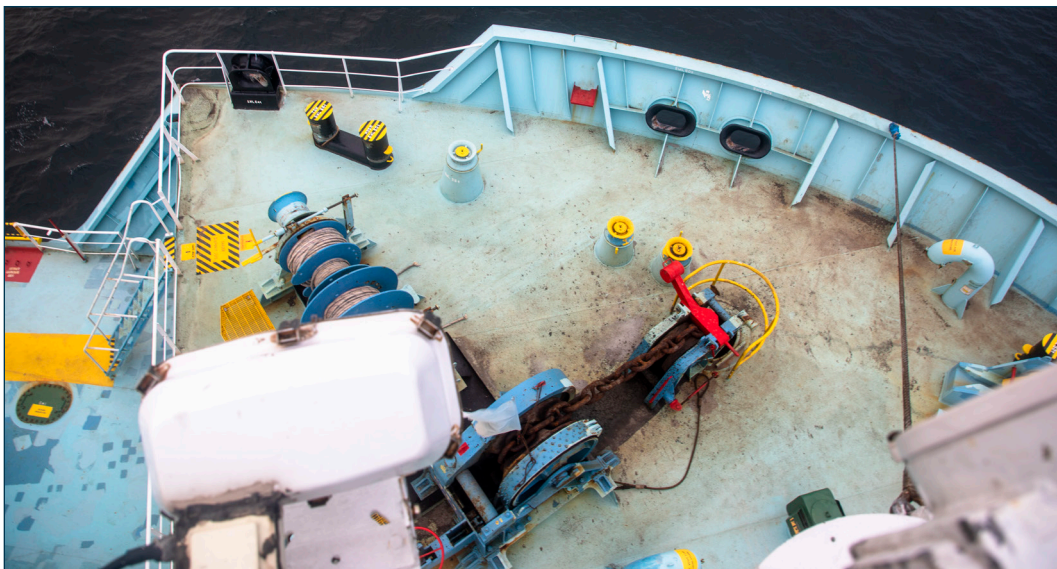
Figure 16: Mooring arrangement forecastle port side
Source: DMAIB

From a review of the general arrangement it was noted that the bollards located near the centre fairlead were symmetrically placed, however on the ship they were not. Additionally, two pedestal rollers were placed on portside, which did not appear on the general arrangement. It was only possible to use the centre fairlead for loose mooring lines or towing lines (figures 16 and 17).

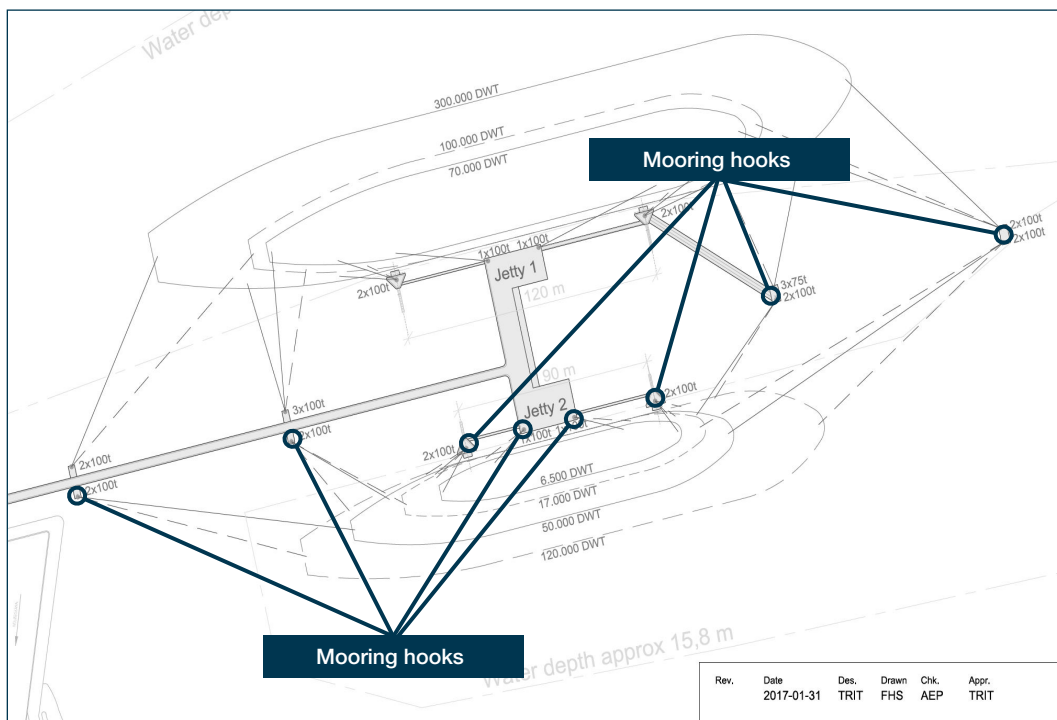
Figure 20: Ensted Oil Terminal mooring plan
Source: Inter Terminals Denmark EOT Aps / DMAIB

Due to the ship's size, STONE I berthed at Jetty 2. Jetty 2 had 14 mooring hooks (figure 20, next page). Jetty 2 was fitted with two loading arms. When berthing the ship, the jetty's loading arms determined the position of the ship, as these needed to be aligned with the ship's manifolds. When the loading arms and manifolds were aligned, the possibilities for mooring the ship depended on the interface between the ship and the jetty and their available mooring equipment.

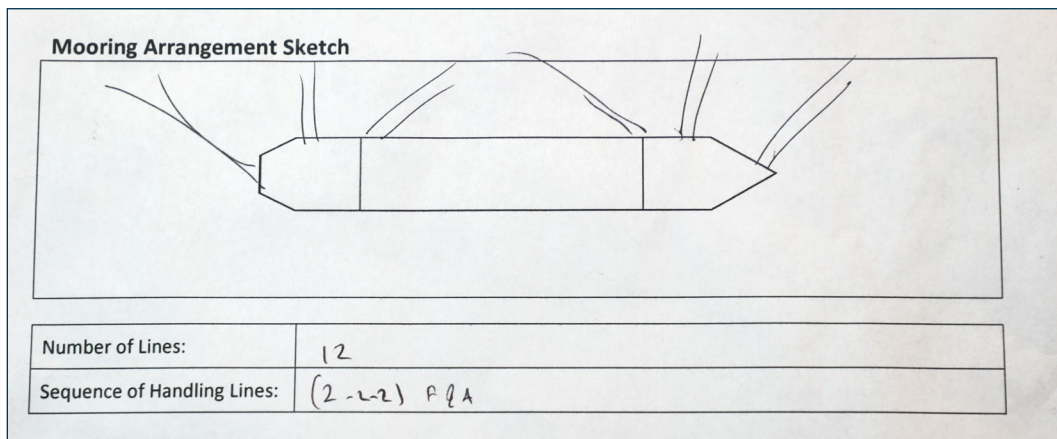
Figure 21: Mooring philosophy according to the mooring management plan
Source: Zenith Gemi Isletmeciligi AS / DMAIB

Prior to arrival at Ensted, the master and pilot planned the mooring configuration. The plan was documented in a form from the ship's safety management manual (Master Pilot Information Exchange, figure 21)

The agreed mooring configuration was similar to the typical mooring pattern in the ship's mooring management plan. However, during berthing, the master was informed that the jetty's bollards and hooks were not aligned to direct the breast lines in an optimal angle. The master assessed the situation and decided to accept the mooring configuration as this seemed to be the only feasible option. STONE I was thus moored with four lines on the forecastle, four lines on the main deck and four lines on the aft (figure 22).
