# KARIN HØJ

Marine accident report on occupational accident

9 MAY 2019

**MARINE ACCIDENT REPORT ON THE OCCUPATIONAL  
ACCIDENT ON KARIN HØJ ON 9 MAY 2019**

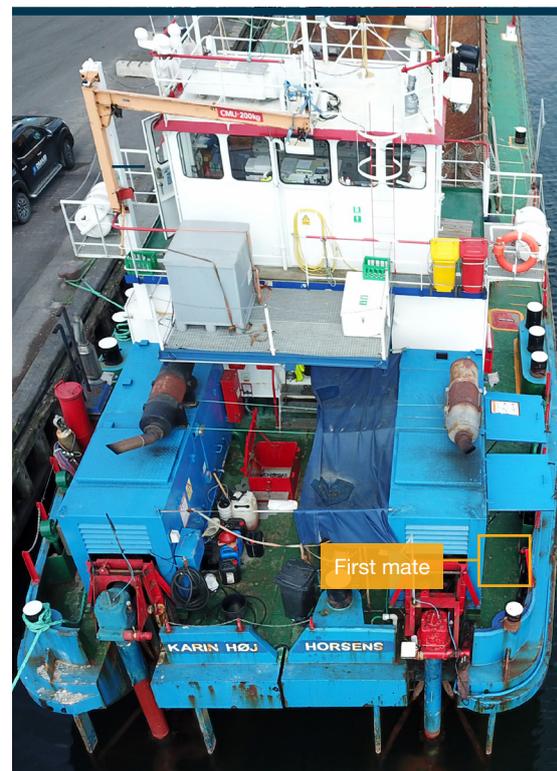
Figure 3: The first mate's location on the aft deck  
 Source: DMAIB, 2019

The first mate, who went to the aft deck during the unsuccessful attempt to get the ship to quay, noticed that hydraulic oil was leaking from the damaged hydraulic hose on the starboard engine and immediately alerted the master on the bridge. The master quickly stopped the engine to prevent oil from spilling into the port. The ship had its aft end towards the quay, and the master found that it was necessary to get out of this situation as soon as possible, because the ship was in danger of further damaging its engines and propellers. The master thus immediately rang the ship's agent and ordered a tug, which could bring the ship safely to berth. Meanwhile, the first mate had started collecting the hydraulic oil spilled on the aft deck (figure 3).

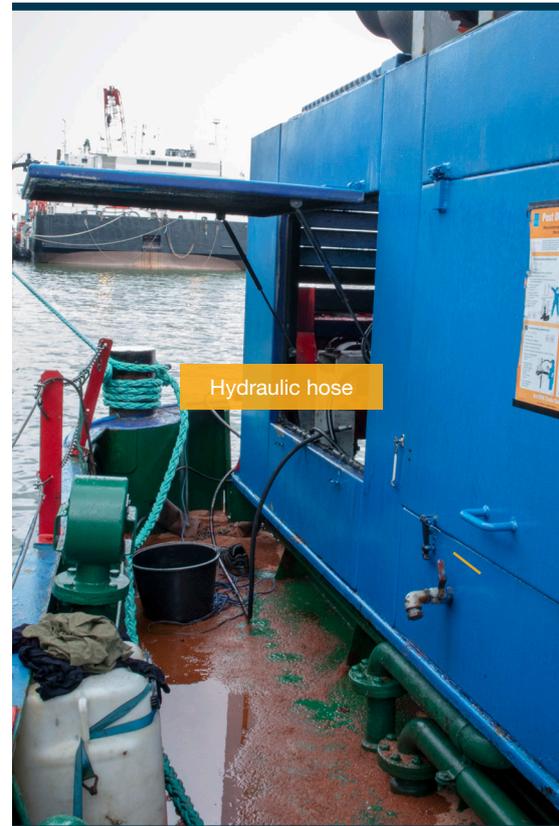
Figure 4: Access to starboard engine  
Source: DMAIB, 2019

The master returned to the bridge to get a status from the ship's agent on the arrival of the tugboat. The agent explained that there was an hour's wait on the tugboat. The master returned to the first mate on the aft deck. The mate had started to change the hydraulic hoses on the actuator and had passed the first hose under the shield to the starboard engine (figure 4).

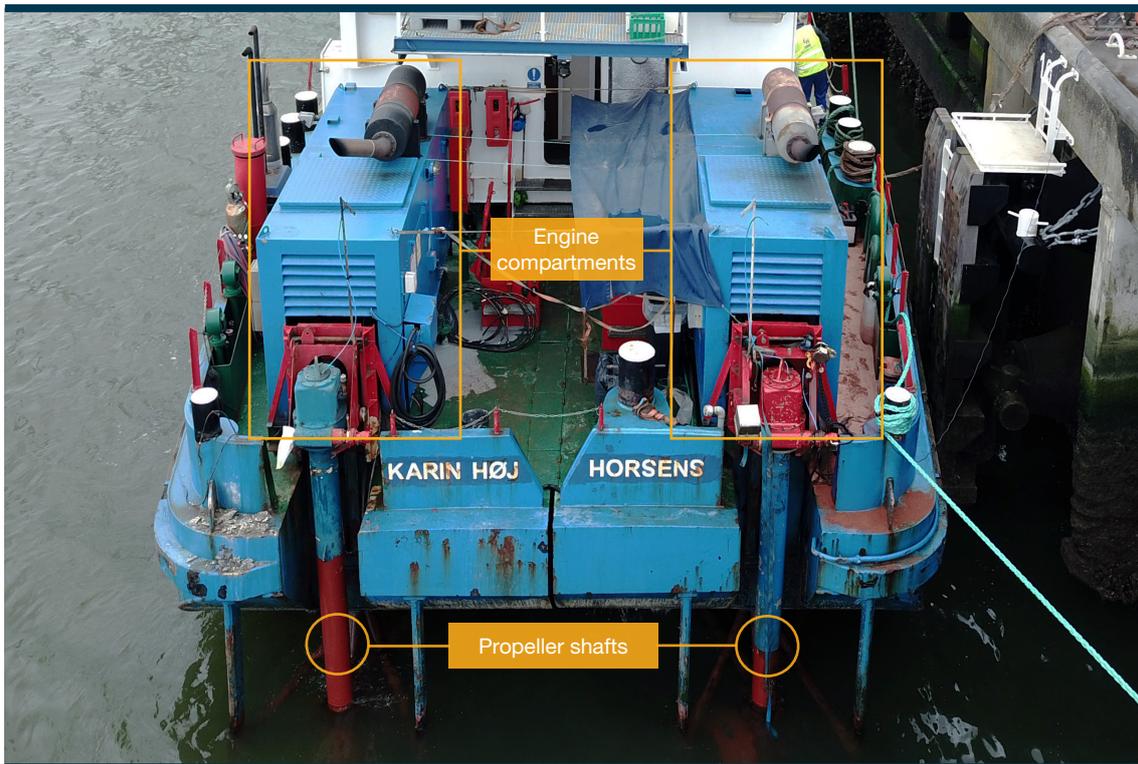
Figure 9: Propulsion engines and propeller shafts.  
Source: DMAIB, 2019

The ship was equipped with two Schottel propulsion systems, one on each side of the ship. Each propeller was powered by a diesel engine via a cardan shaft located in an engine compartment on deck and a vertical propeller shaft (figure 9). Access to the engine compartment and the cardan shafts was afforded on both the port and starboard sides of the engine compartments.

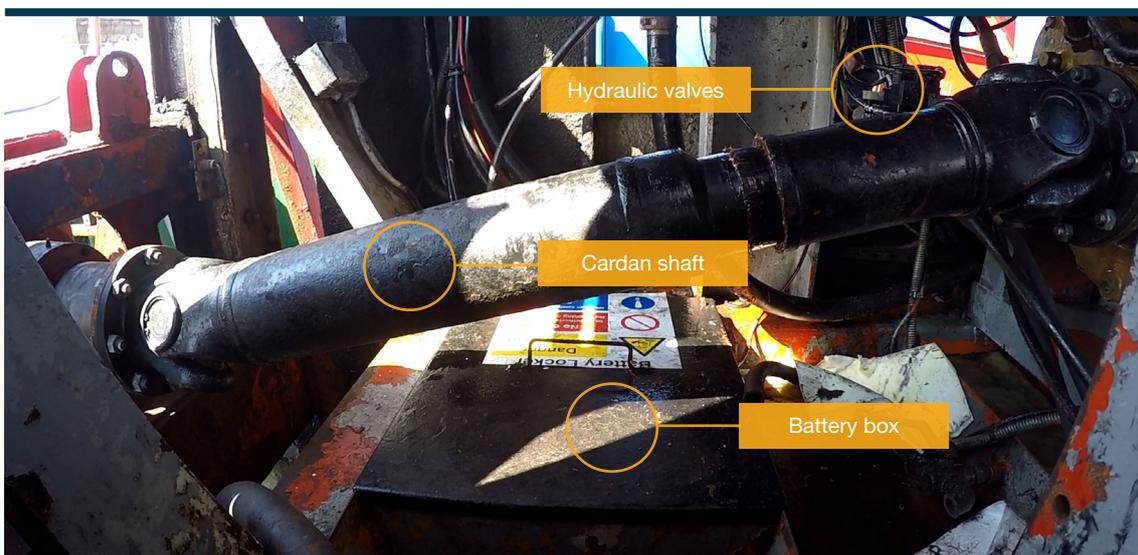
Figure 10: The engine compartment on the starboard side seen through the starboard hatch.  
Source: DMAIB, 2019

In the engine compartments on both the starboard and port sides there was, in addition to the diesel engines, a cardan shaft, a hydraulic valve battery and a battery box. The propeller shafts were driven up and down by the cardan shaft in the engine compartment (figure 10).

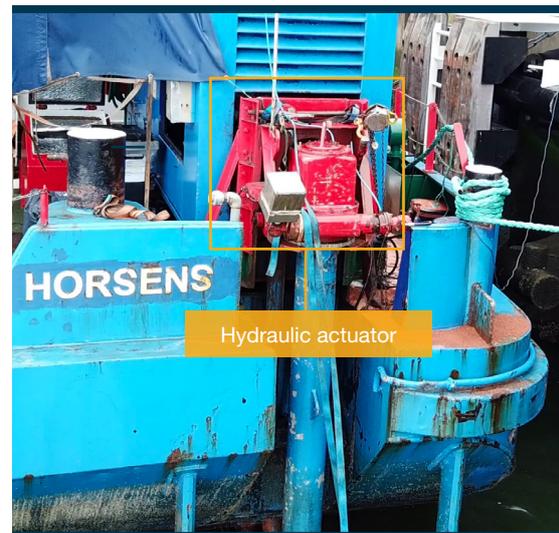
Figure 12: Hydraulic actuator starboard  
Source: DMAIB, 2019

The hydraulic valves operated both as a control unit for the hydraulic piston, which lifted and lowered the cardan shaft, as well as a steering unit for an actuator that turned the propeller shaft (figure 12). From the hydraulic valves several hydraulic hoses were passed out through the engine compartment to the

hydraulic piston and actuator respectively. DMAIB's investigation into the hydraulic system showed that it could be difficult to follow the connection between the hydraulic hoses from the hydraulic piston and the actuator to the valve battery, because the hoses were passed through a sock made of fire hose. The function of the sock was to protect the hoses on deck against wear.
