DMAIB
Danish Maritime Accident Investigation Board

BERGENSFJORD

Summary report on unintended release of rescue boat

6 DECEMBER 2017

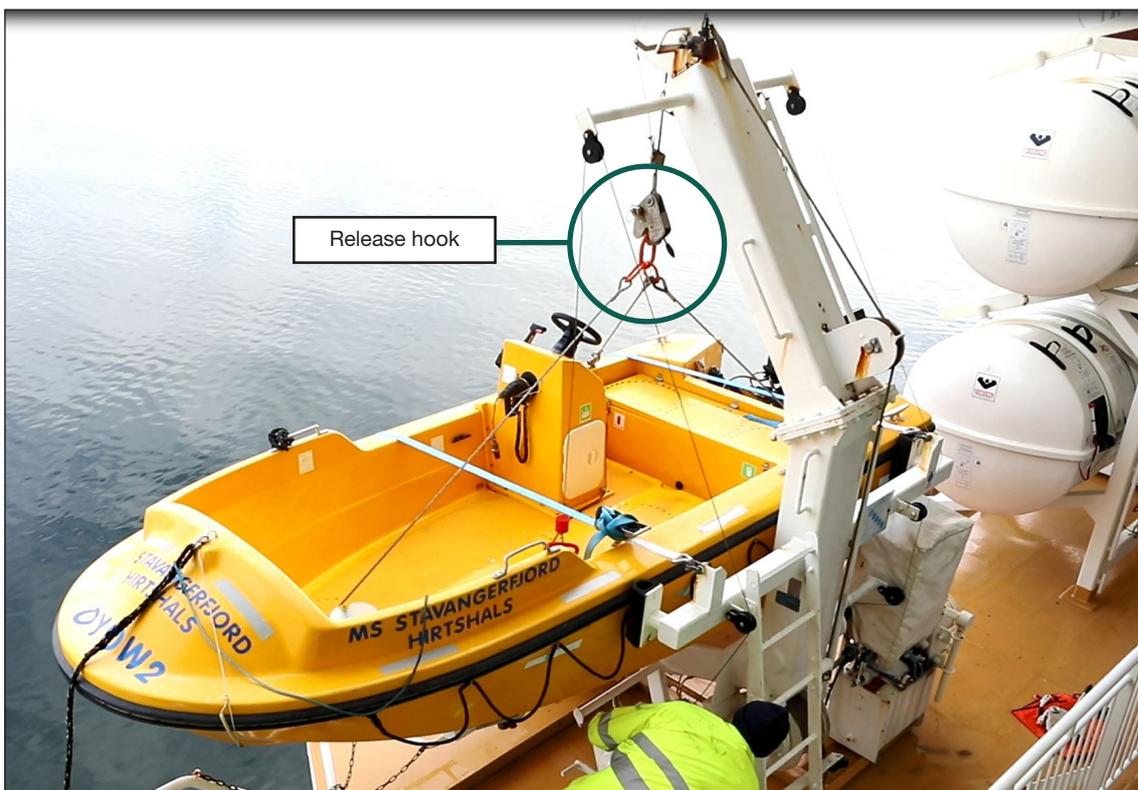
Figure 2: Rescue boat on STAVANGERFJORD
Source: Fjord Line

The photo (figure 2) depicts the rescue boat and launching appliance on board STAVANGERFJORD, which was identical to the launching appliance on board BERGENSFJORD. In the boat's stowed position, it was located in a cradle secured with straps. The boat's suspension was secured at three points on the boat, which were joined to a steel ring fixed in the release hook.

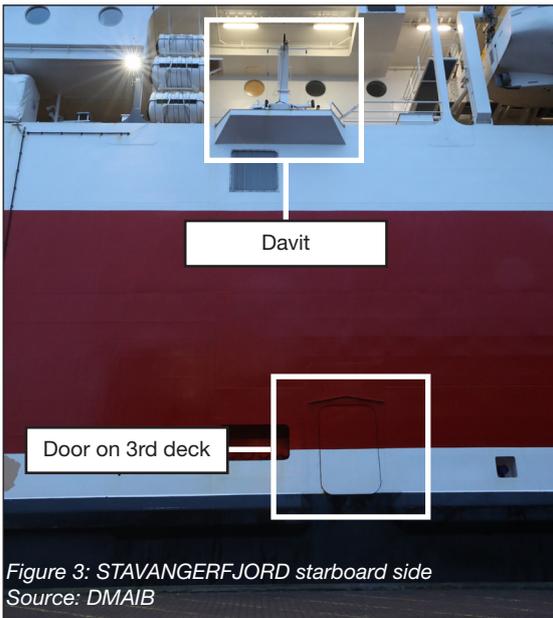
Figure 3: STAVANGERFJORD starboard side
Source: DMAIB

When the boat was to be launched, the straps were removed, and the boat was raised slightly using the electric winch to get it free of the cradle. Then, the davit was lowered to swing the boat overboard, after which the brake on the wire was released, and the boat was lowered to the door on the third deck (figure 3, next page).

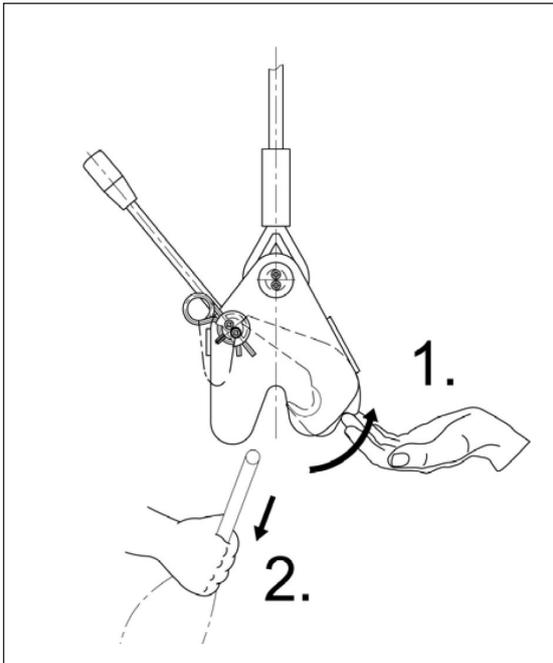
Figure 4: Off-load release
Source: d-i davit international GmbH/DMAIB

Off-load release (figure 4): When the boat was in the sea the boat's suspension would be slack, and the pawl (1), which held the suspension in place could be withdrawn. Then, the boat's suspension could be released (2).

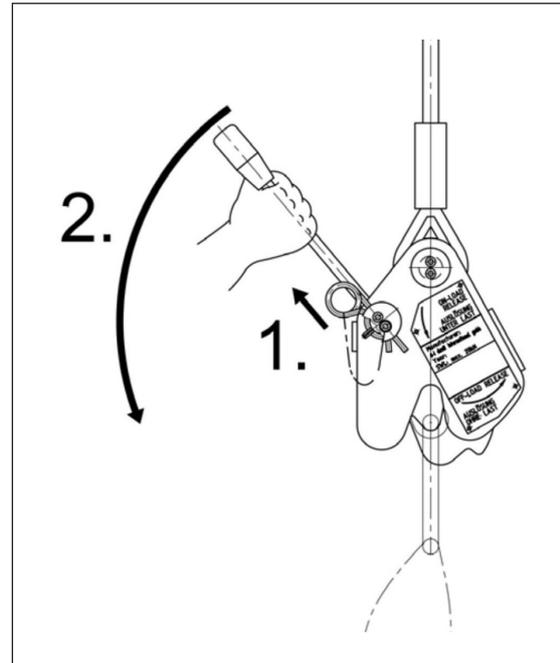
Figure 5: On-load release
Source: d-i davit international GmbH/DMAIB

On-load release (figure 5): If the normal method did not work, or the boat's suspension had to be released, when the suspension was not slack, the pin would have to be removed (1) and the release handle pulled down (2). Then the pawl holding the boat's suspension would automatically be released.
