MARINE ACCIDENT REPORT

AMBER II and SEA WORKER
Loss of tow on 27 January 2016

This marine accident report is issued on 16 December 2016

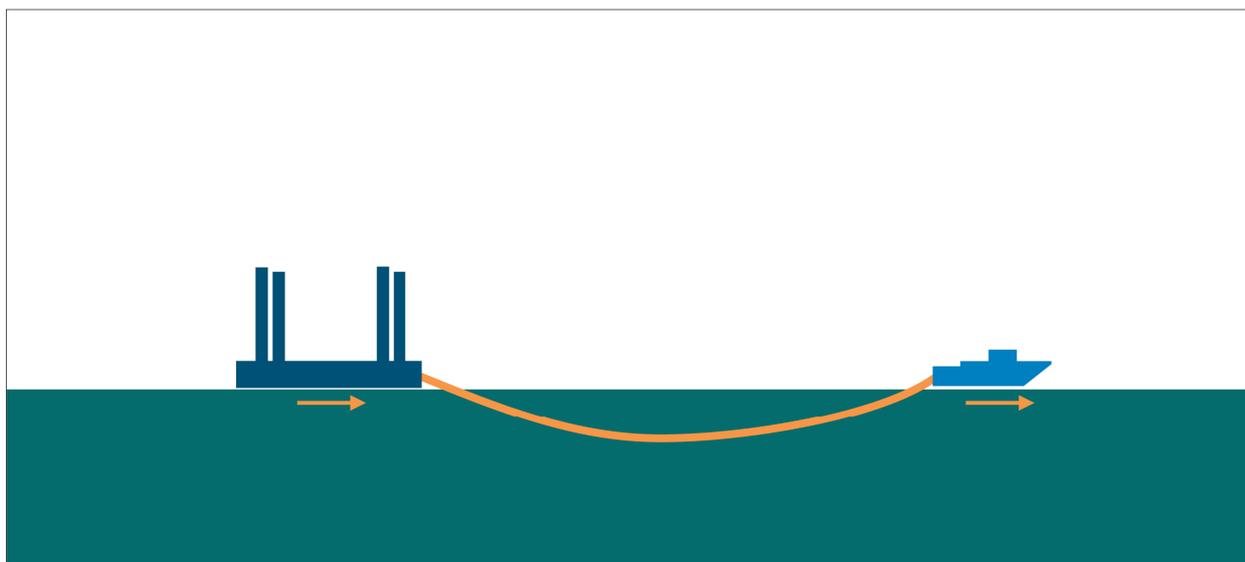
Figure 13: Towing situation with a great amount of catenary
Source: DMAIB

Figures 13 and 14 below show two different towing situations⁷. The top figure pictures how the towing wire ideally should be hanging between the two vessels in a curve. The underwater curve adds flexibility to the tow, so that it is less likely to break.
