# MARINE ACCIDENT REPORT

## April 2016

**CAROLINE MÆRSK**  
**Fire in containers on 26 August 2015**

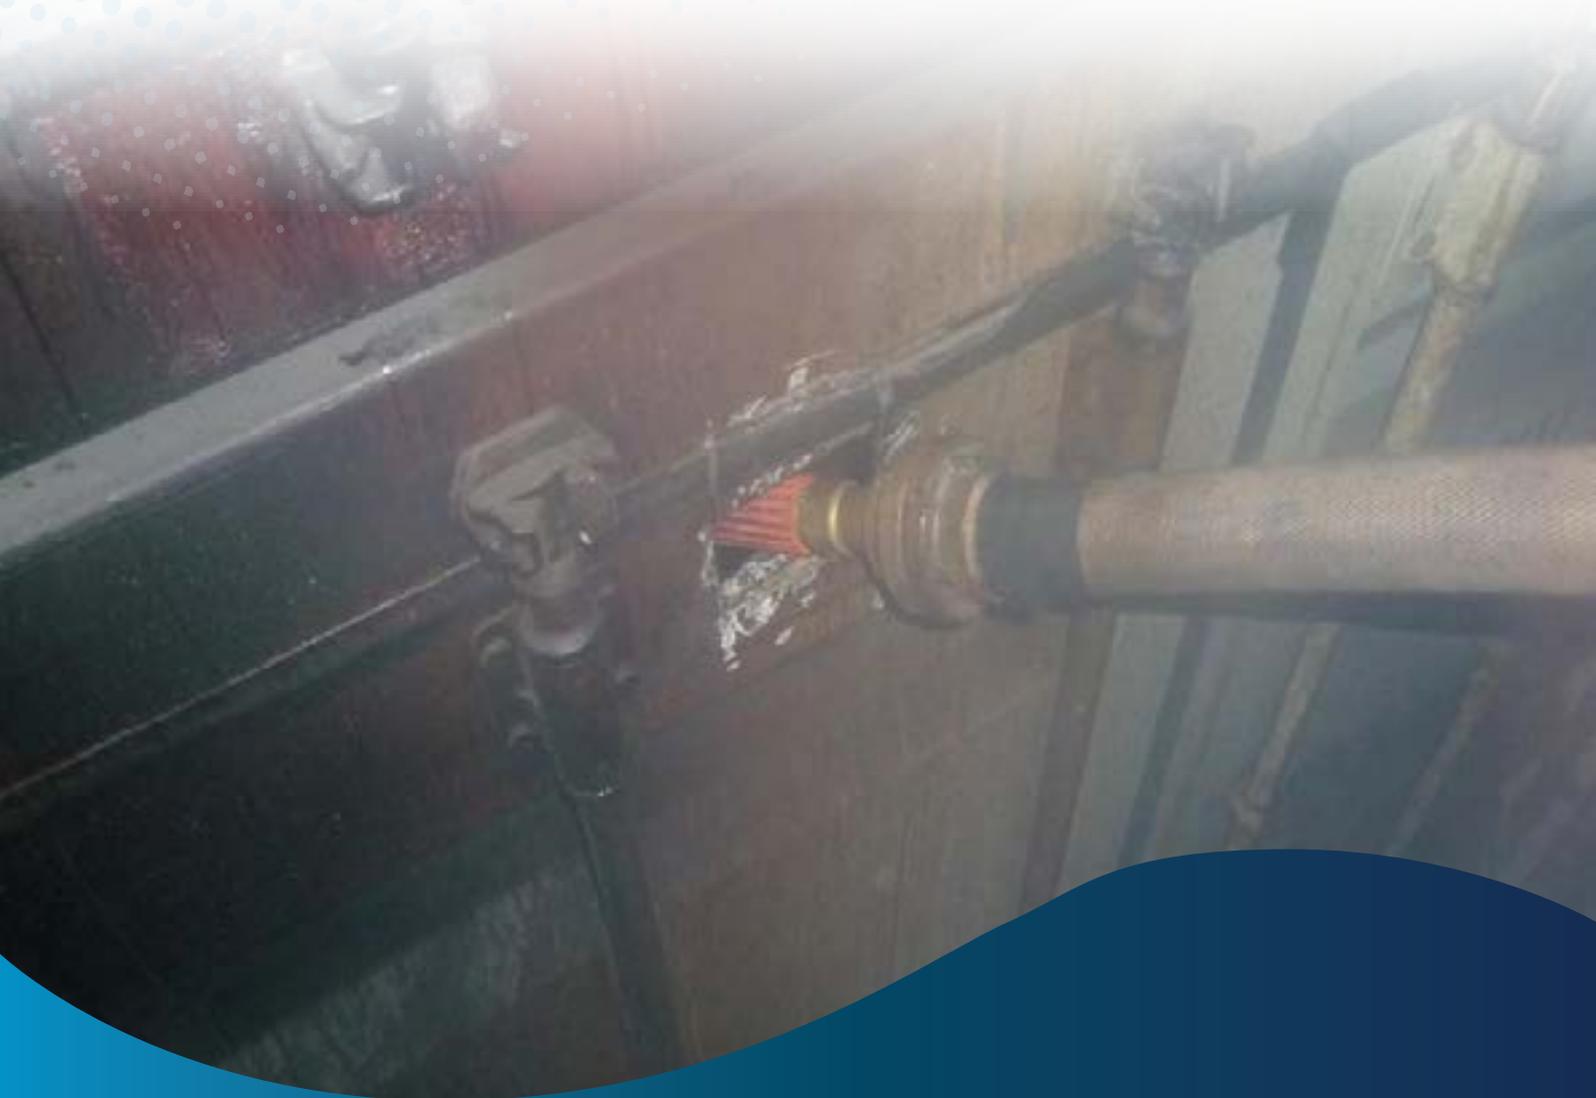
**Front page:** Fire nozzle in container on CAROLINE MÆRSK. Source: Maersk Line.

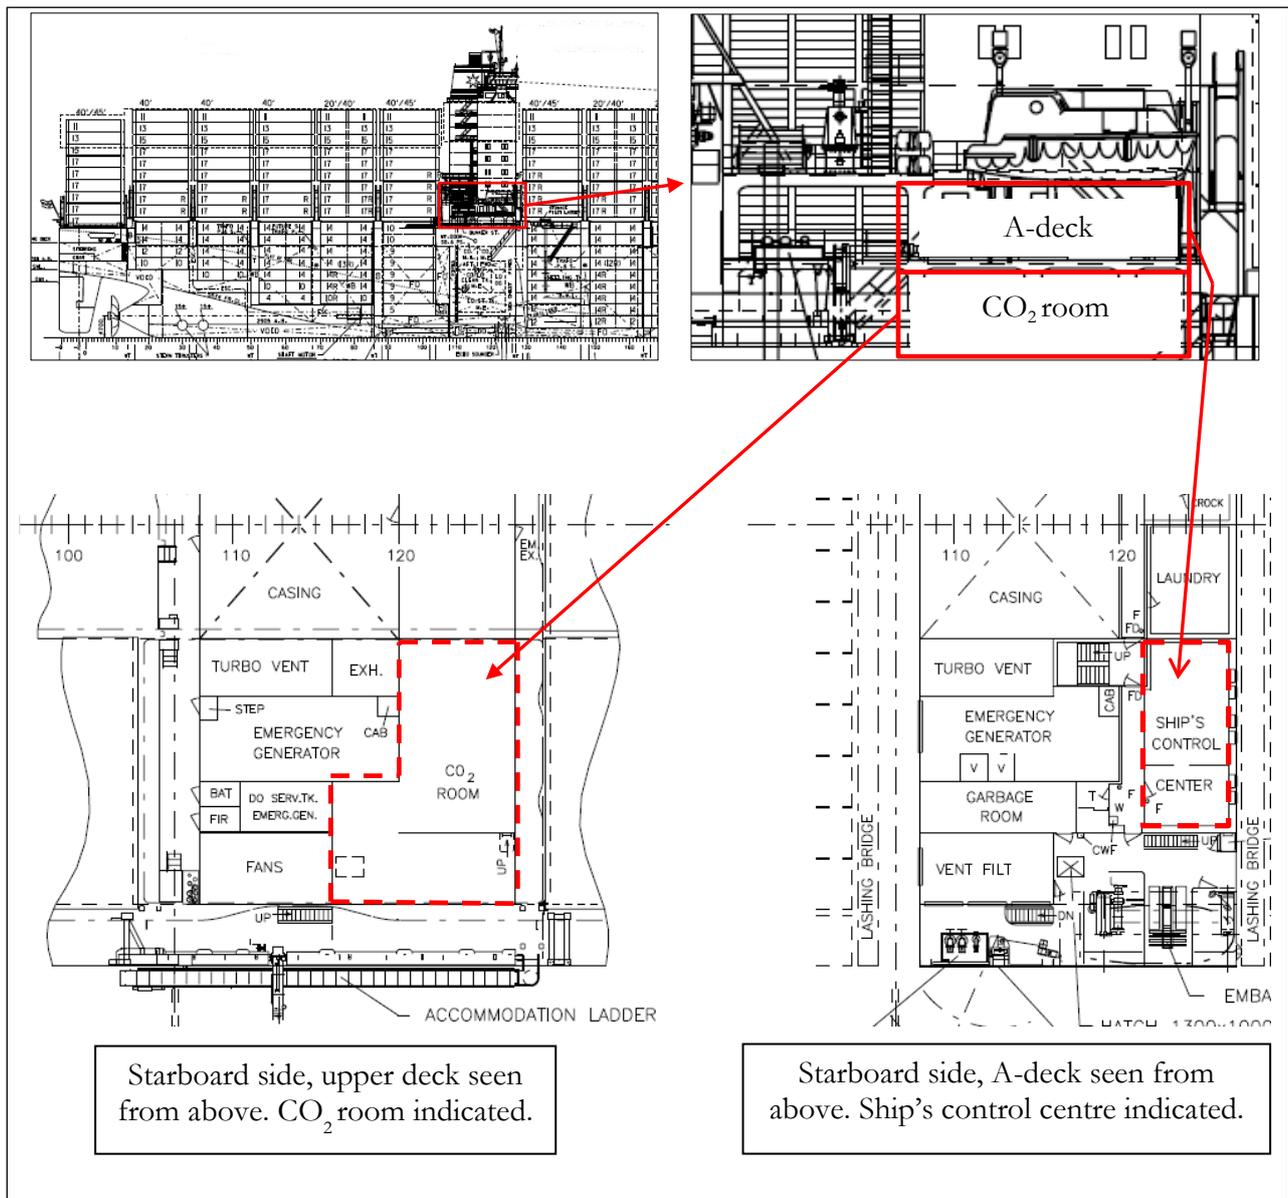
Figure 5: Excerpts from general arr. and capacity plan. A-deck and CO<sub>2</sub> room indicated.  
 Source: MÆRSK Line/DMAIB

With the information provided by the firefighting teams, the master considered his options and decided to deploy the ship's CO<sub>2</sub> extinguishing system. In preparation for releasing the CO<sub>2</sub>, the crew withdrew from the cargo hold area, and the ventilation to the accommodation was switched off. To be safe from any potential leaks from the system into the ship's control centre, the crew mustered on the open deck outside, at the starboard side of the A-deck, above the CO<sub>2</sub>-room (figure 5).

Once inside, he found the room covered in ice from the leaked CO<sub>2</sub>, and with paint peeled off by the freezing. He quickly established that there were no defects on the hoses connecting the cylinders, noted that the main distribution valve for the cargo holds was not open, and that a gasket on the main pipeline had burst. He reported to the master that no CO<sub>2</sub> could have reached the cargo hold. He manually opened the main distribution valve to the cargo hold and left the room. The chief engineer then returned to the ship control centre from where he released a second section of CO<sub>2</sub> cylinders, while keeping his hand on the pipes to check that it was in fact flowing to the cargo hold this time. When he went outside to the deck, he also saw that CO<sub>2</sub> was still leaking out of the room. From the bridge, the master confirmed that some CO<sub>2</sub> had likely reached the hold as he could see an effect on the smoke coming from the hold.

On the day of the accident, although operated in accordance with the procedures, the system failed to release CO<sub>2</sub> into the cargo hold. A subsequent third party examination of the CO<sub>2</sub> system indicated that the cause of failure was that the control valve in the fire control station (ship's control centre) release cabinet was not in the fully opened position. This could have led to the venting of CO<sub>2</sub> from the pilot line causing the distribution valve to not open. The examination showed no signs that the burst gasket in the main pipeline had been of a wrong type or mounted incorrectly. It

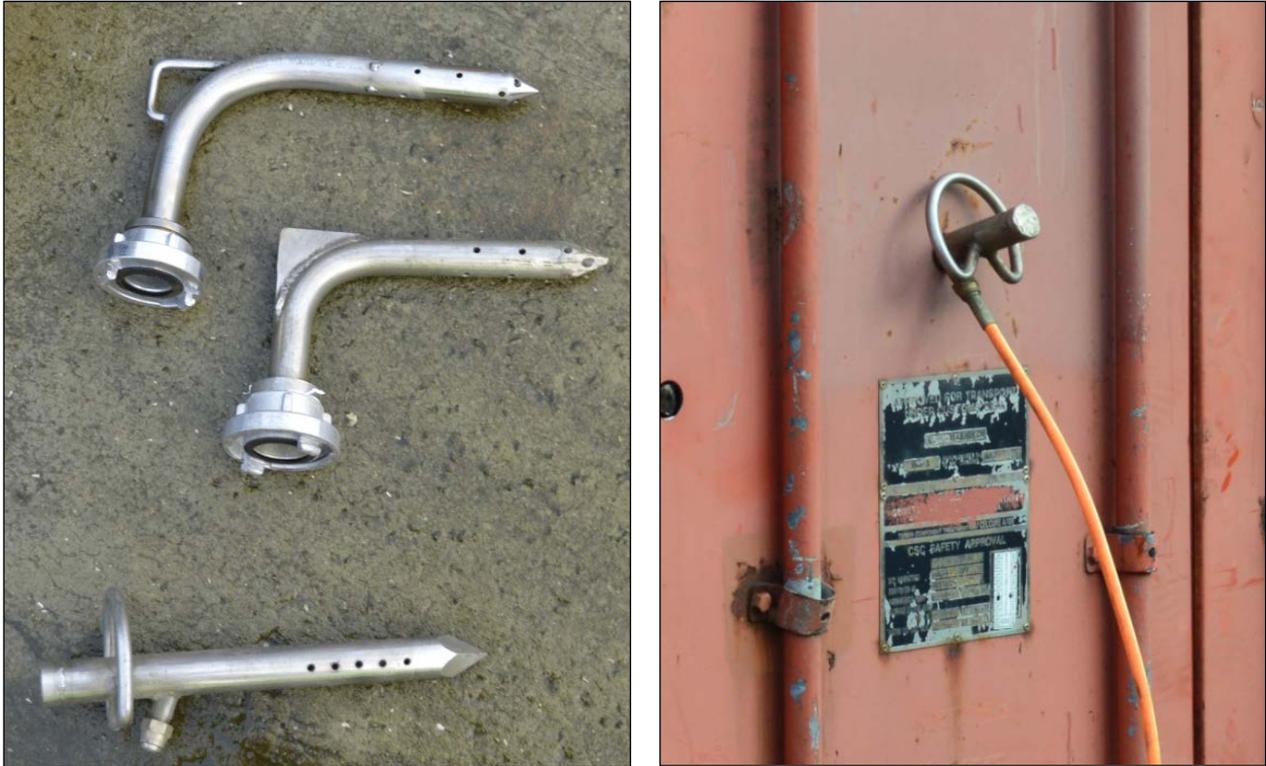
*Figure 10: Firefighting spear nozzles – Left: Two water spears, one CO<sub>2</sub> spear. Right: CO<sub>2</sub> spear mounted in container. Source: DMAIB*

On the day of the accident, the crew of CAROLINE MÆRSK deployed the container firefighting equipment in their attempts to manually extinguish the container fire. The initial attempt was unsuccessful as the drill was not capable of penetrating the container door. The crewmembers that used the equipment reported that the drill was not sufficiently powerful and that the hole saw was too weak, as it was quickly worn down after attempting to penetrate the container. Some crewmembers expressed that the unsuccessful deployment of the equipment was also a demotivating factor that added to an already stressful situation of dealing with a fire on board. Further attempts at penetrating the container were made, using angle grinders, which proved successful, as the crewmember managed to cut holes in a total of three containers, placing fire nozzles inside them and eventually containing the fire.
