Danish Maritime Accident
Investigation Board

MARINE ACCIDENT REPORT

TRITON
Foundering on 18 July 2015

This marine accident report is issued on 4 November 2015.

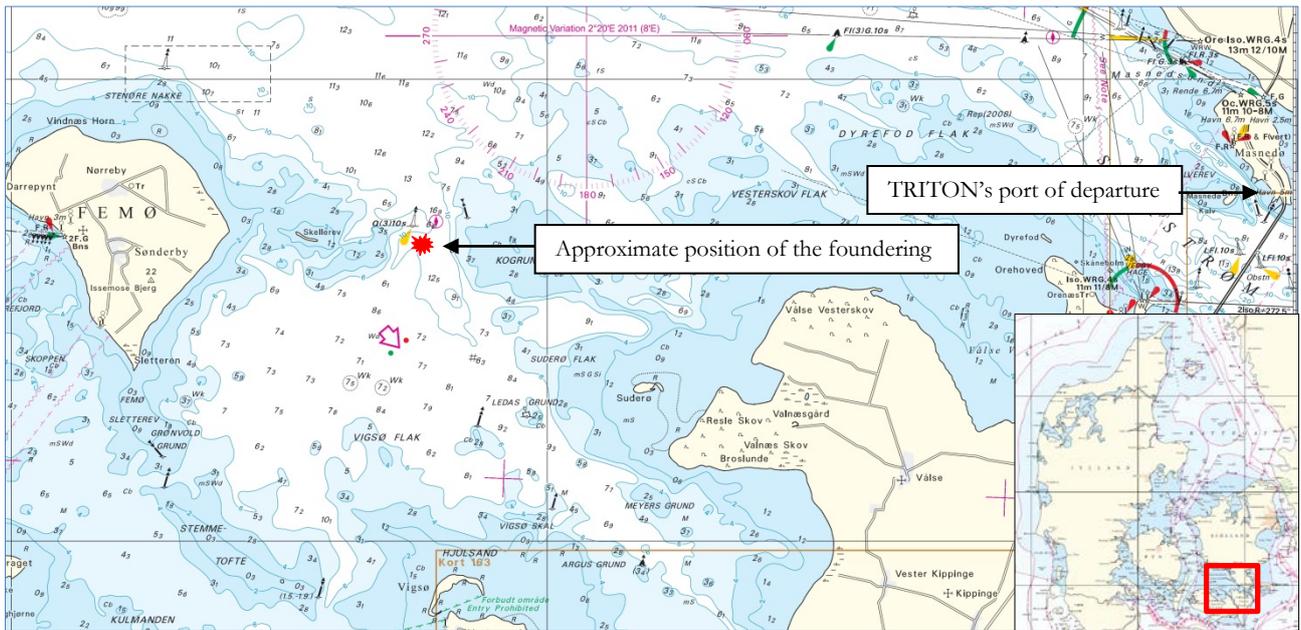
Figure 2: Position of foundering of TRITON

The pilot boat TRITON operated in Danish local and regional waters, but mainly in the local area of southern Zealand (see figure 2 above). The pilot boat was typically manned with one or two crewmembers depending on the circumstances of the voyage, e.g. weather conditions, distance and the carriage of passengers. On the day of the accident there was one crewmember on board the pilot boat.

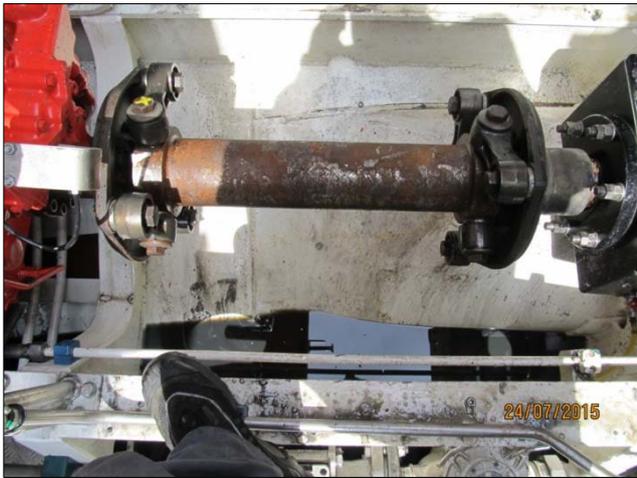
Figure 6: Intact drive shaft system on starboard side
Source: Survey Association

A picture of the intact starboard side drive shaft can be seen below on figure 6. The port side engine clutch housing was fractured (figure 7), presumably due to the excessive vibrations from the drive shaft breakdown.

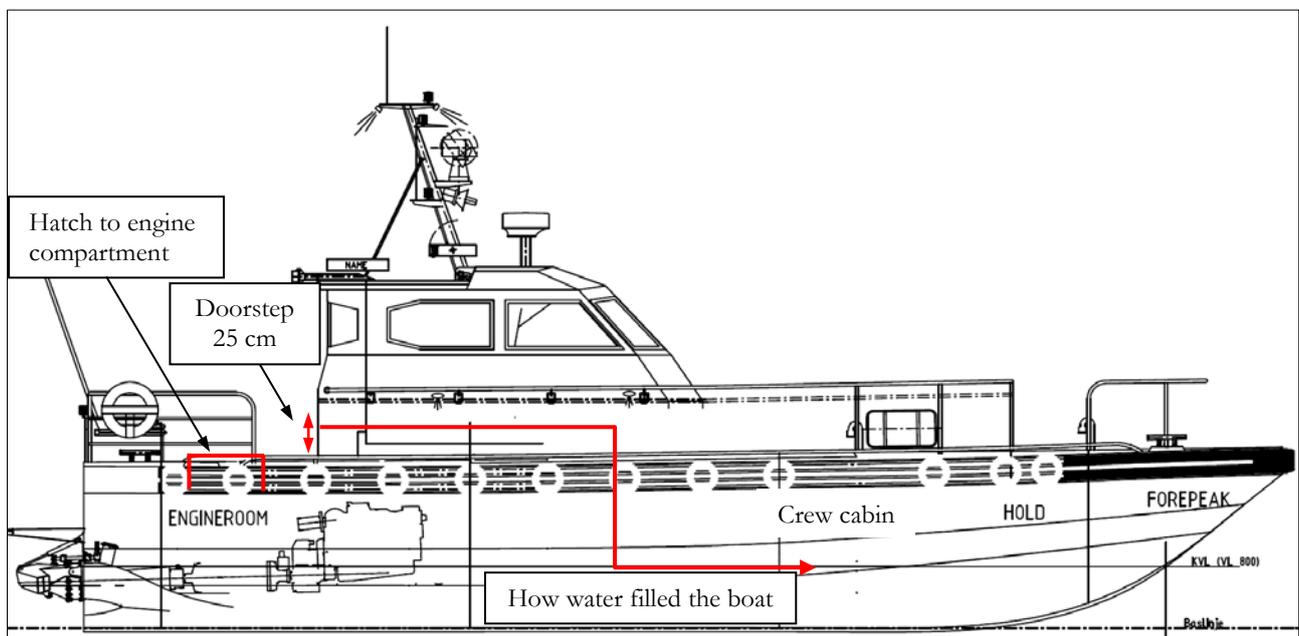
Figure 10: Section from general arrangement
Source: DanPilot

The boatman assumed that the flooding was caused by a leakage in one of the engine systems and therefore attempted to close the over board valves. Overwhelmed by the extent of the ingress of water, he abandoned the engine compartment and closed the deck access hatch to the engine compartment (figure 10).

As the water level in the engine compartment increased, the stern of the boat was submerged until the water reached the entrance to the wheelhouse. Once the wheelhouse threshold of approximately 25 cm was submerged, the water could fill the entire wheelhouse and crew cabin below via the staircase in the wheelhouse (figure 10).
