This marine accident report is issued on 2 July 2015.

On 1 November 2014, the Marshall Islands-registered chemical/products tanker KRASLAVA collided in restricted visibility with the St. Kitts & Nevis-registered refrigerated cargo ship ATLANTIC LADY in the Drogden Channel in the southern part of the Sound, Denmark.

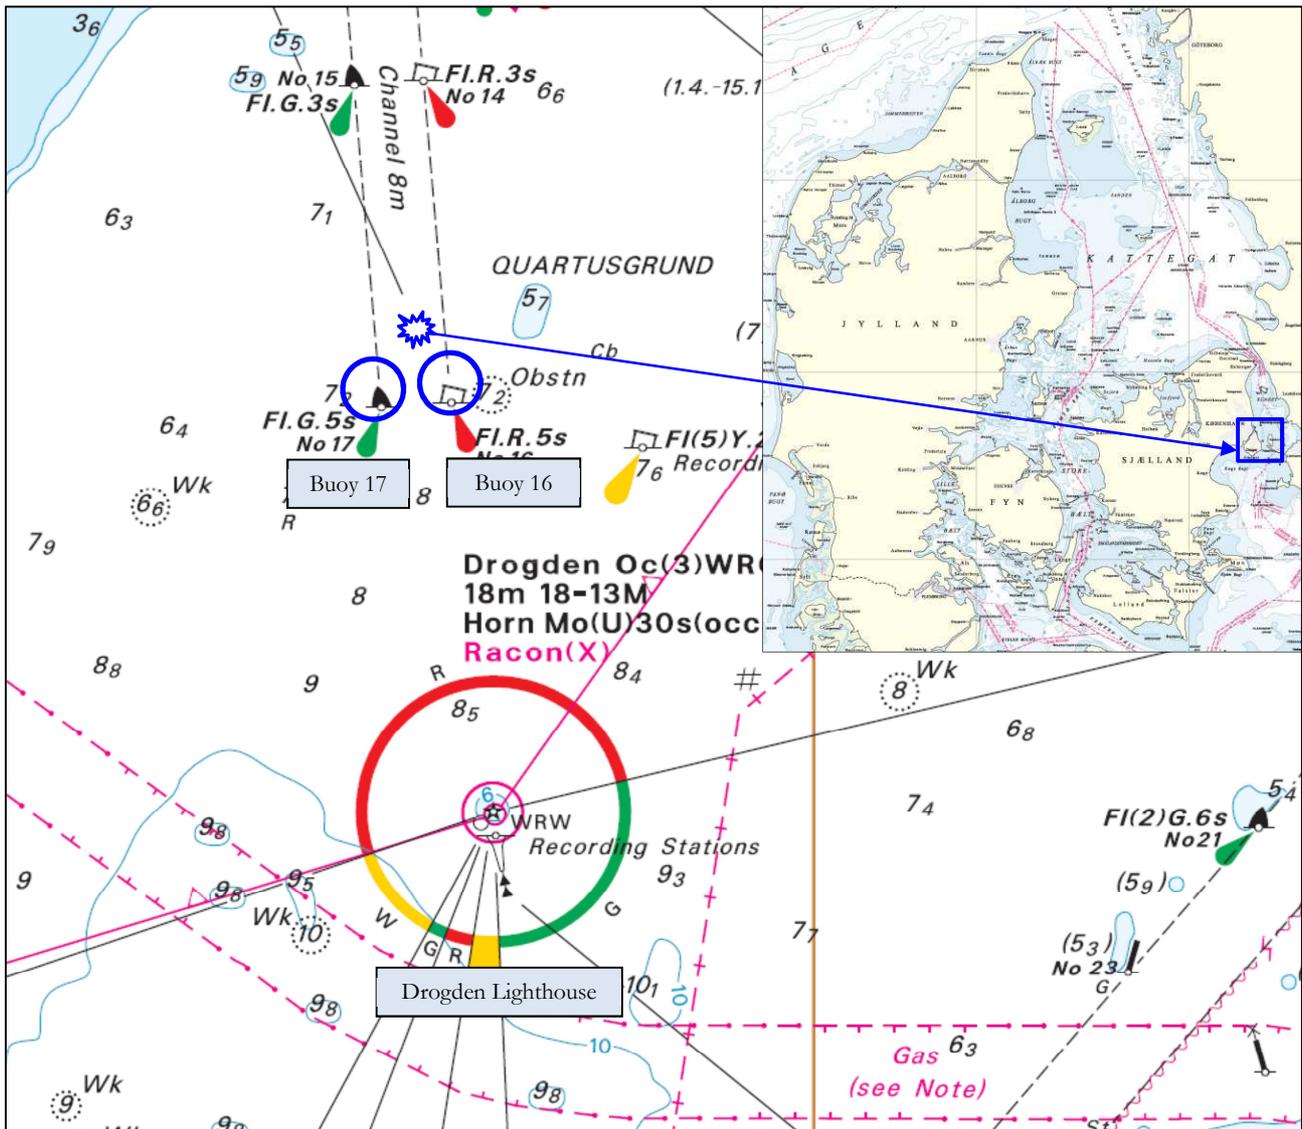
Figure 3: Scene of the collision. Southern part of the Sound, Denmark
 Source: Chart no 133, Danish Geodata Agency

As KRASLAVA proceeded to the exit of the Drogden Channel, ATLANTIC LADY was noticed on the radar approaching Drogden Lighthouse, south of the Drogden Channel (figure 3). The bridge team assumed that ATLANTIC LADY's intention was to pass the lighthouse on the port side and then make a starboard turn to enter the Drogden Channel, passing close to buoy no. 16. The pilot had seen ATLANTIC LADY before, while piloting ships in the sound, and was therefore familiar with it. The pilot did not observe anything irregular about ATLANTIC LADY's approach to the Drogden Channel, which seemed to be in accordance with normal practice when navigating in the area.

When KRASLAVA was approaching buoys 16 and 17 (figure 3), ATLANTIC LADY was seen on the radar passing close to buoy 16, presumably with the intention of turning to starboard after having passed the buoy. At this time was the visibility from the bridge on KRASLAVA approximately 70 metres.

As ATLANTIC LADY approached the Drogden Lighthouse south of the Drogden Channel (figure 3), there was a dense fog, and the visibility was significantly reduced. The reduced visibility was not considered to pose a significant risk, because there was only sparse traffic in the area.

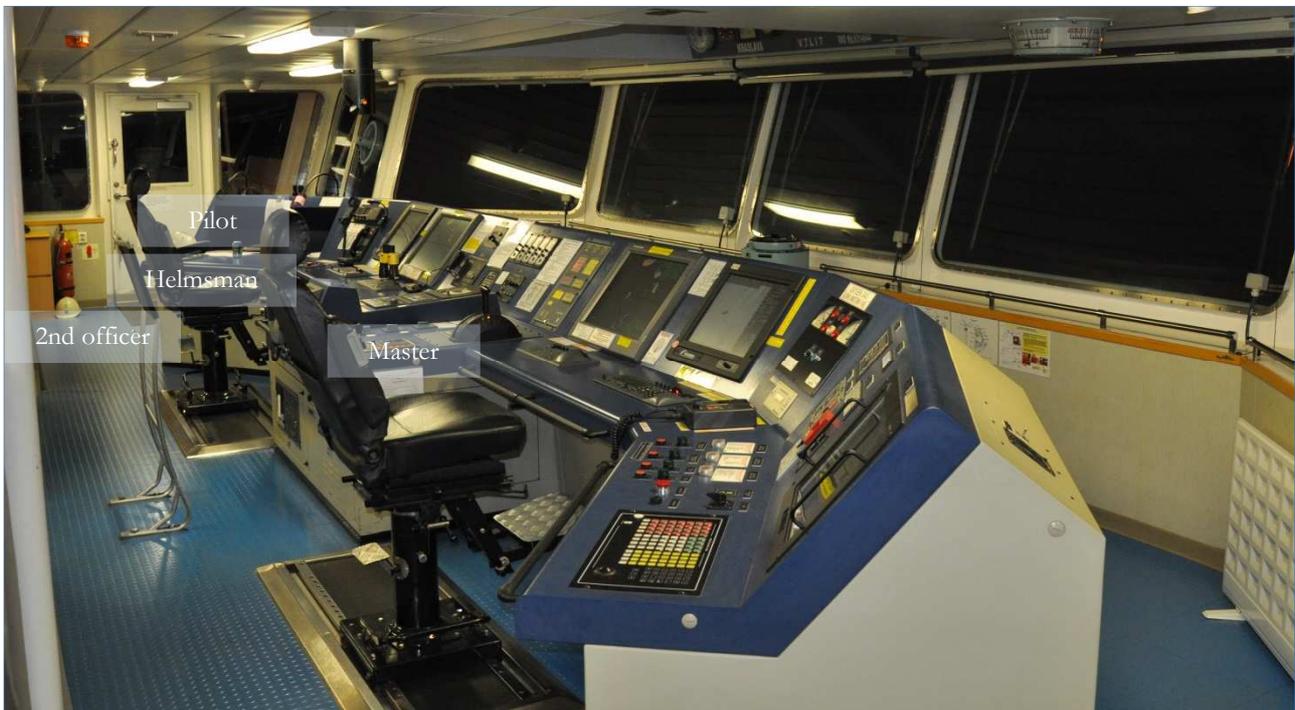
Figure 12: Bridge on KRASLAVA
Source: DMAIB

During the voyage through Danish waters, the pilot was positioned at the port side conning station (figure 12) and the master was on the starboard side. Both conning stations had an ECDIS and a radar display. The 2nd officer was moving around on the bridge, tasked with plotting positions on the paper chart, and was not involved in the monitoring of the other ship's manoeuvres.

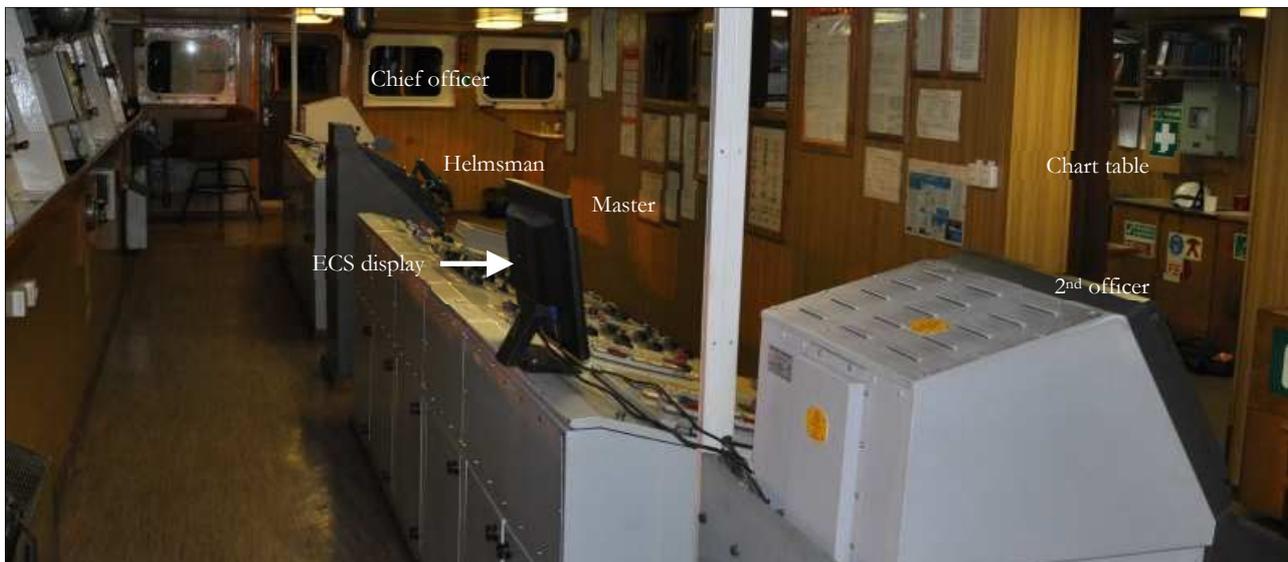
Figure 14: Bridge on ATLANTIC LADY
Source: DMAIB

Navigation was based on paper charts, supported by one ECS display slightly off centre to the port side of the bridge (figure 14). There were two radars, one on each side of the bridge operated by the officer of the watch and the chief officer. The chart table was situated aft of the conning stations and behind a wall with small windows. These provided a limited view out of the bridge front end windows while standing at the chart table.

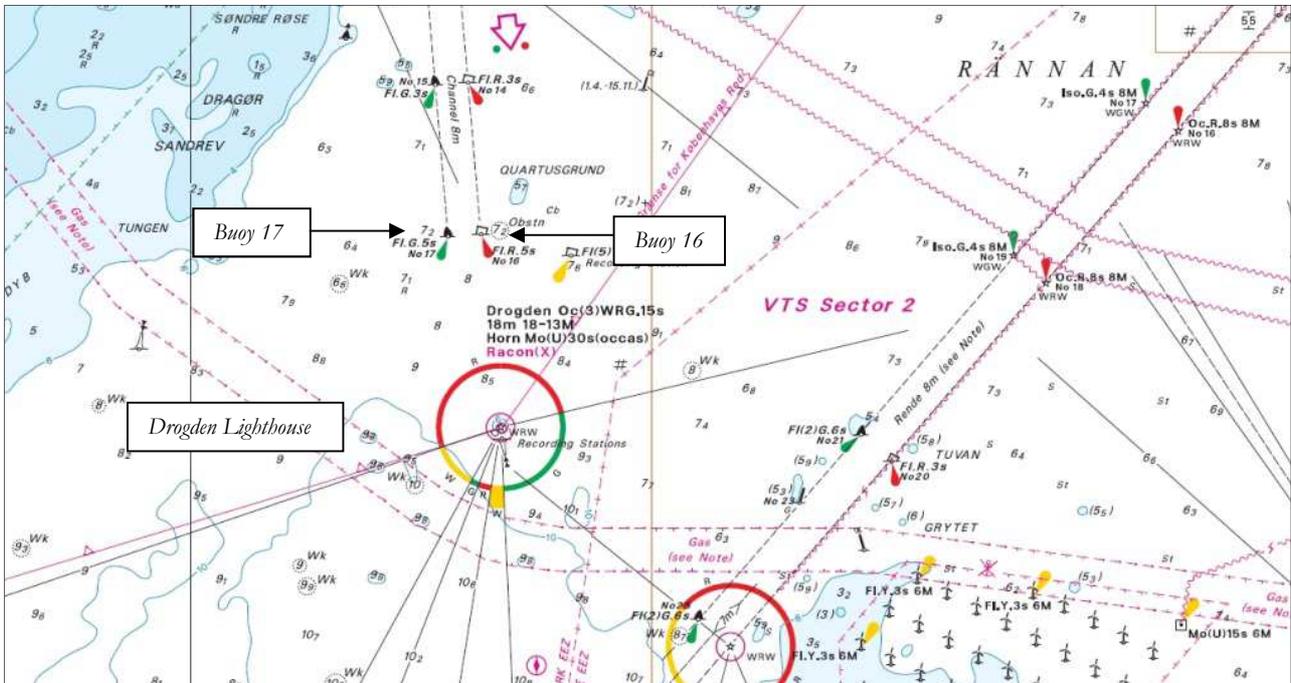
Figure 16: Drogden Channel and Drogden Lighthouse. Extract from chart 133
Source: Danish Geodata Agency

The pilot normally disembarks just south of the entrance to the channel, i.e. south of buoy no. 17 (figure 16).
