Danish Maritime Accident
Investigation Board

MARINE ACCIDENT REPORT

SEA GALE
Fire on 20 May 2014

This marine accident report is issued on 4 May 2015

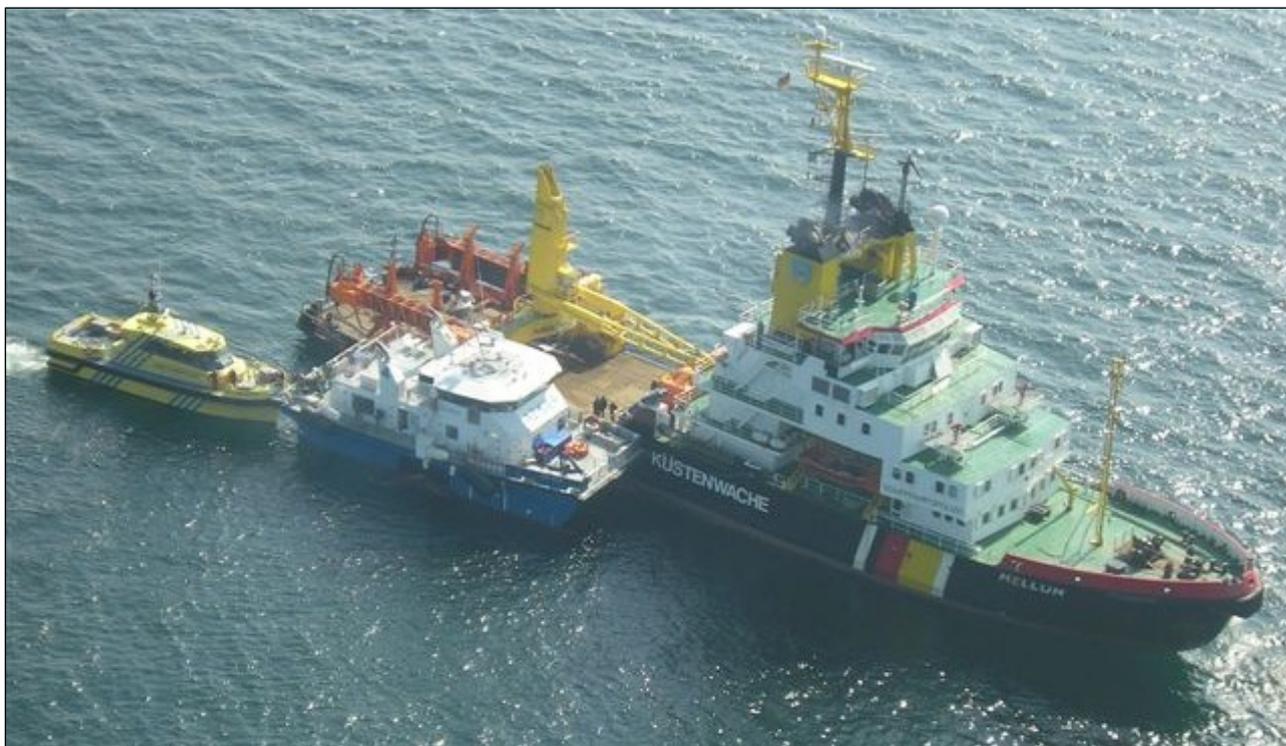
At 1100, the fire was reported to be under control. The MELLUM had made fast alongside SEA GALE half an hour earlier, and the firefighting teams continued the firefighting efforts and keeping watch on the situation (figure 7).

Figure 7: German Coast Guard vessel MELLUM alongside SEA GALE. Aft SC AMETHYST.
Source: Havariekommando
