**This marine accident report is issued on 3 March 2015.**

## 1. SUMMARY

On 10 July 2014, the Danish fishing vessel INGER MARIE and the Maltese general cargo ship RIG collided approximately 11 nautical miles north-east of the Island of Læsø, Denmark. INGER MARIE foundered shortly after the collision and the skipper, who was the only crew member on board, perished.

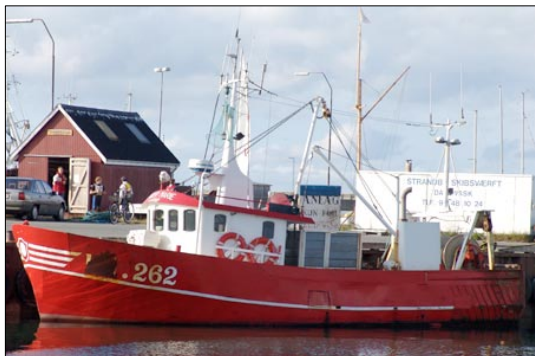
Figure 1: INGER MARIE, XP 3057  
Source: G. Vejen, [www.fiskerforum.dk](http://www.fiskerforum.dk)

The extent of the damage is not known. That INGER MARIE foundered with a considerable port list within one minute after the collision suggests that the damage was substantial.

Only the starboard side hull and superstructure was visible. Neither the starboard bow nor the side showed any signs of damage above or below the waterline, which means that the substantial part of the damage must have been suffered on the port side.

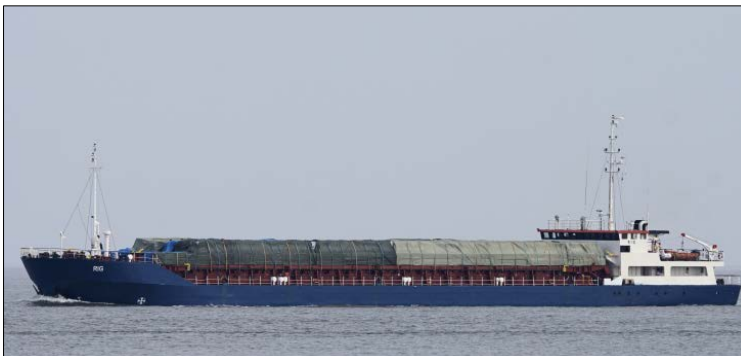
Figure 2: RIG, [www.shipspotting.com](http://www.shipspotting.com)  
Source: Claus Schaefer

Type of marine casualty/incident: Collision  
IMO classification: Very serious  
Date, time: 10 July 2014 at 0607 CET  
Location: Kattegat, Sweden  
Position: 57°26,81' N – 011°27,17'  
Ship's operation, voyage segment: RIG: International  
INGER MARIE: Coastal  
Place on board: Ship side  
Human factor data: Yes  
Consequences: INGER MARIE foundered immediately after the collision and the skipper perished. RIG suffered minor damage to port side anchor.

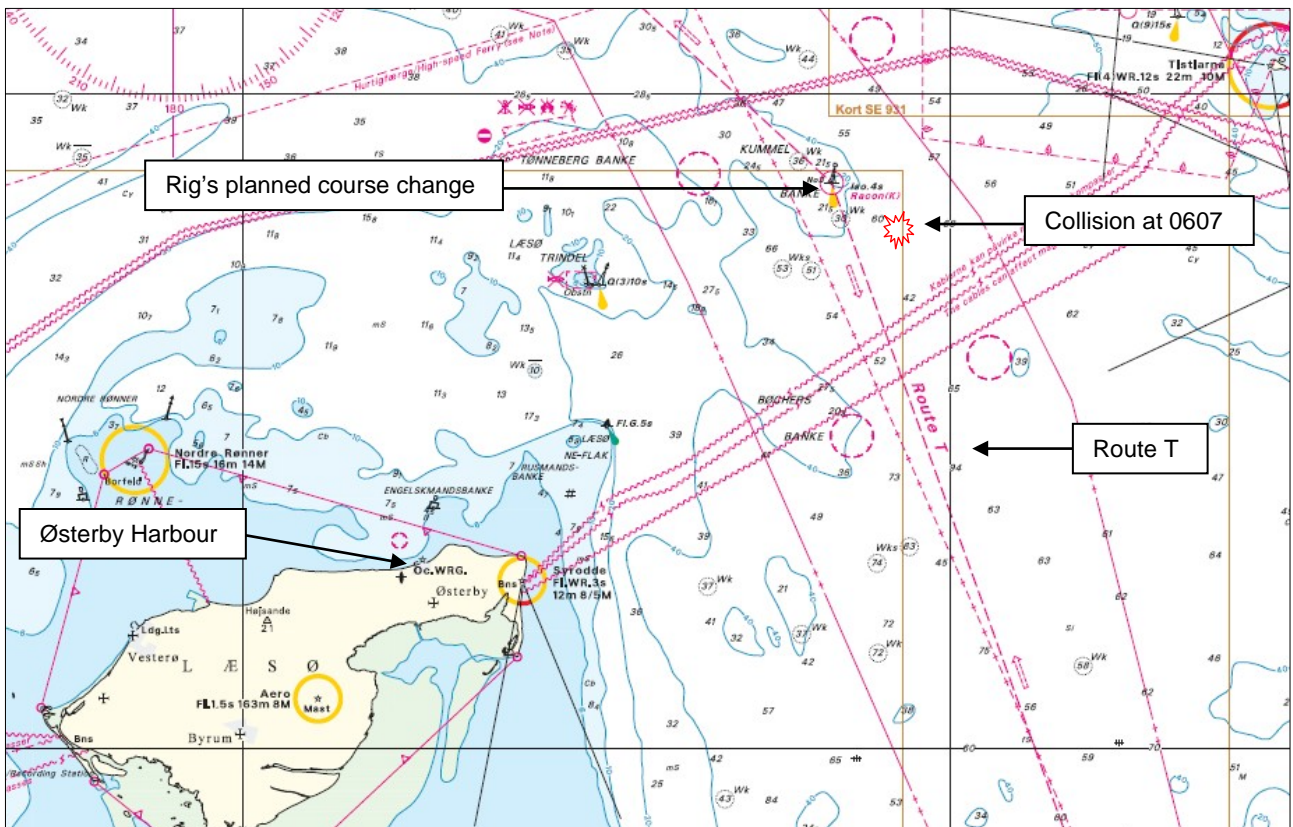
Figure 4: Overview of area of the collision  
Source: Chart no. 101. Danish Geodata Agency and DMAIB

On the morning of 10 July 2014 at approximately 0300, the chief officer came on watch, while the ship was proceeding on a northerly course following Route T (figure 4). The weather did not cause any concern as the visibility was good, force 3 winds and a slight sea.

Approximately 10 minutes before the planned course change at buoy no. 3 by Kummel Banke (figure 4), the officer of the watch suddenly saw a small fishing vessel approaching on a crossing course at close quarters on the starboard side. He then quickly went to the centre of the bridge, disengaged the auto steering and put the rudder to full starboard. As the ship was in the starboard turn, RIG's port side collided with INGER MARIE's port side at 0607 LT.
