MARINE ACCIDENT REPORT

March 2015

RIG and INGER MARIE
Collision on 10 July 2014

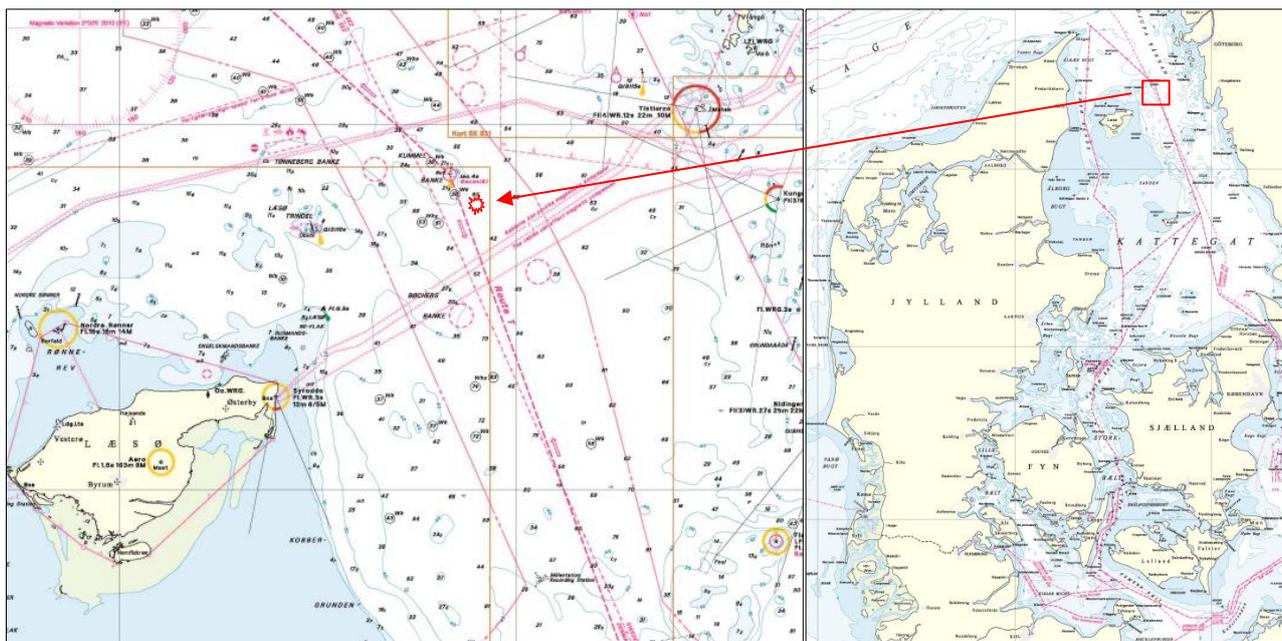
Figure 3: Approximate position of collision

On 10 July 2014, the Danish fishing vessel INGER MARIE and the Maltese general cargo ship RIG collided approximately 11 nautical miles north-east of the Island of Læsø, Denmark. INGER MARIE foundered shortly after the collision and the skipper, who was the only crew member on board, perished.

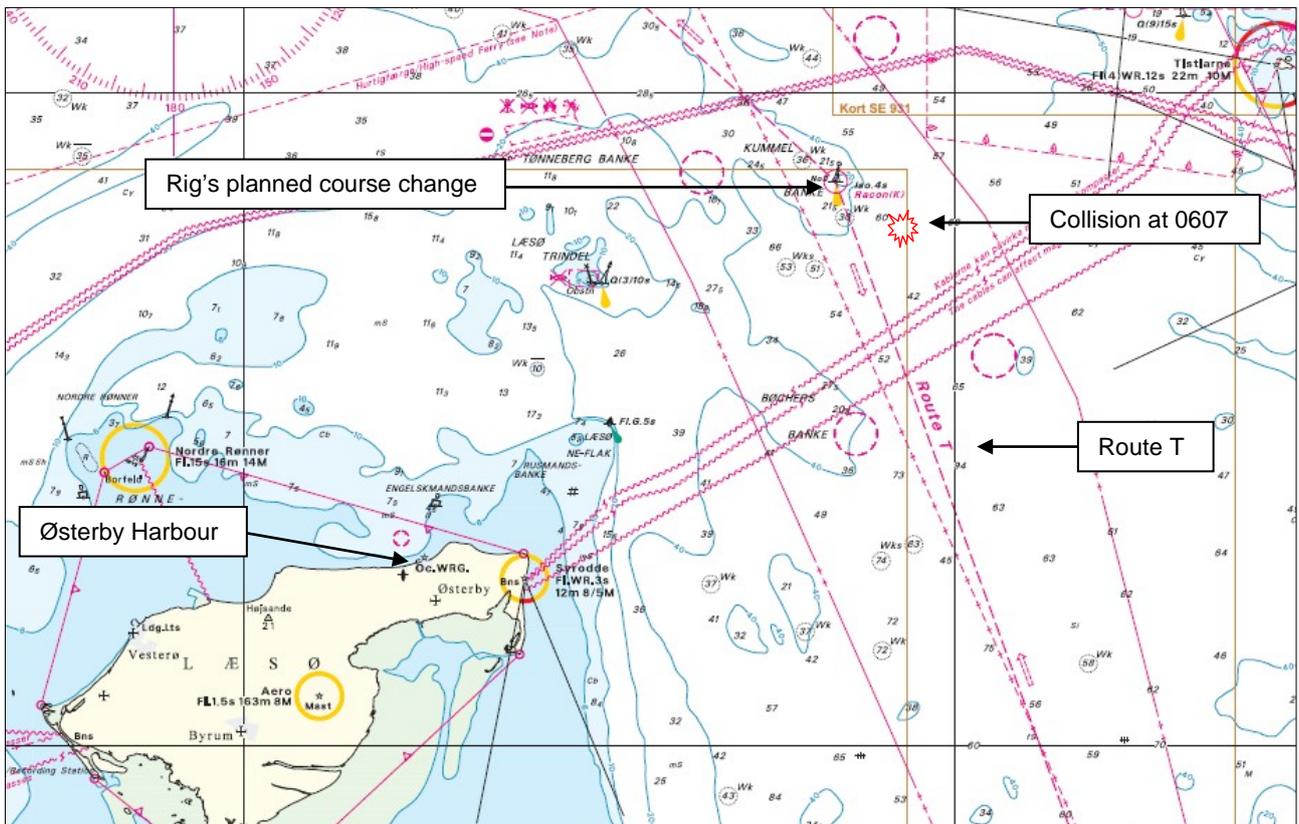
Figure 4: Overview of area of the collision
Source: Chart no. 101. Danish Geodata Agency and DMAIB

On the morning of 10 July 2014 at approximately 0300, the chief officer came on watch, while the ship was proceeding on a northerly course following Route T (figure 4). The weather did not cause any concern as the visibility was good, force 3 winds and a slight sea.

Approximately 10 minutes before the planned course change at buoy no. 3 by Kummel Banke (figure 4), the officer of the watch suddenly saw a small fishing vessel approaching on a crossing course at close quarters on the starboard side. He then quickly went to the centre of the bridge, disengaged the auto steering and put the rudder to full starboard. As the ship was in the starboard turn, RIG's port side collided with INGER MARIE's port side at 0607 LT.
