MARINE ACCIDENT REPORT

SVENDBORG MÆRSK
Heavy weather damage on 14 February 2014

This marine accident report is issued on 5 September 2014

Case number: 2013010519

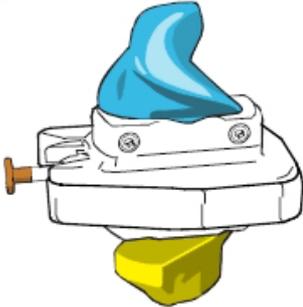
Figure 5: Fully Automatic Twistlocks (FATs)
Source: Maersk Line A/S

Throughout the cargo deck “Fully Automatic Twistlocks” (FATs) were used (figure 5). FATs were manually locked on containers positioned in tiers 82, 84 and 86. Above tier 86 the FATs were left in automatic mode. This type of twistlocks was designed to eliminate the time consuming task of unlocking twistlocks during cargo discharge operations in port, and to add an element of safety for the stevedores who did not need to climb ladders and container stacks etc.

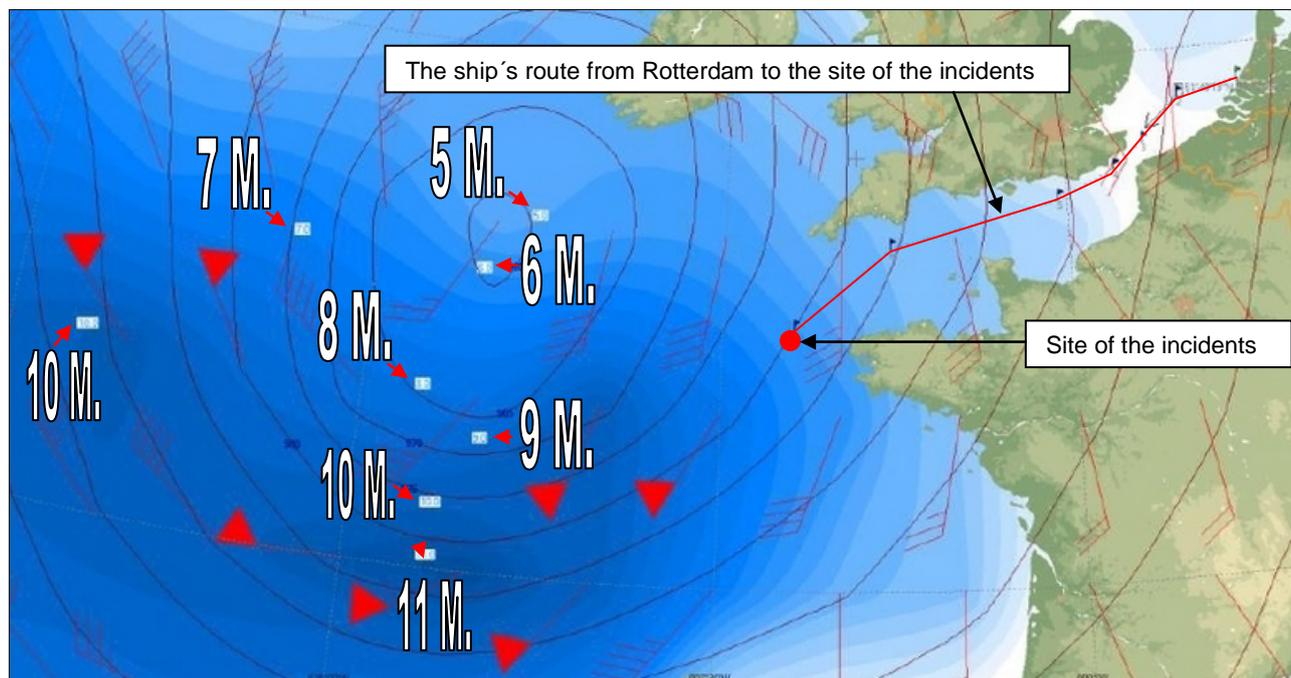
Figure 10: SPOS weather forecast for 14 February 2014 at 1200 UTC as forecasted on 13 February at 1200 UTC showing significant wave height (highlighted in large figures by DMAIB), air pressure isobars and wind speed/direction.

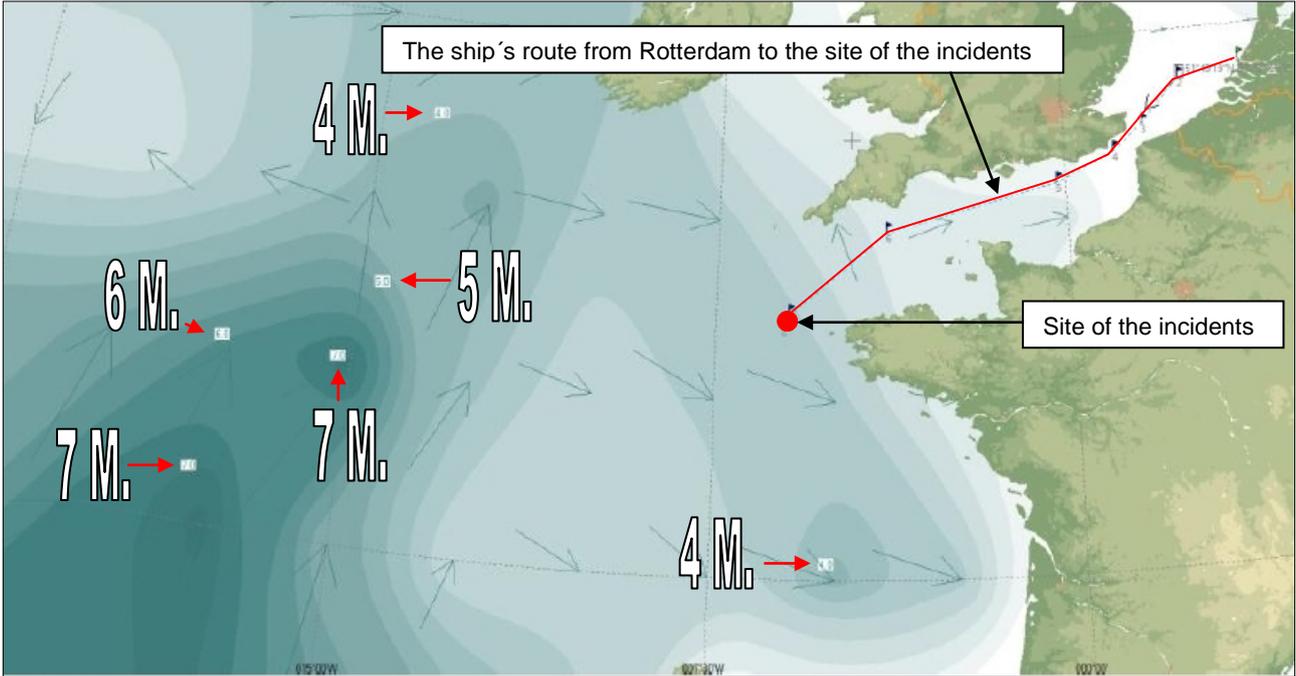
Figure 11: SPOS weather forecast for 14 February 2014 at 1200 UTC as forecasted on 13 February 2014 at 1200 UTC showing swell height (highlighted in large figures by DMAIB) and direction.
Source: MeteoGroup

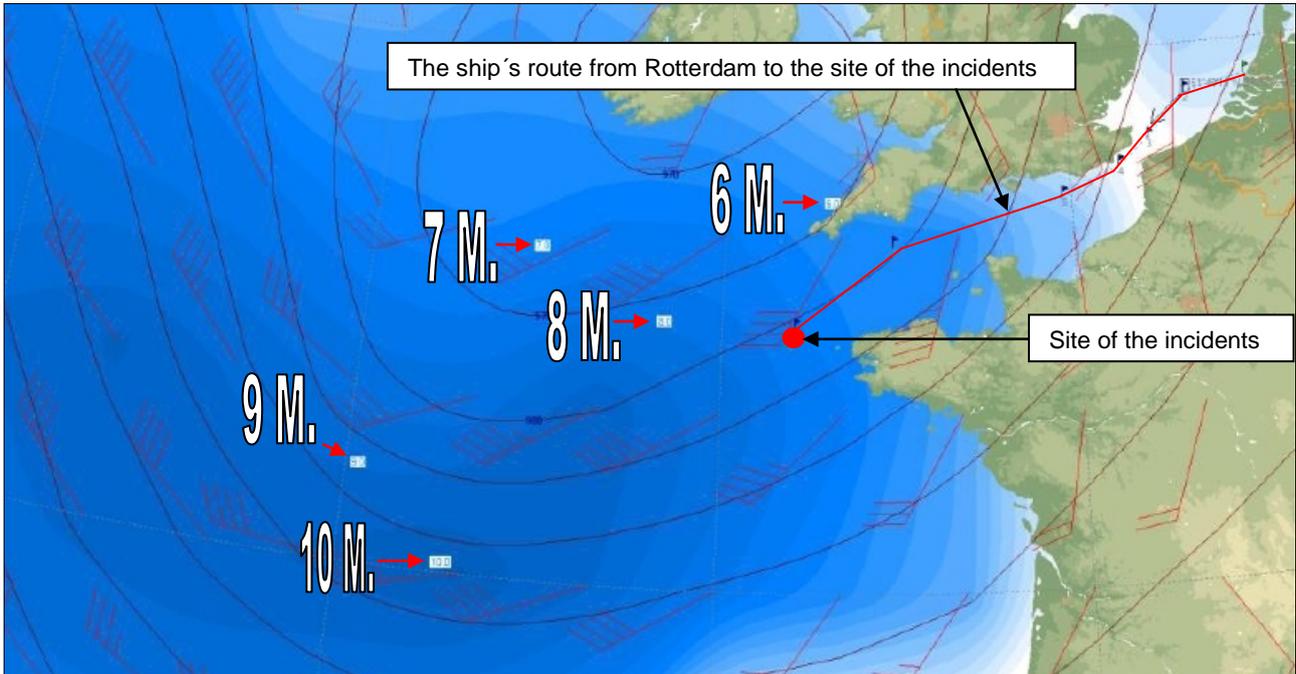
Figure 12: SPOS weather forecast for 14 February 2014 at 1800 UTC as forecasted on 13 February 2014 at 1200 UTC showing significant wave height (highlighted in large figures by DMAIB), air pressure isobars and wind speed/direction.
Source: MeteoGroup

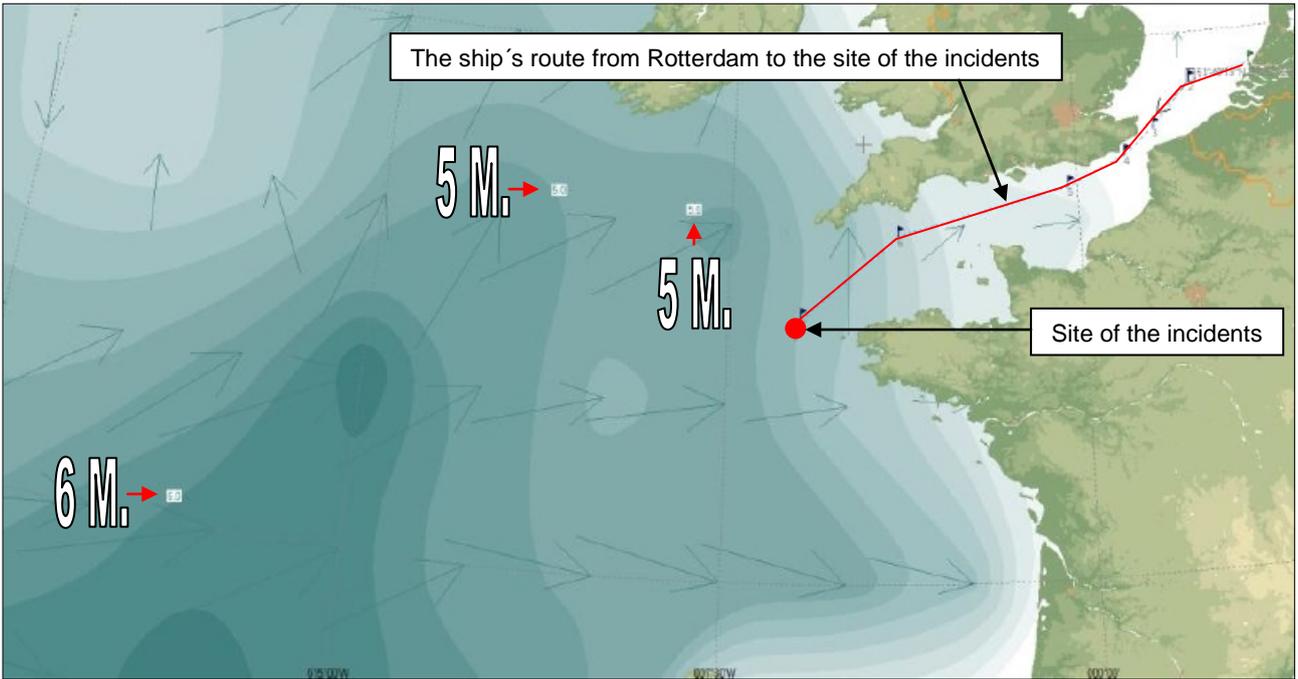
Figure 13: SPOS weather forecast for 14 February 2014 at 1800 UTC as forecasted on 13 February 2014 at 1200 UTC showing swell height (highlighted in large figures by DMAIB) and direction.
Source: MeteoGroup

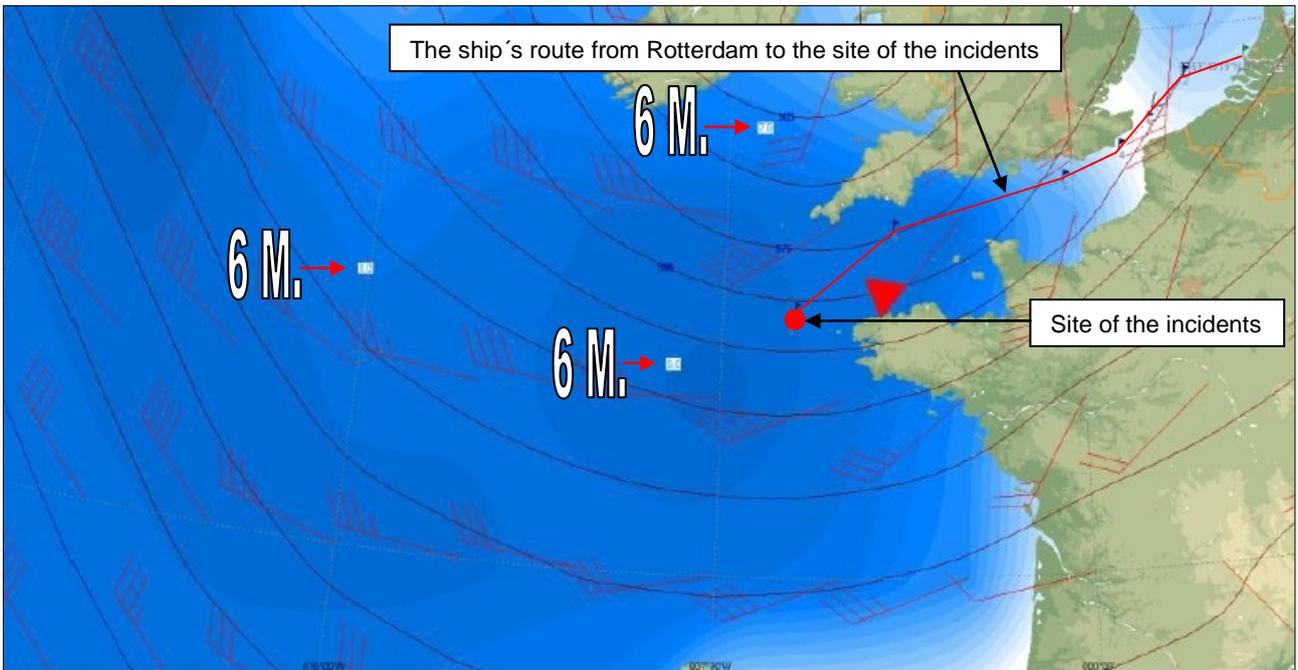
Figure 14: SPOS weather forecast for 15 February 2014 at 0000 UTC as forecasted on 13 February 2014 at 1200 UTC showing significant wave height (highlighted in large figures by DMAIB), air pressure isobars and wind speed/direction.
Source: MeteoGroup

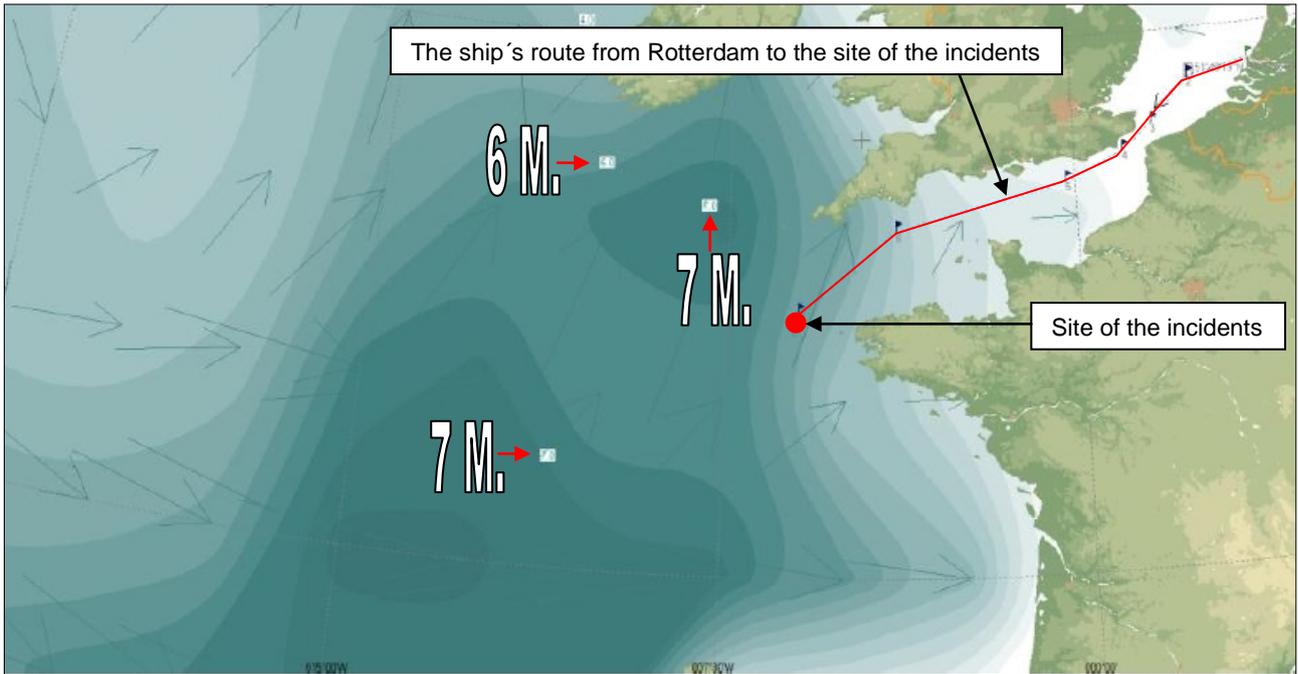
Figure 15: SPOS weather forecast for 15 February 2014 at 0000 UTC as forecasted on 13 February 2014 at 1200 UTC showing swell height (highlighted in large figures by DMAIB) and direction.
Source: MeteoGroup
