Danish Maritime Accident
Investigation Board

SUMMARY REPORT

September 2014

CHR. HØY
Mooring accident on 5 February 2014

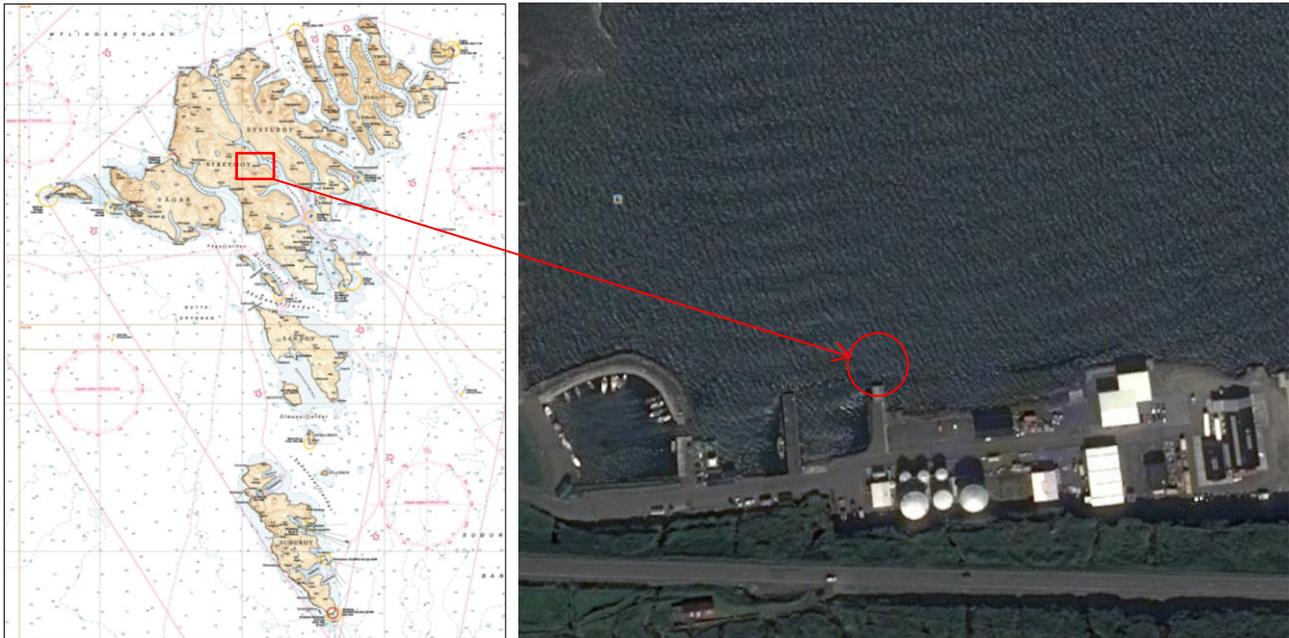
Figure 2: Pier where CHR. HØY was alongside.
Source: Danish Geodata Agency and Google Earth

The berth was shorter than the ship and therefore the mooring lines had to be secured on bollards on the pier and on shore (figure 2). The plan was to approach the pier with the bow first, secure a spring line and use the propulsion and rudder to manoeuvre the ship alongside. Thereafter, the ship was to be moored 1/2 – i.e. by means of one headline and two spring lines. Two of the spring lines (wire ropes) came from the shore side. The ratings were to finish the mooring forward before they secured the moorings aft.
