Danish Maritime Accident
Investigation Board

MARINE ACCIDENT REPORT

June 2014

URD
Fire on 4 March 2014

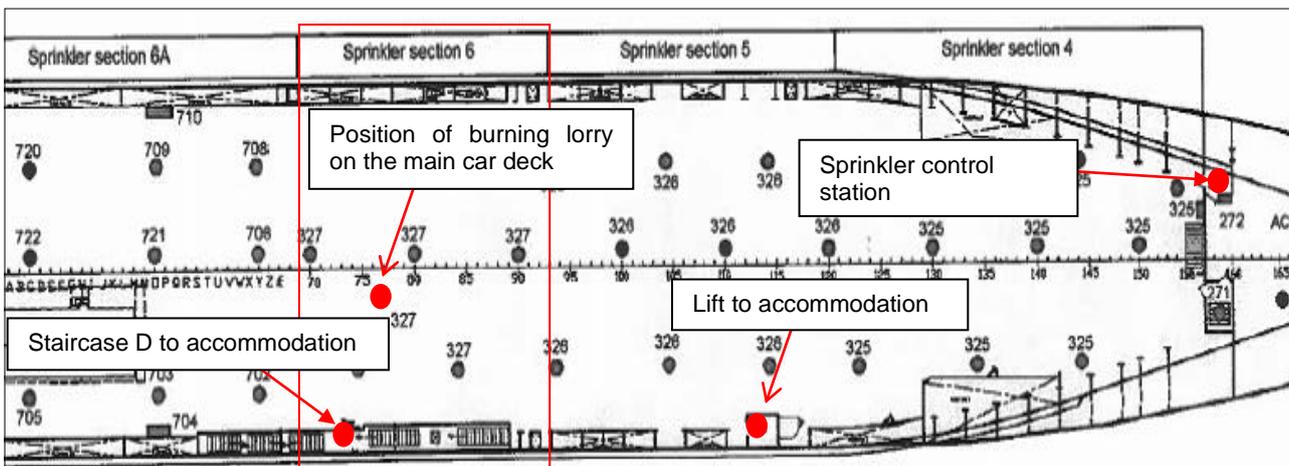
Figure 3: Forward end of main car deck on board URD
Source: Stena Line

At the sprinkler control station the 2nd engineer met an able seaman (AB). The AB informed the 2nd engineer that he was sure that the fire was in section 6 (figure 3). At 0750, the car deck sprinkler system was activated in section 6, where the burning lorry was situated. Subsequently, the 2nd engineer made his way to fire station no. 1 on the bridge deck to muster in accordance with the fire muster list. The 3rd engineer proceeded to the engine control room also to muster according to the fire muster list.

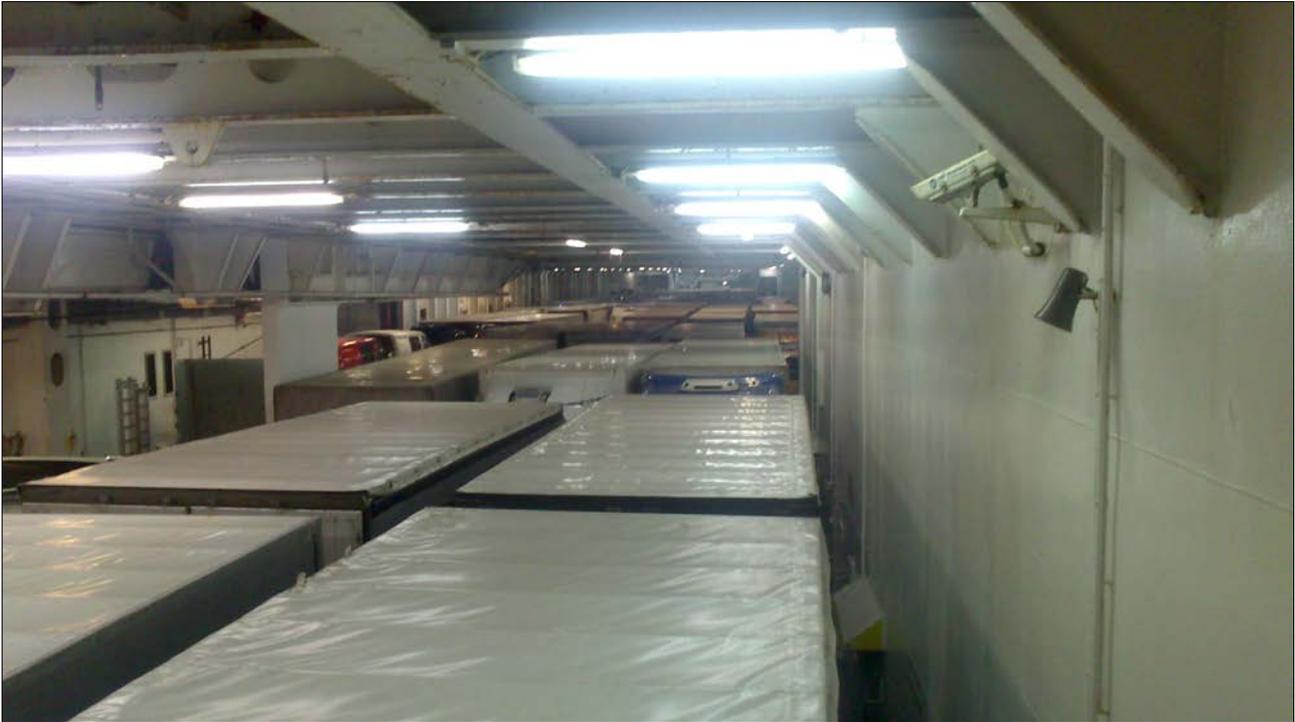
Figure 4: Main car deck on board URD, fully stowed on the day of the fire. Looking aft
Source: Stena Line

flames could be observed from the trailer. A fire hose was put into action, but the firefighters experienced difficulties in their efforts due to the densely stowed vehicles on the car deck (figure 4). The chief officer joined them and climbed onto the cabin of the lorry next to the one on fire. A knife was handed to the chief officer so that he could cut open the rest of the burnt tarpaulin on the lorry in order to pour water directly onto the cargo inside the lorry by means of the fire hose.

The burnt lorry was situated on the main car deck in the third vehicle lane, counting from the star-board side where the firefighters rigged their fire hose. Between the position of the firefighters and the lorry on fire was a car with a trailer and another lorry in the adjacent vehicle lines.

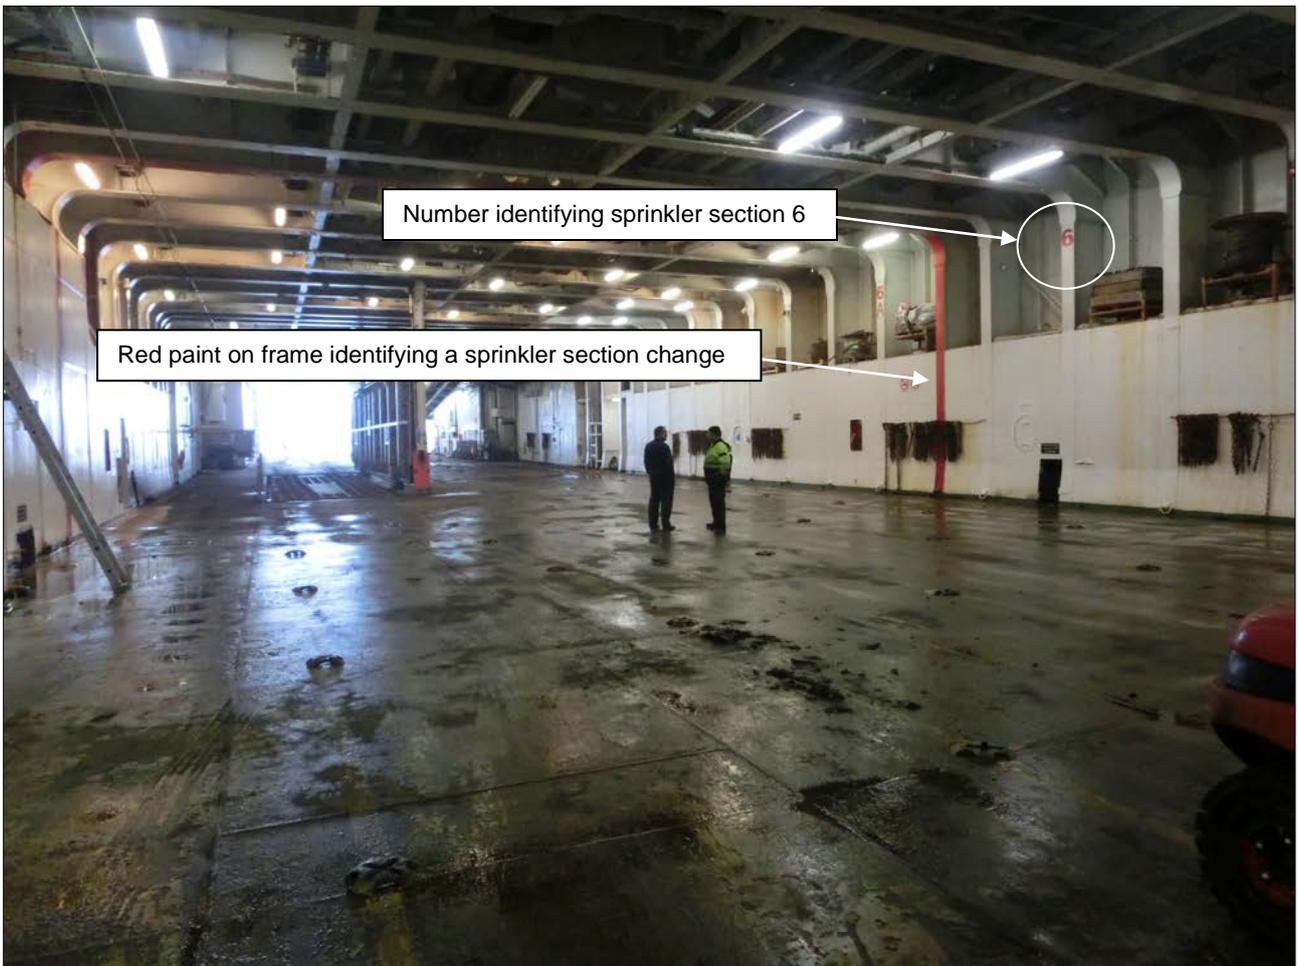
Figure 10: Identification of sprinkler sections on the empty main car deck on board URD
Source: DMAIB

As smoke developed, it gathered underneath the deck above, limiting the visibility between the deck above and the top of the lorries. This made it difficult to identify the individual sprinkler sections as they were marked with numbers on the frames on the ship's sides (figures 9 & 10).

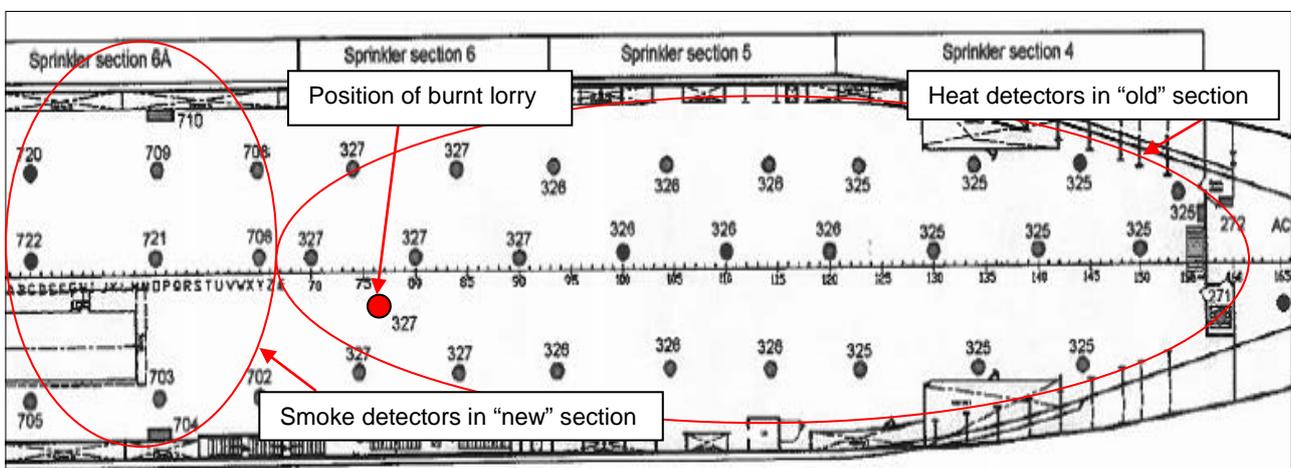
Figure 12: Main car deck automatic fire detectors (numbered dots), forward end
Source: Stena Line

Automatic fire detectors were placed throughout the car deck. In the new section, smoke activated detectors were installed on the main car deck. In the original sections of the ship, at both ends, heat detectors were installed. To activate a smoke detector on the main car deck, smoke would need to develop sufficiently to reach the new section. The burnt lorry was situated in the original forward section approx. 20 metres from the closest smoke detector in section 6A, delaying the automatic fire detection as it did not initially create sufficient heat to activate the heat detectors in sprinkler section 6 (figure 12).
