MARINE ACCIDENT REPORT

SPRING GLORY / JOSEPHINE MÆRSK

Collision on 5 June 2012

This marine accident report is issued on 3 May 2013

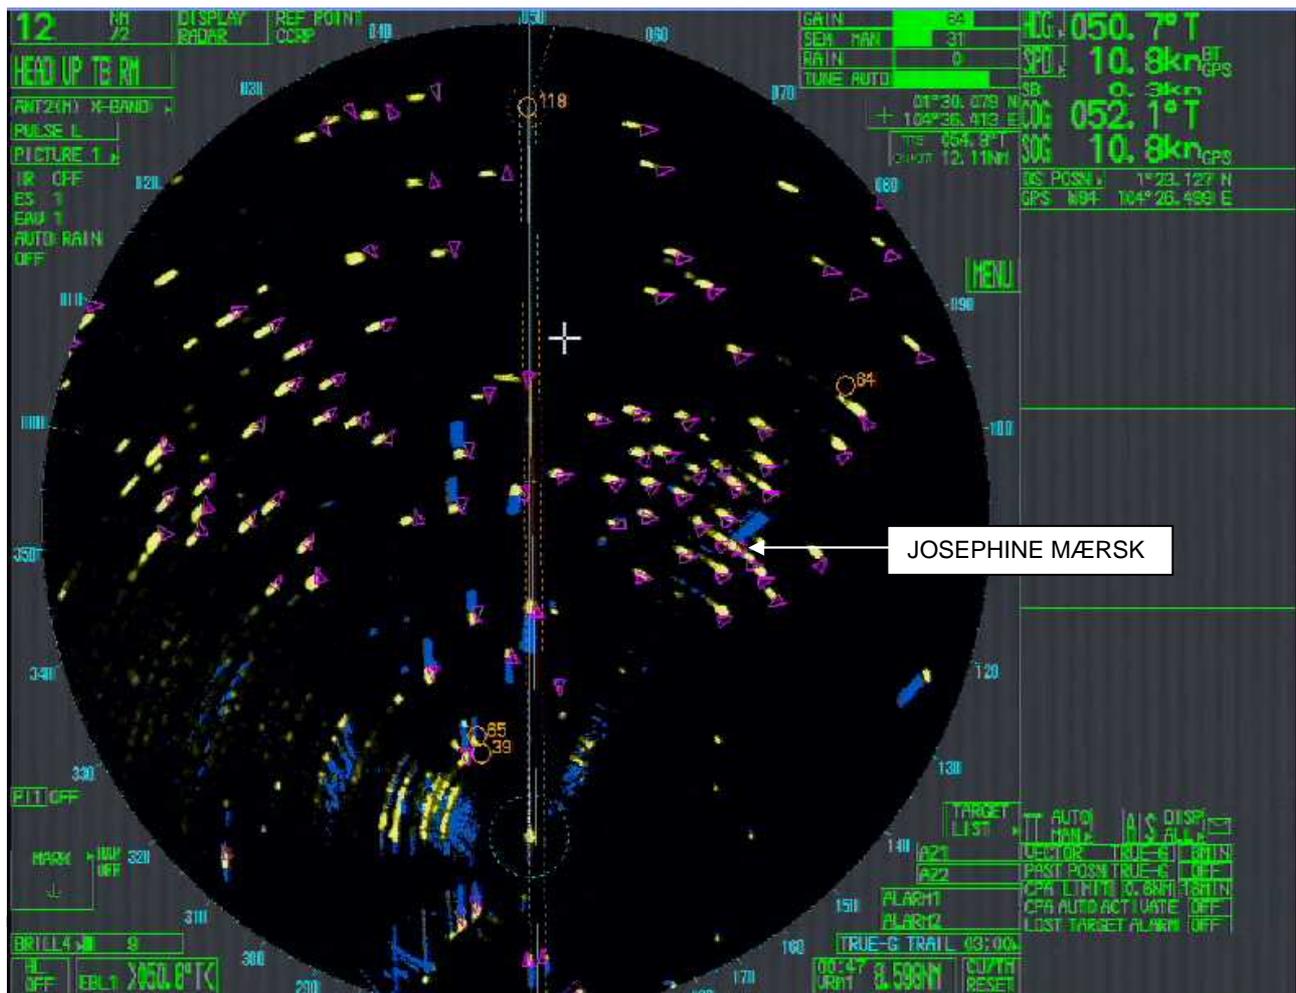
Figure 5: Recording of radar from SPRING GLORY at 22:16:05
Source: VDR/SPRING GLORY

The radar setting was 6 nm range head up, off centre and relative motion. The ARPA plot functions were not used, but trails were used. The radar had AIS overlay. At 2216 hours, the radar range was 12 nm for about 15 seconds as shown in figure 5 below. JOSEPHINE MÆRSK was then visible with a clear trail at a distance of approx. 10 nm on the starboard bow and crossing the course of SPRING GLORY. Thereafter and until the collision, JOSEPHINE MÆRSK remained visible on the radar at a setting of 6 nm.

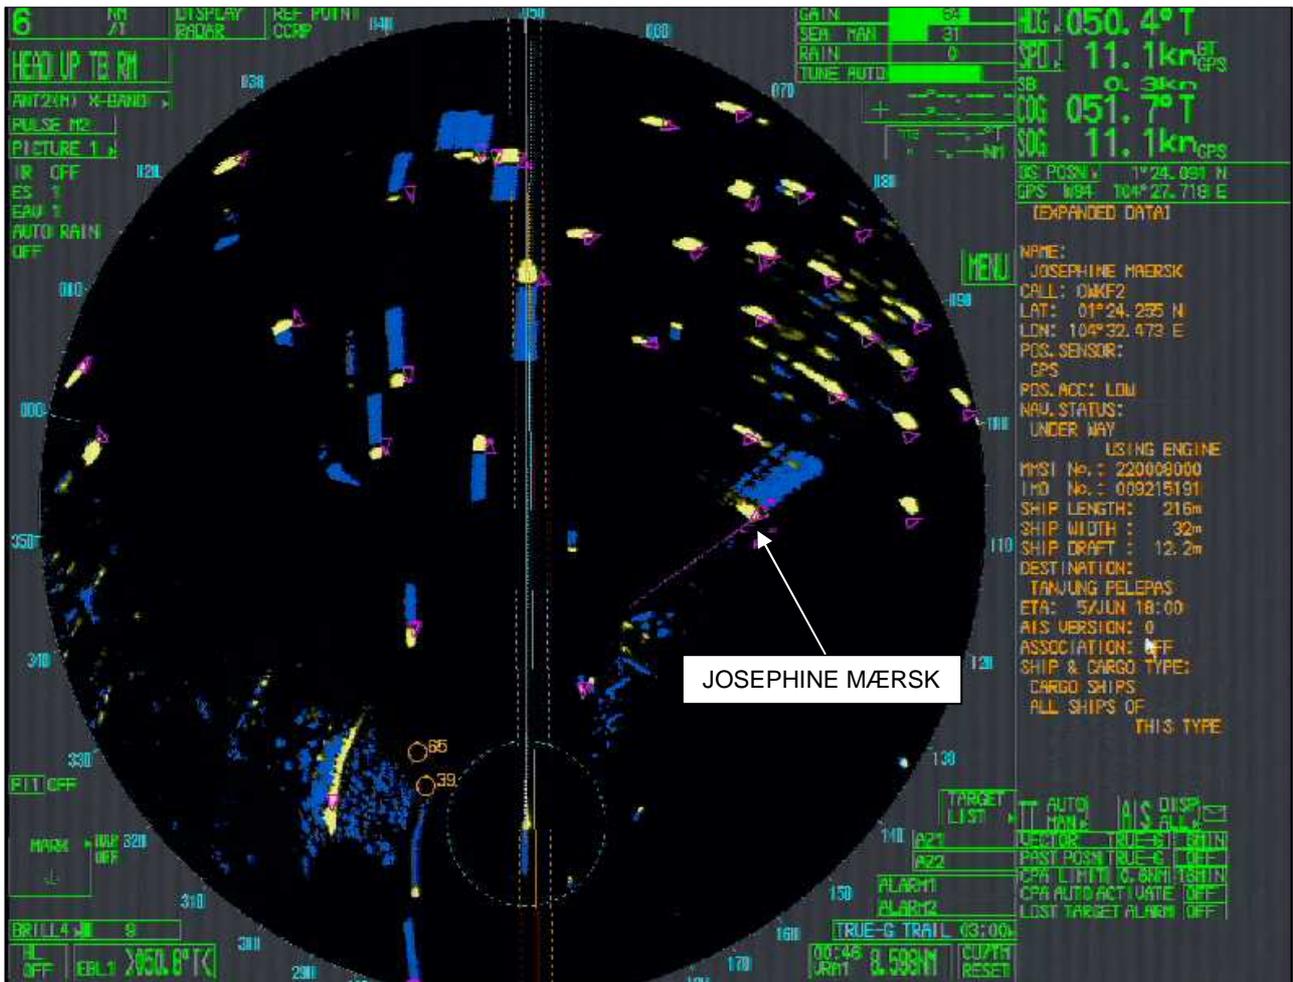
Figure 6: Recording of radar from SPRING GLORY at 22:24:36
Source: VDR/SPRING GLORY

At 22:24:04 hours, at a distance of approx. 5 nm, JOSEPHINE MÆRSK was selected as a target on the radar and identified with expanded data on the AIS. The bearing on JOSEPHINE MÆRSK had not changed. On the port bow SPRING GLORY had several oncoming ships and on the starboard bow apart from JOSEPHINE MÆRSK a few oncoming vessels, probably fishing vessels, and several ships at anchor as shown in figure 6 below.

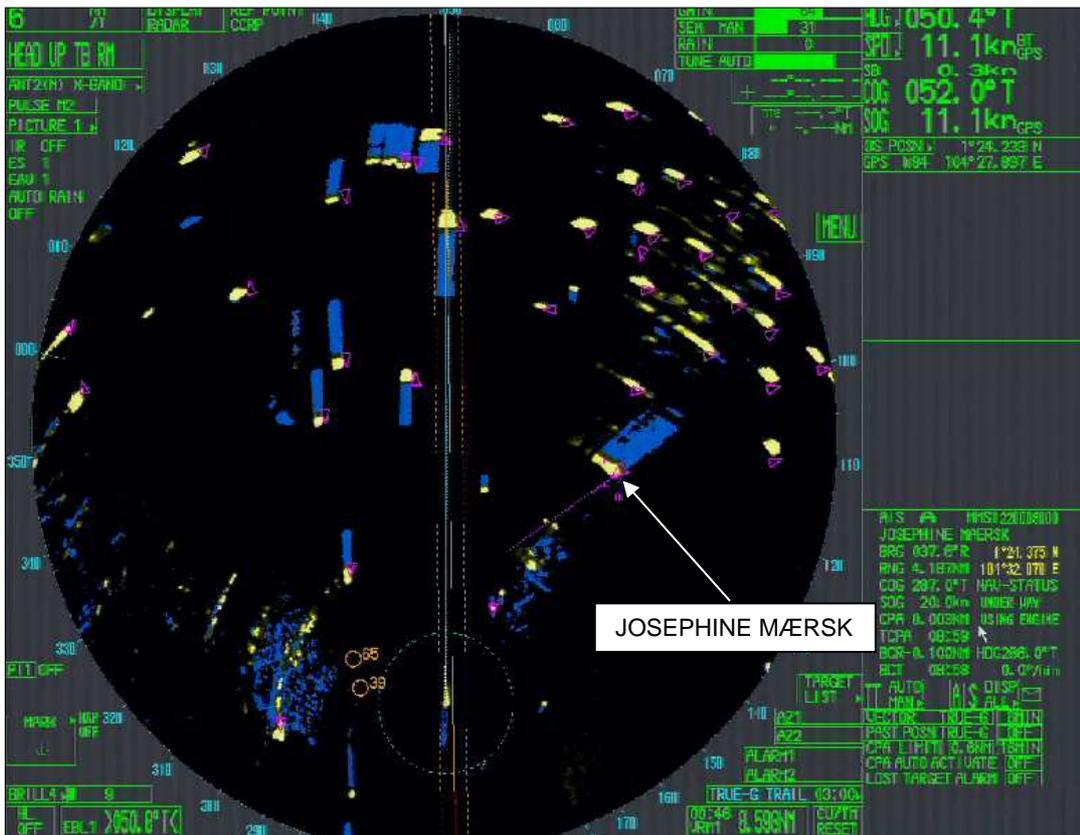
Figure 7: Recording of radar from SPRING GLORY at 22:26:00
Source: VDR/SPRING GLORY

A few minutes later, at 22:26:00 hours, JOSEPHINE MÆRSK's closest point of approach (CPA) was indicated as 0.03 nm and the time to the closest point of approach (TCPA) was indicated as 8:59 minutes on the radar of SPRING GLORY as show in figure 7 on the next page.

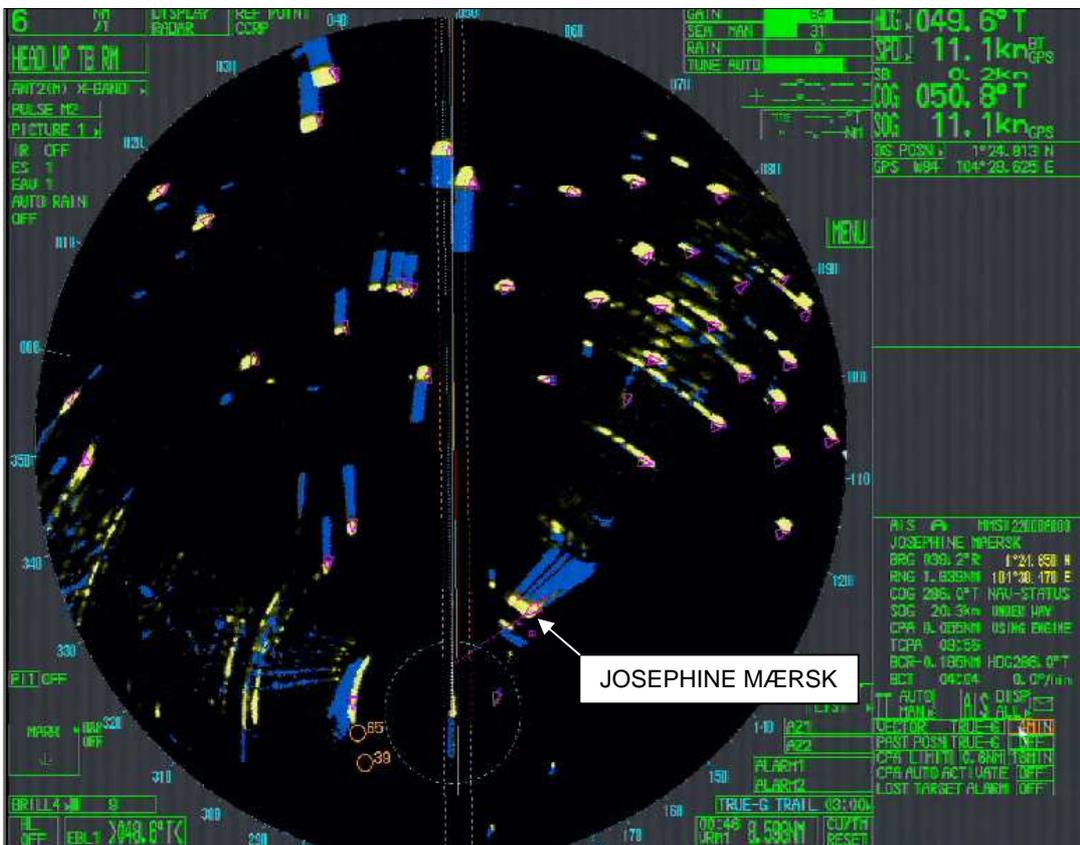
Figure 8: Recording of radar from SPRING GLORY at 22:31:00
Source: VDR/SPRING GLORY

At 22:30:53 hours, at a distance of approx. 2 nm, the officer of the watch on SPRING GLORY called JOSEPHINE MÆRSK on VHF channel 16 without receiving any reply. The situation is shown in figure 8 on the previous page.

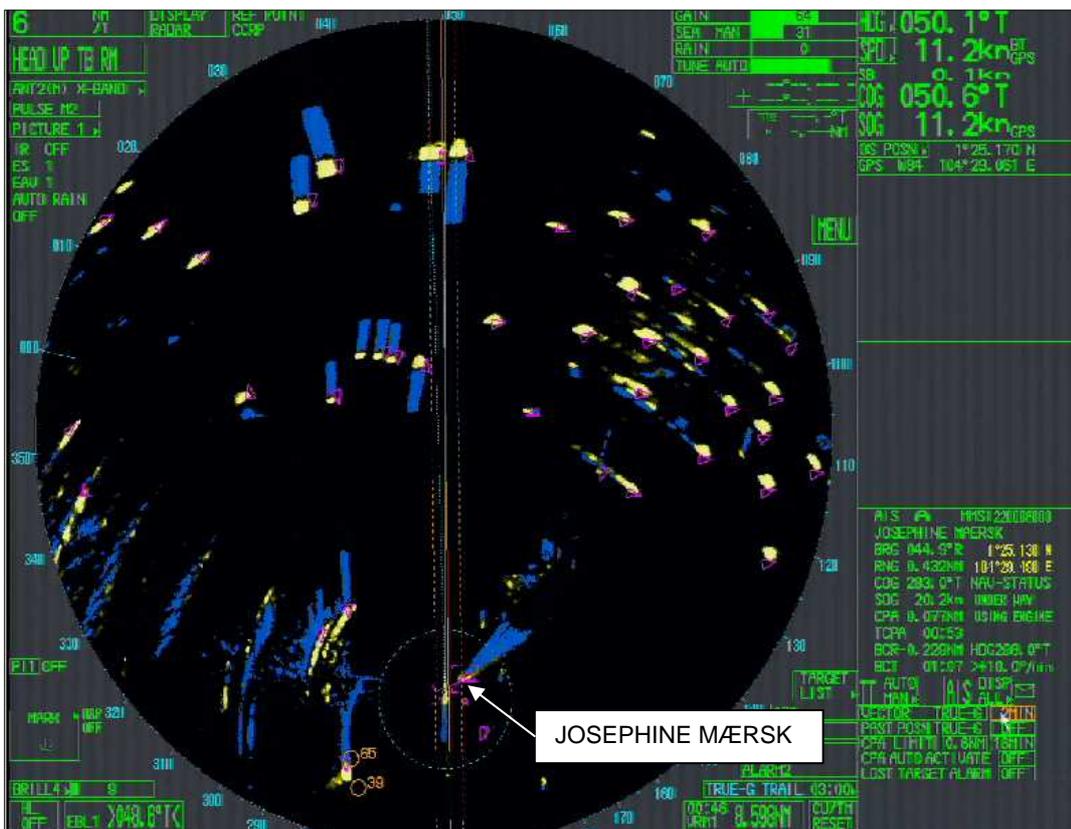
Figure 9: Recording of radar from SPRING GLORY at 22:34:00
Source: VDR/SPRING GLORY

At 22:34:00 hours, at the heading 50° and speed 11.2 knots and a very short distance to JOSEPHINE MÆRSK, SPRING GLORY initiated a hard turn to port. The situation is shown in figure 9 on the previous page.

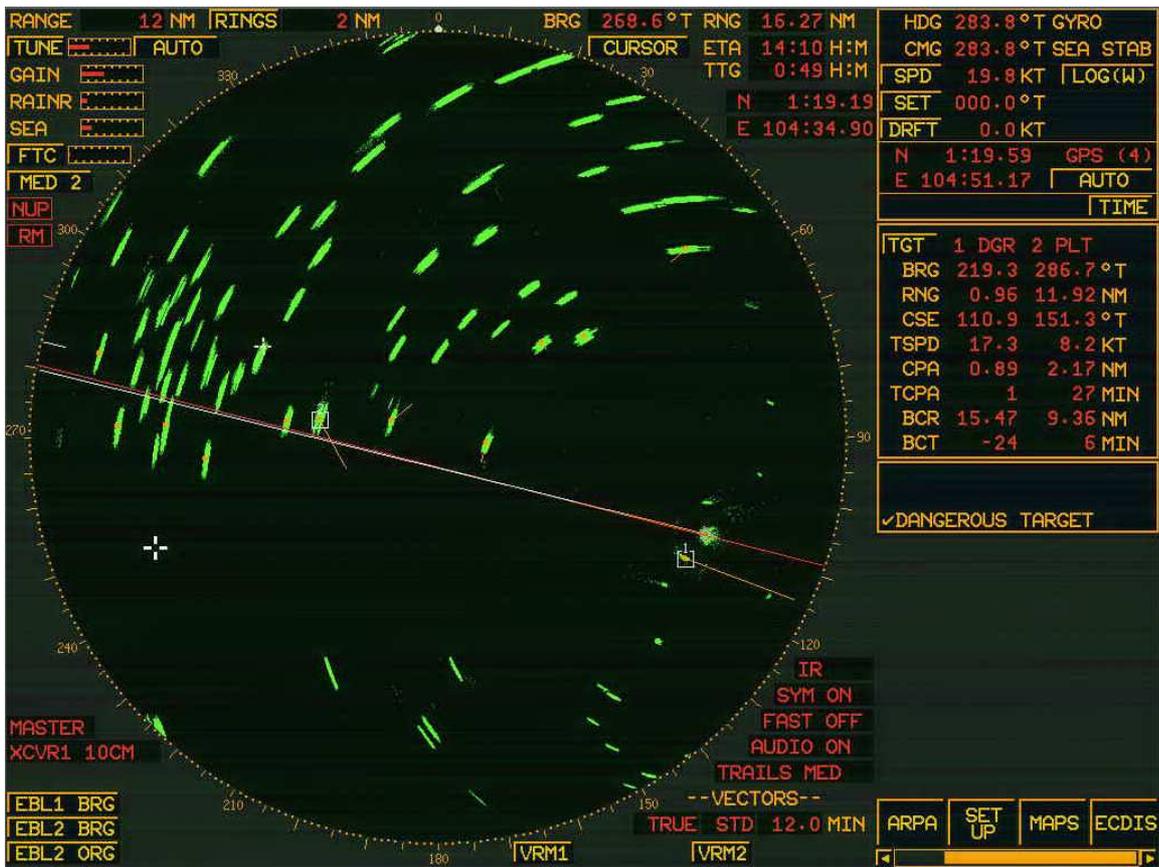
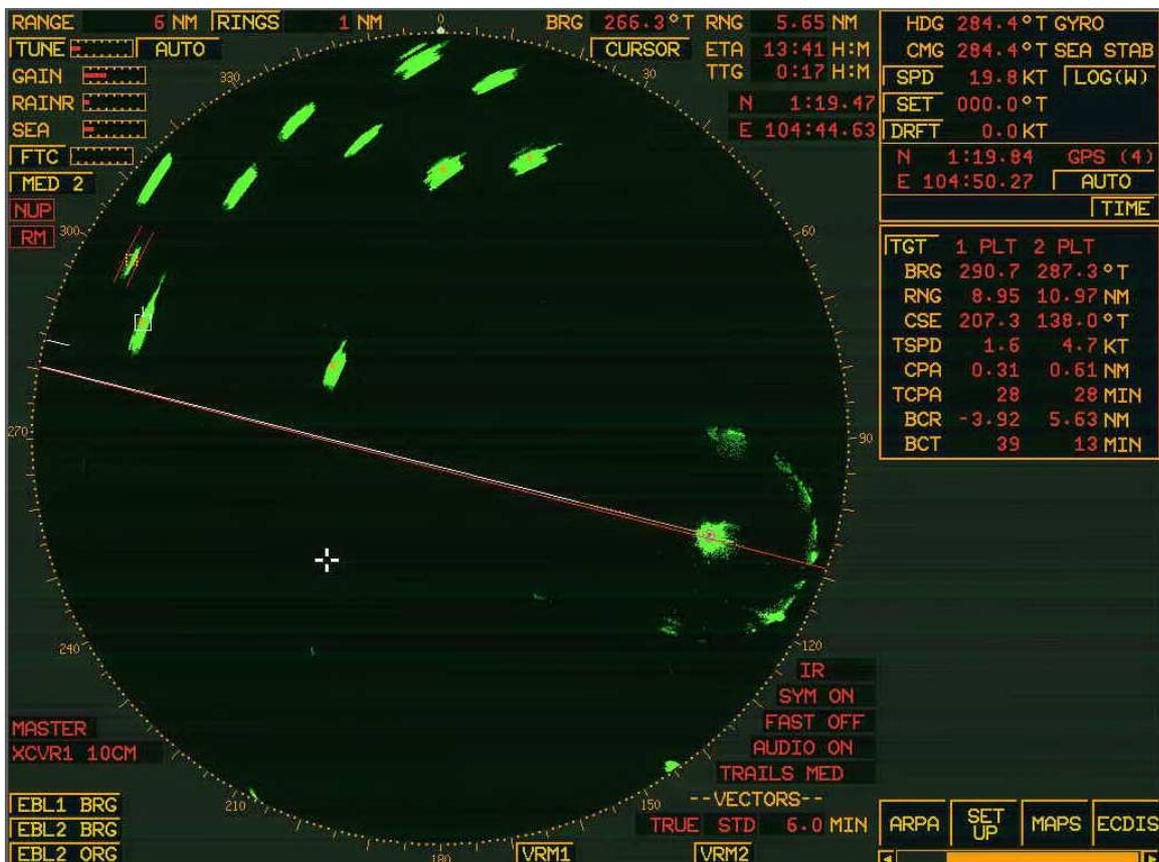
At approx. 2130 hours, at pos. 01°19.47' N – 104°50.27' E on course 284°, the officer of the watch noticed many ships ahead at anchor and also many fishing vessels on the starboard bow. There was a clearance of at least 0.5 nm between any other ship and JOSEPHINE MÆRSK. He considered the clearance satisfactory since all ships were at anchor. The radar range was then set on 6 nm and thereafter briefly on 12 and 3 nm, still north up, relative motion and off centre as shown in figures 12 and 13 on the next page.

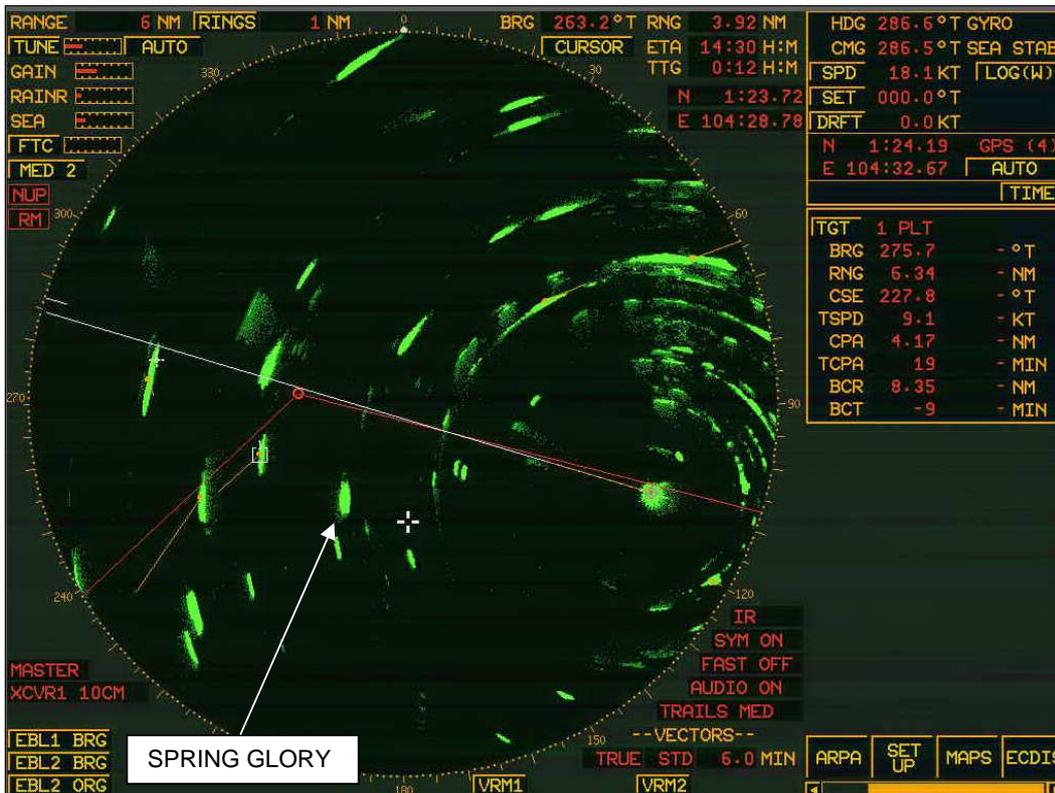
Figure 14: Recording of radar from JOSEPHINE MÆRSK at 22:24:00
Source: VDR/JOSEPHINE MÆRSK

At 22:14:00 hours, while the radar was on 6 nm range, SPRING GLORY became visible on the radar at a distance of approx. 11 nm, and at 22:24:00 hours at 01°24.19' N – 104°32.67' E, while SPRING GLORY was still visible on the radar at a distance of approx. 5 nm as shown in figure 14 below, it could be identified on AIS.

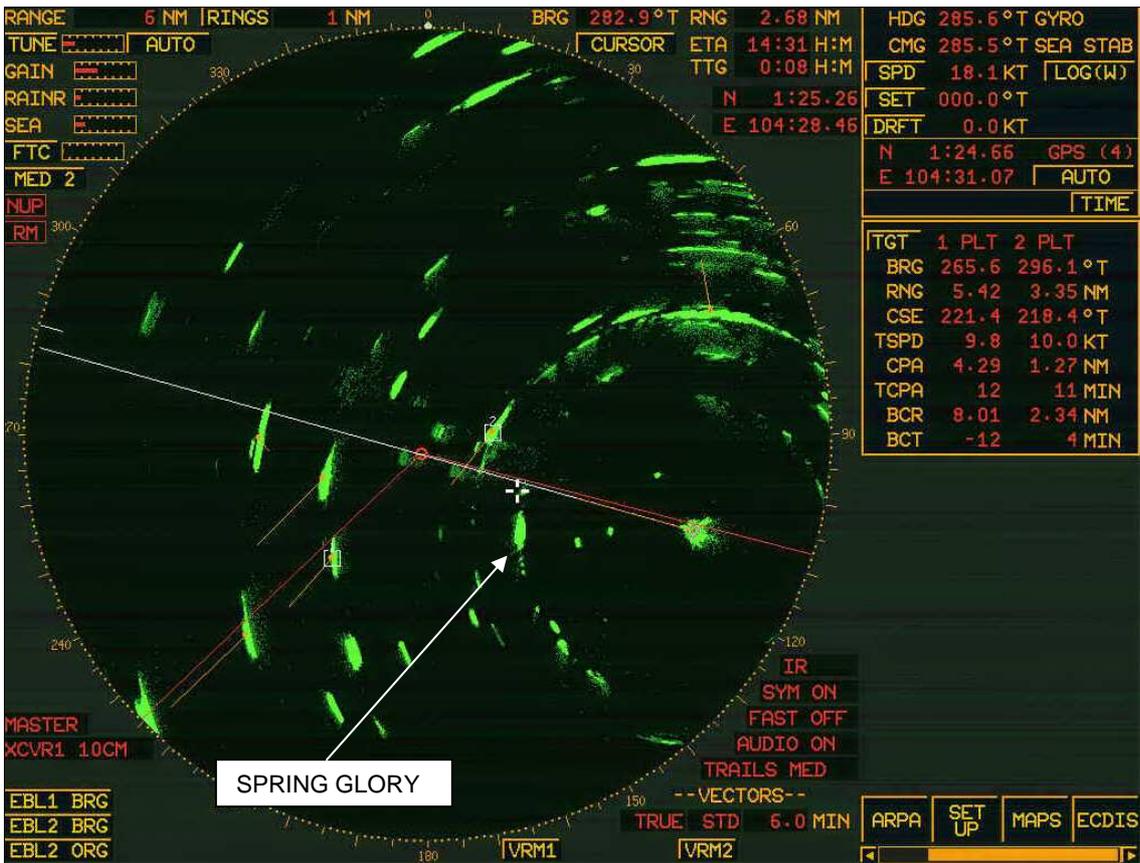
Figure 15: Recording of radar from JOSEPHINE MÆRSK at 22:29:00
 Source: VDR/JOSEPHINE MÆRSK

The situation on the bridge appeared normal until suddenly at 2229 hours when the officer of the watch observed a green light on the port side bow at a distance of 2 nm or a little more. He went to the port side bridge wing and observed through the binocular the green light and went back to the radar in the wheelhouse, placed the cursor on the ship in question and found that the distance between the ships was approx. 2 nm. Then he checked his own position on the GPS and plotted it into the chart. The situation at 22:29:00 is shown in figure 15 on next page.

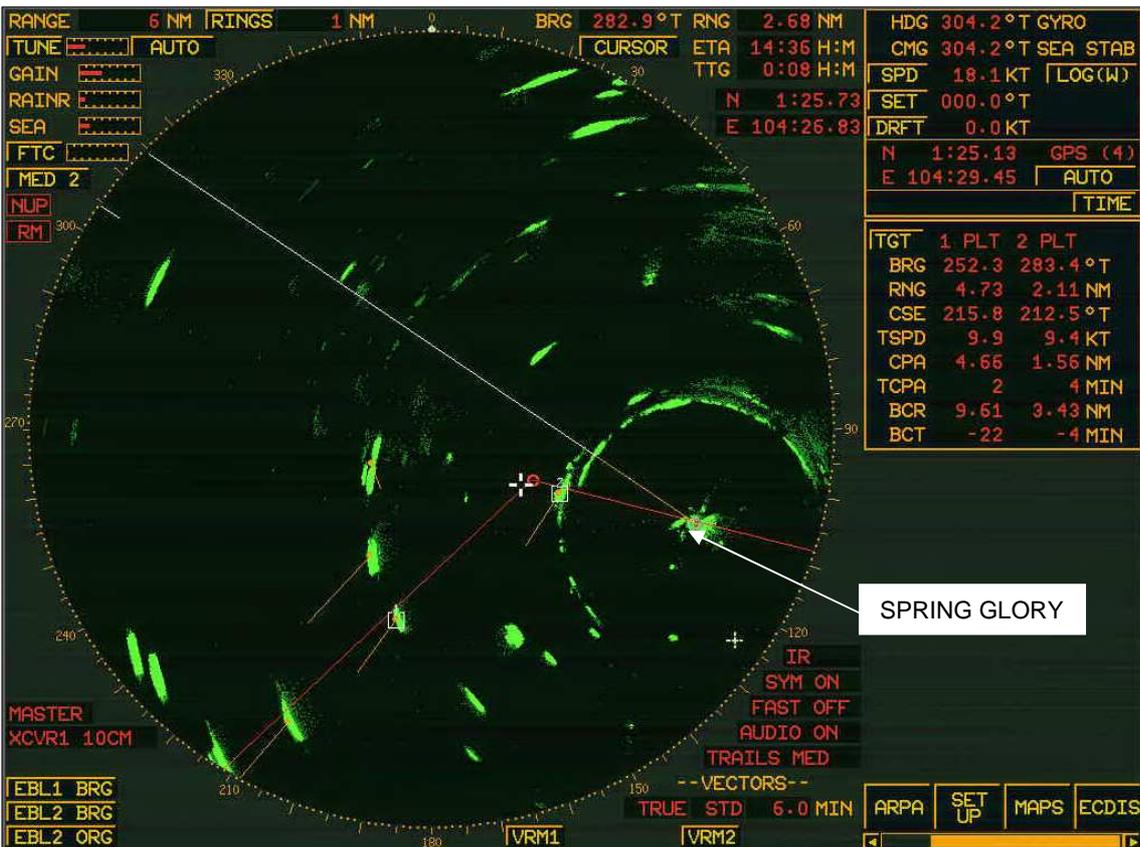
Figure 16: Recording of radar from JOSEPHINE MÆRSK at 22:34:00
 Source: VDR/JOSEPHINE MÆRSK

When the master arrived on the bridge at 22:34:30 hours, JOSEPHINE MÆRSK was still in a hard turn to starboard and SPRING GLORY was very close to the port side. A few moments later, at 22:34:40 hours, the starboard side of SPRING GLORY hit into JOSEPHINE MÆRSK 's port side and a few seconds later into the port side quarter. The situation at 22:34:00 is shown in figure 16 on page 19.
