# MARINE ACCIDENT REPORT

**MAERSK CHAMPION**  
**Fire in accommodation on 9 January 2012**

**This marine accident report is issued on 1 November 2012**

**Case number: 201200421**

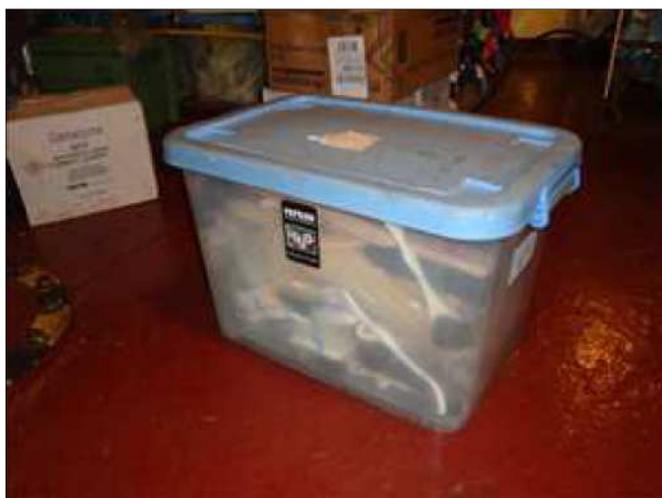
Figure 3: A plastic box of the similar type  
Source: Maersk Supply Service A/S

On 9 January 2012 between 0830 hours and 0930 hours, outdated medicine, six plastic bags with plastic containers holding chloride-containing granules for fresh water treatment and two aluminium bottles each containing approximately 0.5 litre of liquid insecticide/cockroach repellent ("insect lacquer"), had been collected in a plastic box in the ship's hospital in order to be taken ashore for destruction at next port of call. The two bottles of insecticide were standing upright in the plastic box and the box was closed with a lid and left on the floor in the hospital. See figure 3 below.

It was found that the fire had occurred in the plastic box placed in the ship's hospital used to contain medicine and chemical residues.

The cause of the fire was with high probability determined to be self ignition by a chemical reaction between chlorine-containing granules and other chemical substances in the plastic box with medicine and chemical residues that was located in the ship's hospital.

However, the cause of the fire was, with high probability, self ignition by a chemical reaction between chemical substances from liquid insecticide and chlorine-containing granules contained in the plastic box.
