MARINE ACCIDENT REPORT

MAERSK TENDER
Fatal diving accident on 24 July
2010

The report has been issued on: 19 October 2011.

Case: 201008713

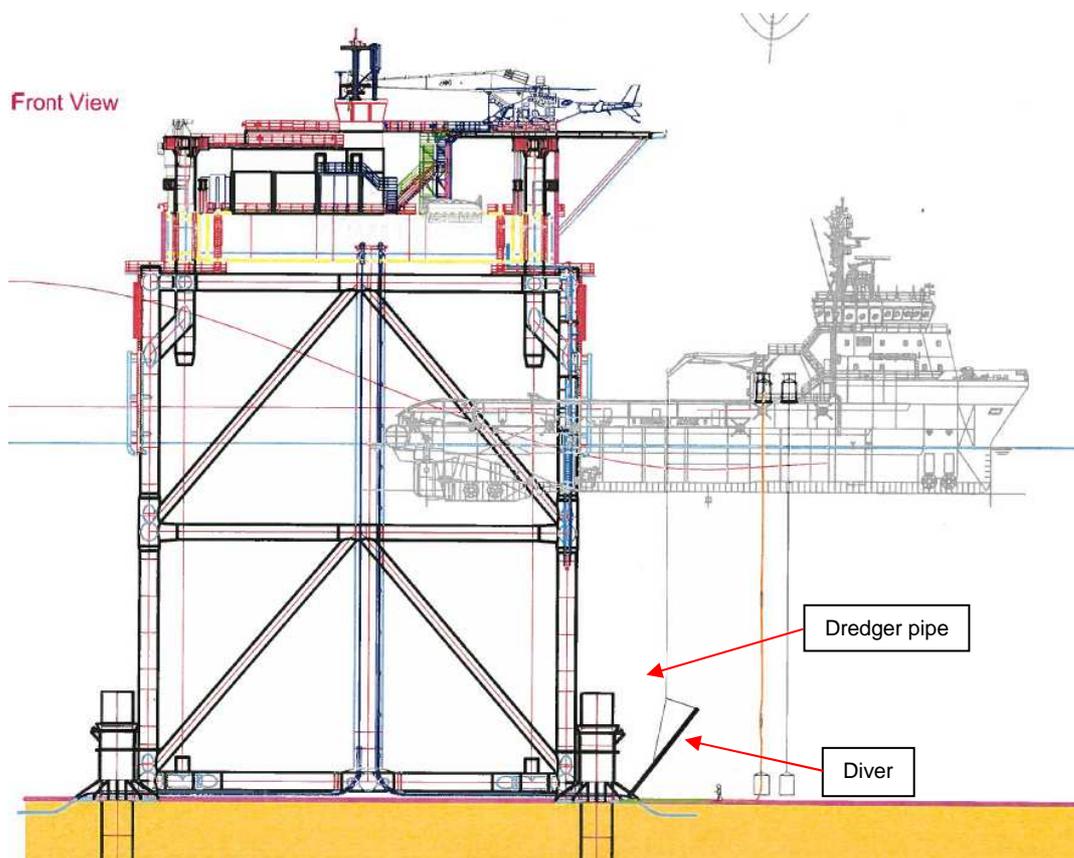
Due to the usage of a "DP 2" vessel, with running thrusters to maintain position, it was agreed between BARD and the diving company to use two diving baskets that had to be operated on the vessel. The diving method had been predetermined by the diving company and could not be altered by the diving supervisor.

The diving company's layout of the operation (This image shows two diving baskets deployed. During the accident, only the forward basket was deployed, and the aft basket was on the ship's deck for the purpose of standby diver)

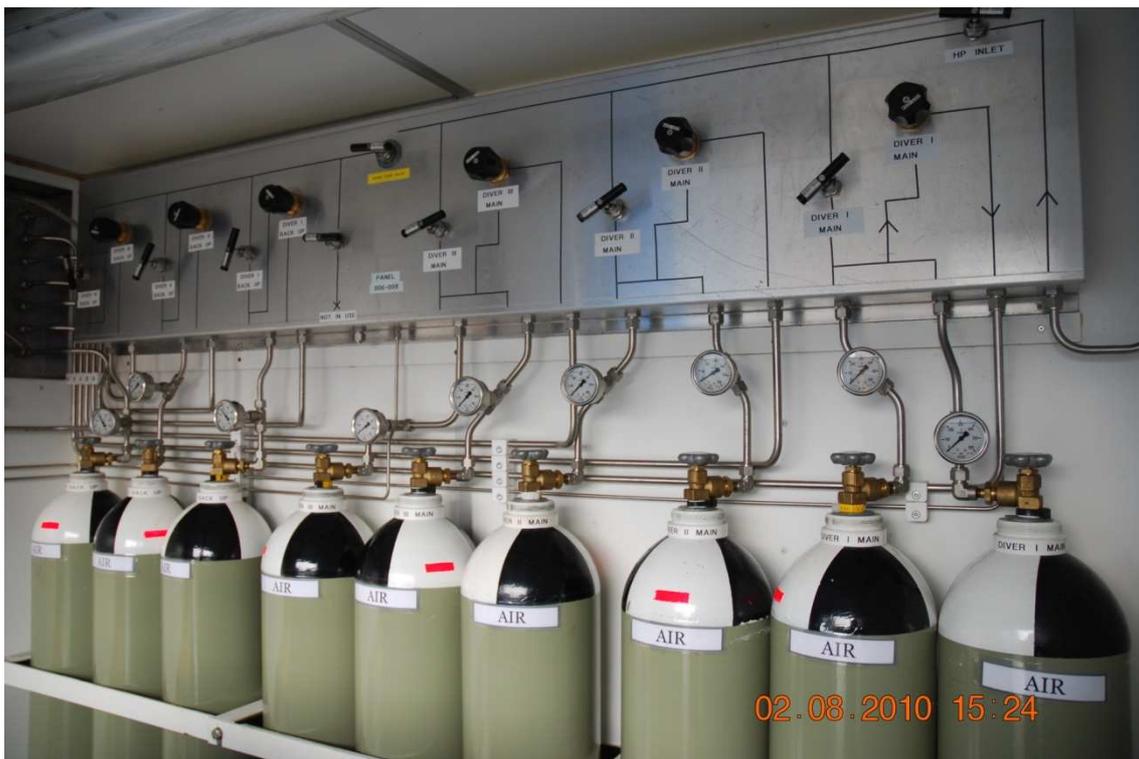
It has been stated that because of noise caused by the diver's breathing, vibration of pressure gauges, pipes with small diameters and high air flows, etc., the diving supervisor used to throttle the air supply in order to better understand what the diver said.

It has been stated that the high noise in the panel arose because something was wrongly connected in the panel.

Diving control station air bottle bank

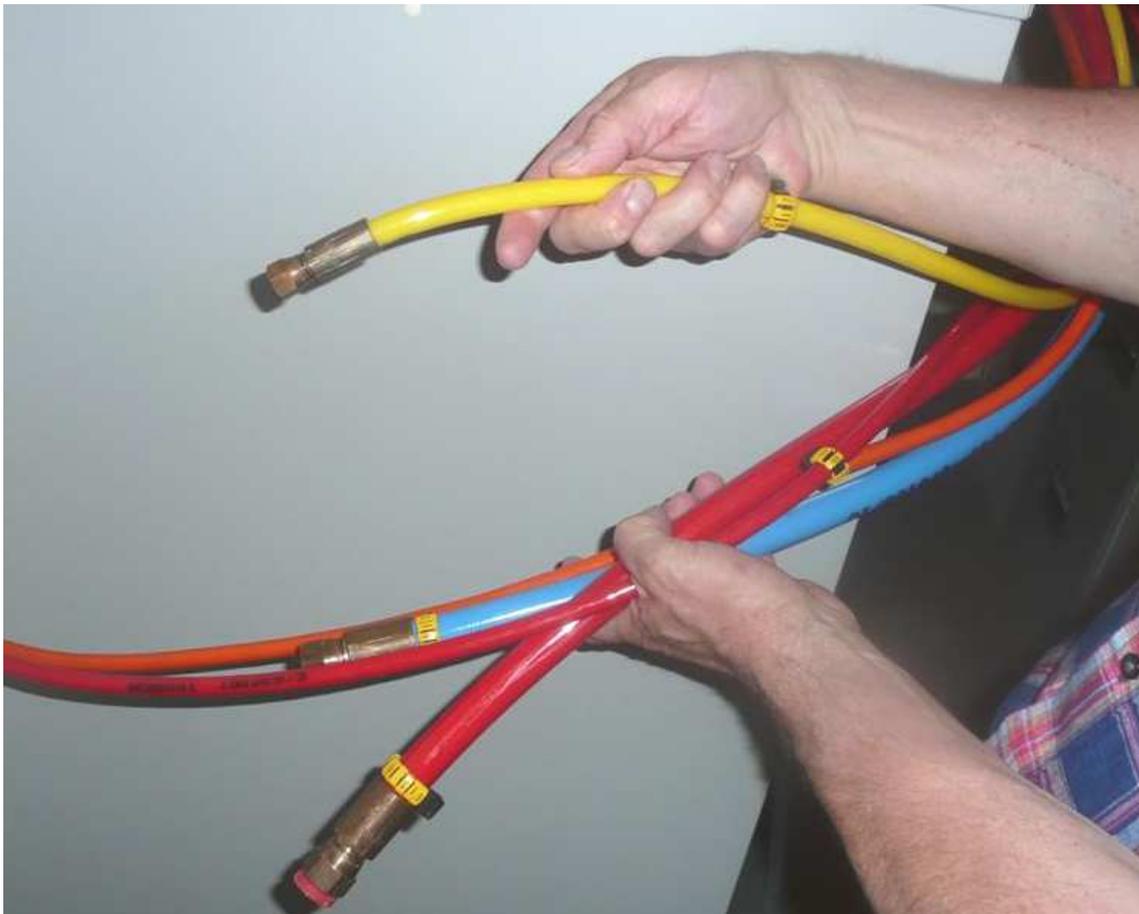
To use the pneumo as an emergency air supply the diver had to put the hose into his helmet via the neck dam, and the diving supervisor should open fully for the air supply through this hose. This is in no way an easy task, especially if the diver is under the influence of e.g. nitrogen narcosis, carbon dioxide poisoning, panic, etc., and the usage of a pneumo hose is not considered a reliable or valuable emergency air supply for diving with a demand mode helmet.

Yellow hose: The pneumo

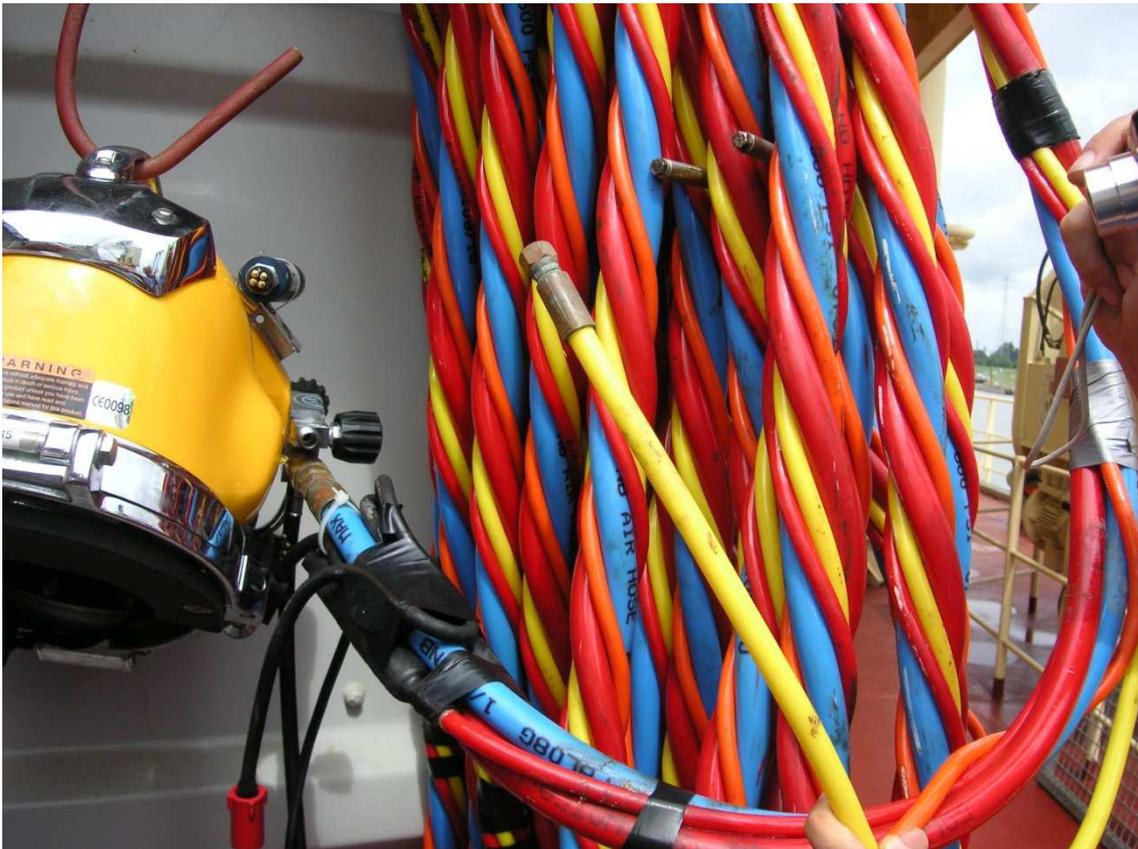
At the request of the German Water Police, a sample piece of 3 metres in length of the diver’s umbilical was subject to an examination by the Bundeswehr Technical Centre for Ships and Naval Weapons, Germany, to find out whether the air supply could be cut off by pinching the umbilical. It was found that the air supply could be totally cut off if the umbilical was bent by a great force and the air hose was at the inner position.

Umbilical of the same type as the one used by the diver, the yellow hose is the pneumo
